Bridge Needs Study

INSPECTION SUMMARY REPORT

Town of Gravenhurst

August
29, 2024

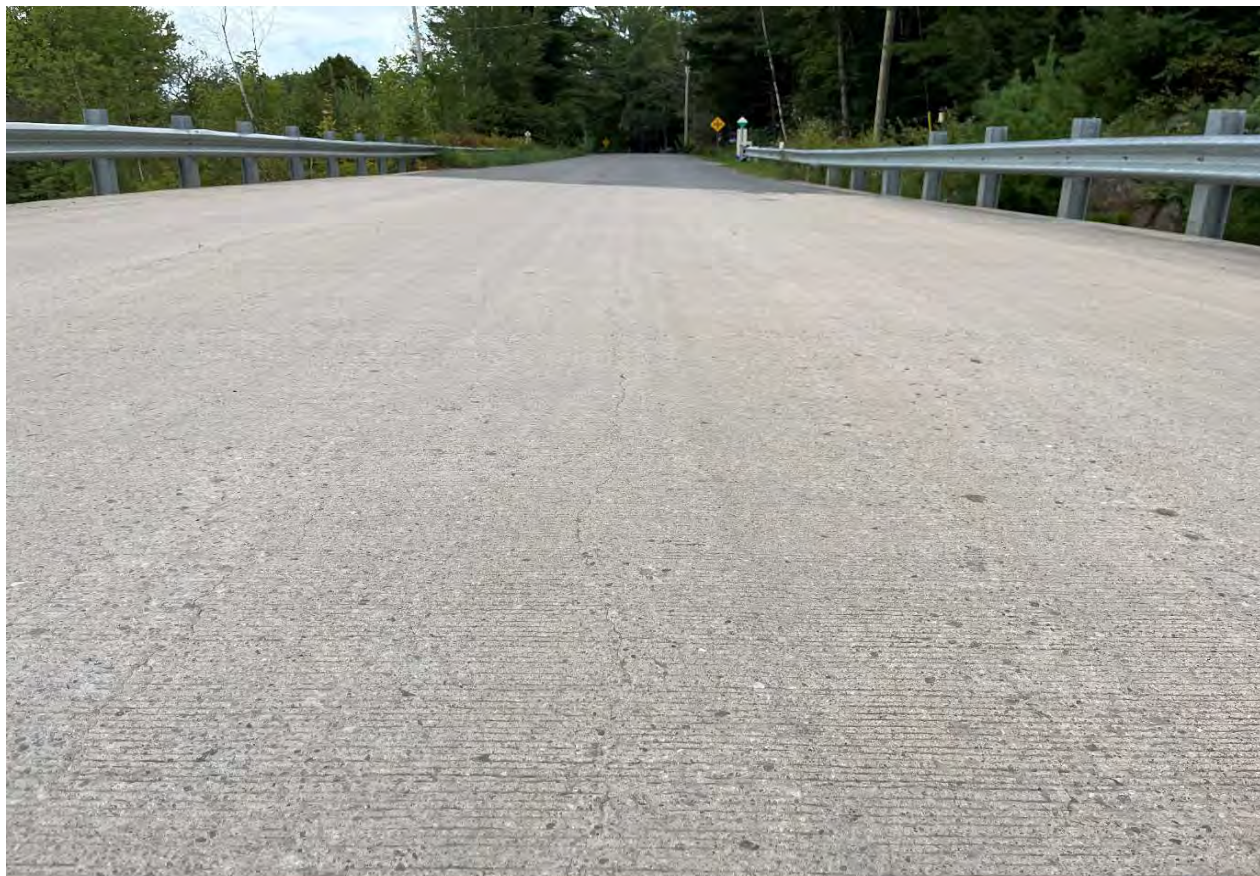
Description of Photo: Narrow crack, typ.

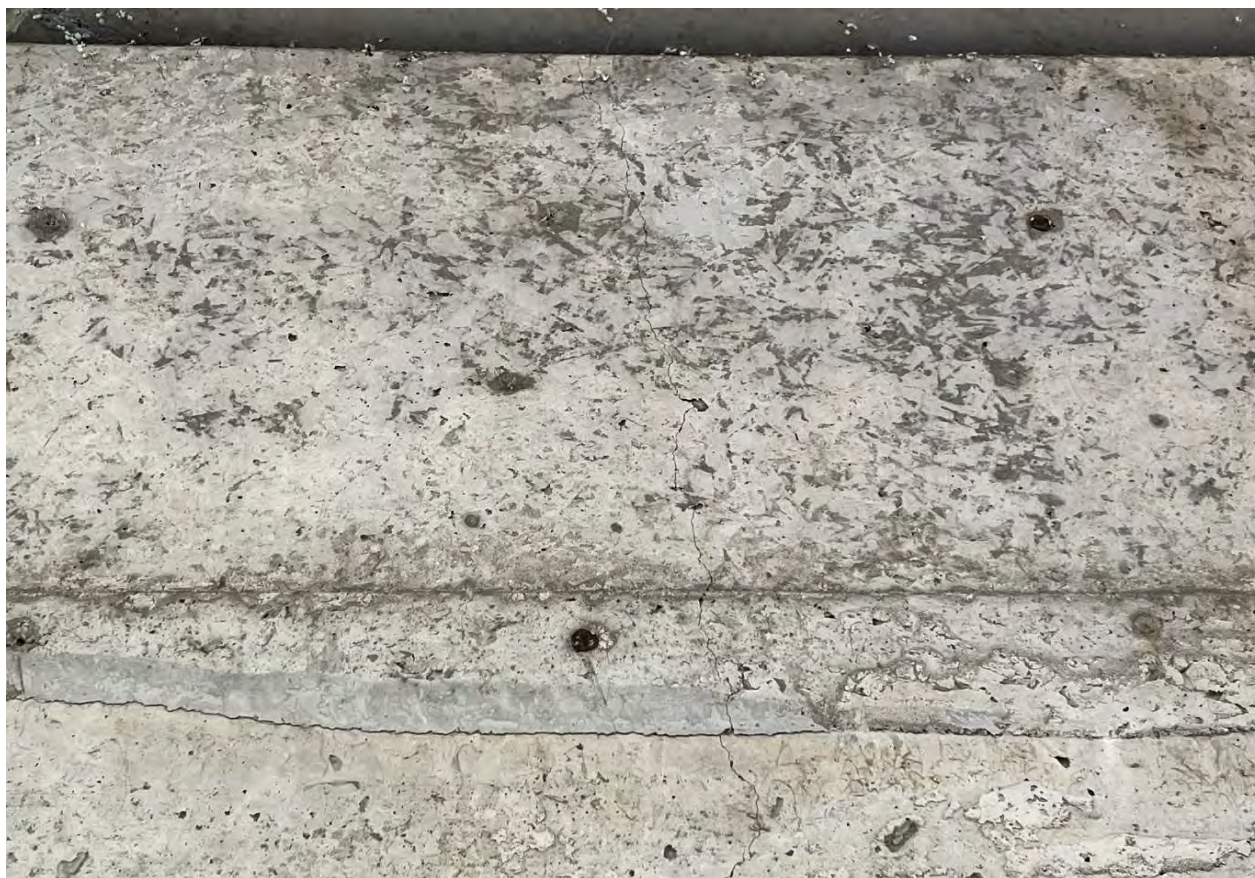
Description of Photo: Narrow vertical crack, typ.

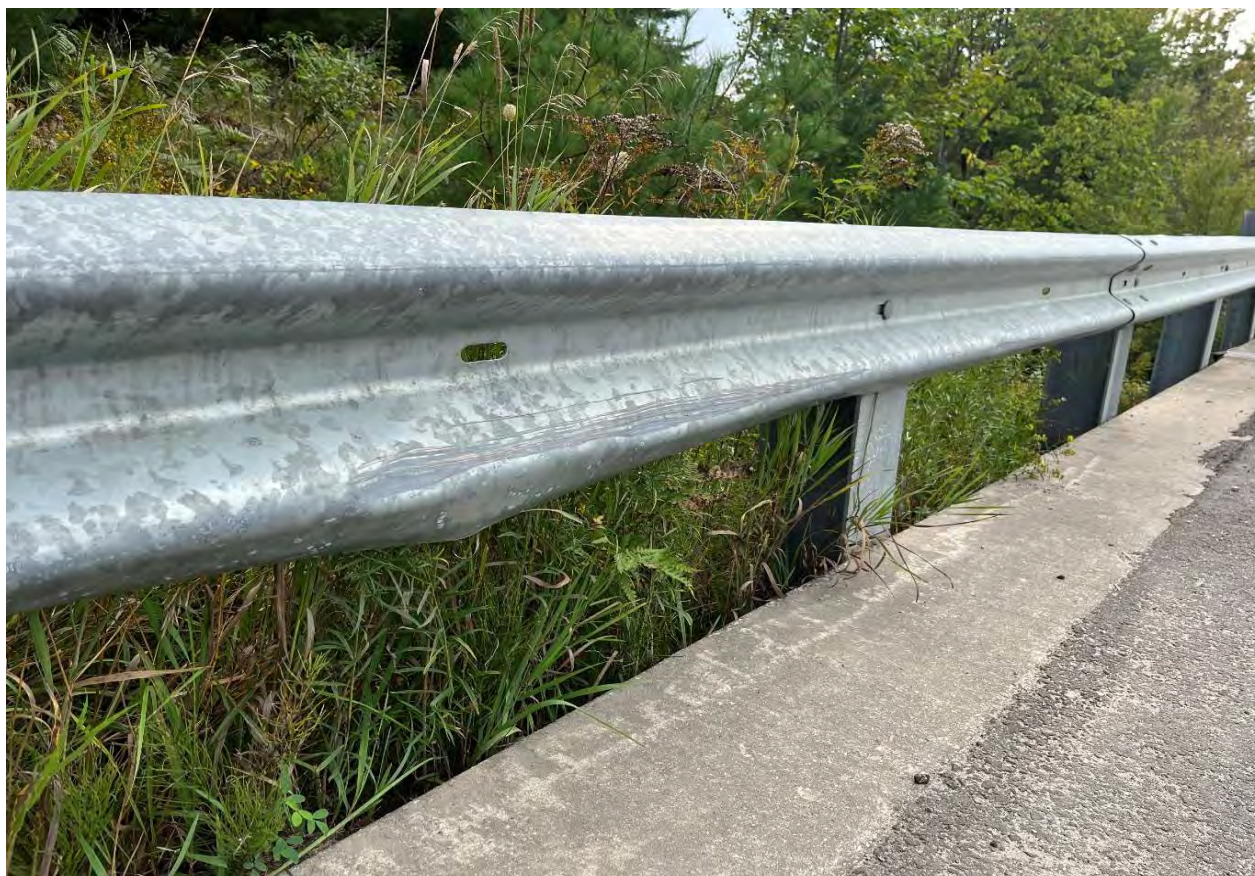
Description of Photo: Isolated deformation, typ.

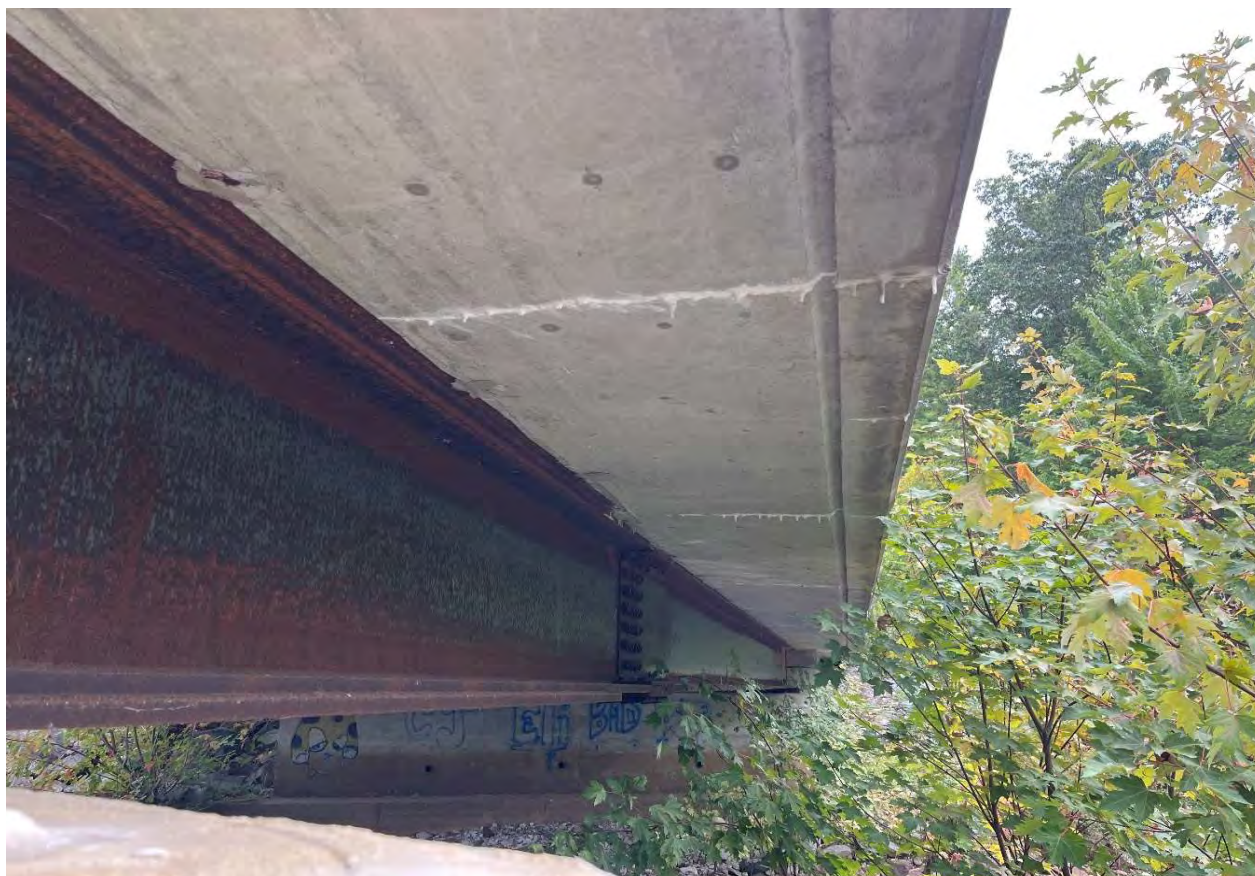
Description of Photo: Efflorescence on exterior soffit

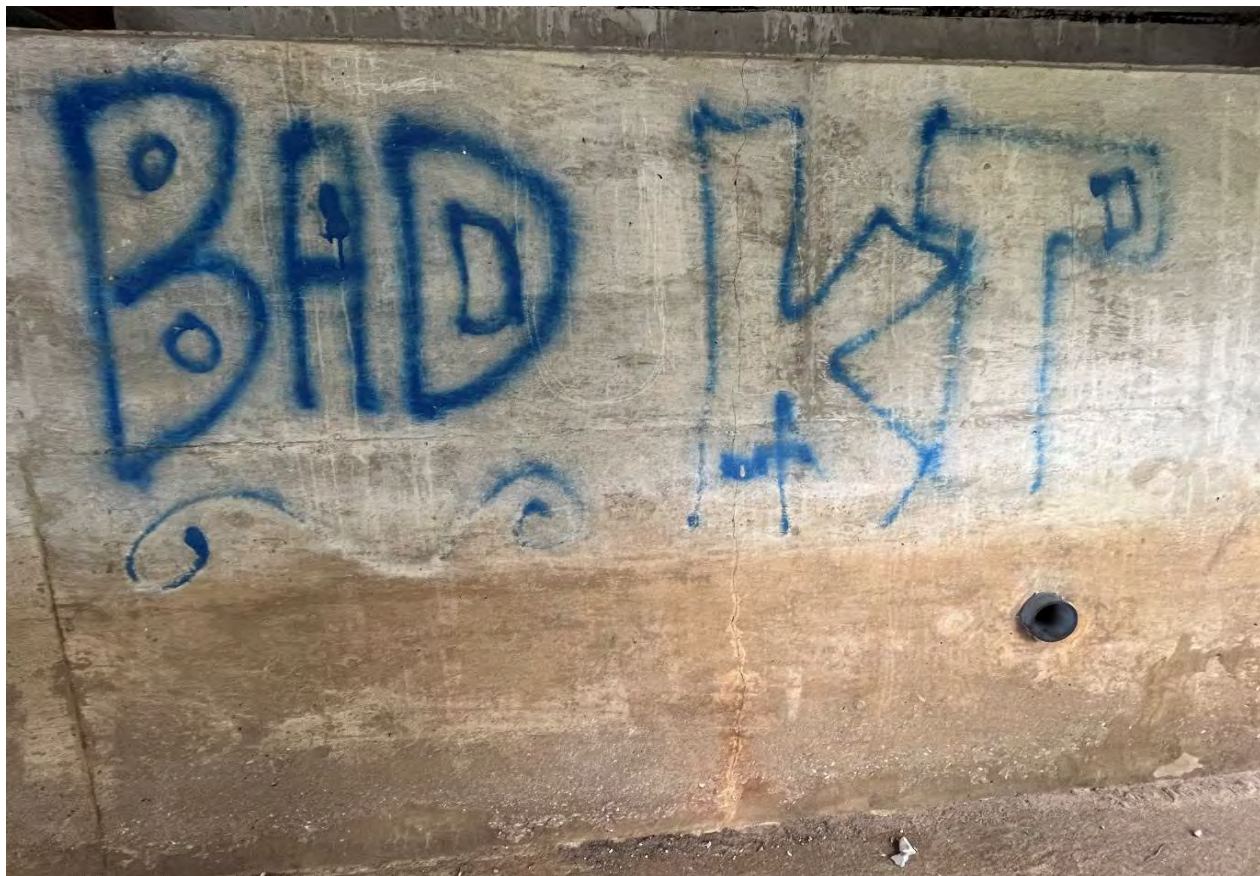
Description of Photo: Narrow vertical crack

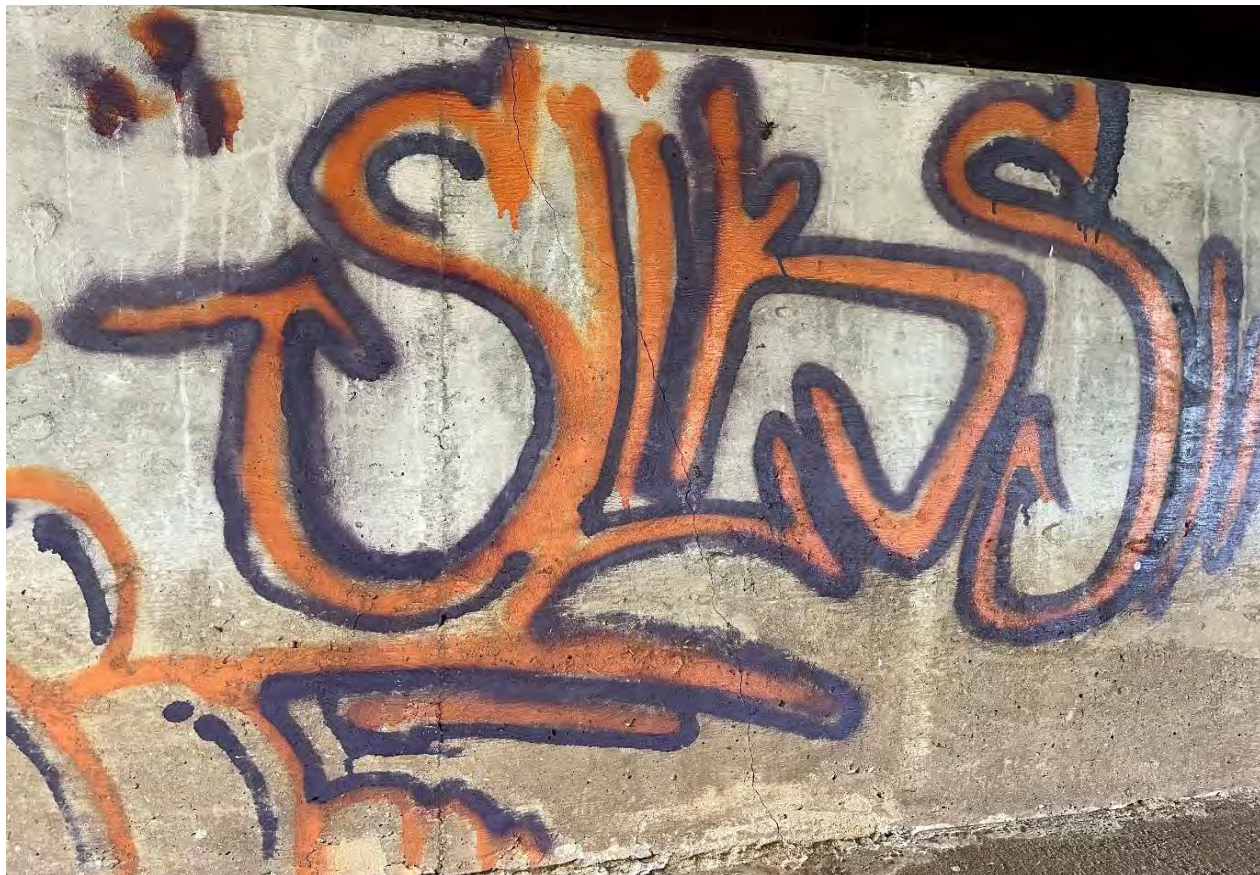
Description of Photo: Medium vertical crack

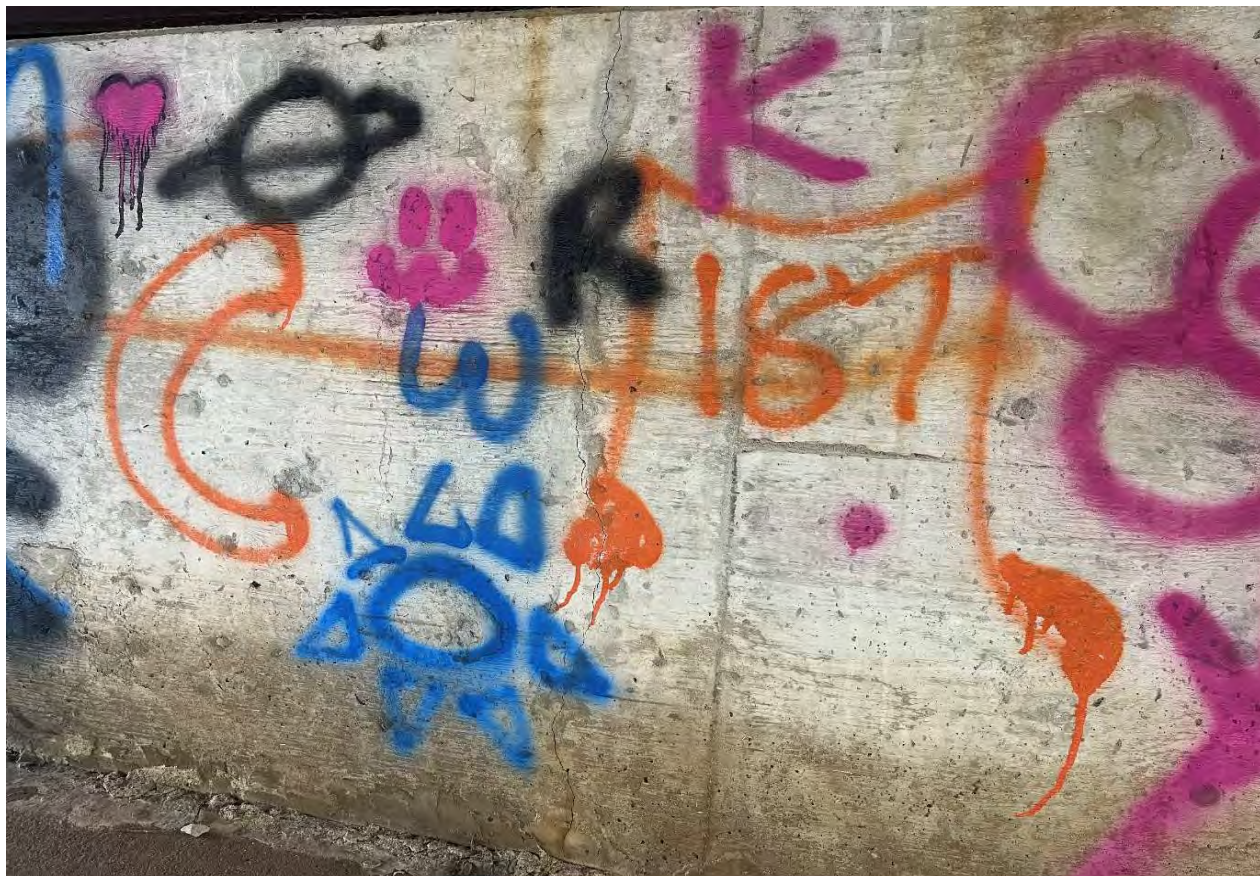
Description of Photo: Medium vertical crack

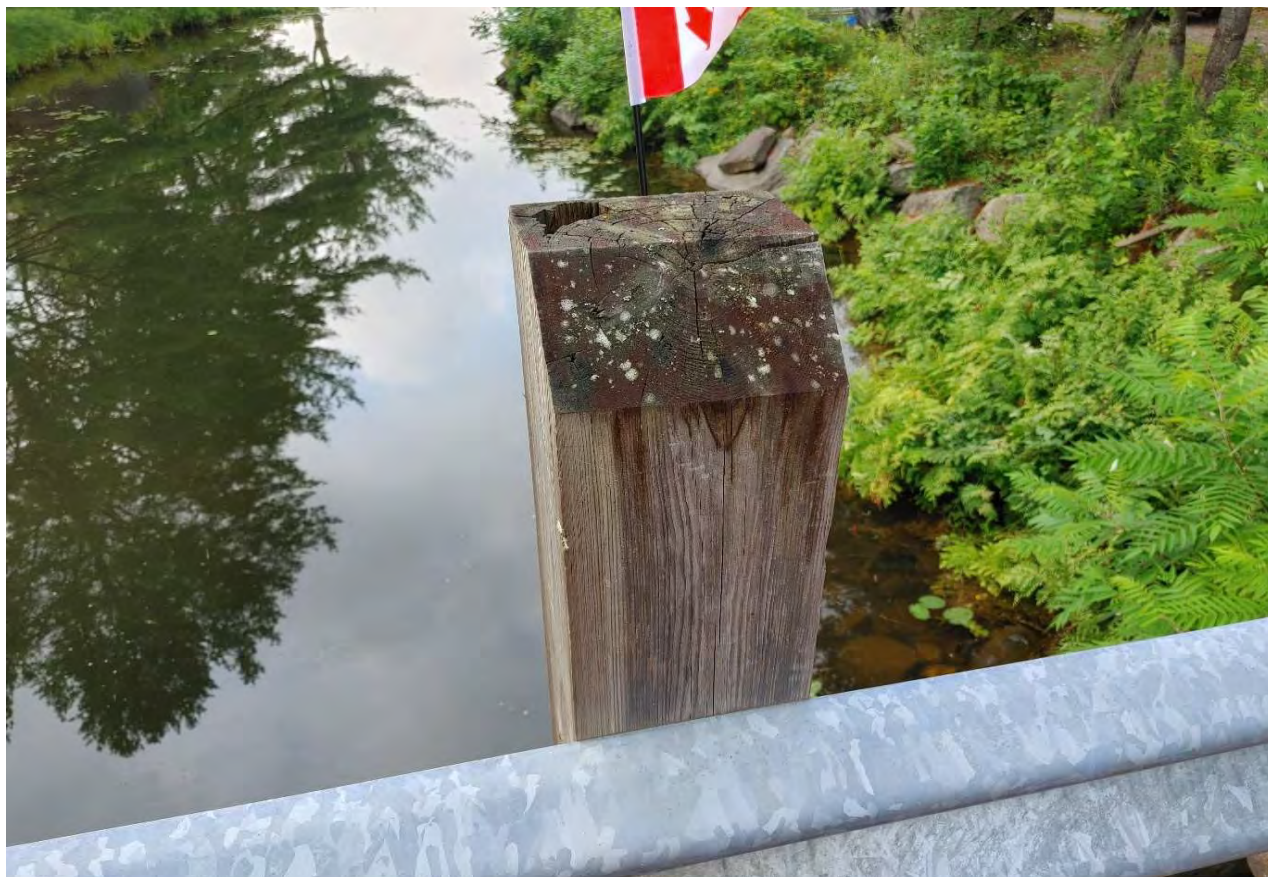
Description of Photo: Checks and rot on post

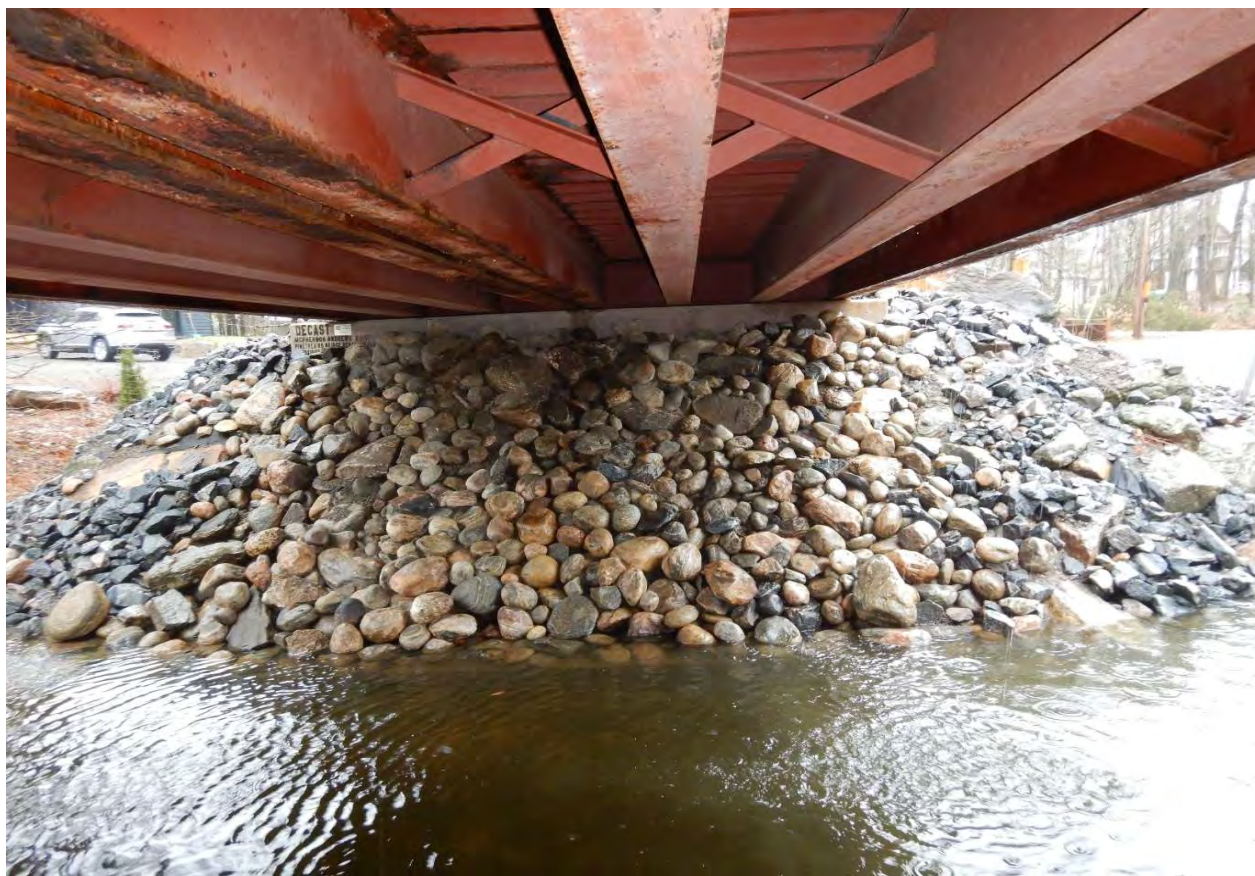
Description of Photo: Light corrosion along girders, typ.

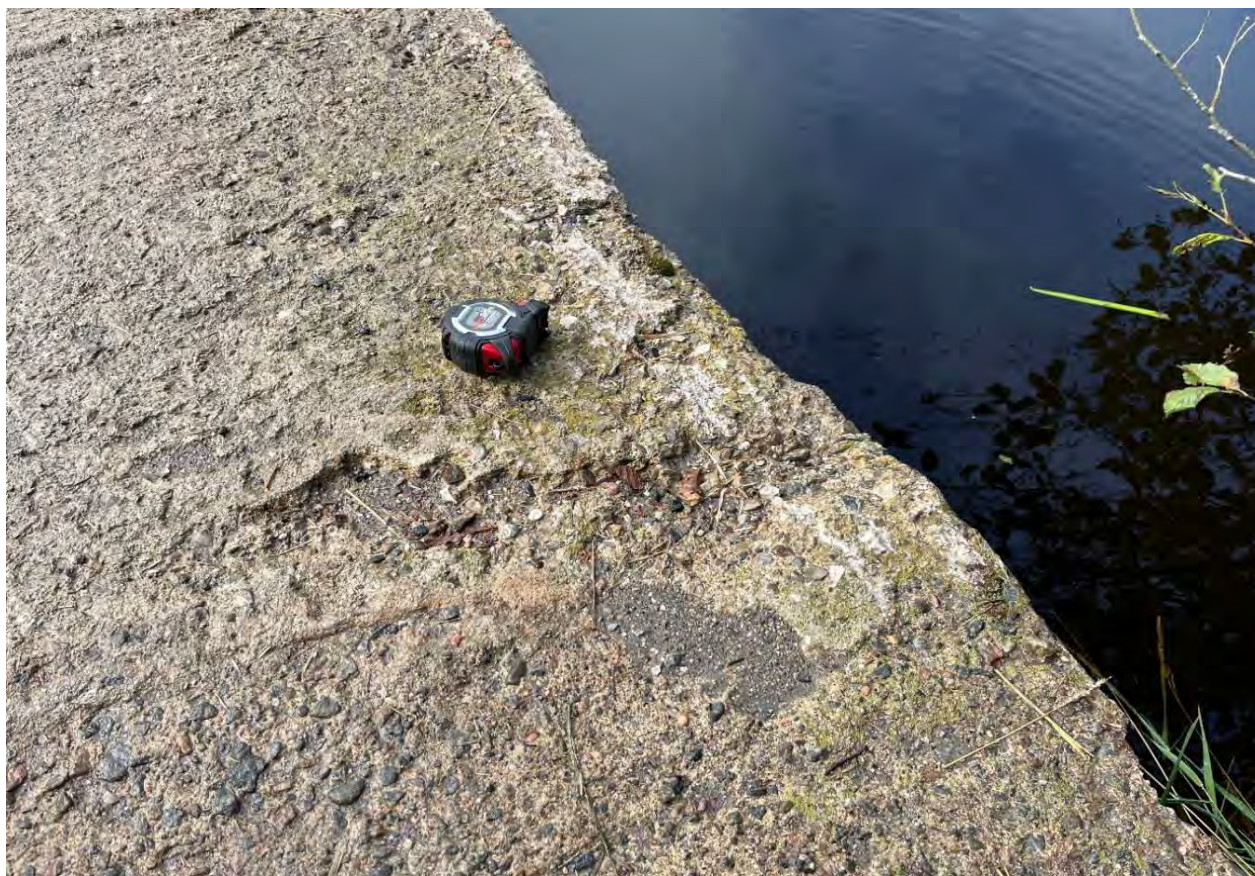
Description of Photo: Isolated concrete spall

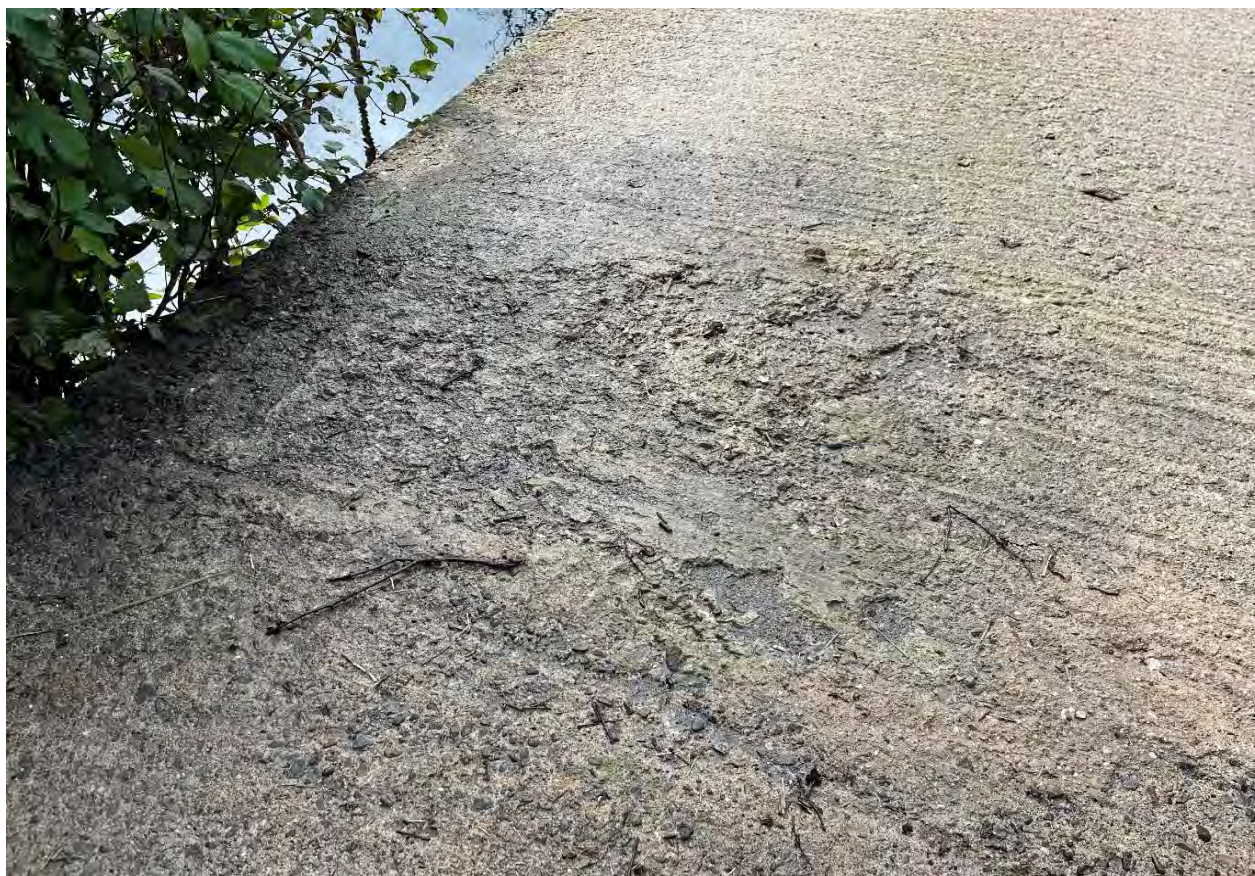
Description of Photo: Isolated severe scaling

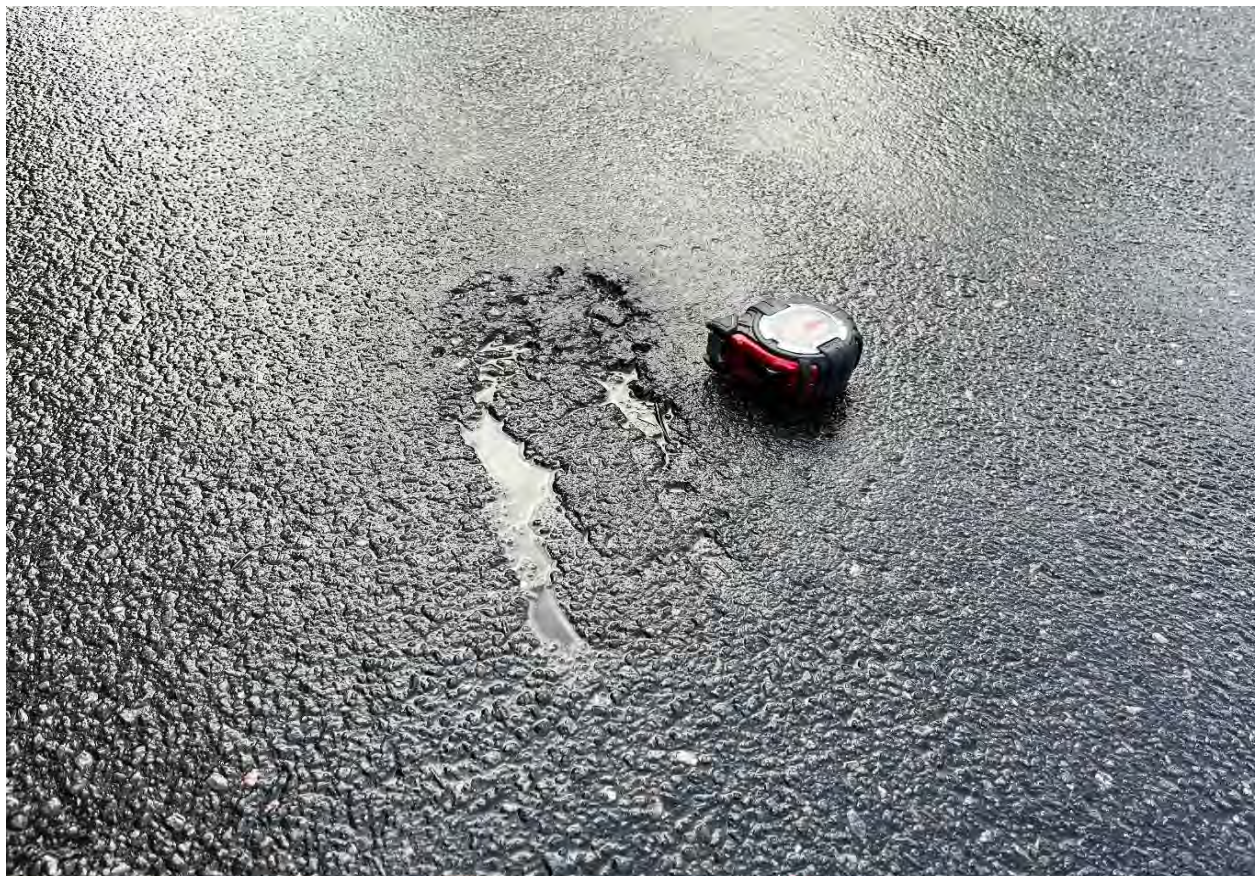
Description of Photo: Isolated severe abrasion

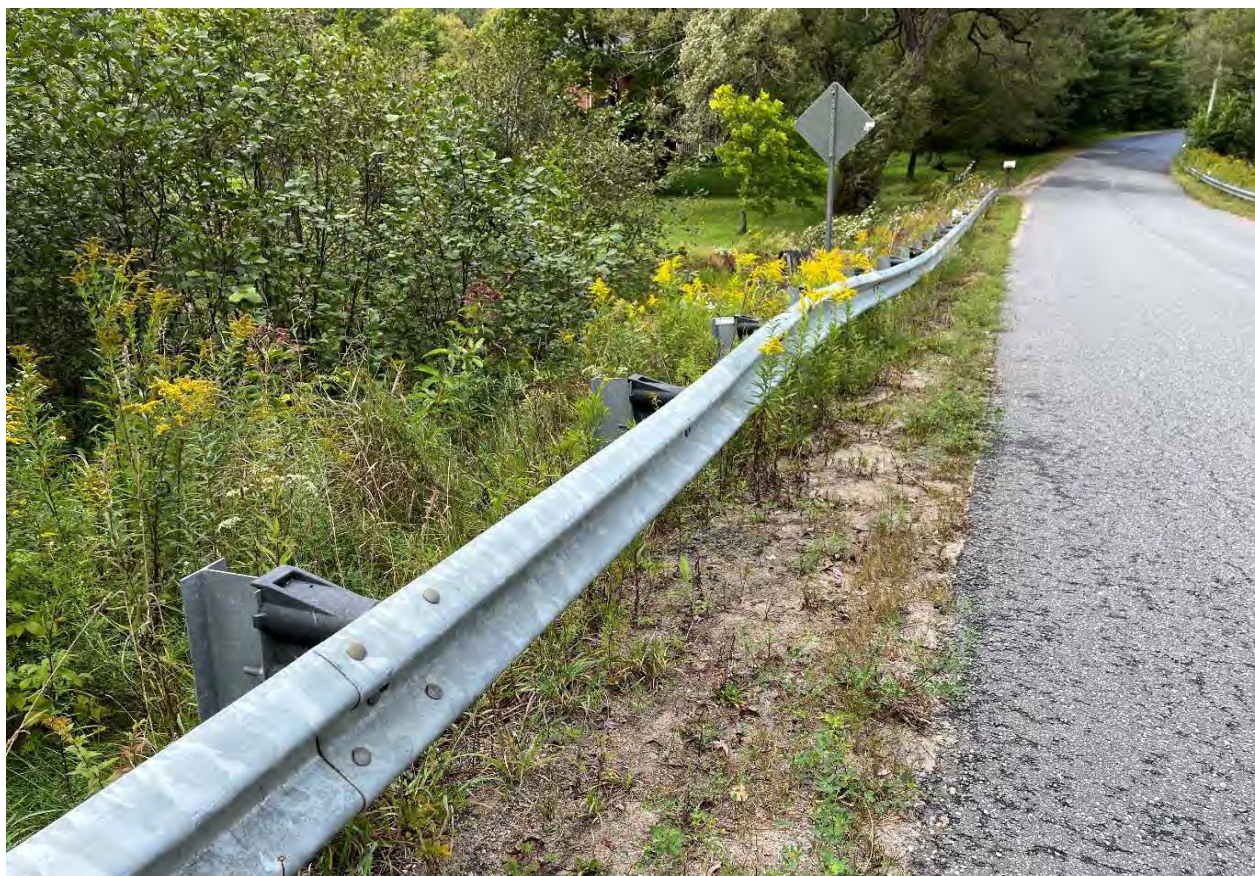
Description of Photo: Approach guide rail - impacted damage

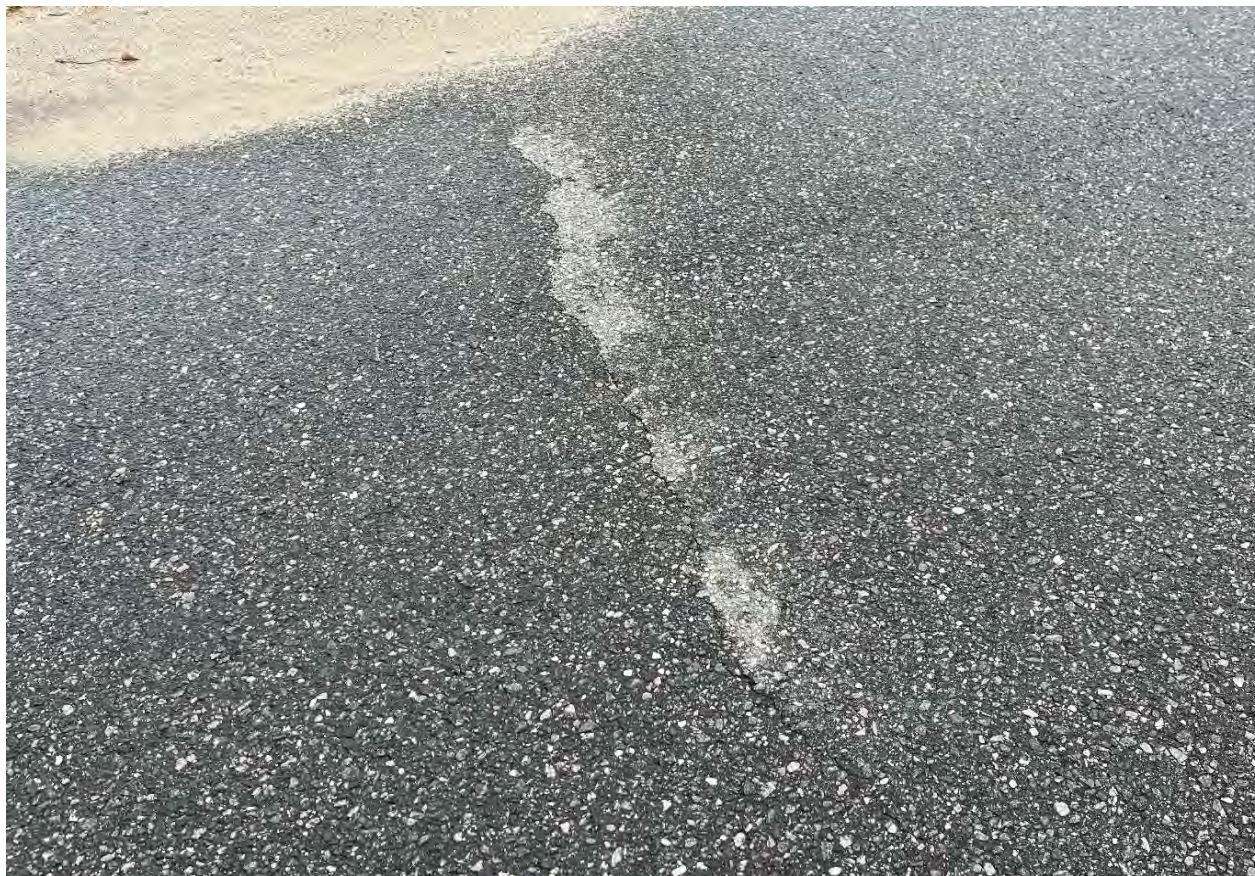
Description of Photo: Transverse crack

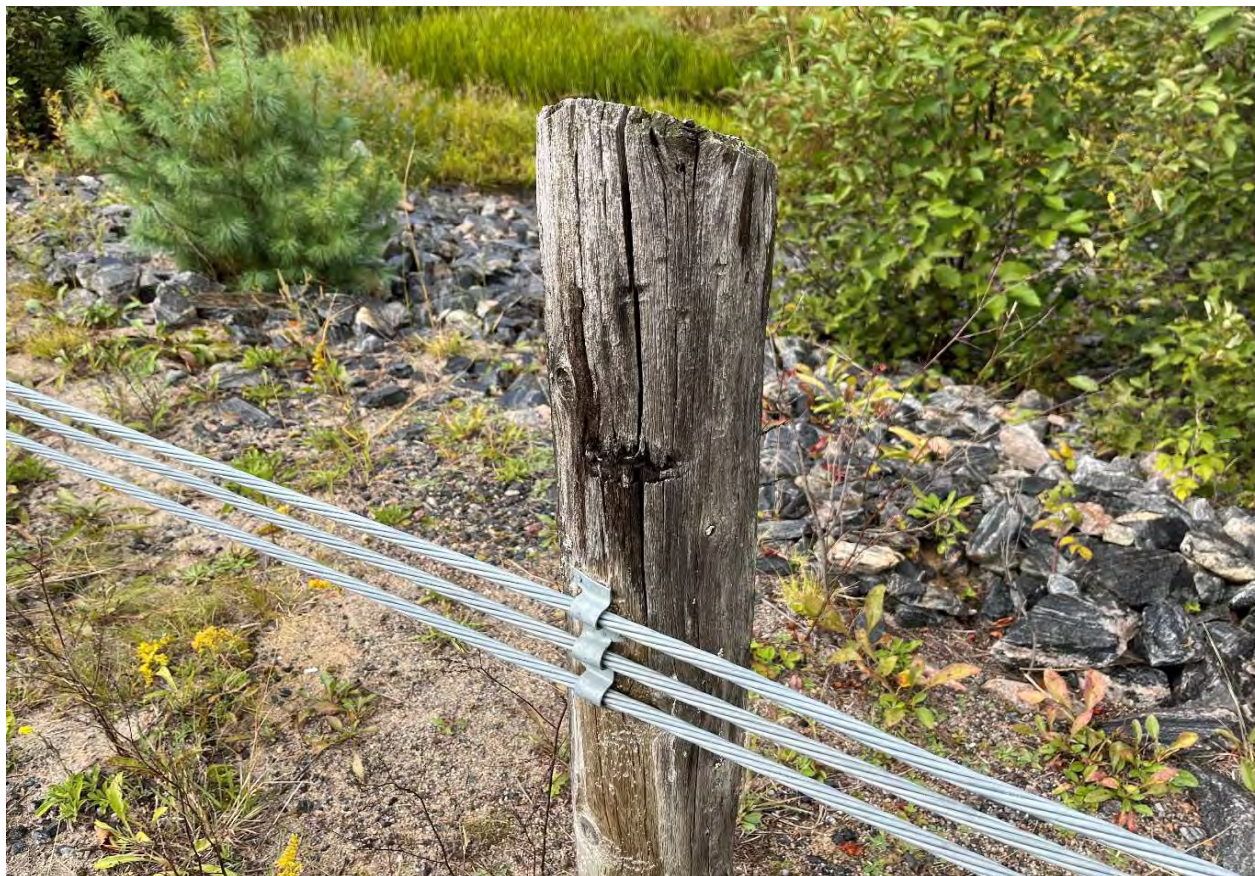
Description of Photo: Post deterioration, typ.

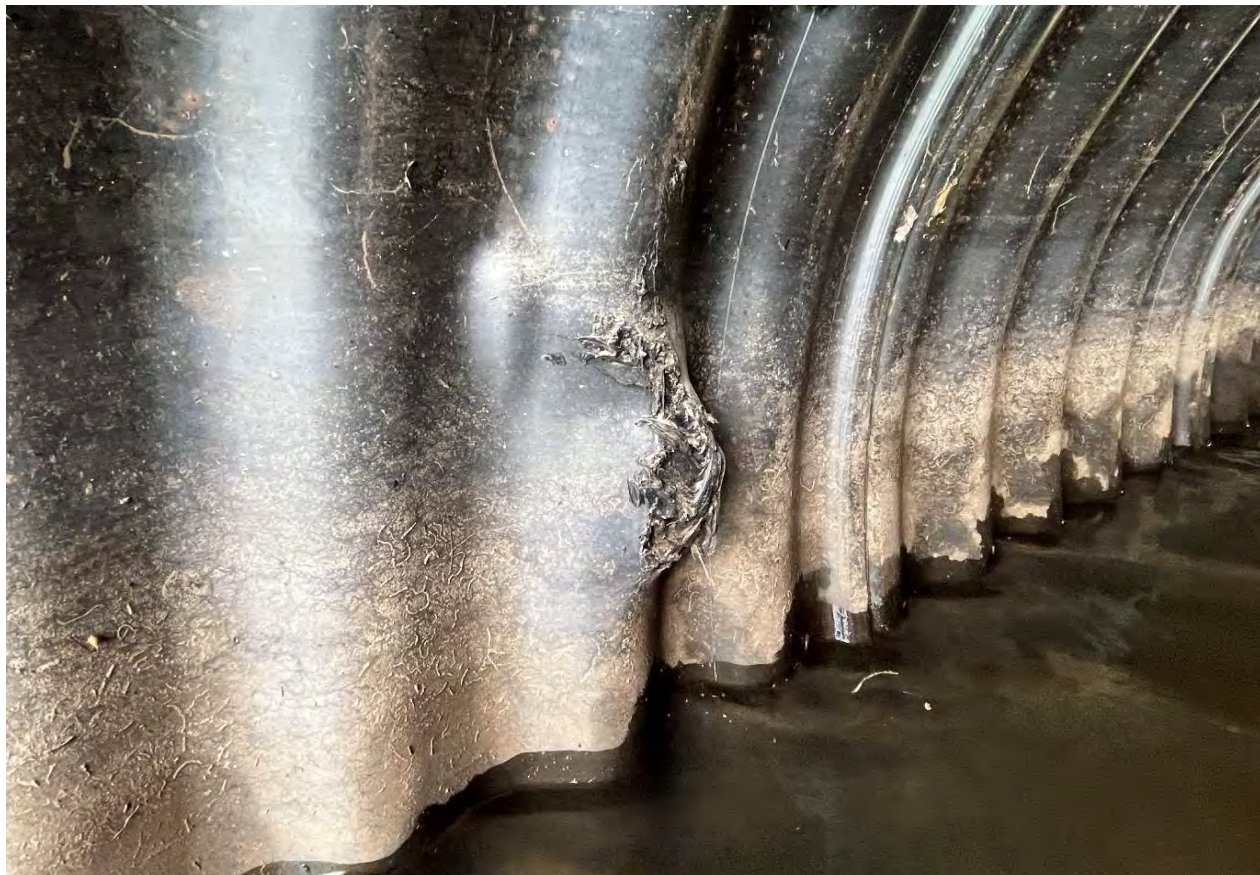
Description of Photo: Damage on culvert barrel
