Bridge Needs Study

INSPECTION SUMMARY REPORT

Town of Gravenhurst

August
29, 2024

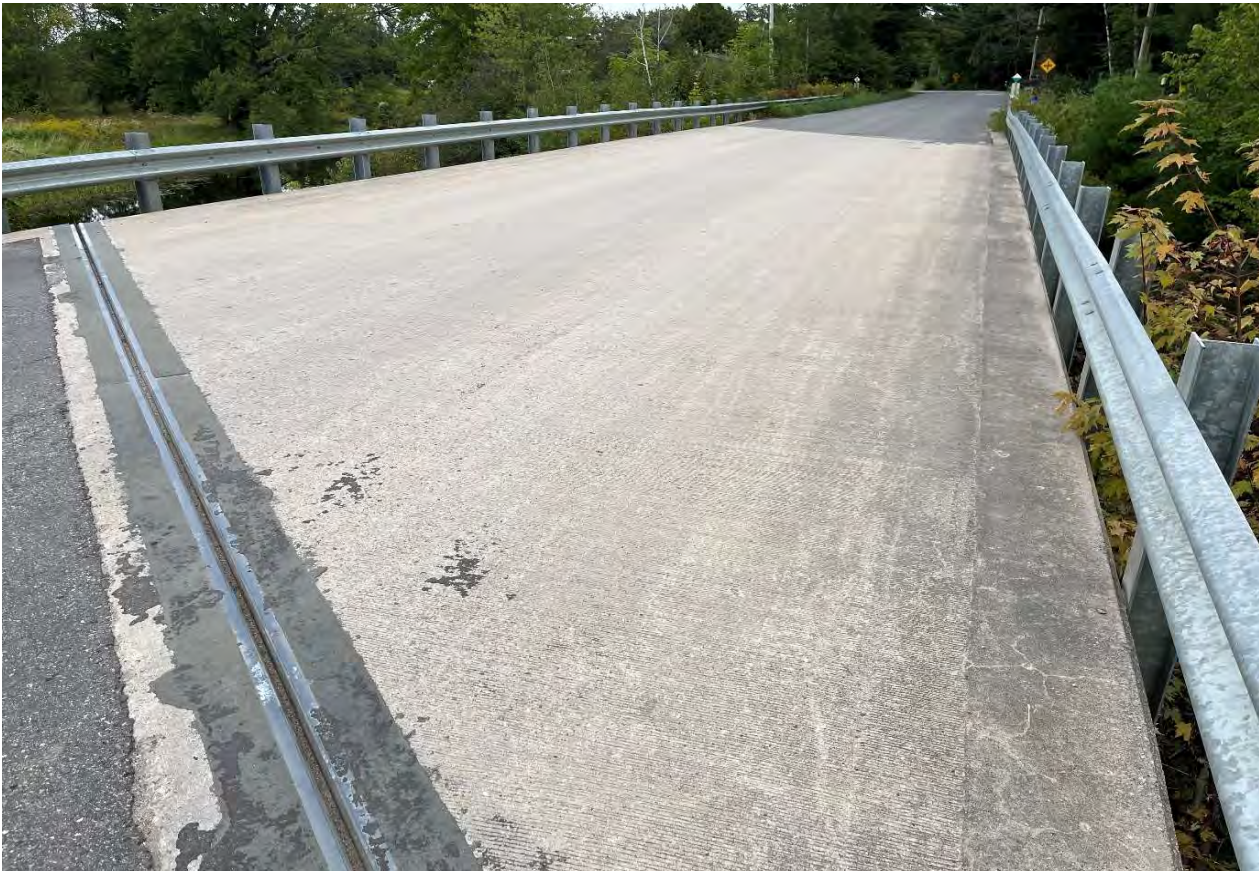
Description of Photo: Concrete deck top - looking east

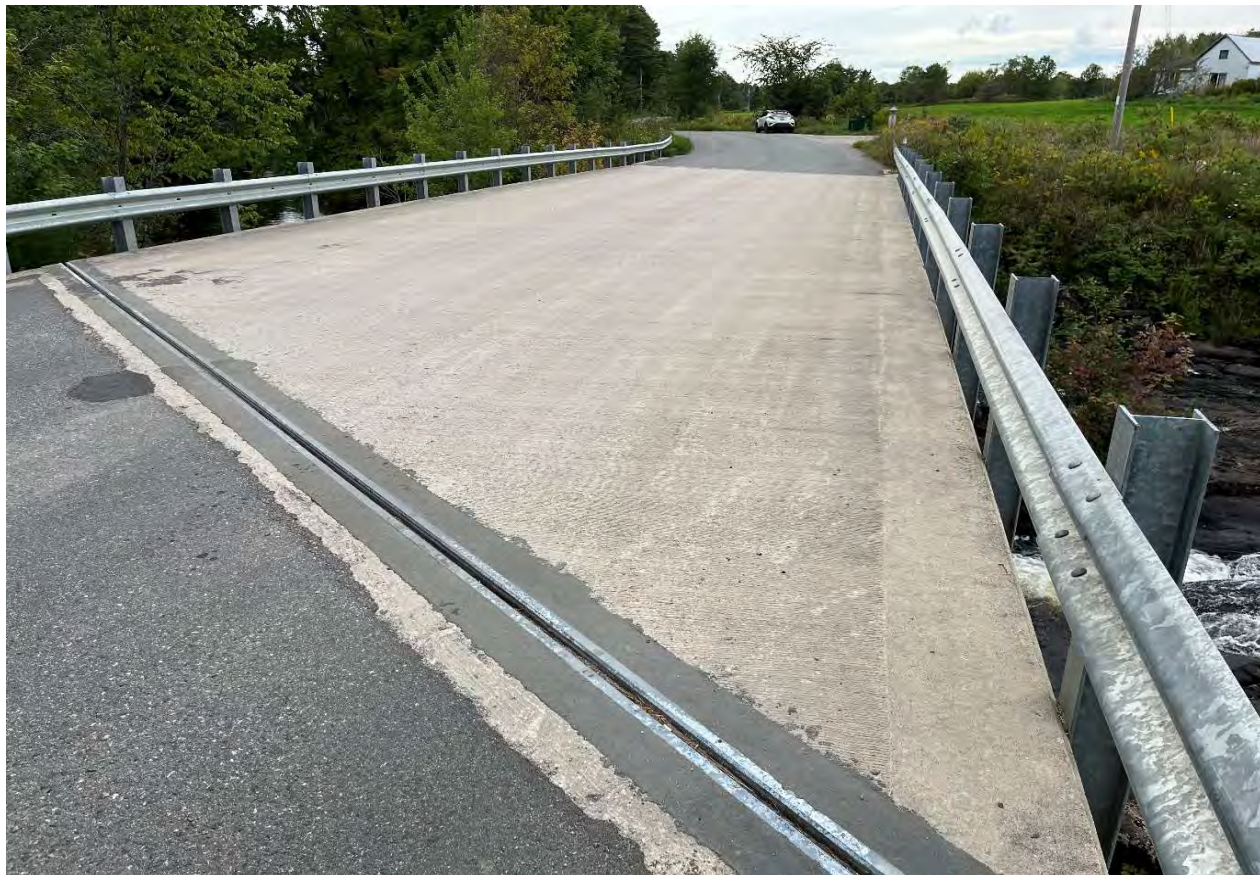
Description of Photo: Concrete deck top - looking west

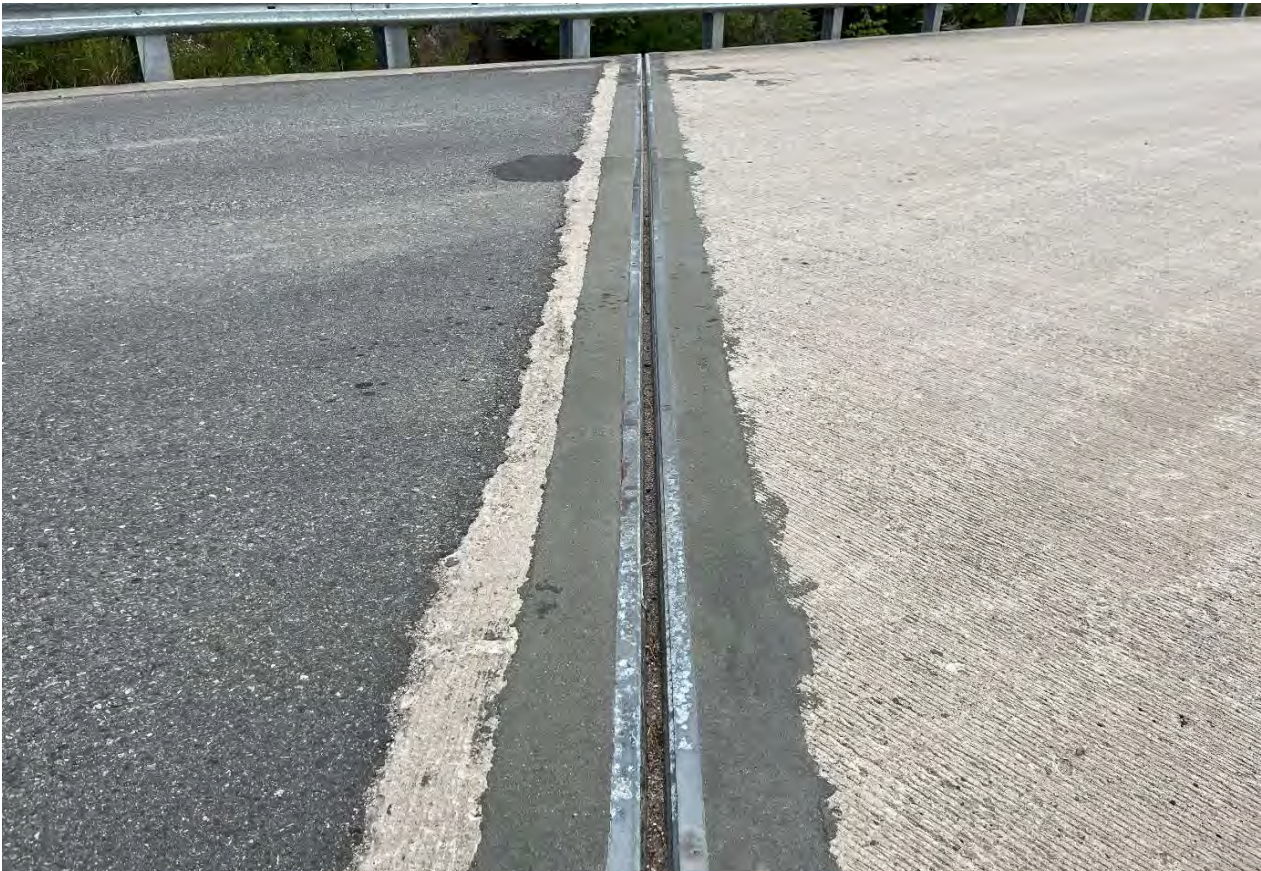
Comments: No observed defects. Debris buildup in both seals, with isolated areas of asphalt in west joint.

Description of Photo: East joint

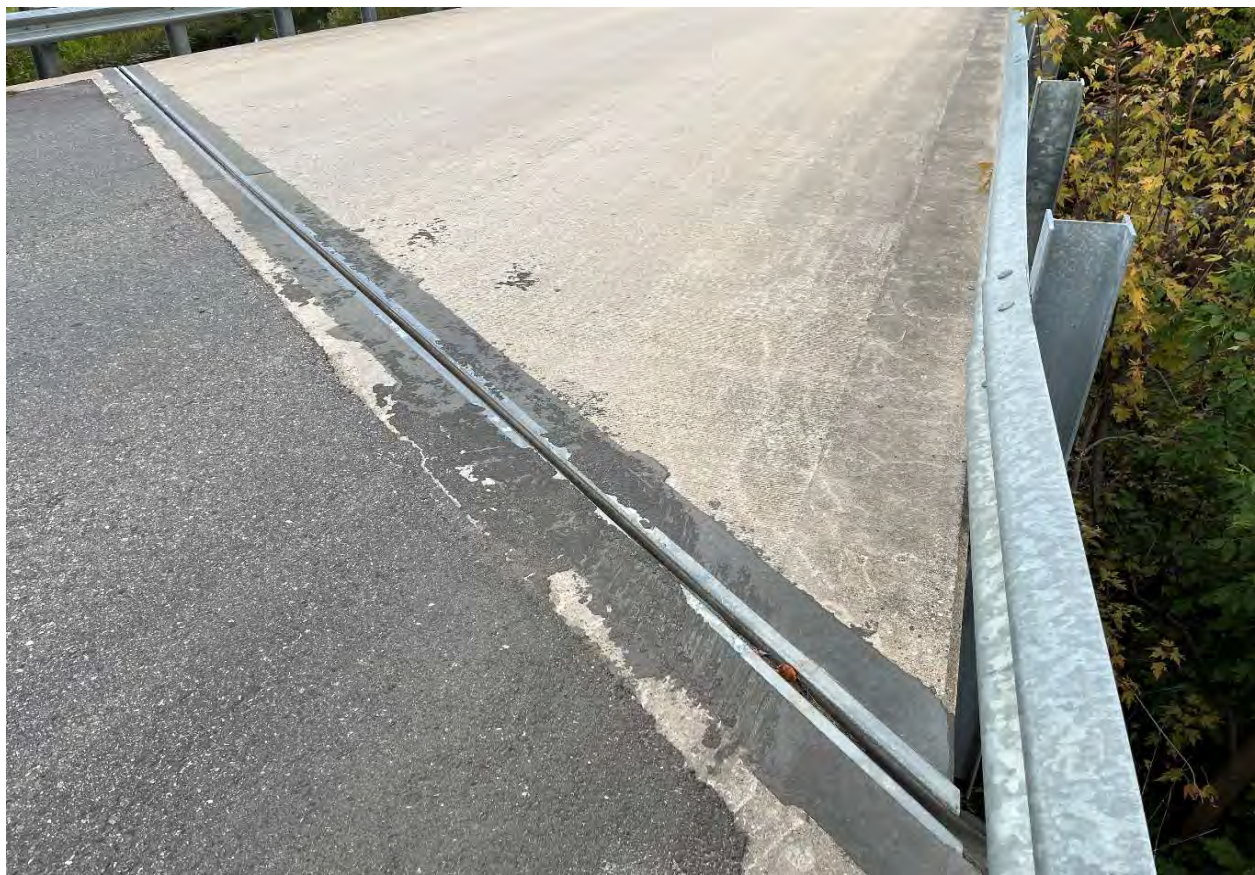
Description of Photo: West joint

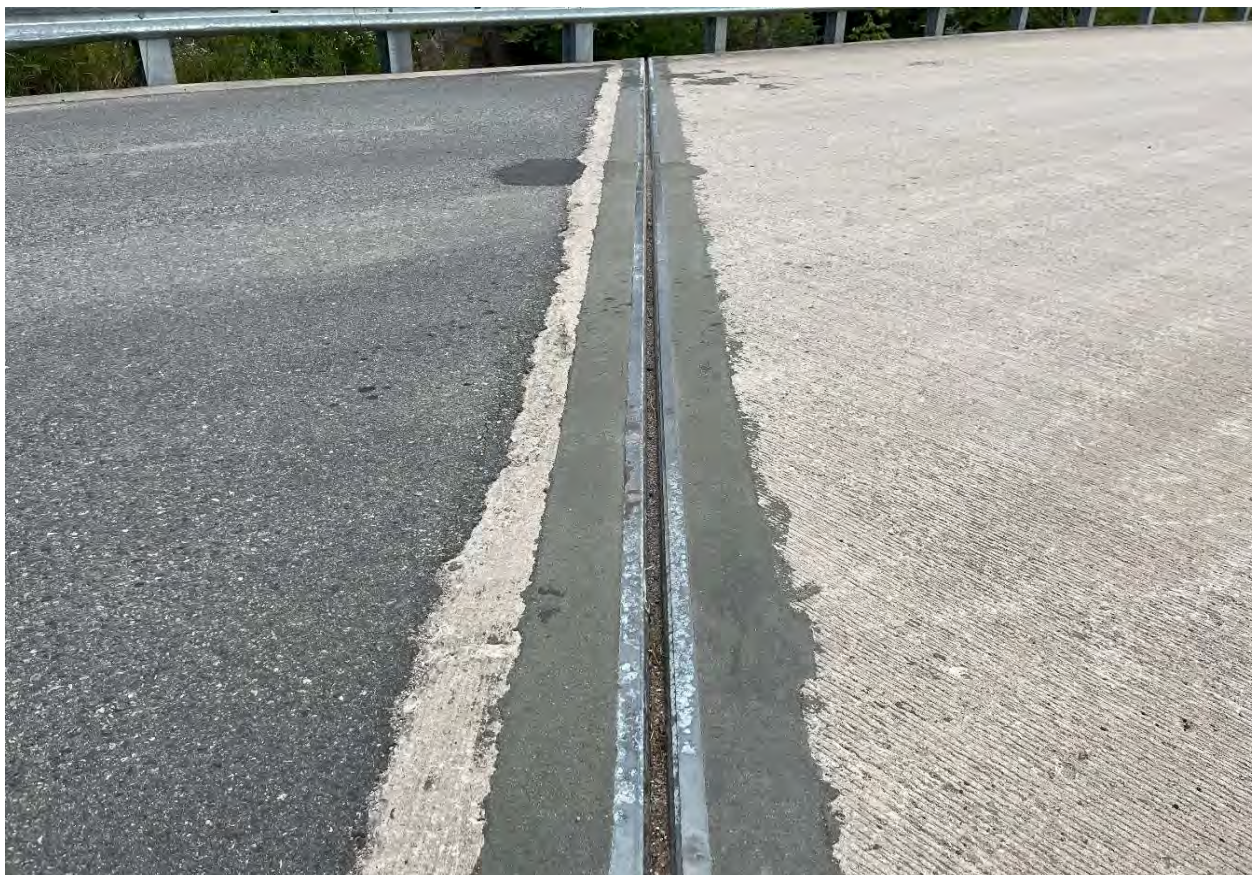
**Description of Photo:** East concrete end dam

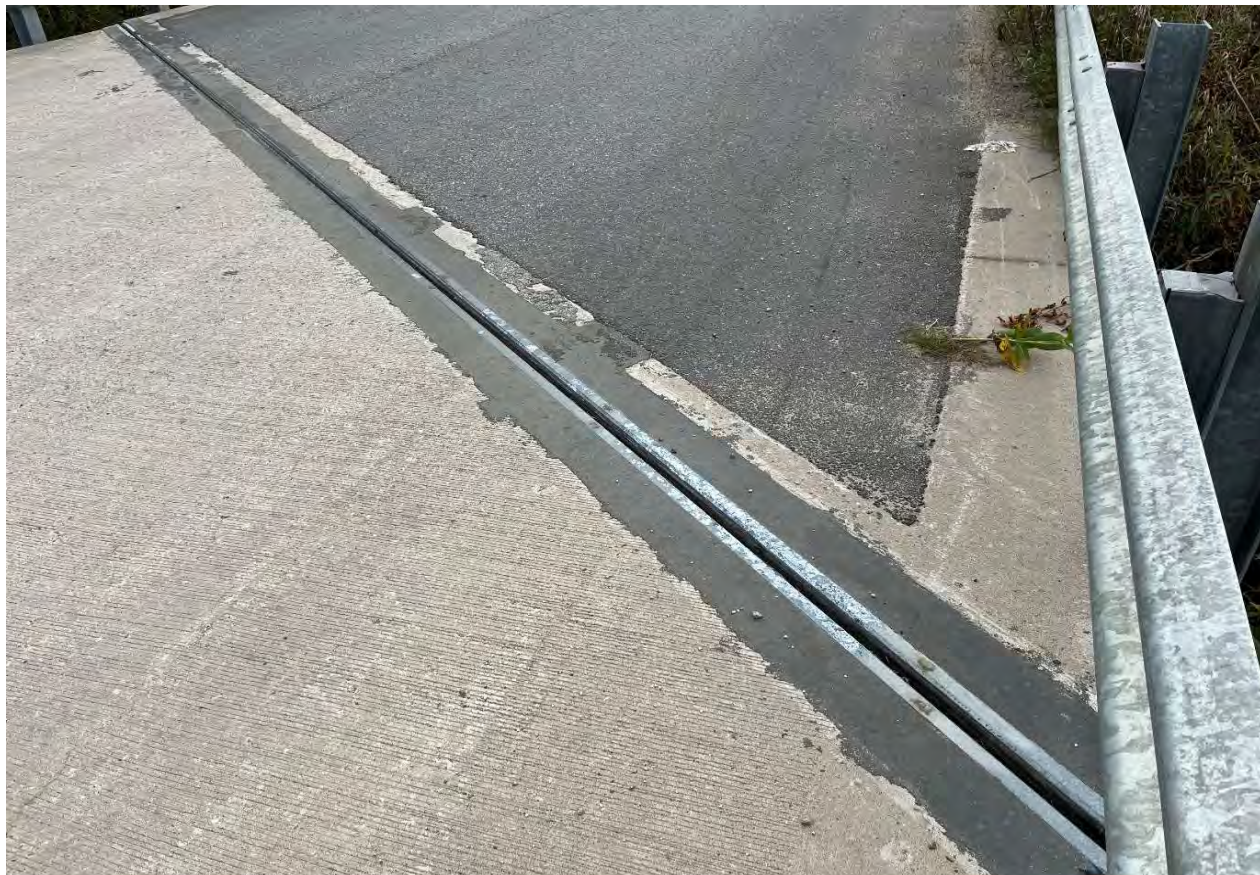
Description of Photo: West concrete end dam

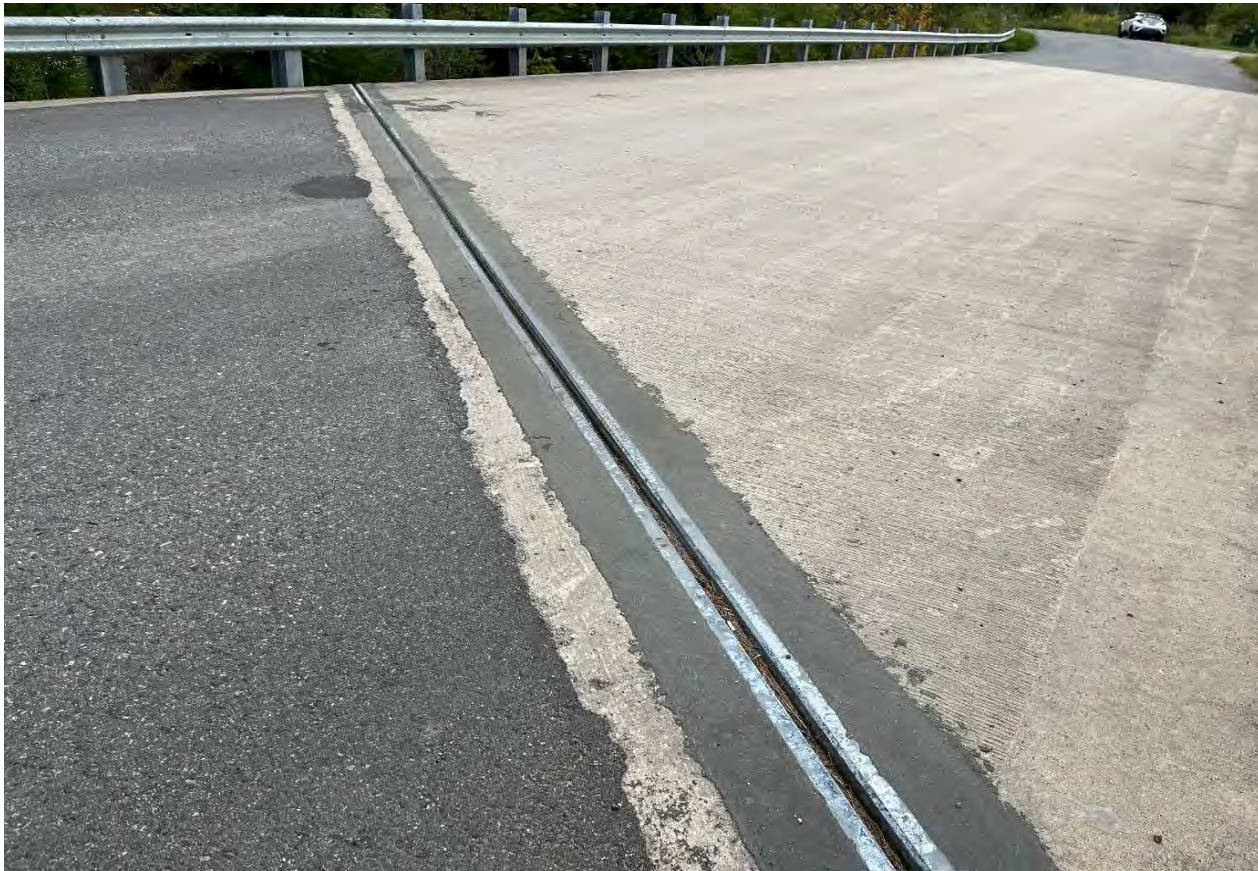
Description of Photo: Joint armour device, typ.

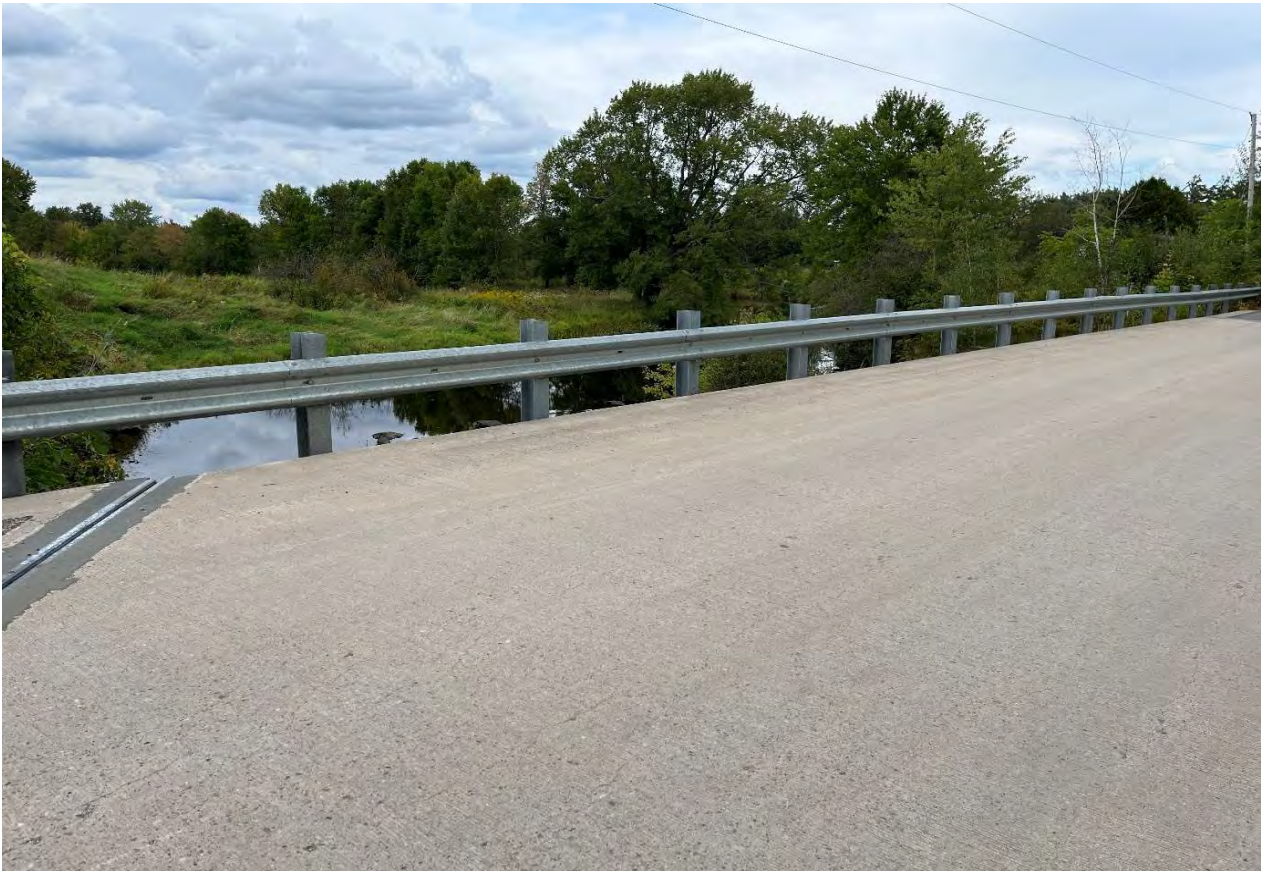
**Description of Photo:** Railing system - looking north

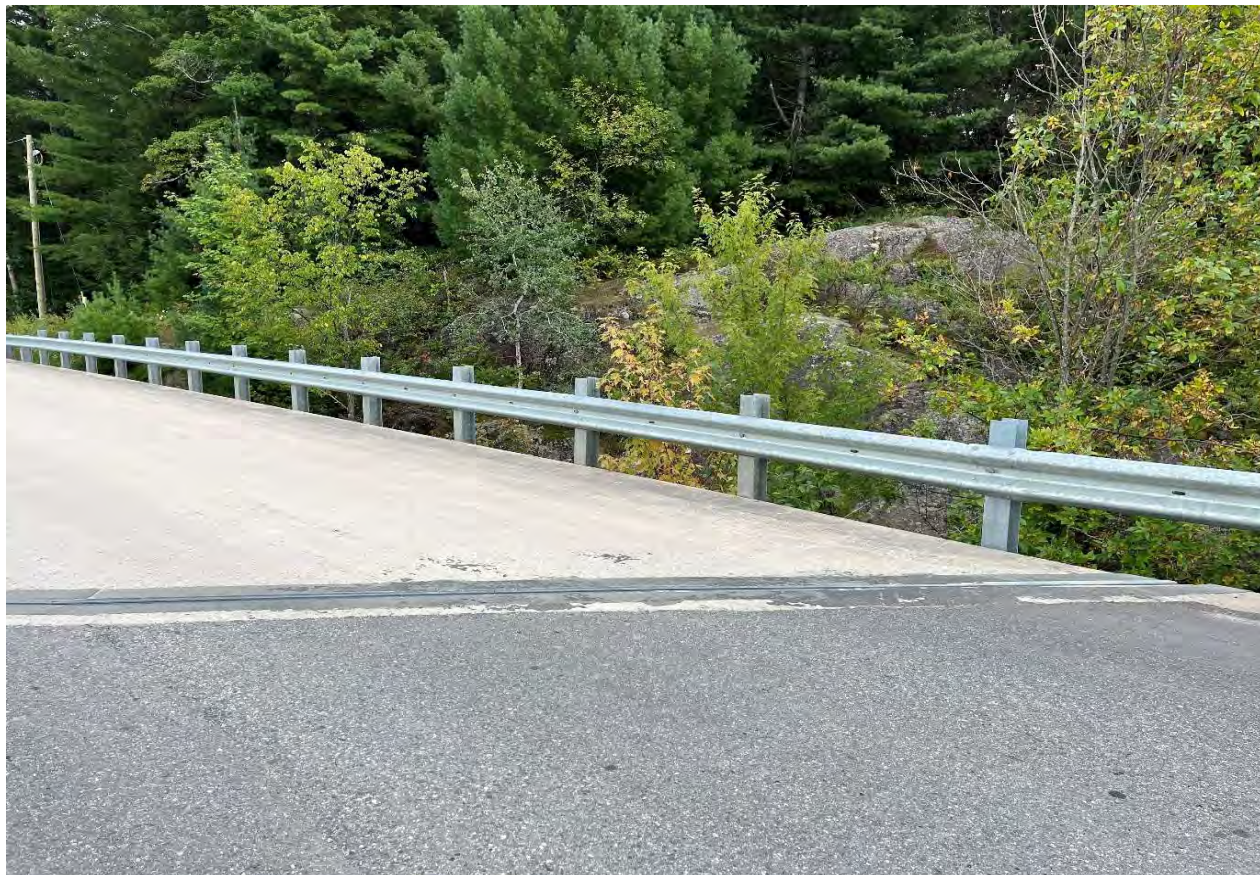
Description of Photo: Railing system - looking south

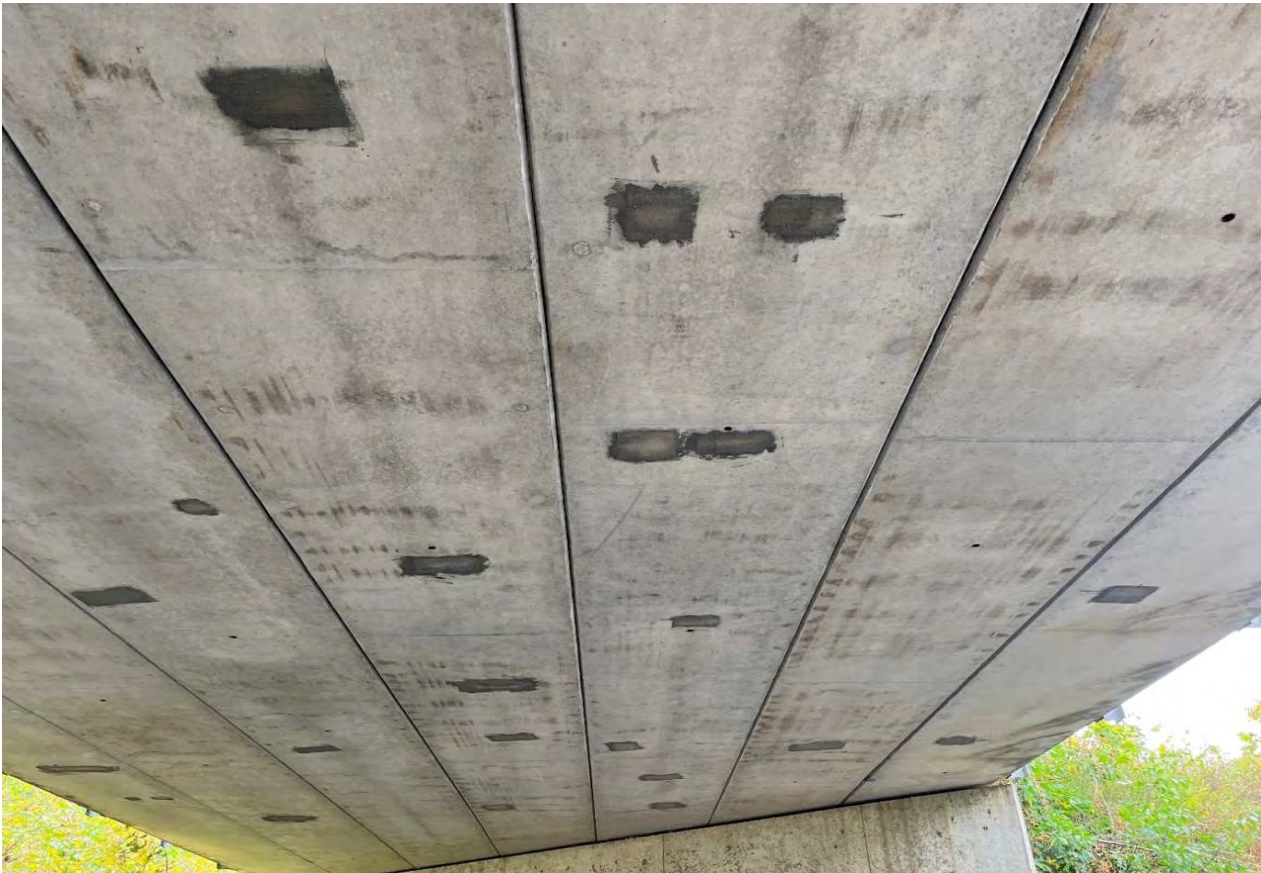
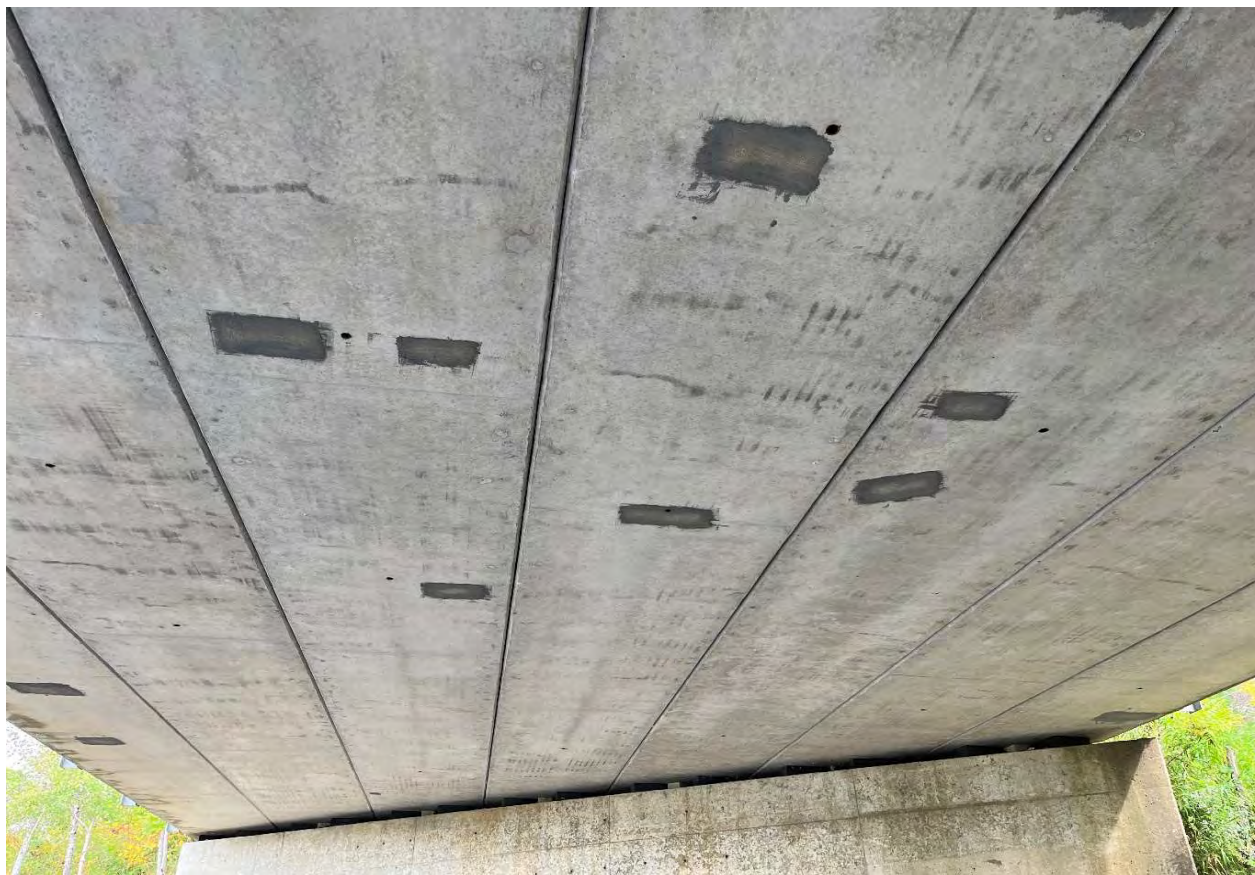
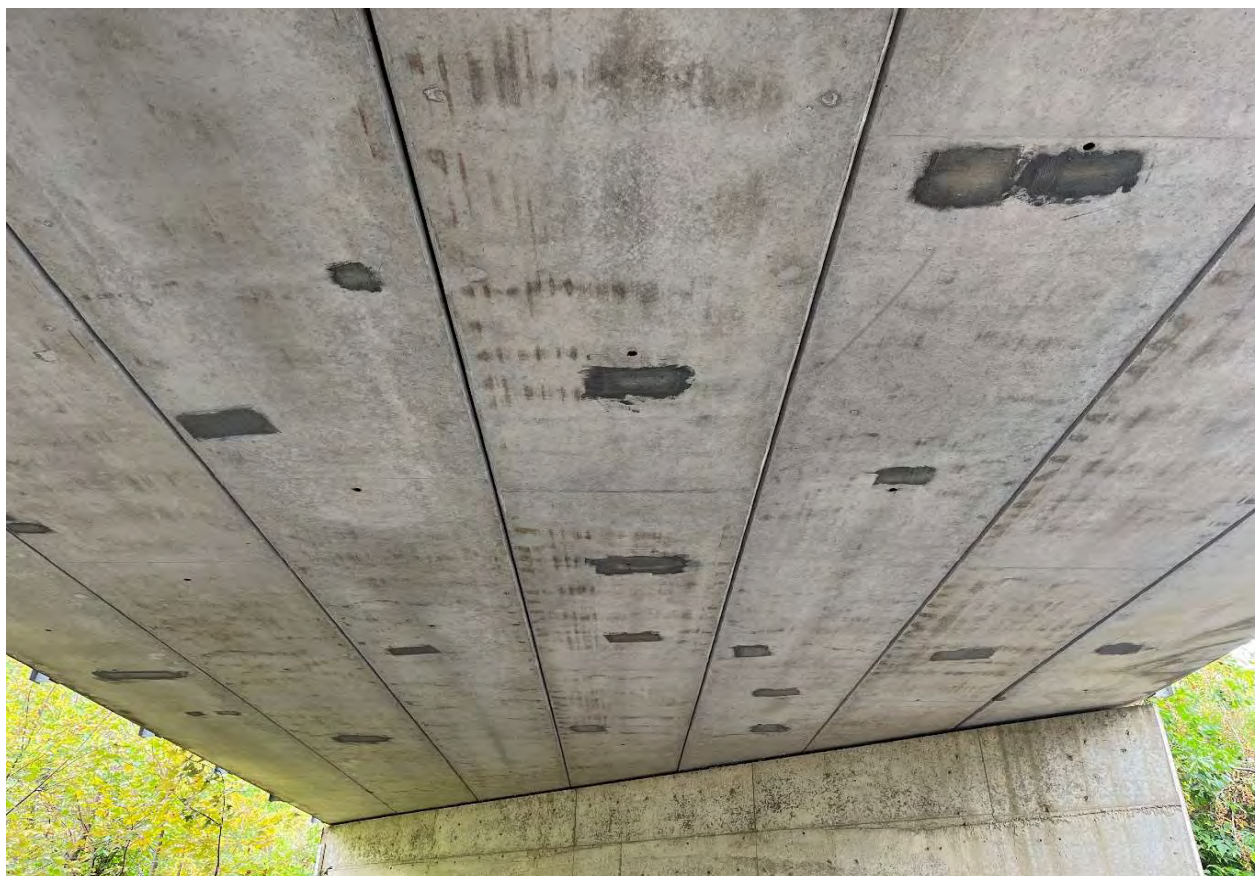
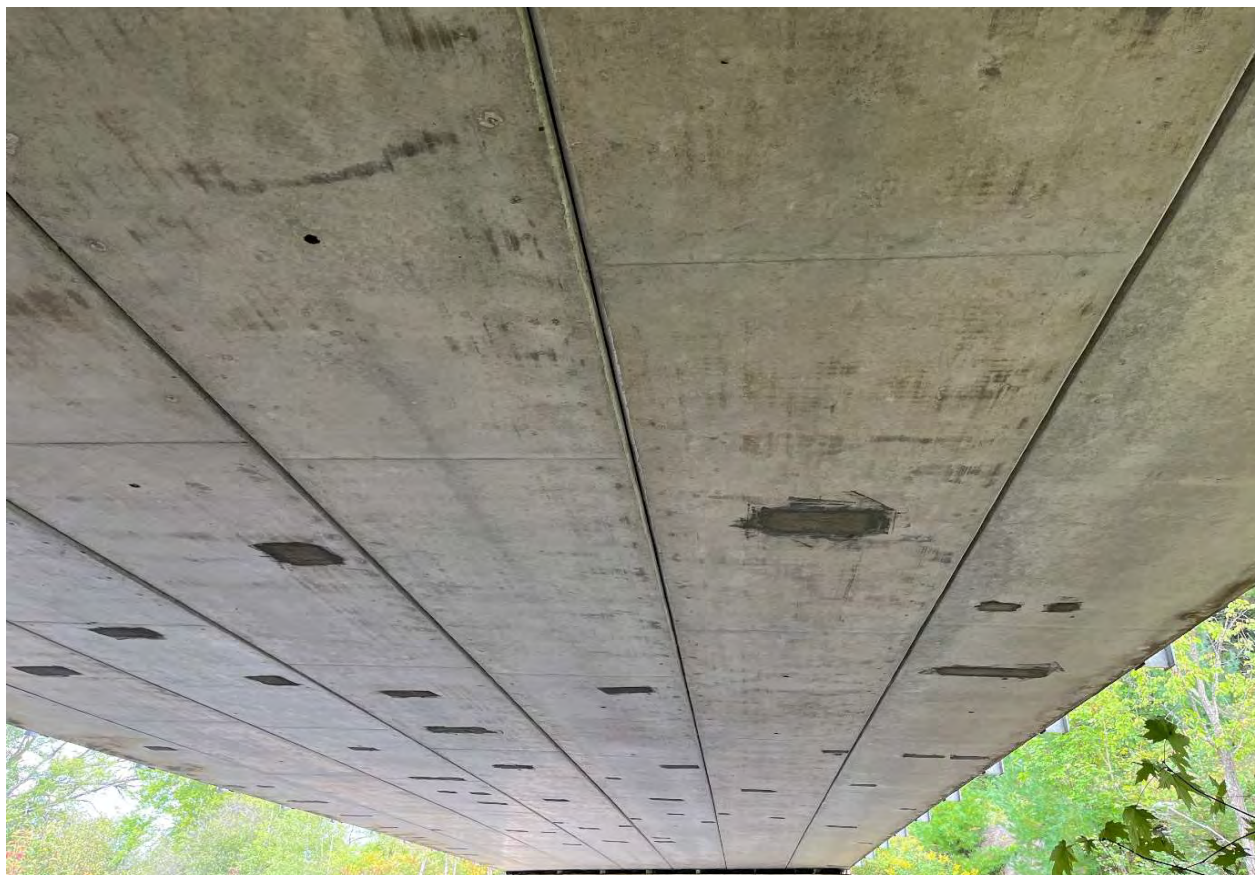
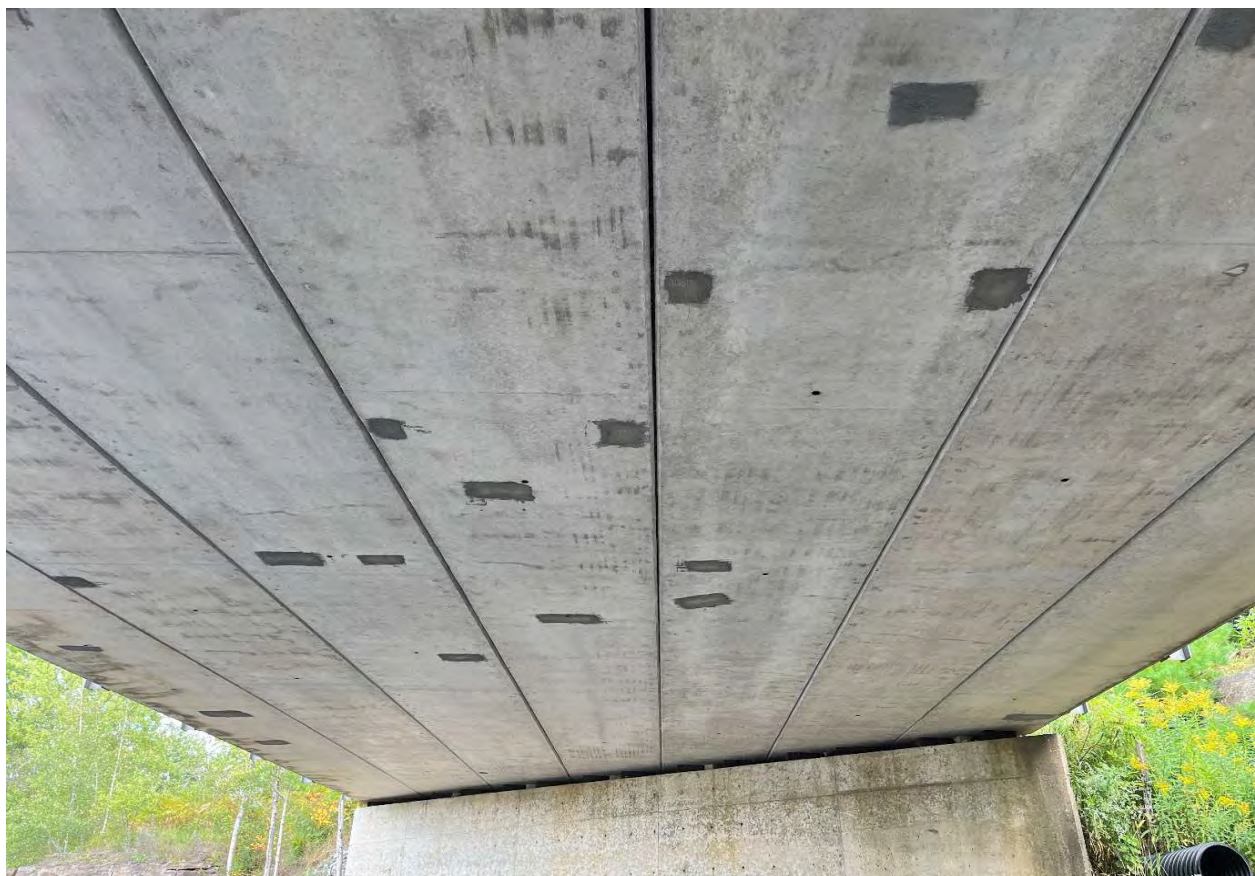
Description of Photo: Concrete box girder, typ.

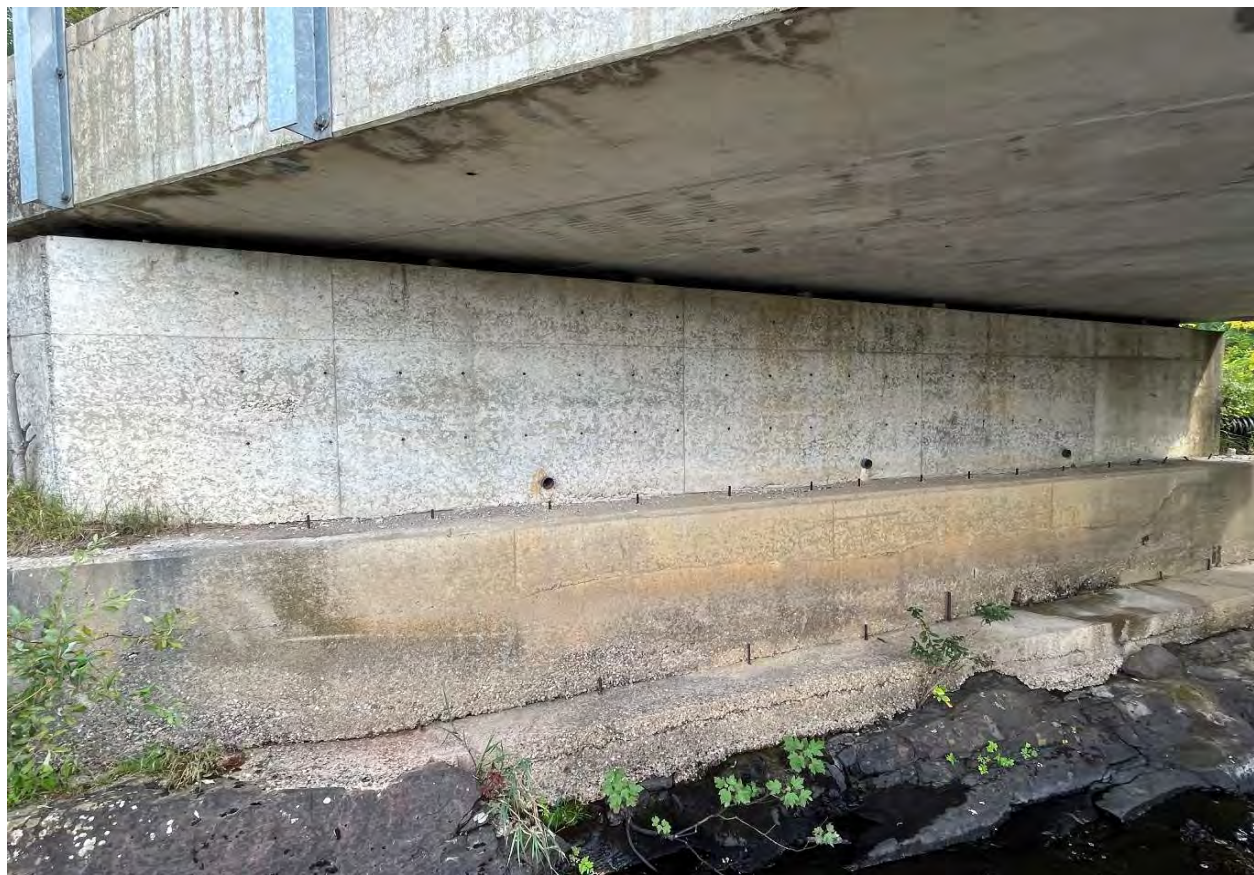
Description of Photo: East abutment wall

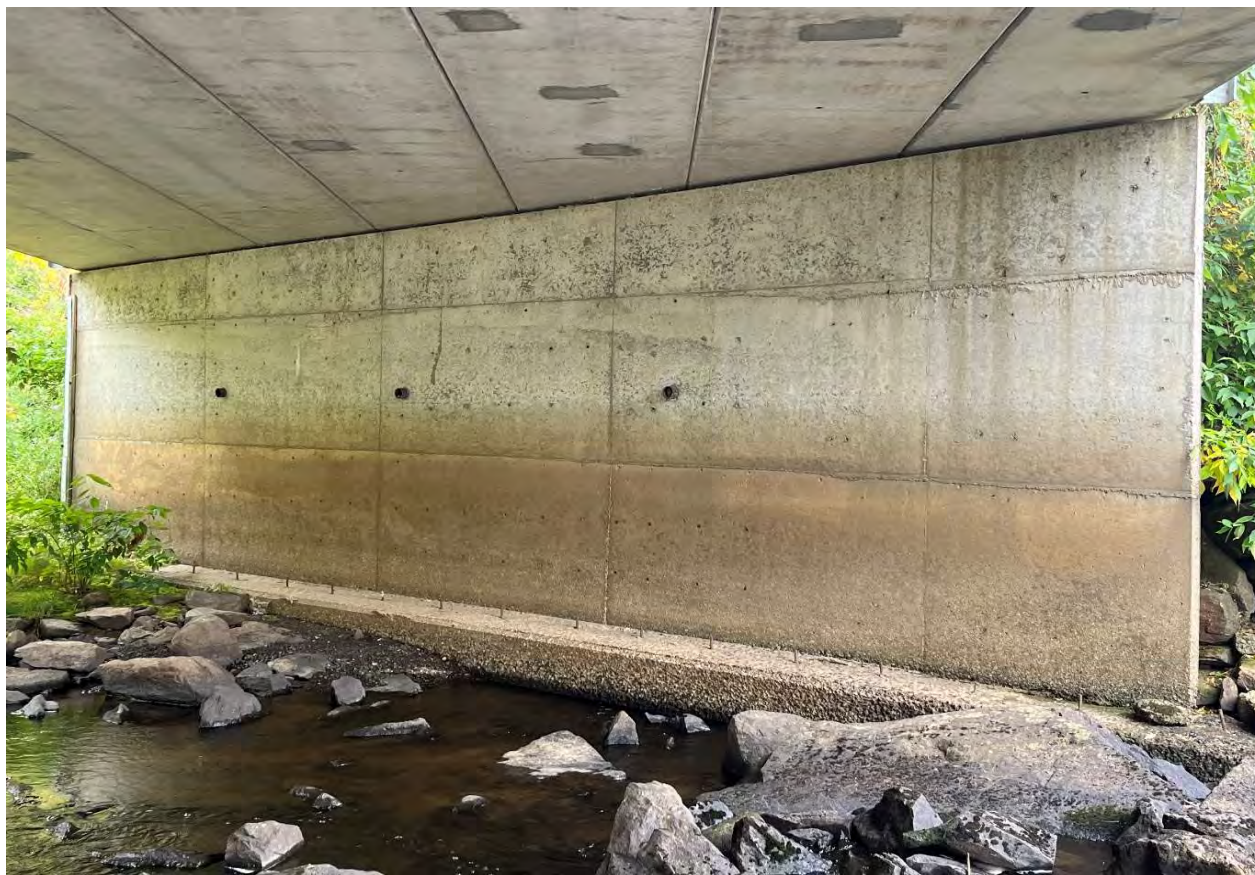
Description of Photo: West abutment wall

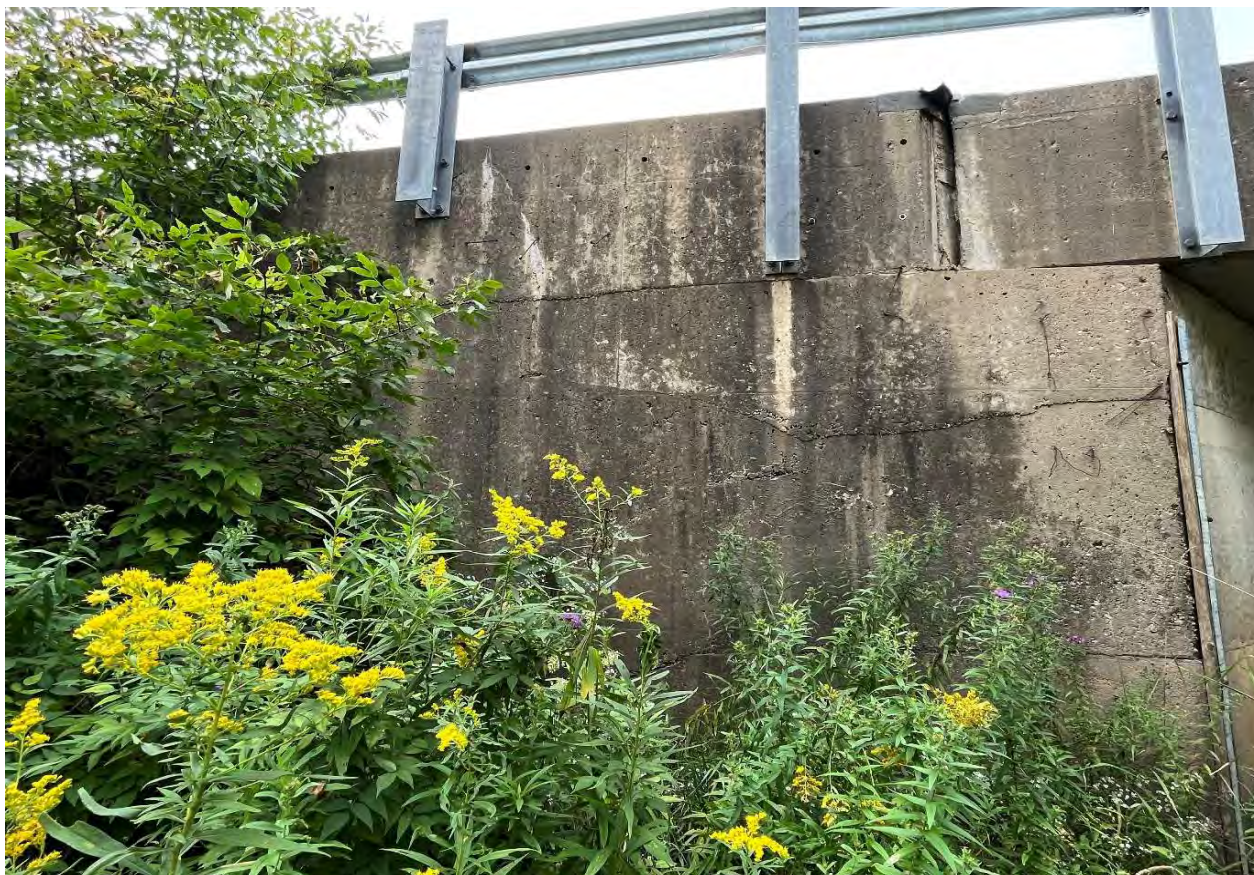
Description of Photo: Southwest wing wall

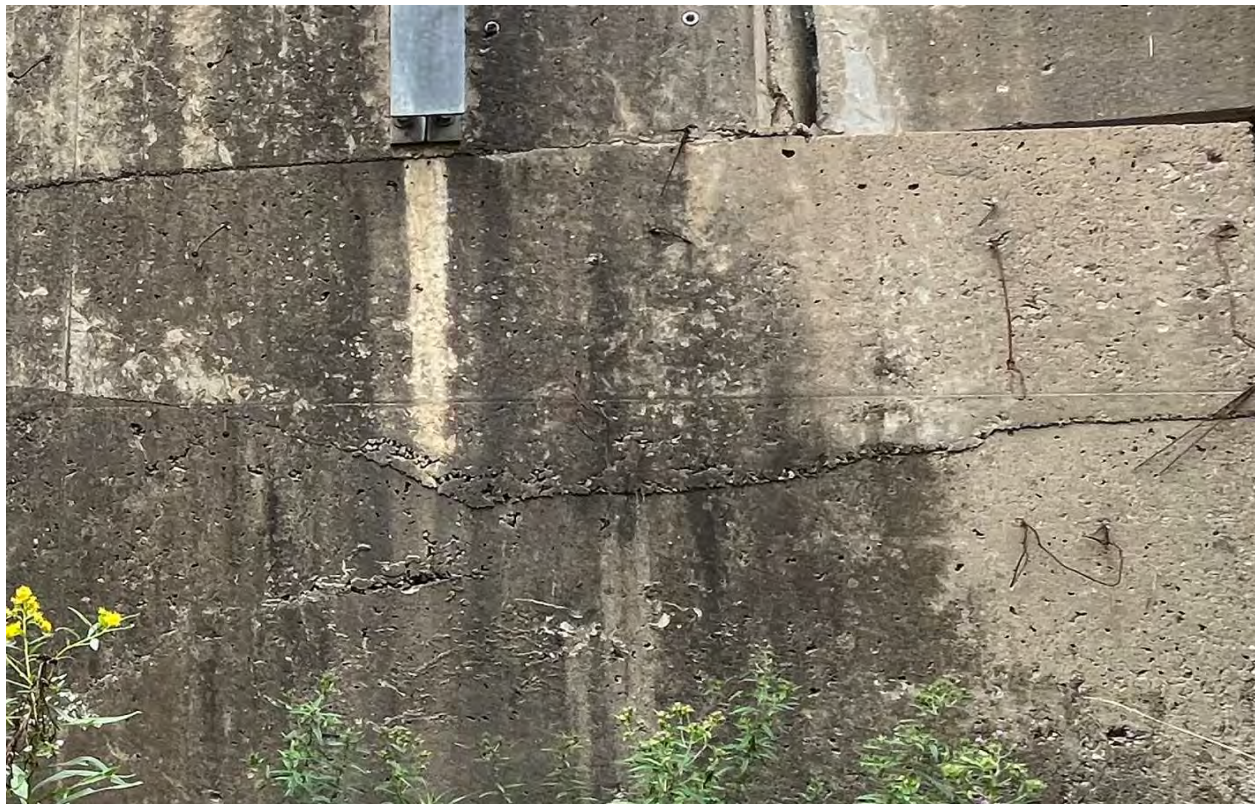
Description of Photo: Honeycombing at cold joint

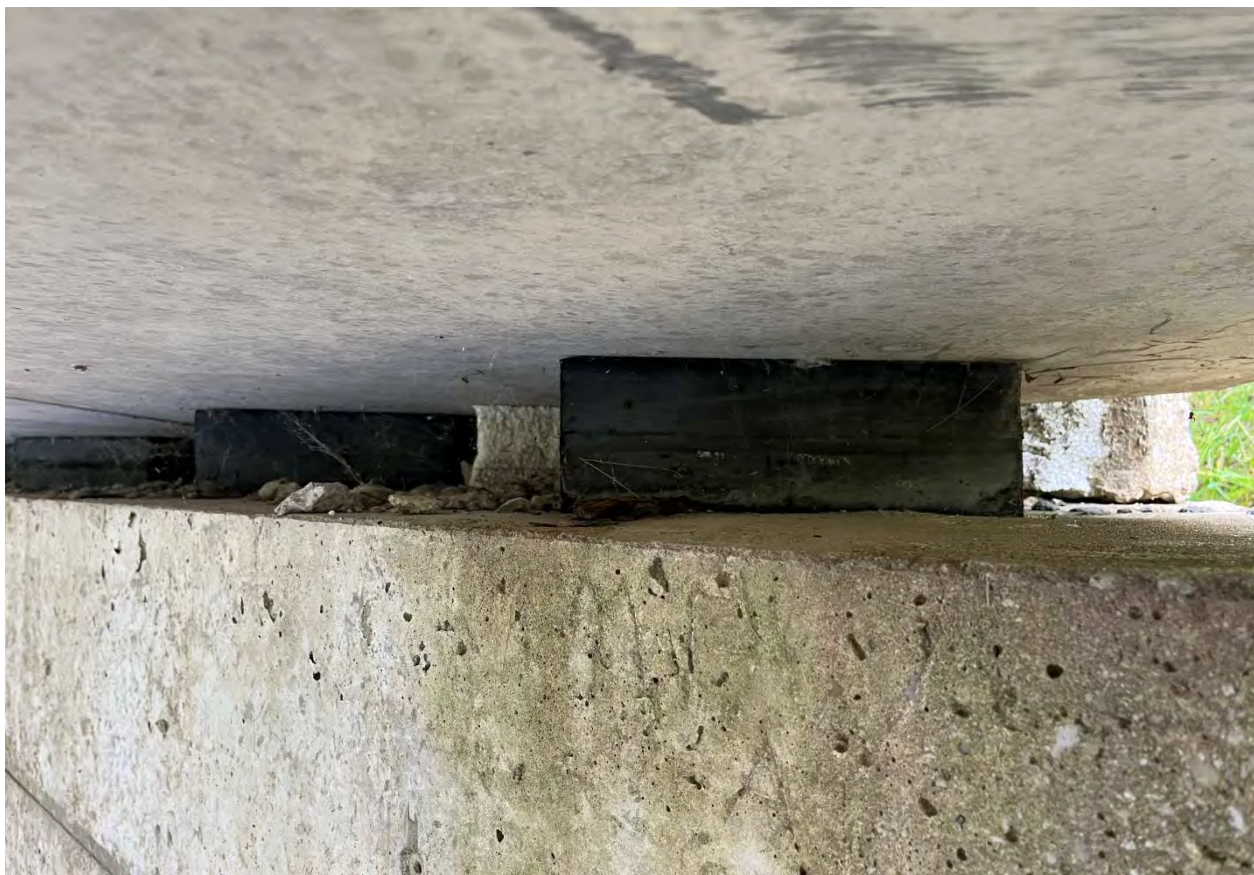
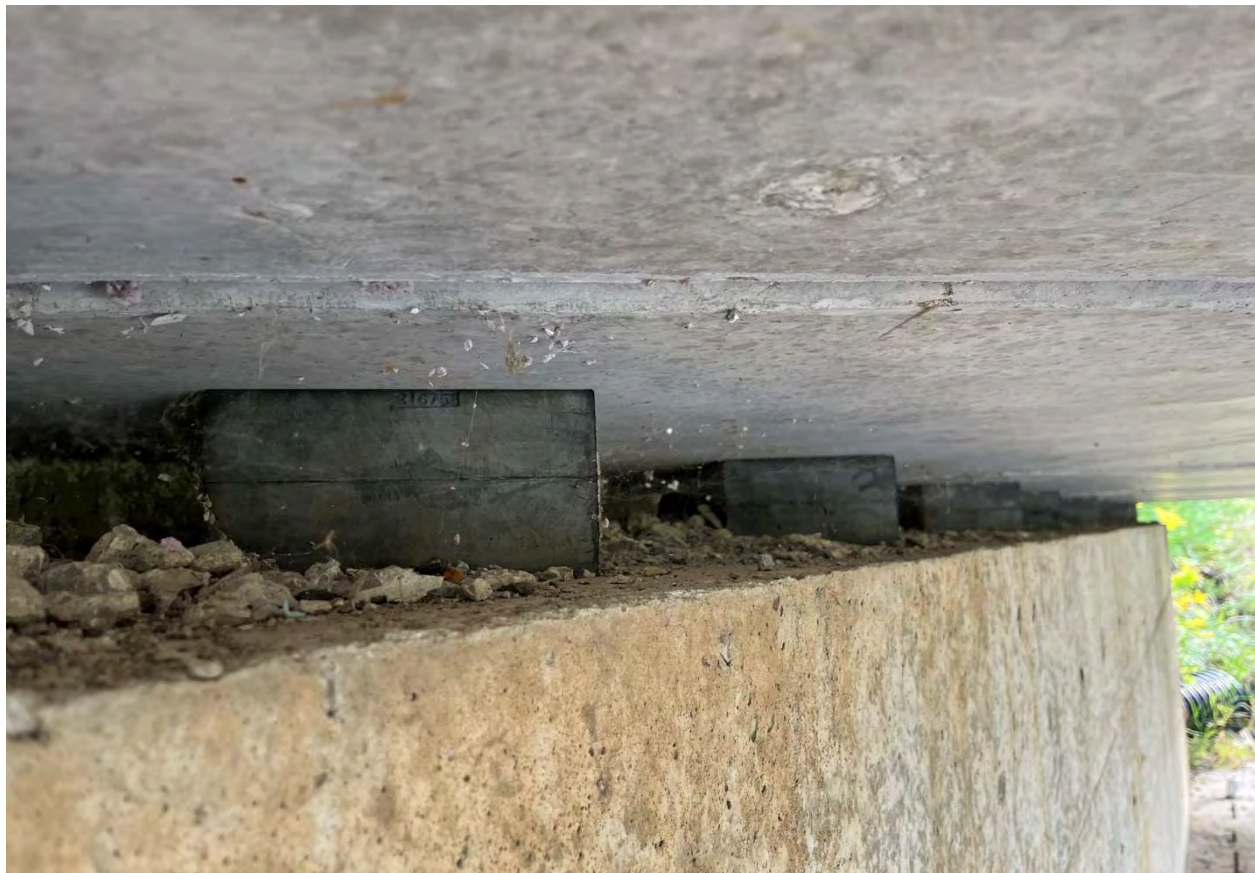
Description of Photo: East abutment bearing, typ.

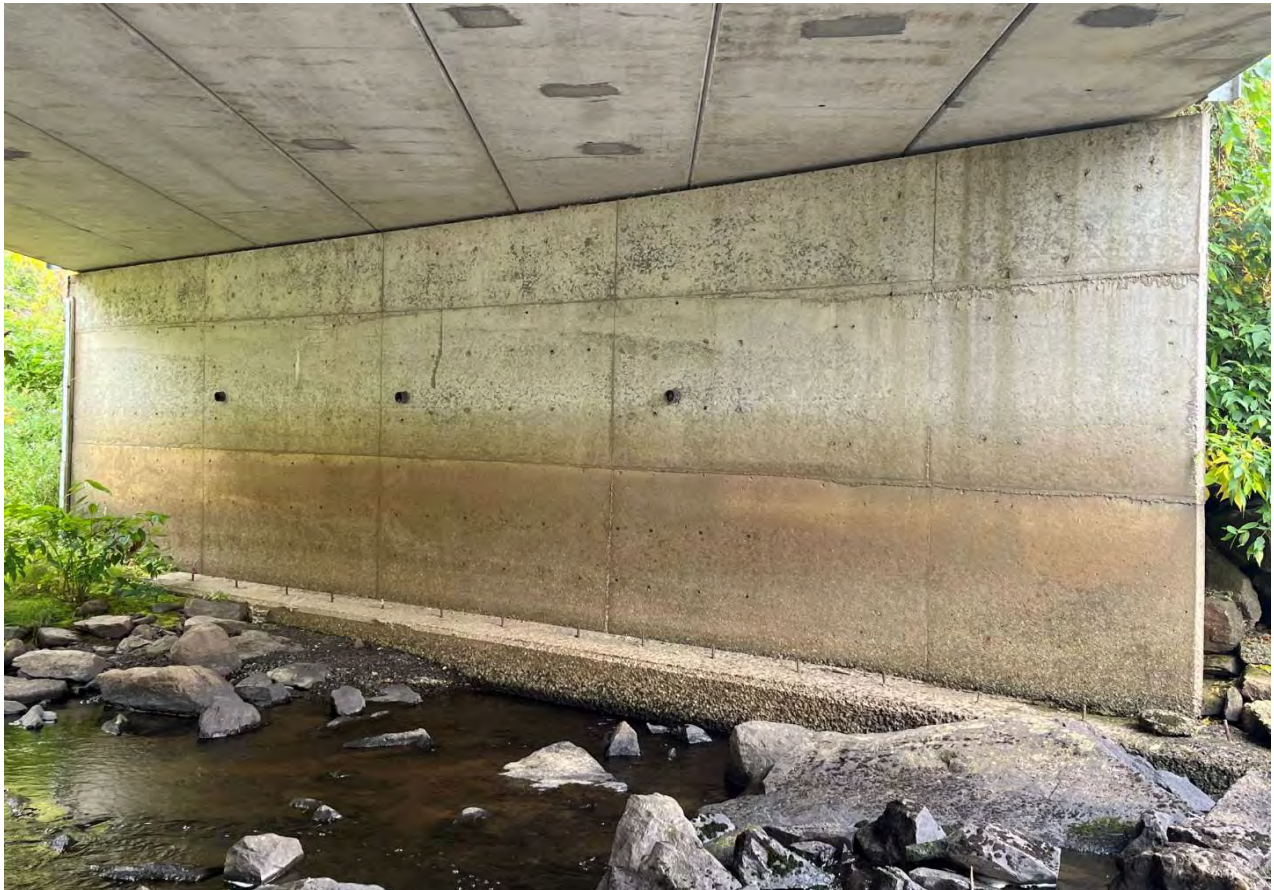
Description of Photo: West abutment bearing (not accessible)
