Bridge Needs Study

INSPECTION SUMMARY REPORT

Town of Gravenhurst

August
29, 2024

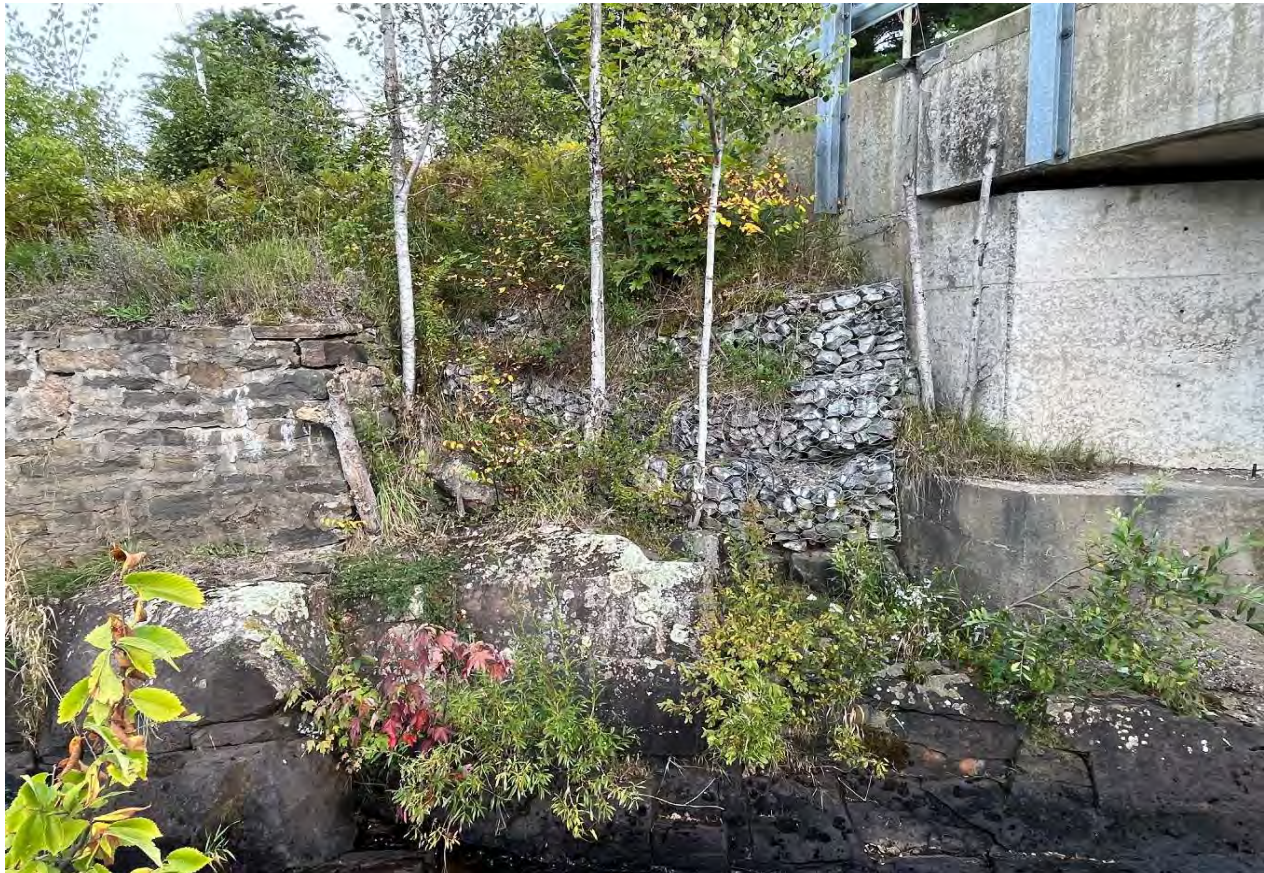
Description of Photo: Northeast gabion retaining wall

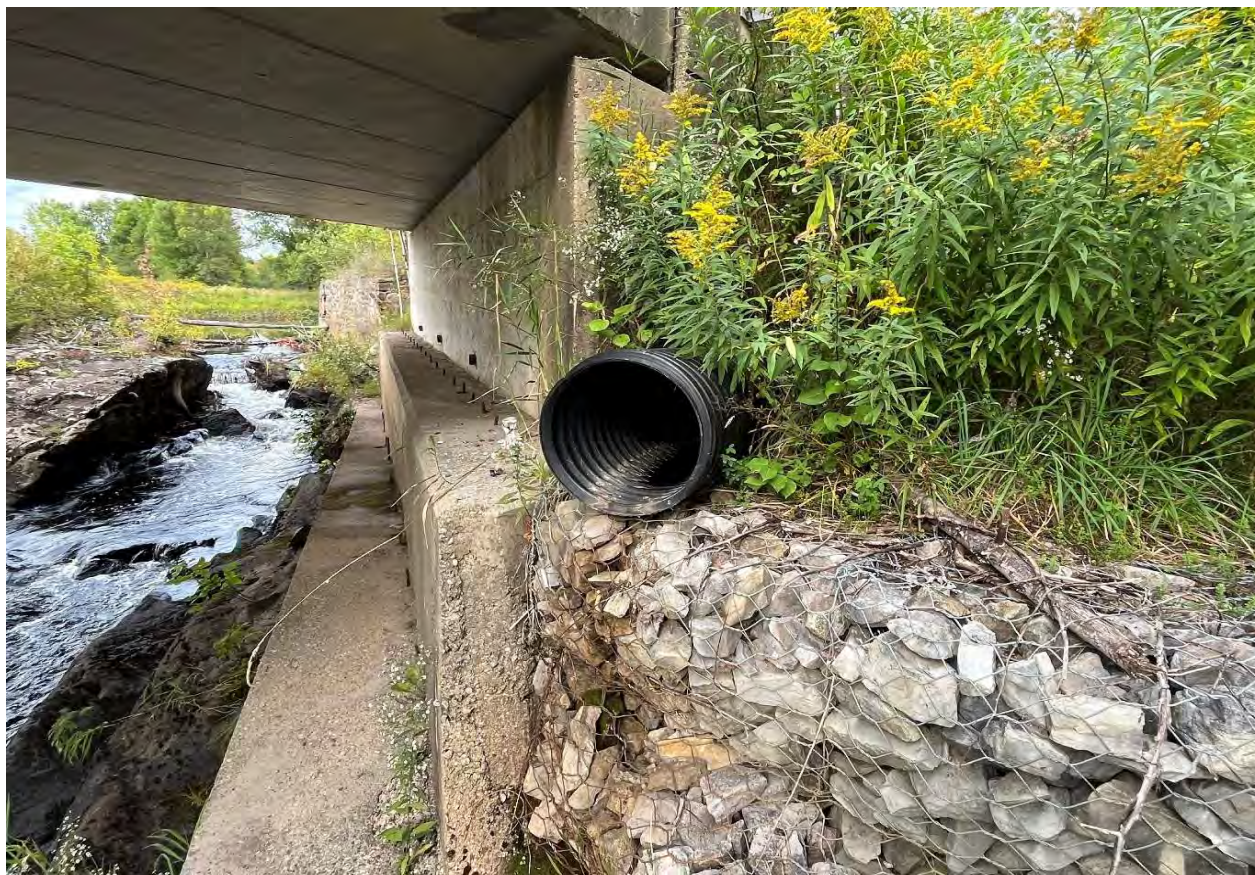
Description of Photo: Southeast gabion retaining wall

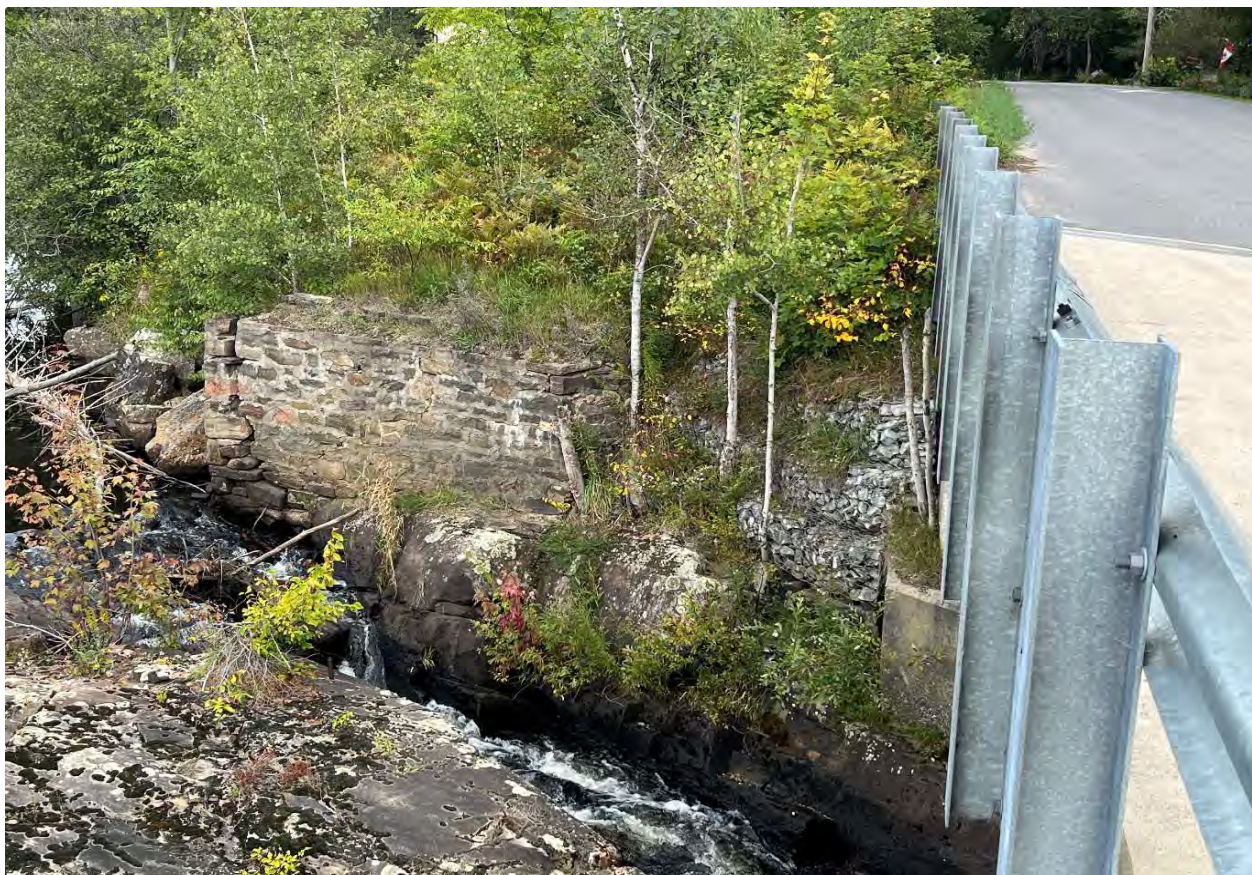
Description of Photo: Northeast embankment

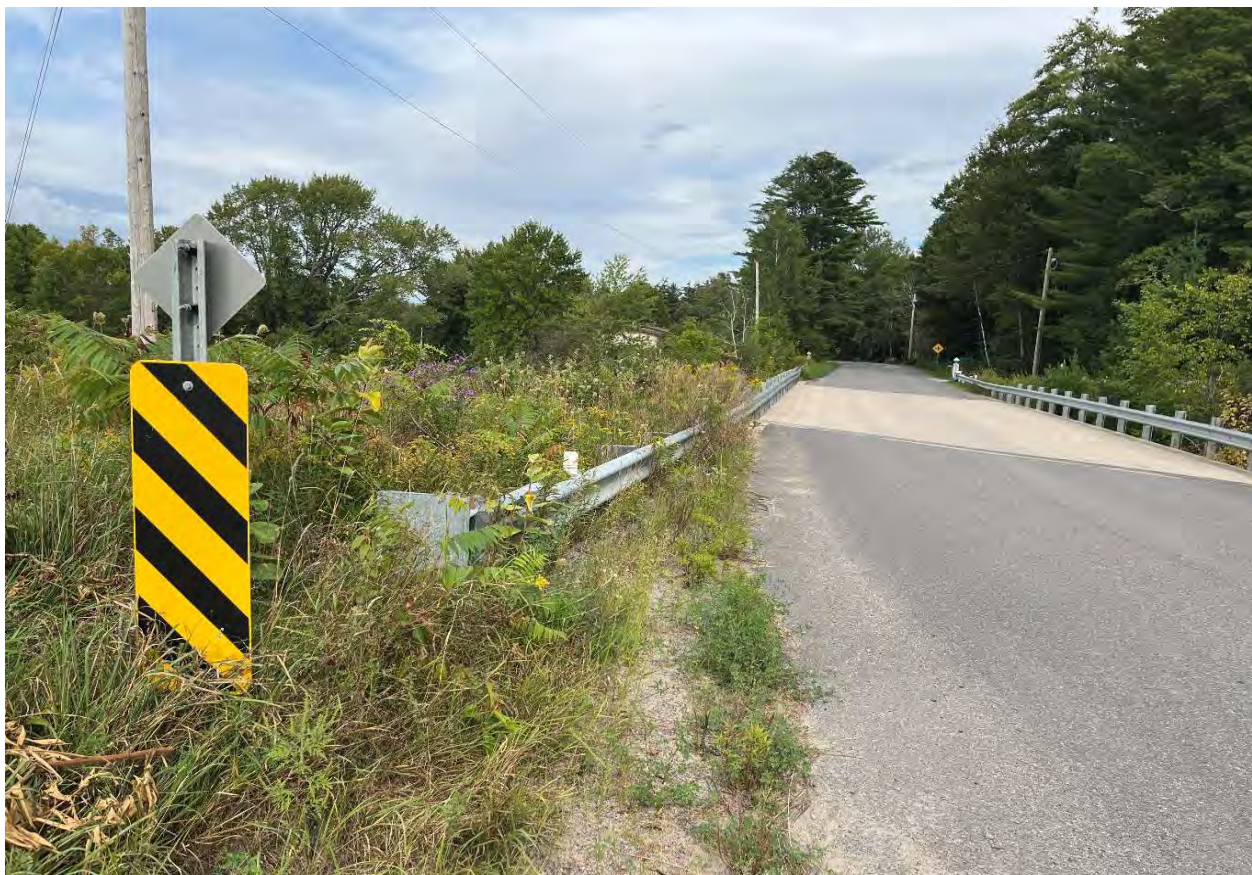
Description of Photo: Hazard warning sign, typ.

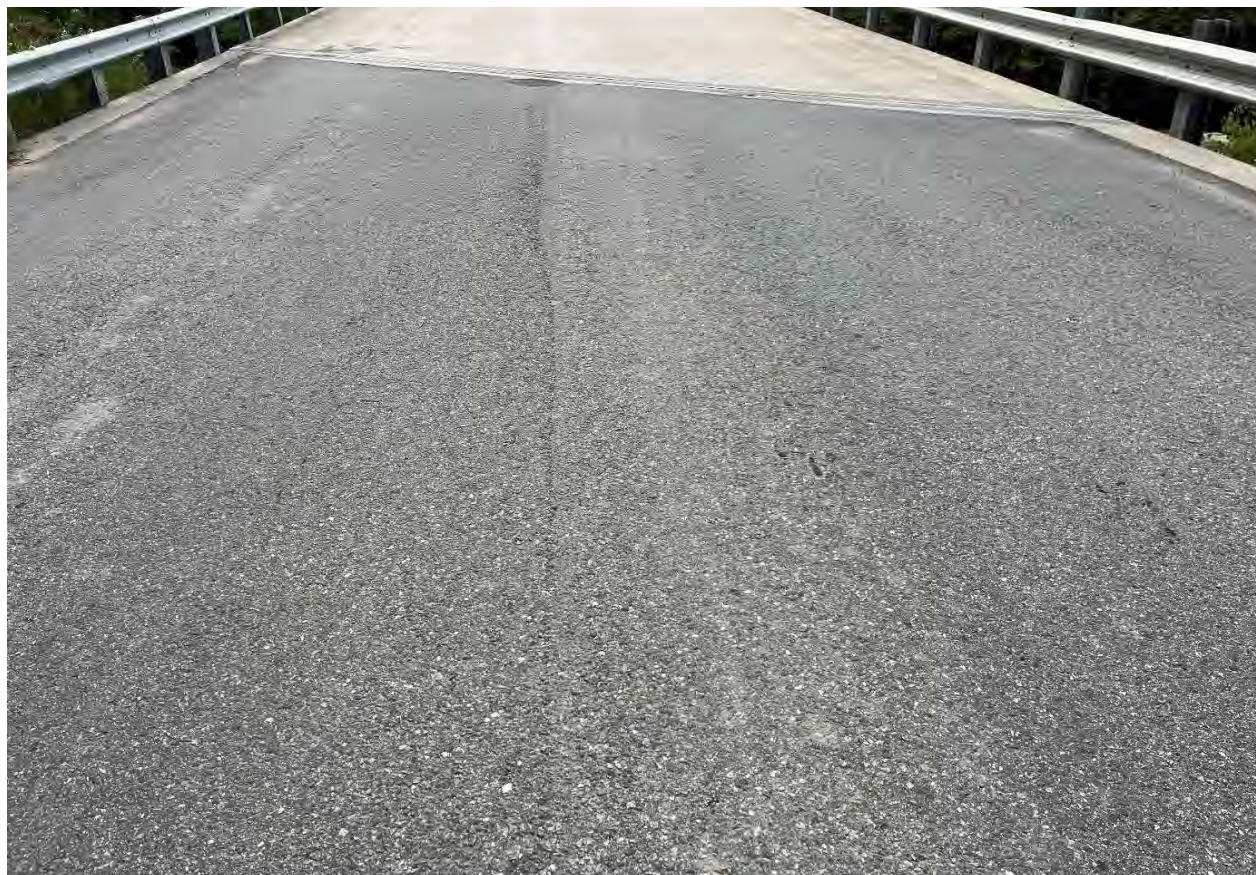
Description of Photo: East approach wearing surface

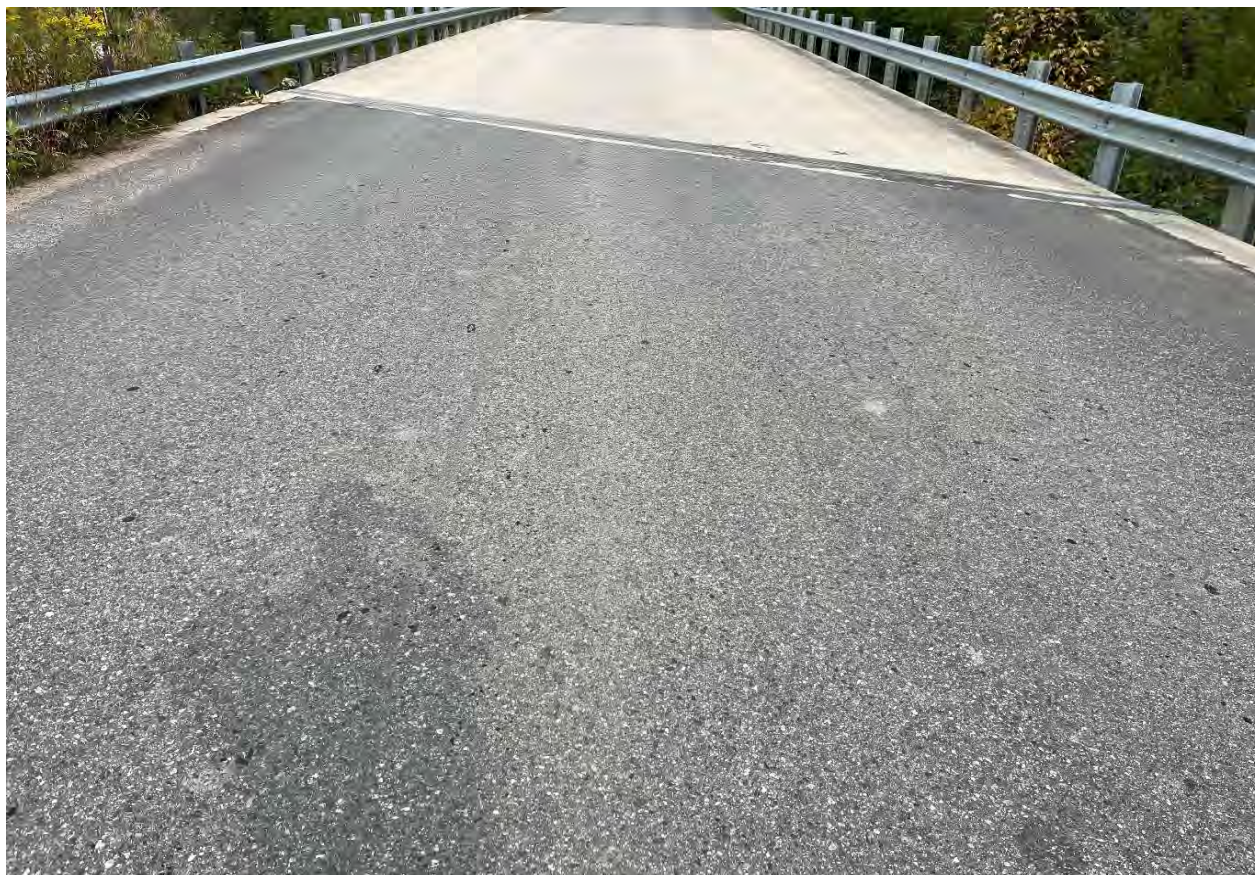
Description of Photo: West approach wearing surface

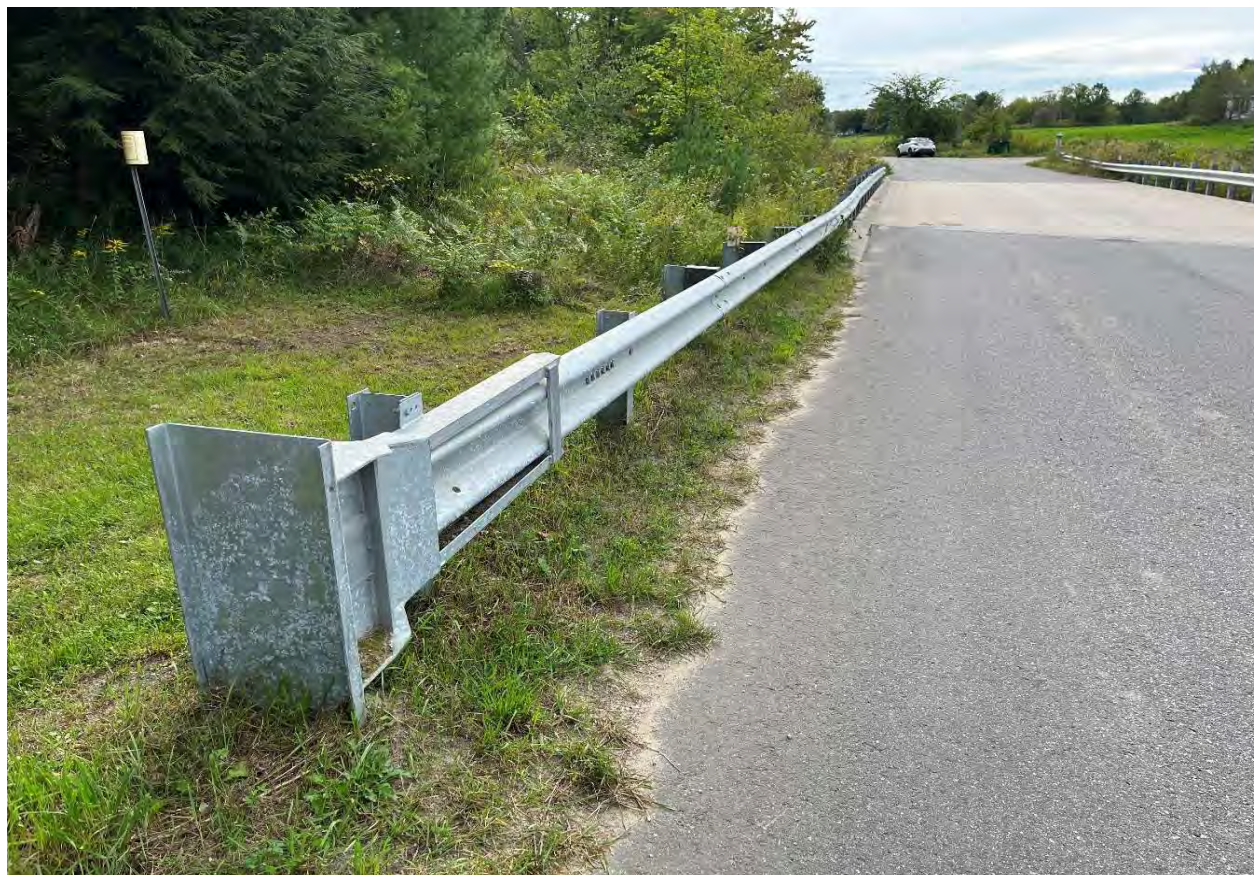
Description of Photo: Southeast approach guide rail

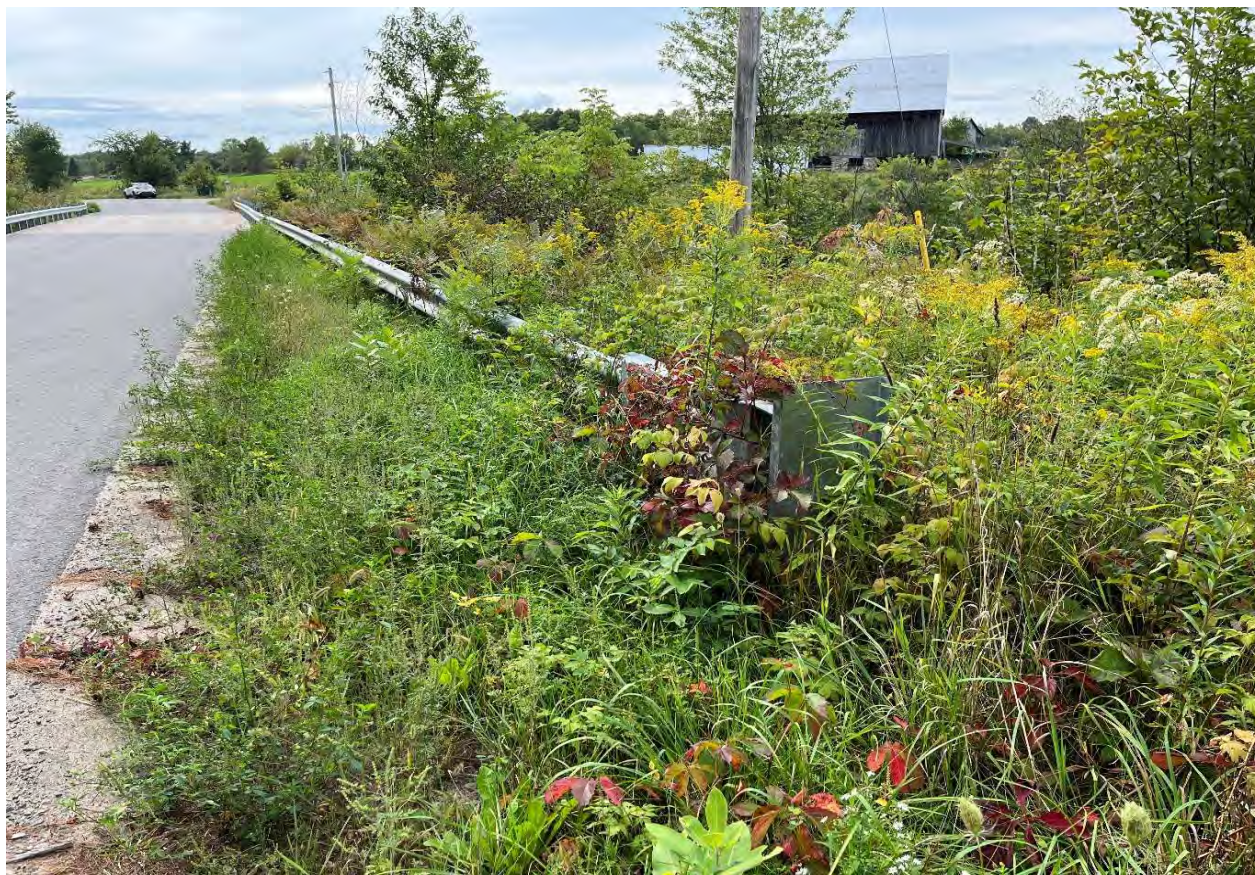
Description of Photo: Northeast approach guide rail

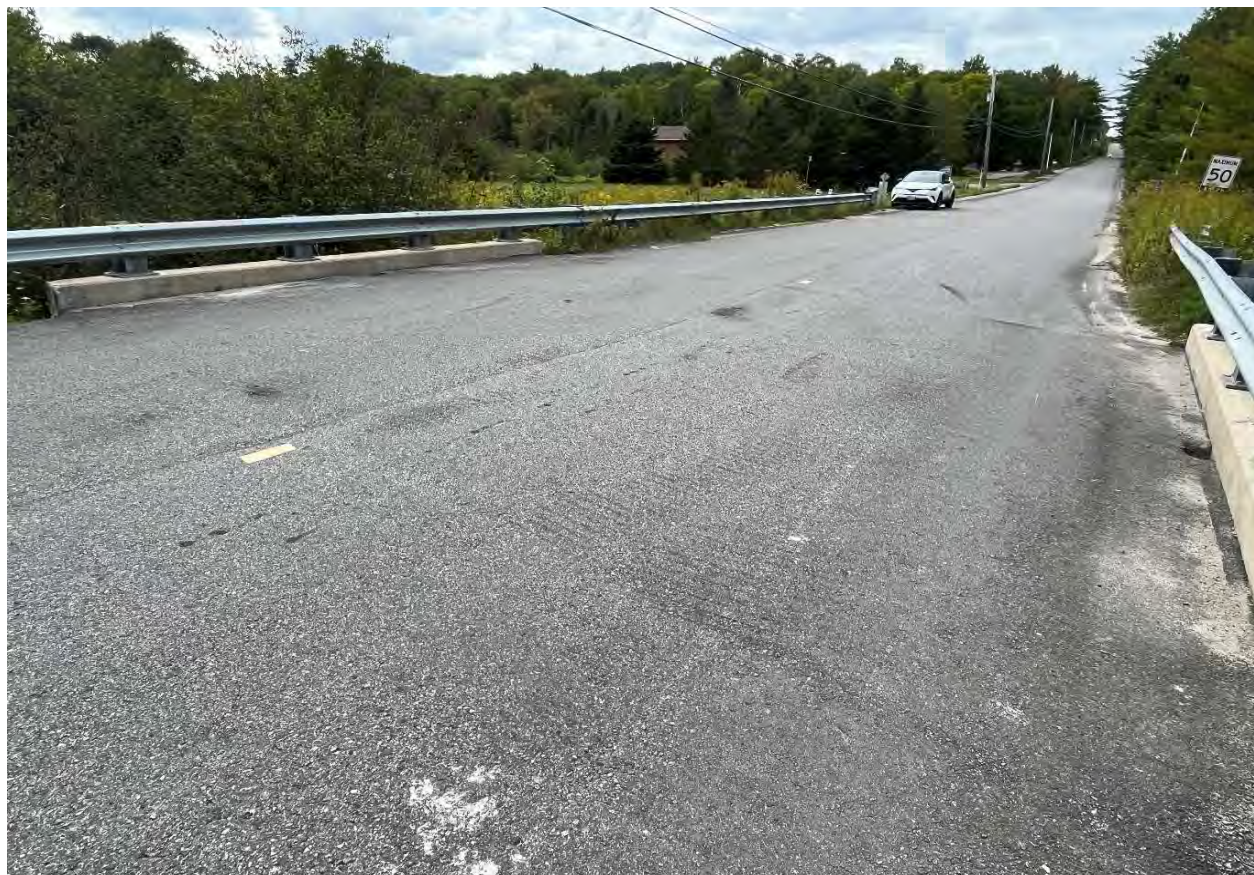
Description of Photo: Wearing surface - looking west

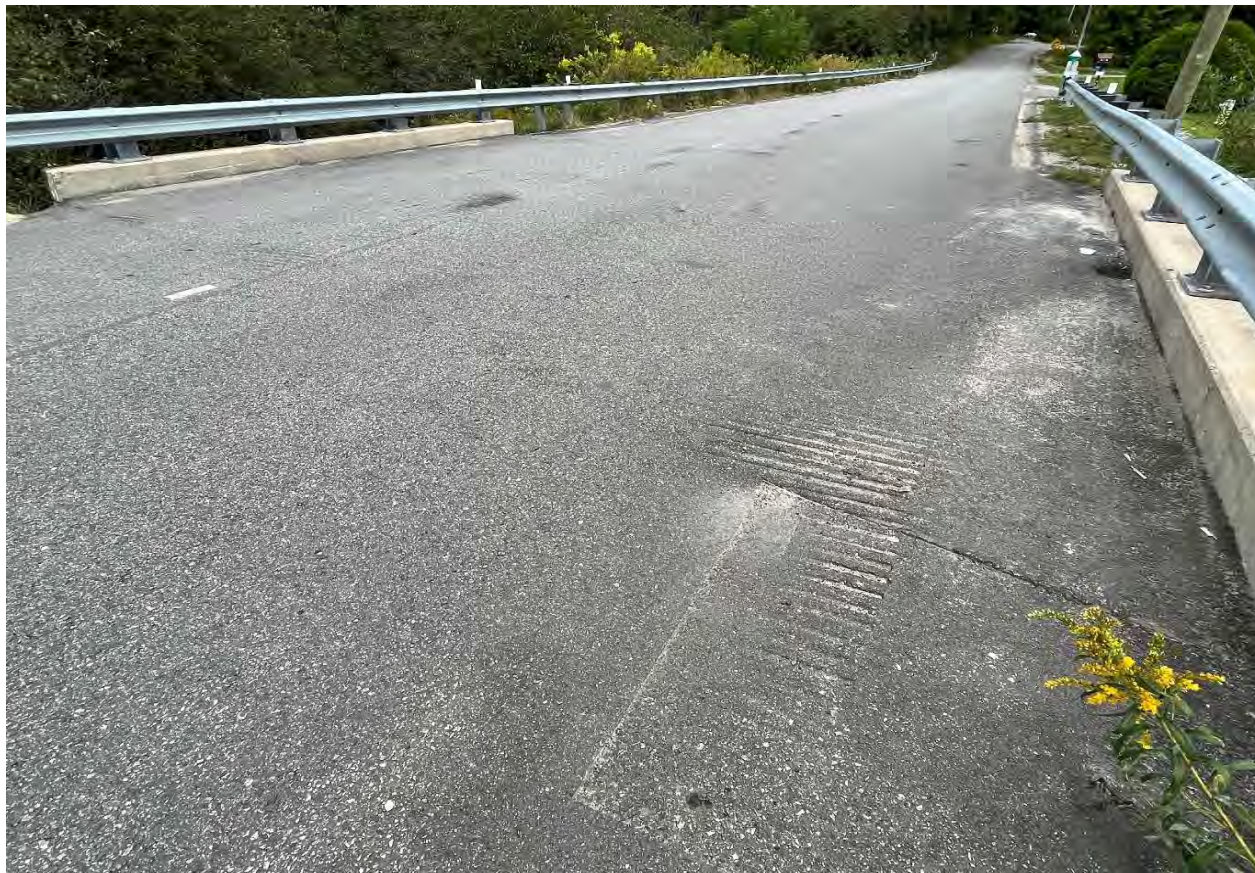
Description of Photo: Wearing surface - looking east

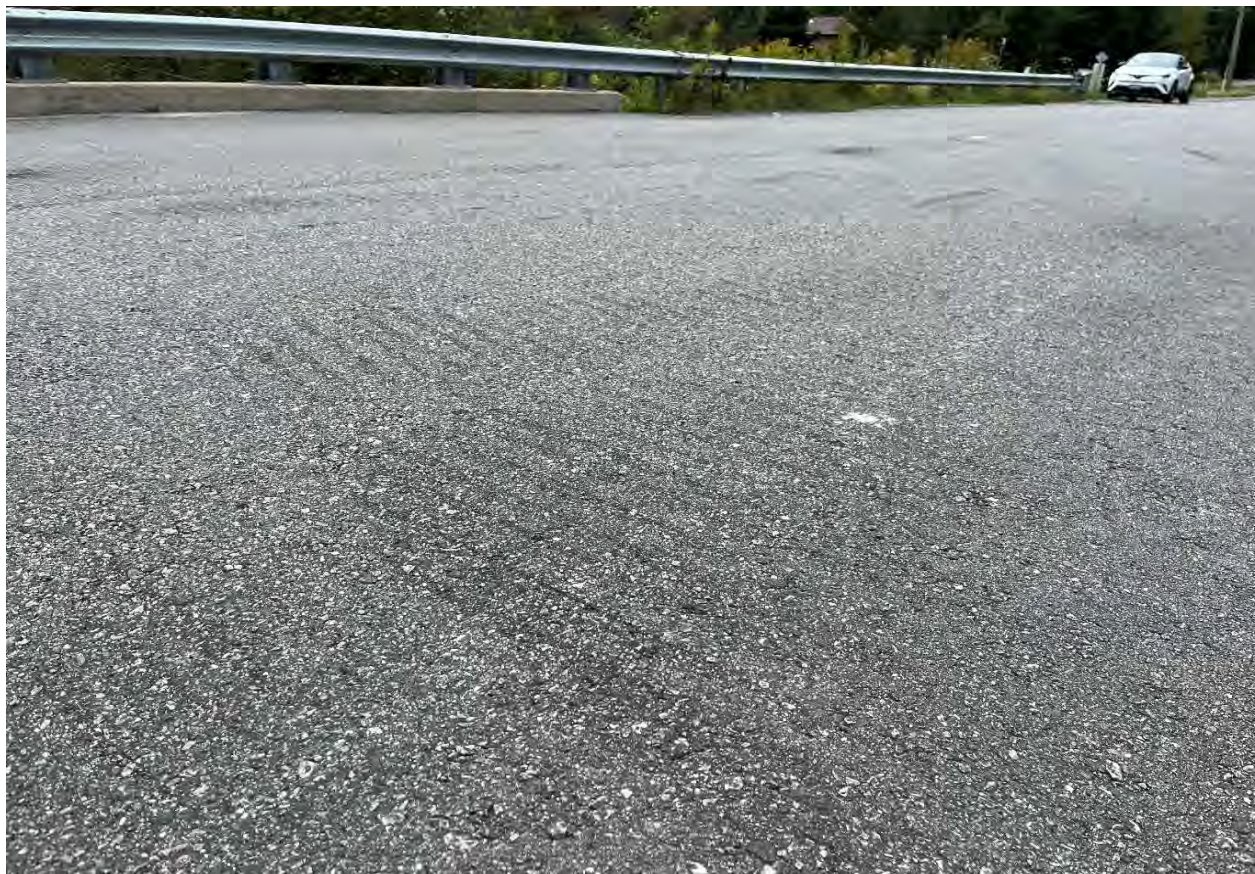
Description of Photo: Ripping, typ.

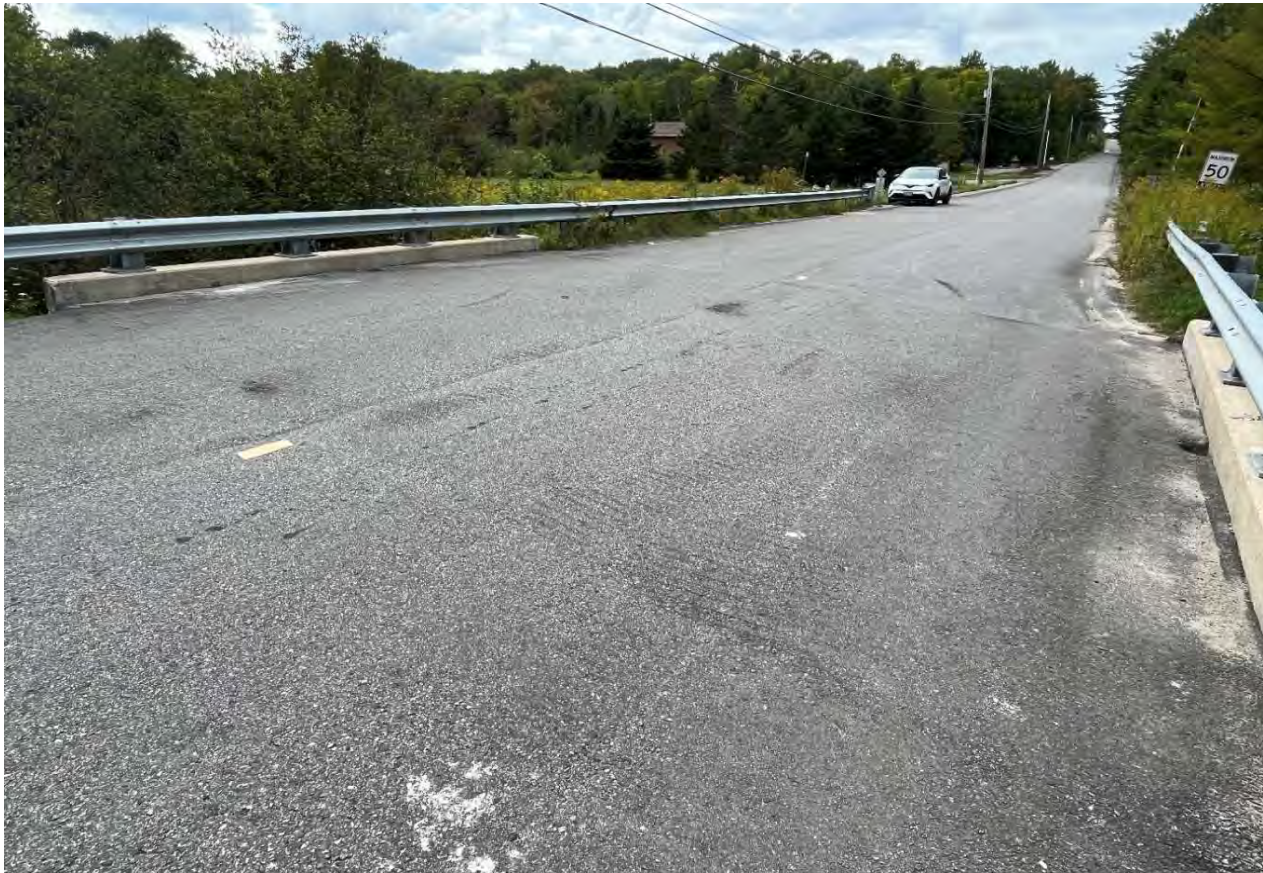
Description of Photo: Asphalt covered concrete deck

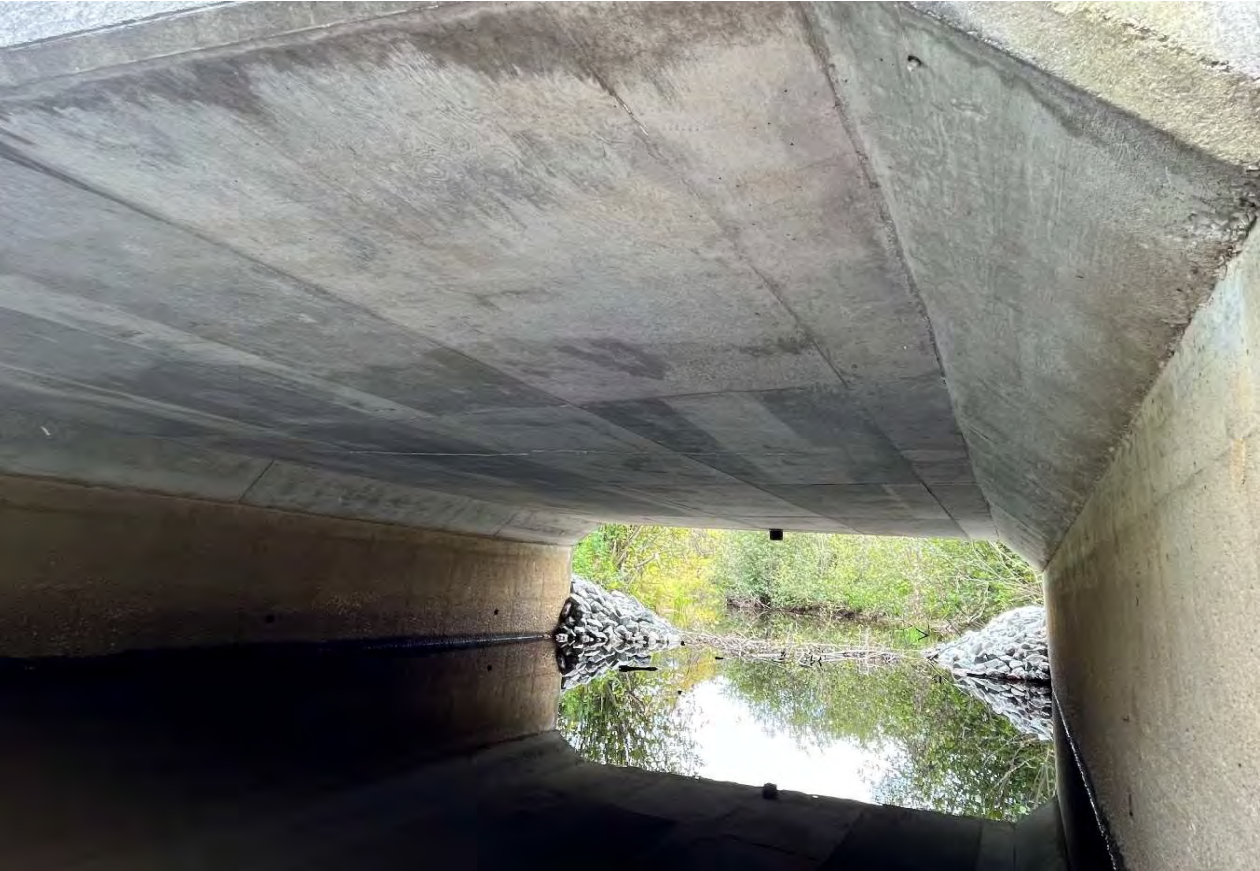
</div>						
<div> <div>Description of Photo:</div> <div>Soffit - looking south</div> </div>

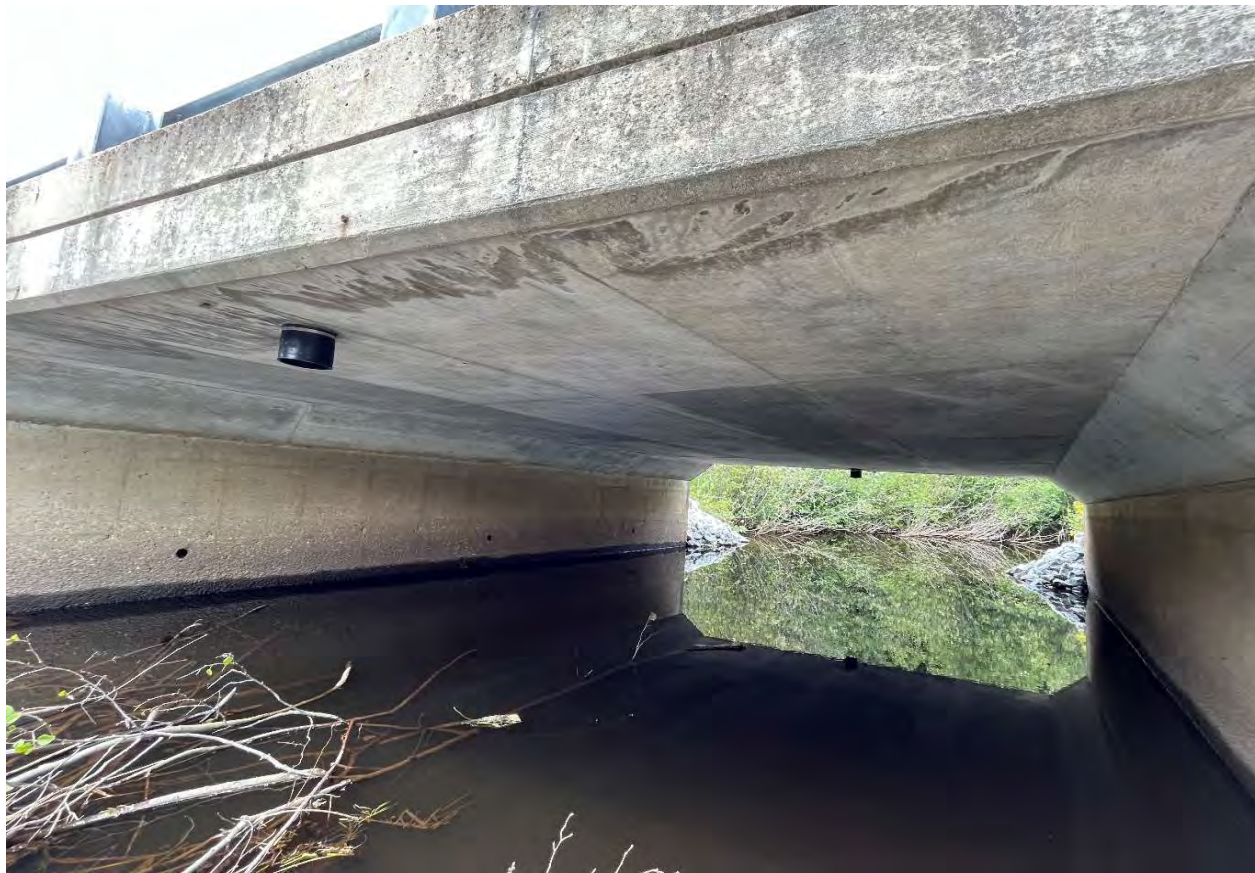
Description of Photo: Soffit - looking north

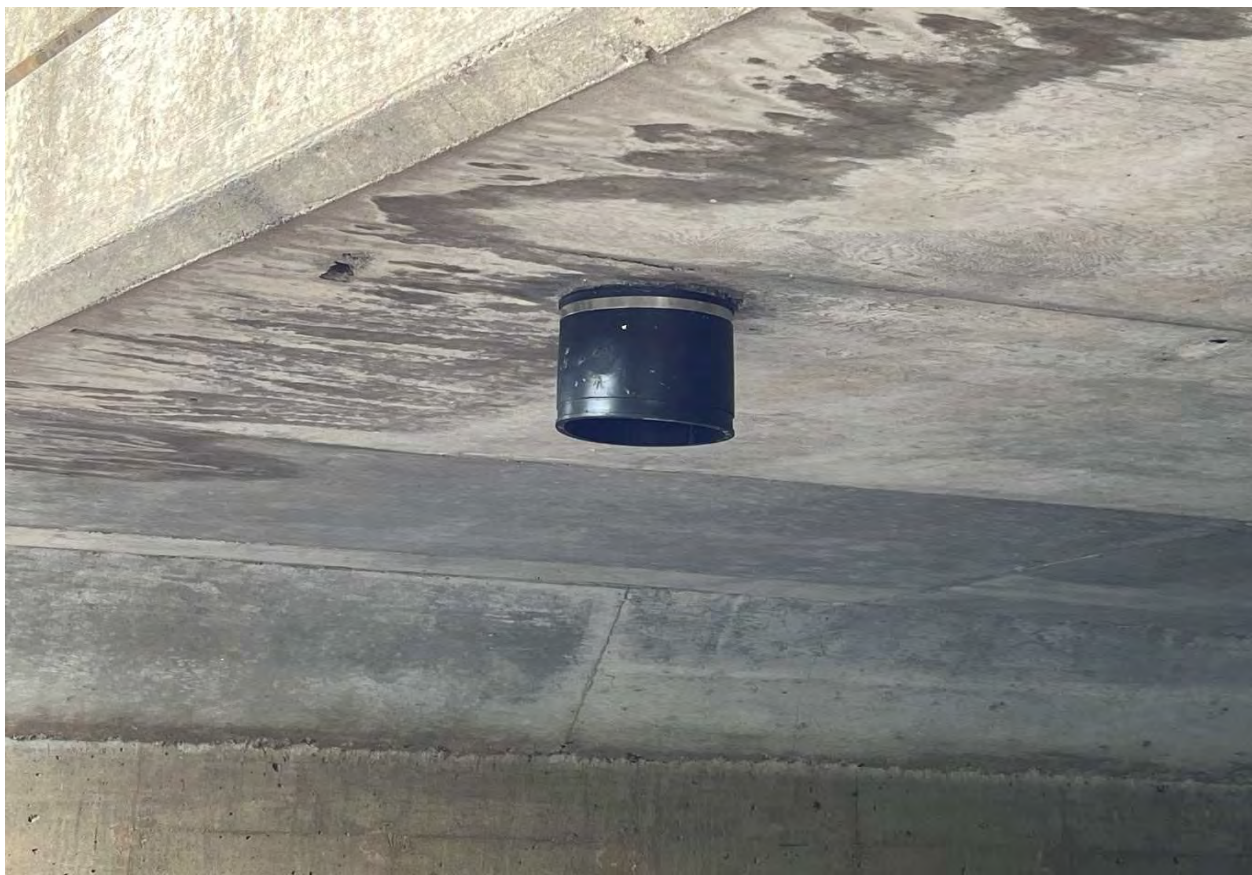
Comments: Light corrosion on the steel. No observed defects on the 2023 elastomeric extentions.

Description of Photo: Deck drain - extension, typ.

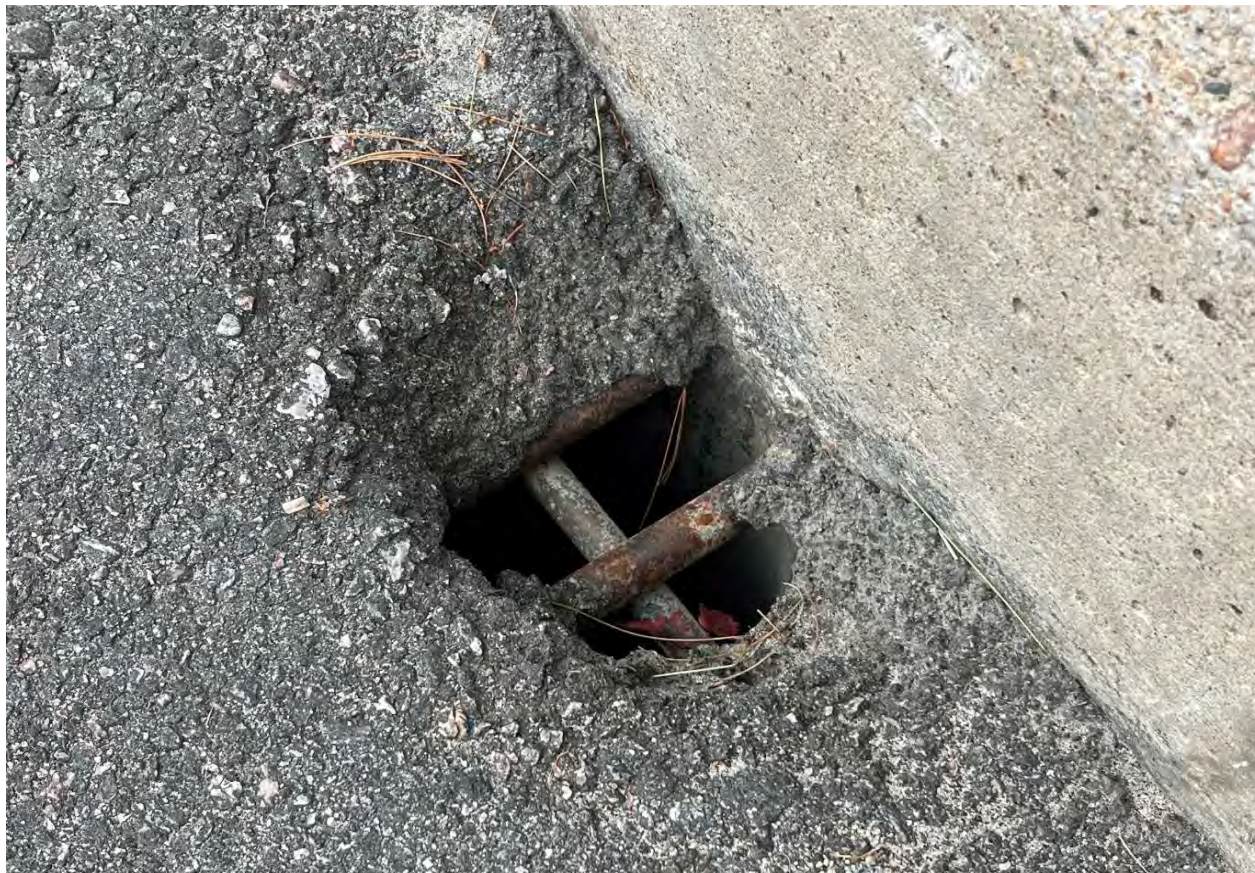
Description of Photo: Deck drain - Steel, typ.

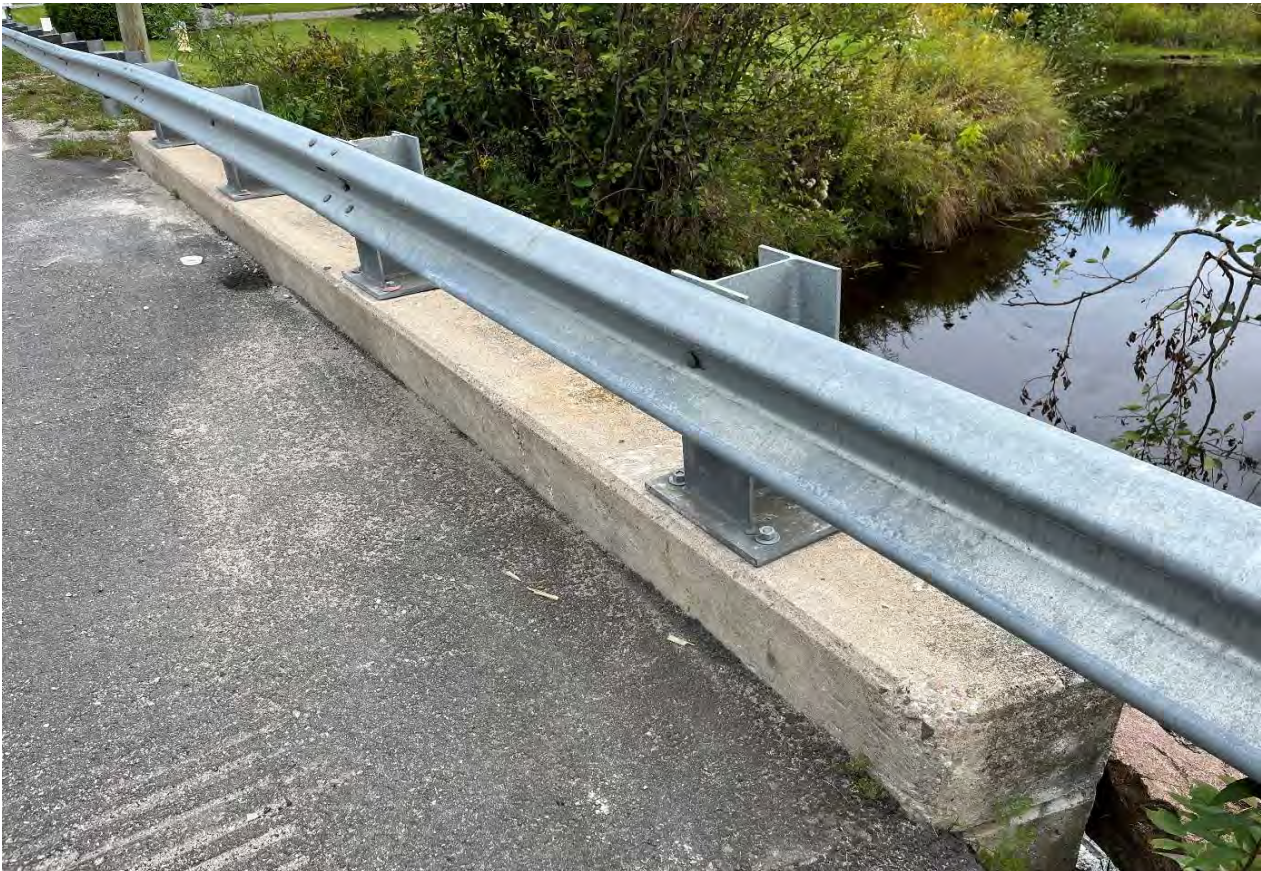
Comments: **No observed defects.**

**Description of Photo:** Railing syetem - looking south

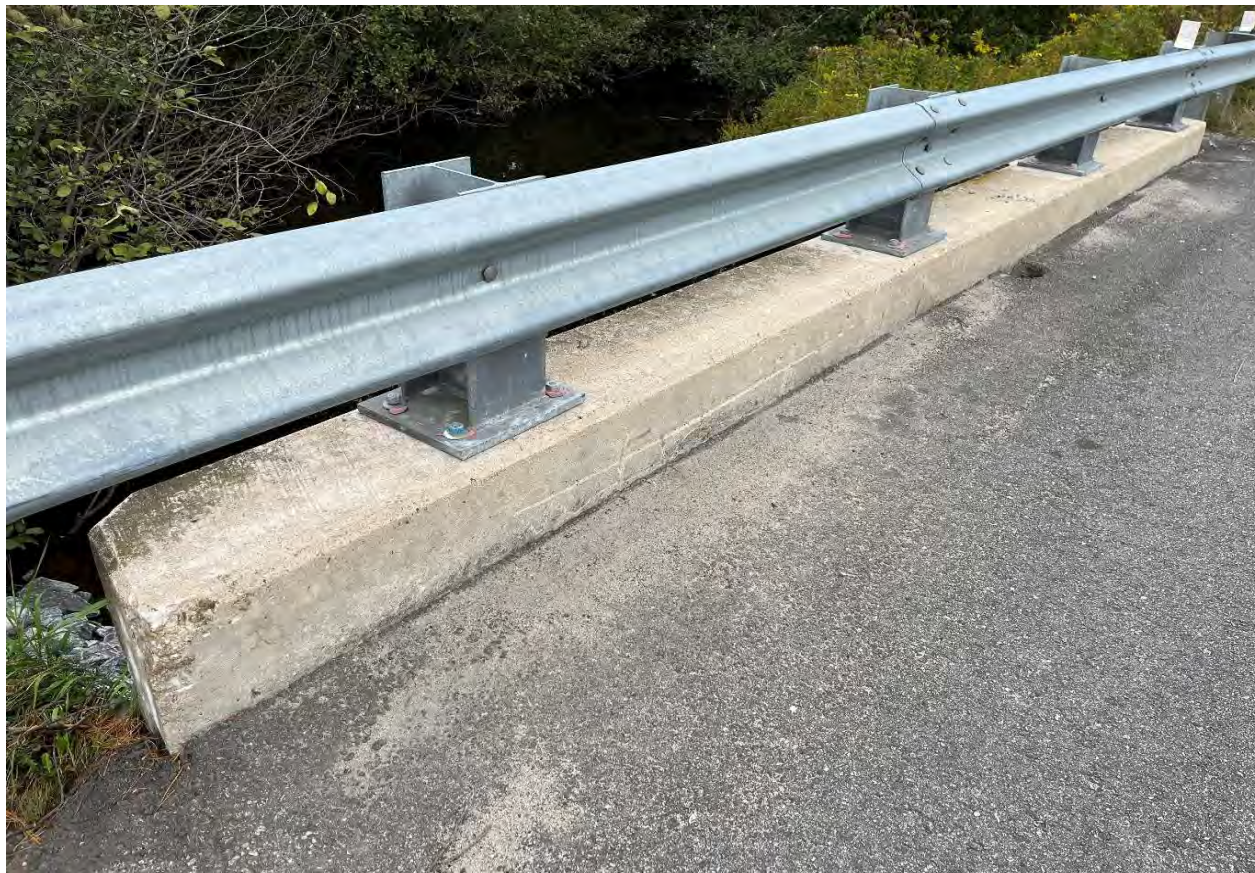
Description of Photo: Railing system - looking north

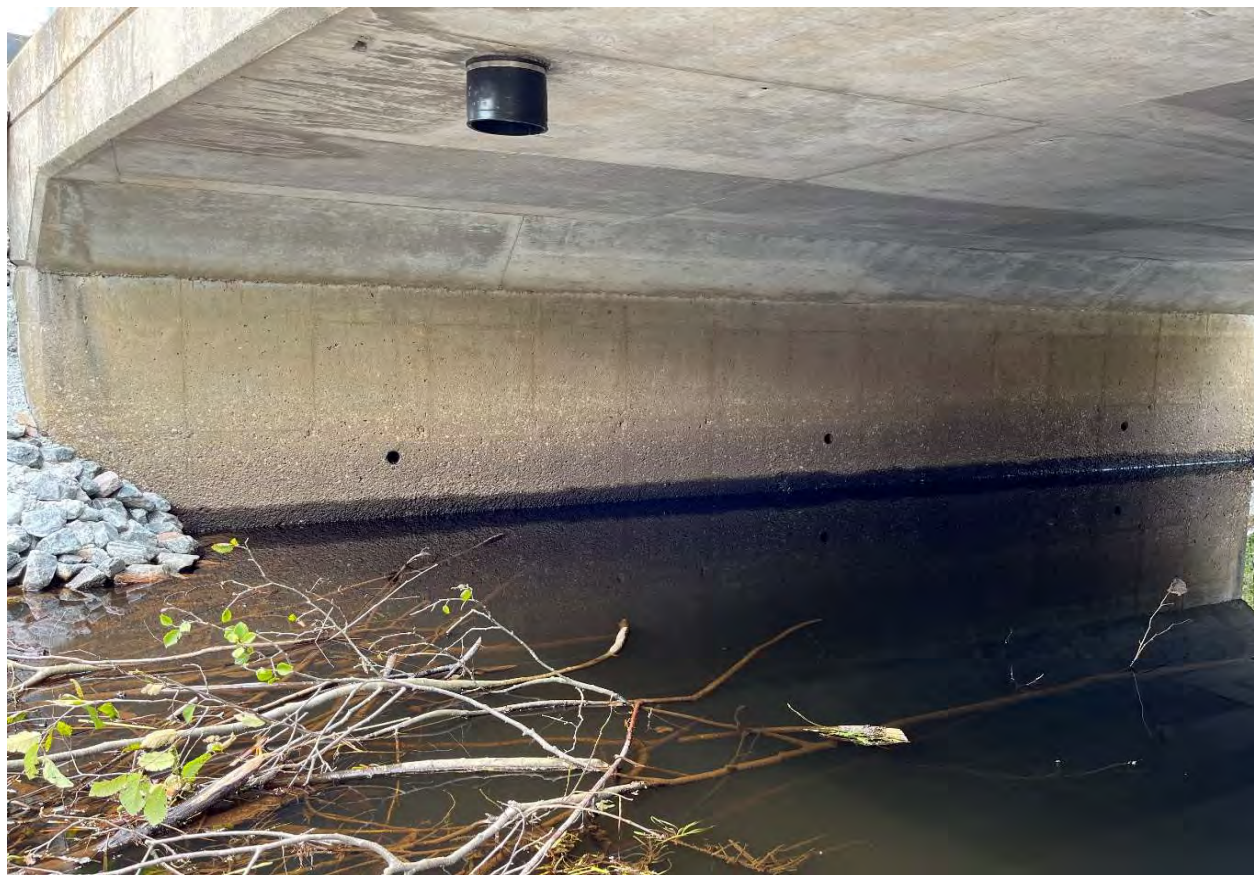
Description of Photo: West abutment wall

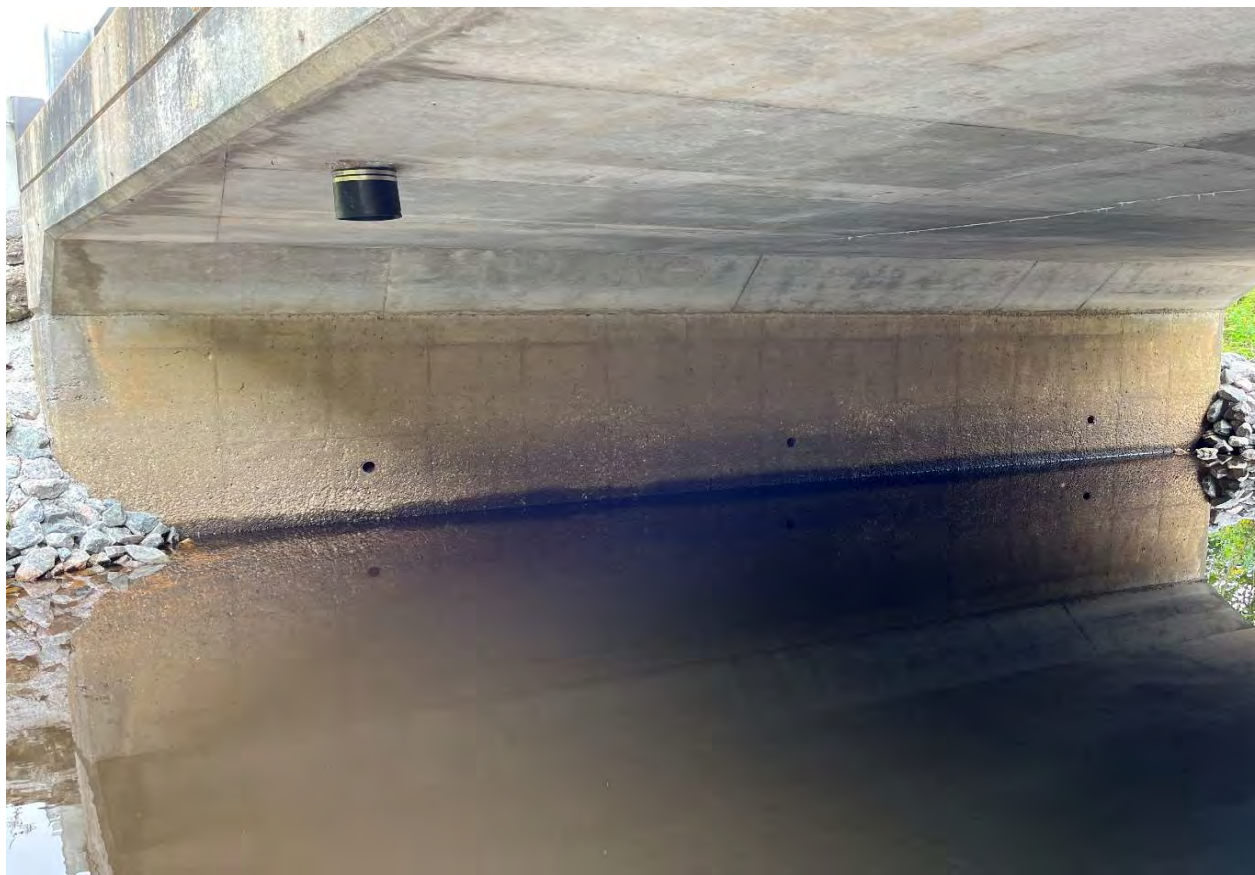
Description of Photo: East abutment wall

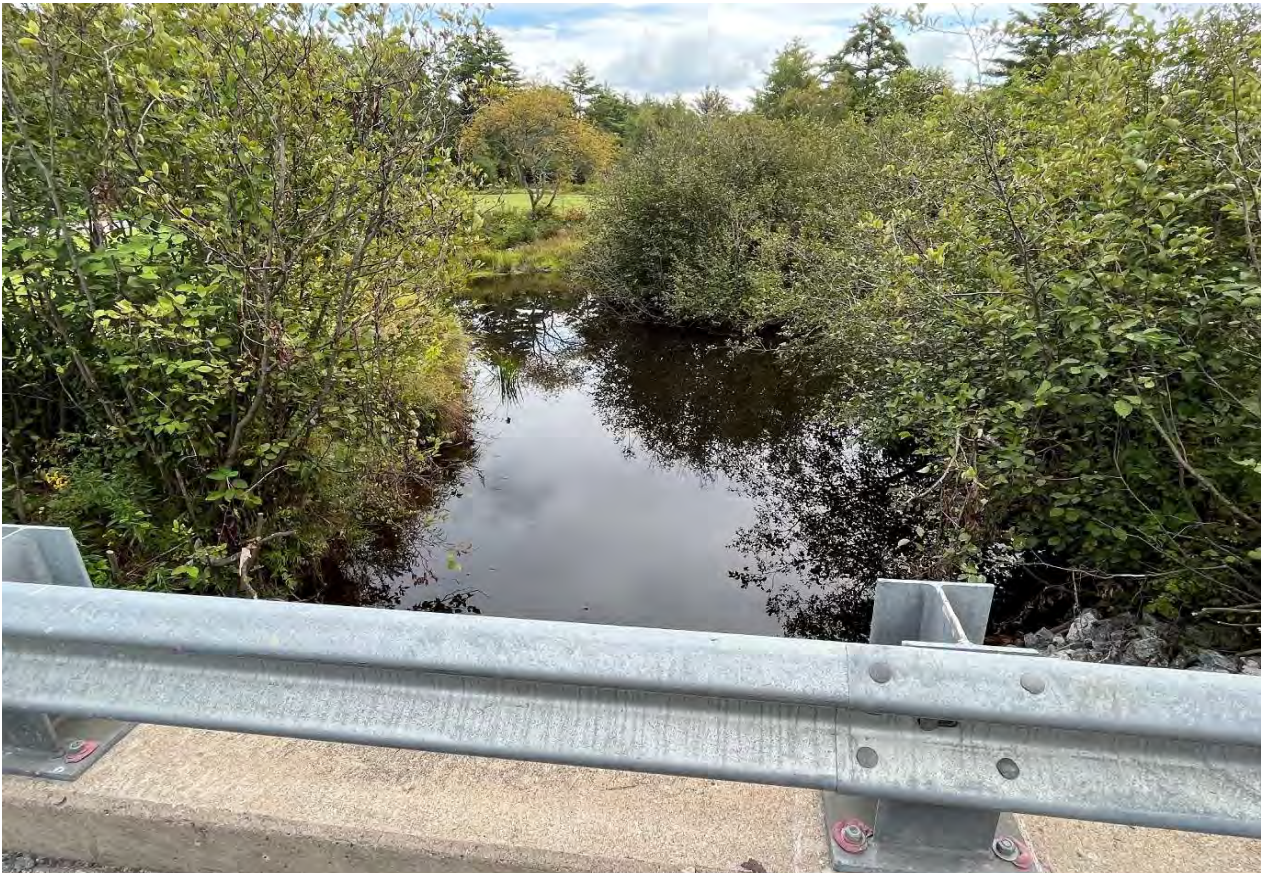
Description of Photo: Watercourse - looking south
