Bridge Needs Study

INSPECTION SUMMARY REPORT

Town of Gravenhurst

August
29, 2024

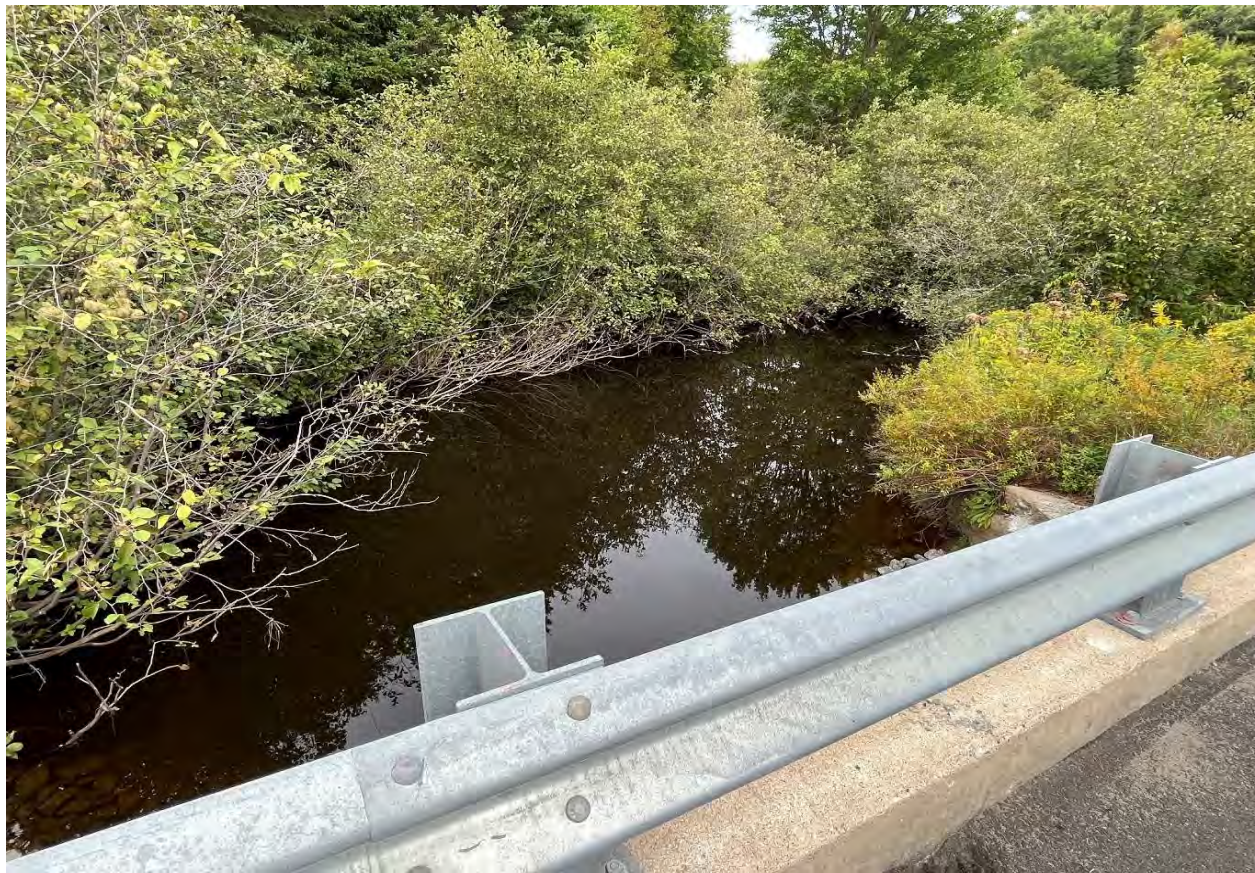
Description of Photo: Watercourse - looking north

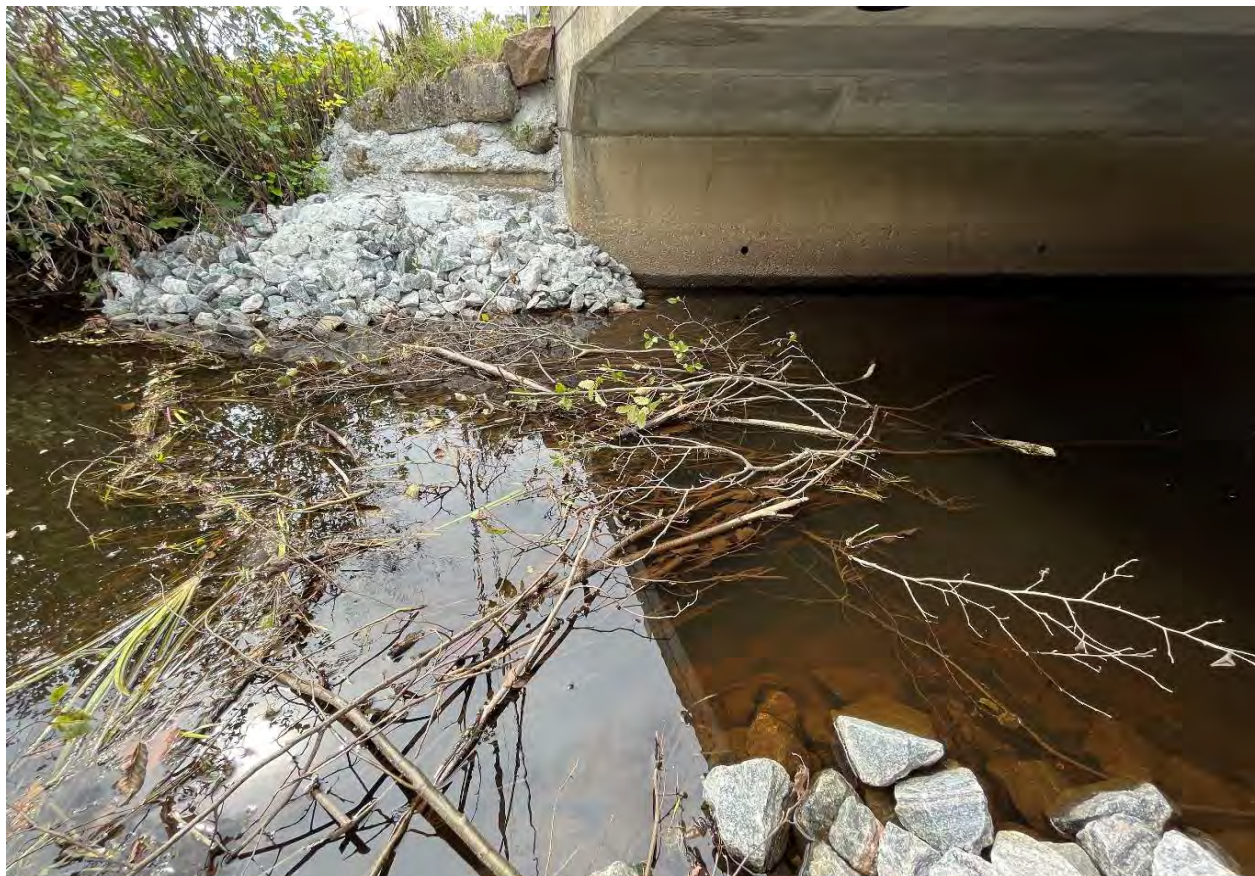
Comments: No observed defects. Debris buildup at upstream, however, not affecting flow.

Description of Photo: Debris buildup at upstream

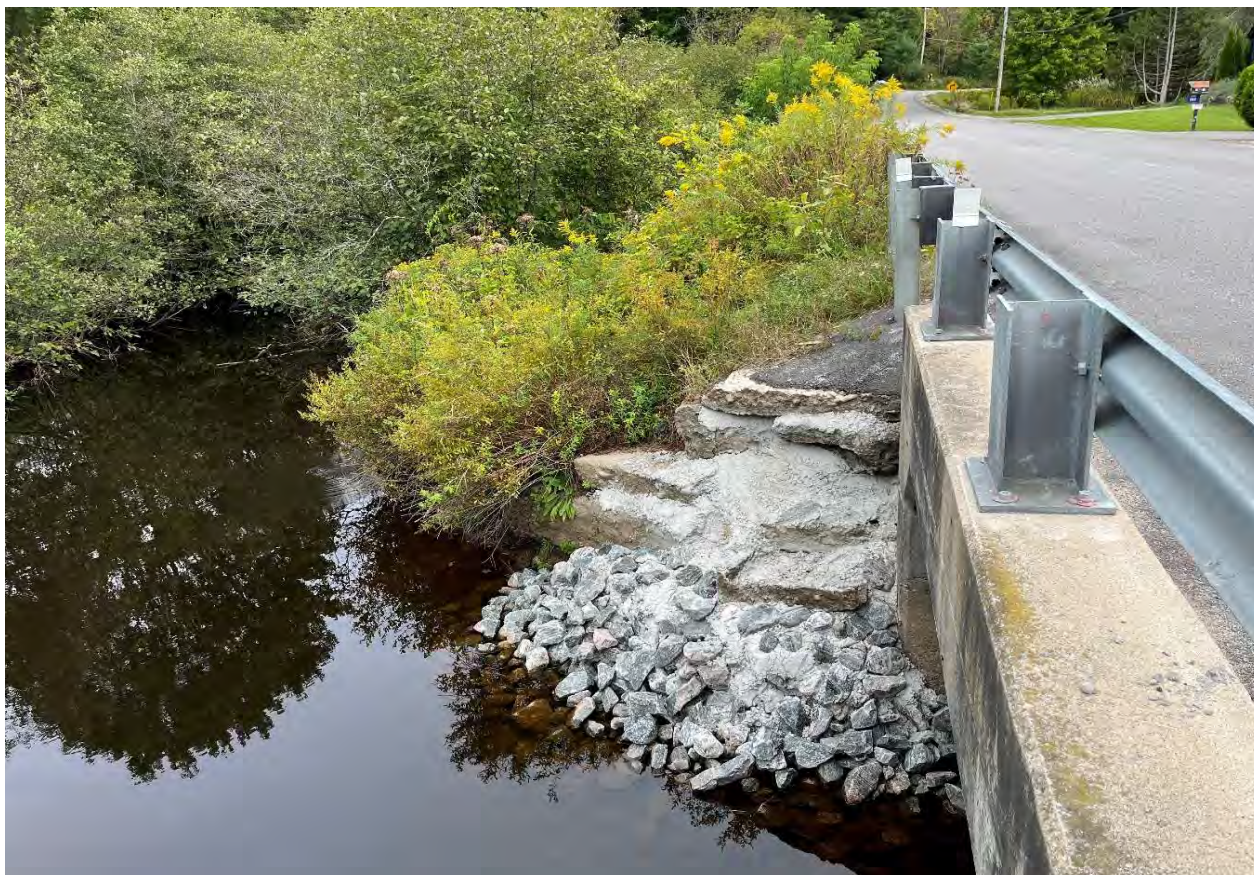
Comments: **No observed defects.**

Description of Photo: Northeast embankment

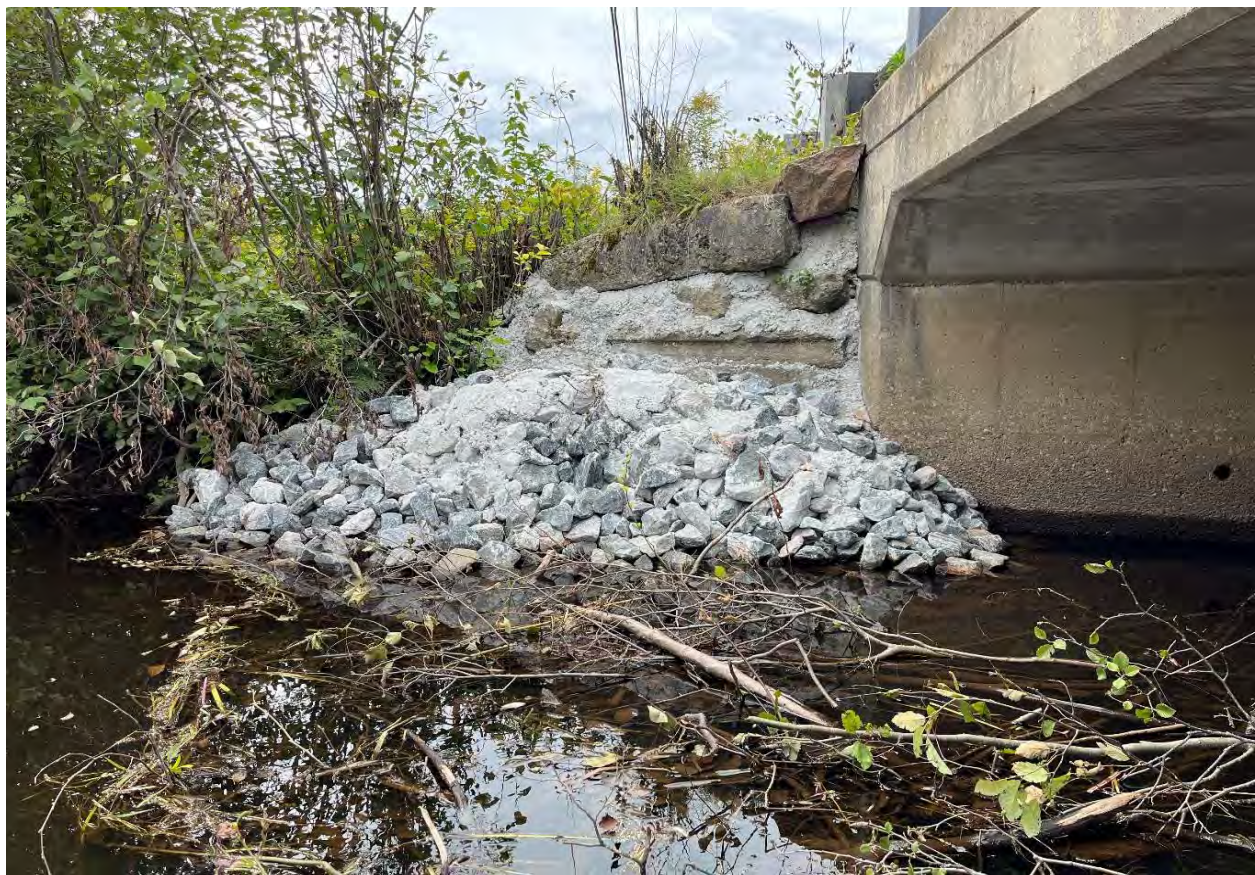
Description of Photo: Southwest embankment

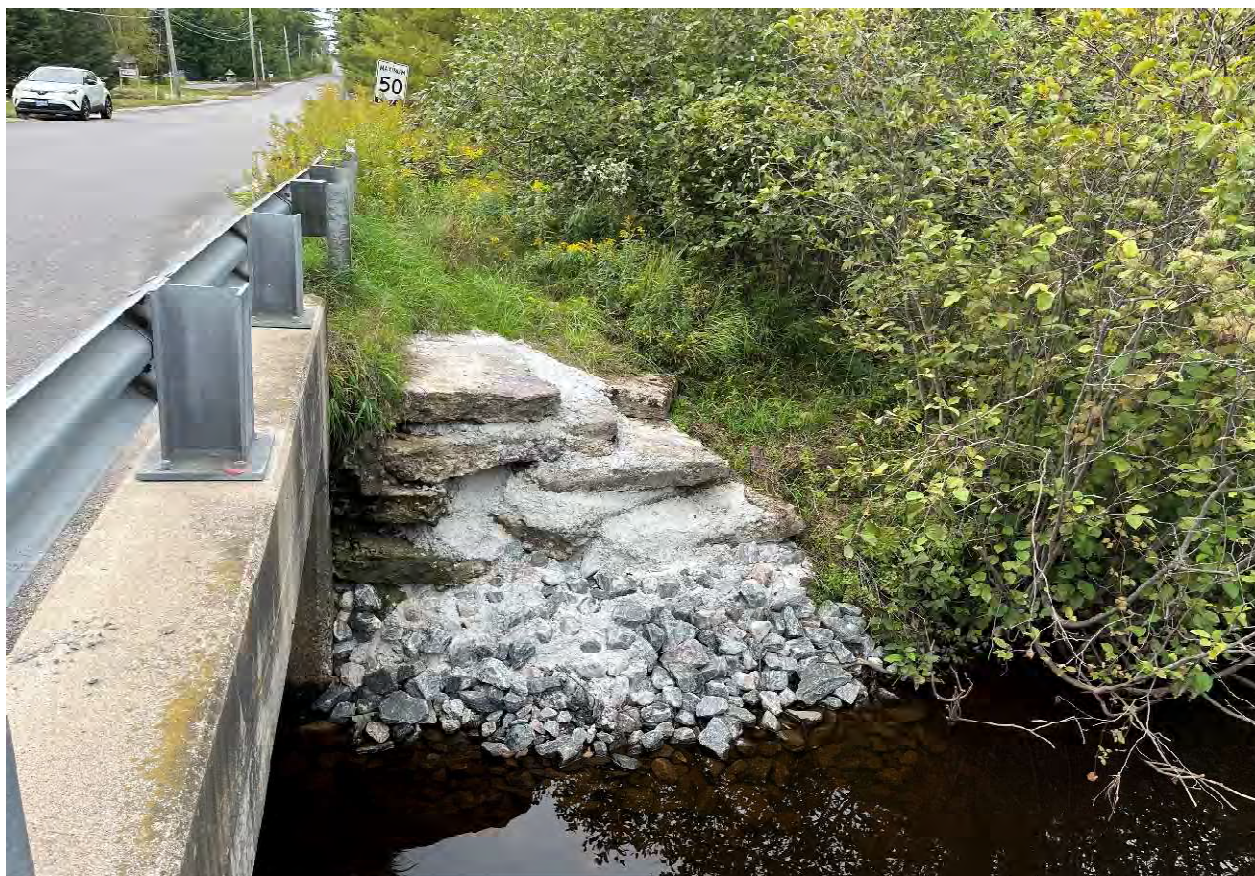
Description of Photo: Northwest embankment

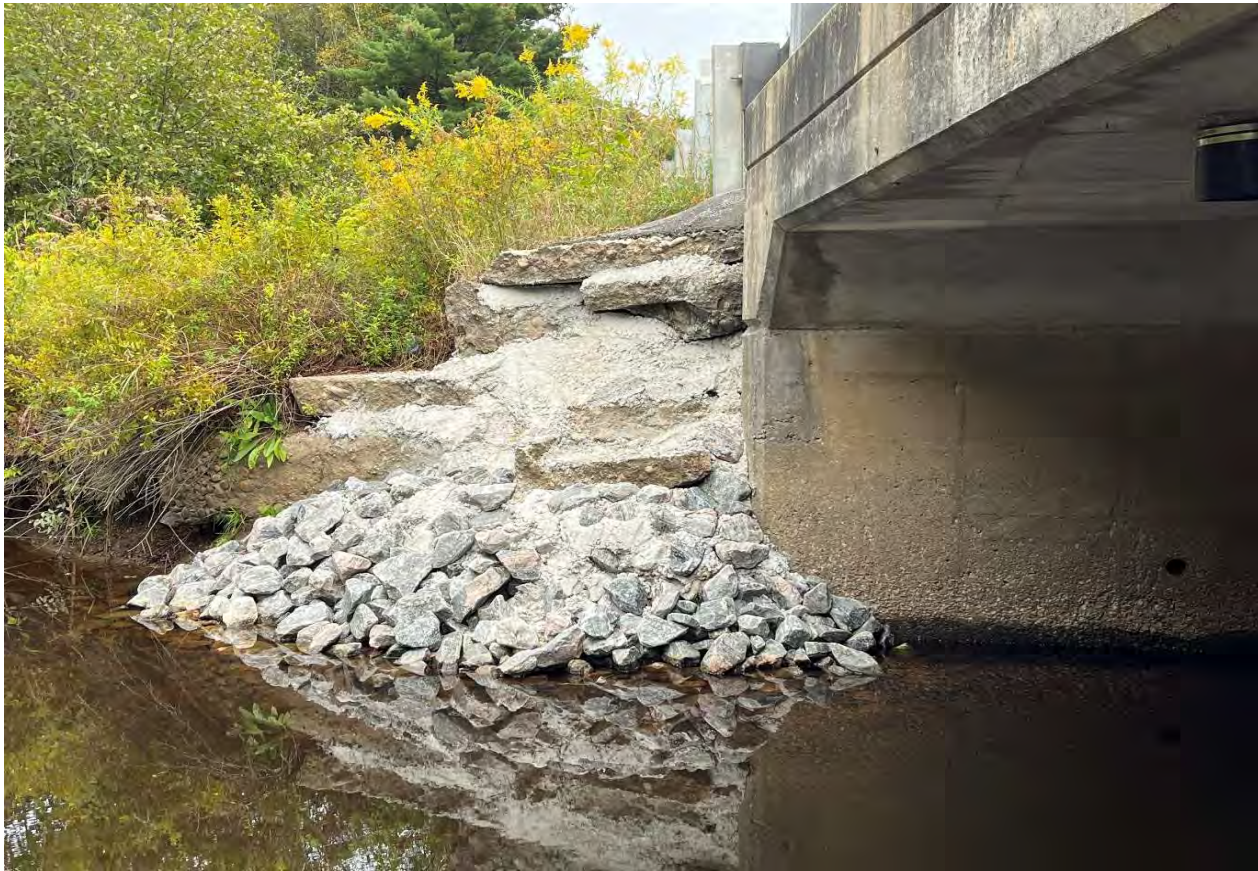
Description of Photo: Northeast slope protection

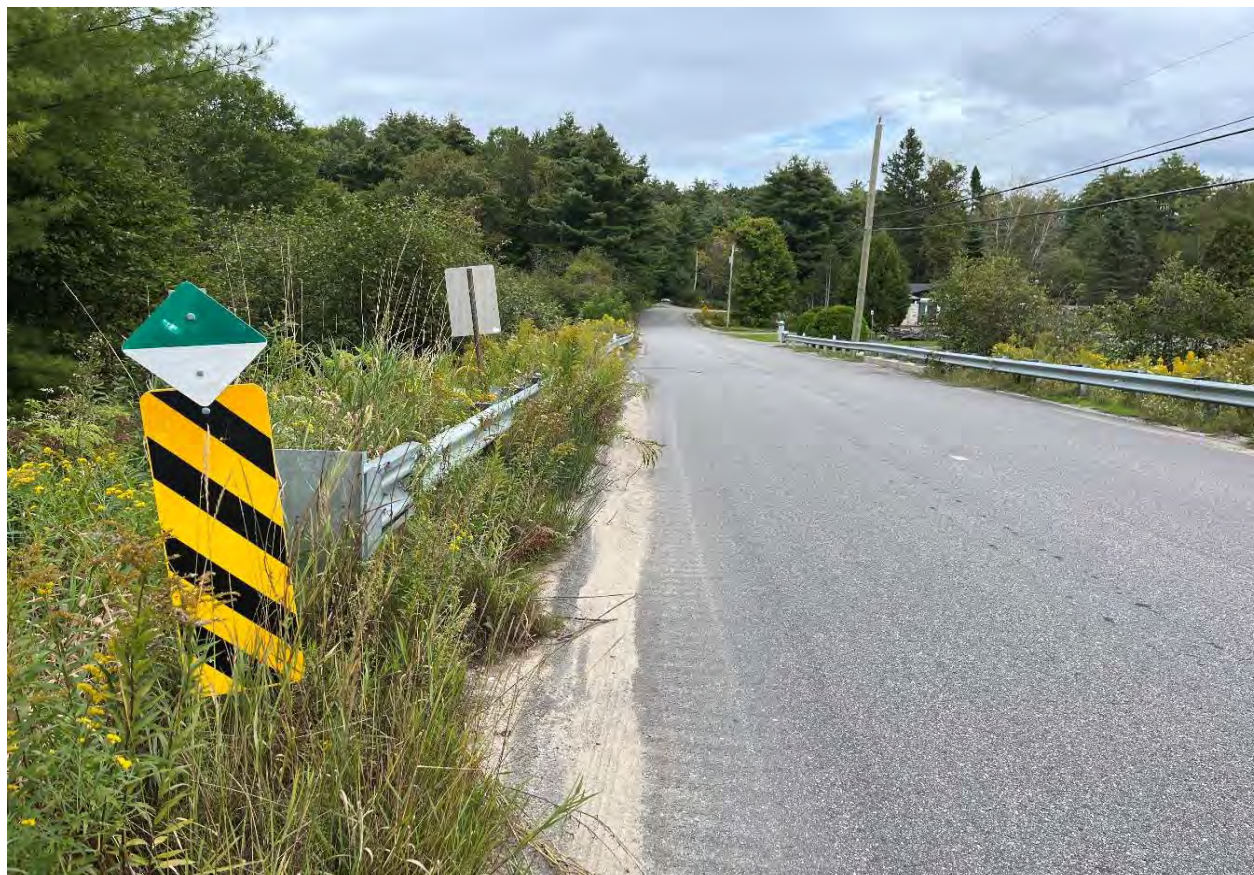
**Description of Photo:** Hazard warning sign, typ.

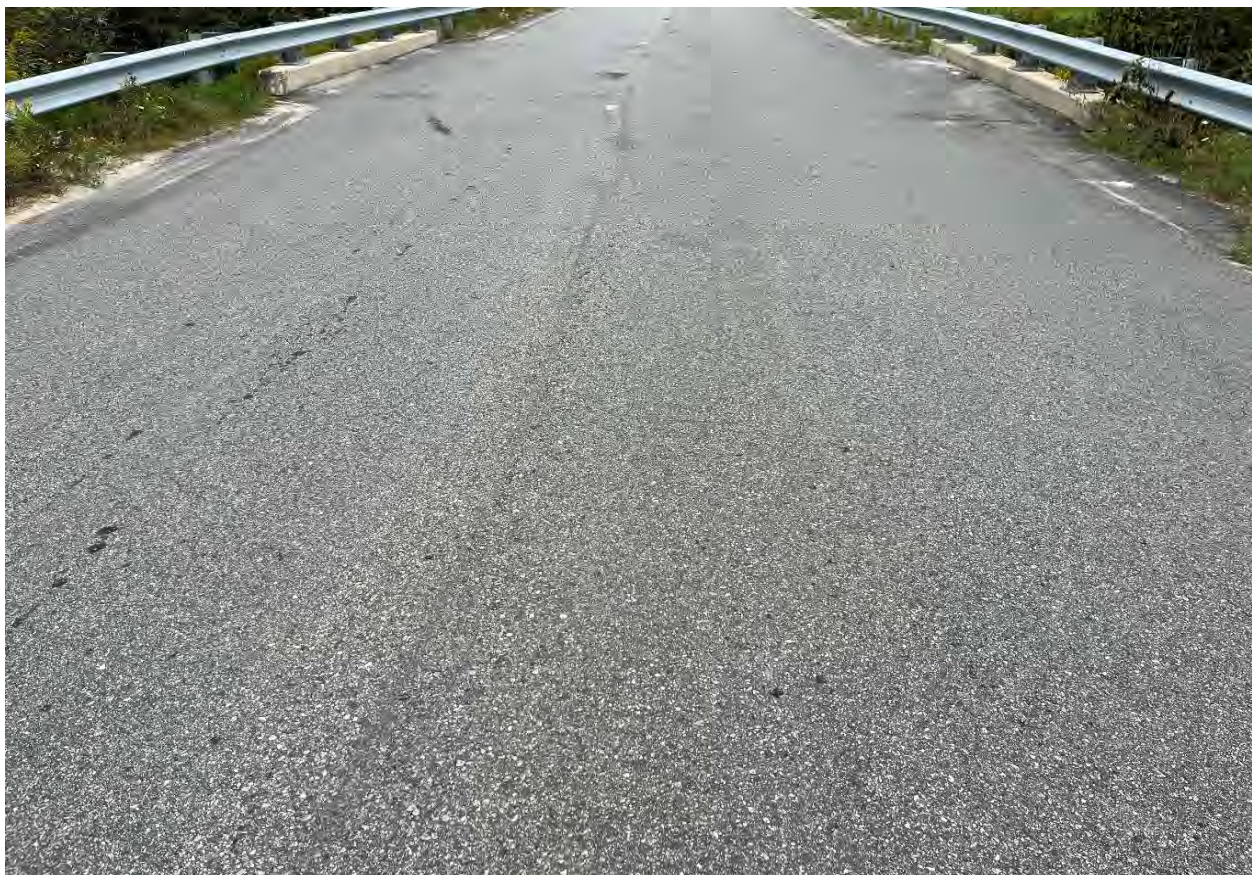
Description of Photo: Approach wearing surface - looking east

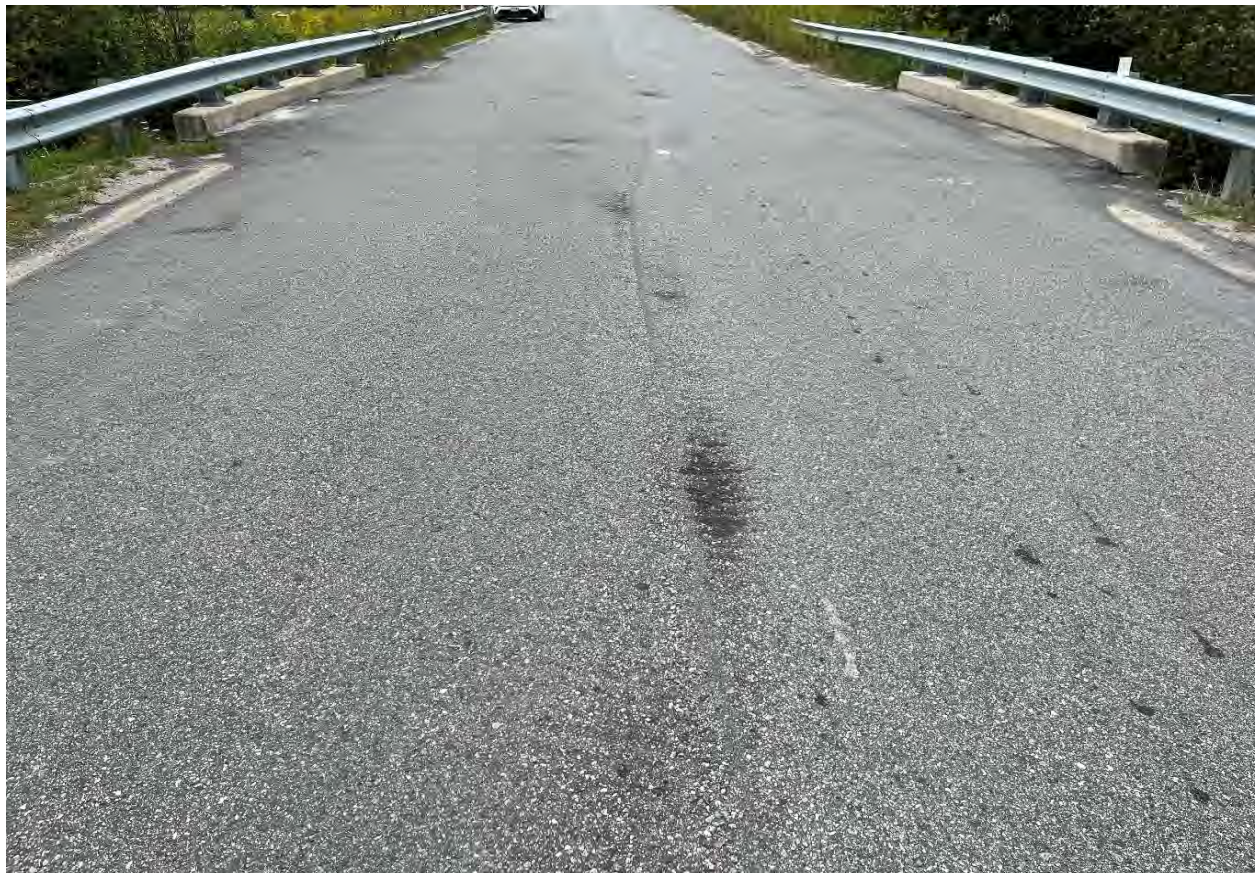
Description of Photo: Approach wearing surface - looking west

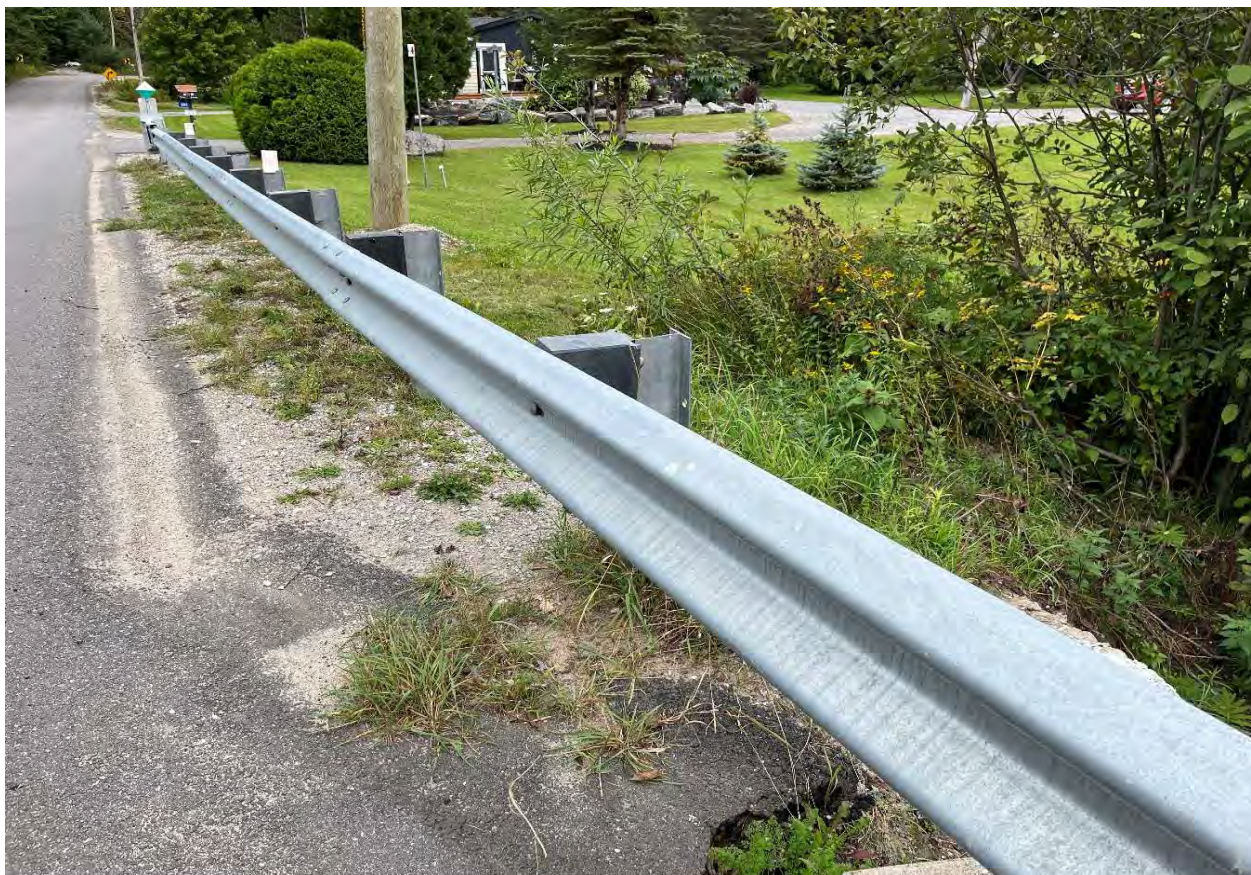
Description of Photo: Approach guide rail - southeast quadrant

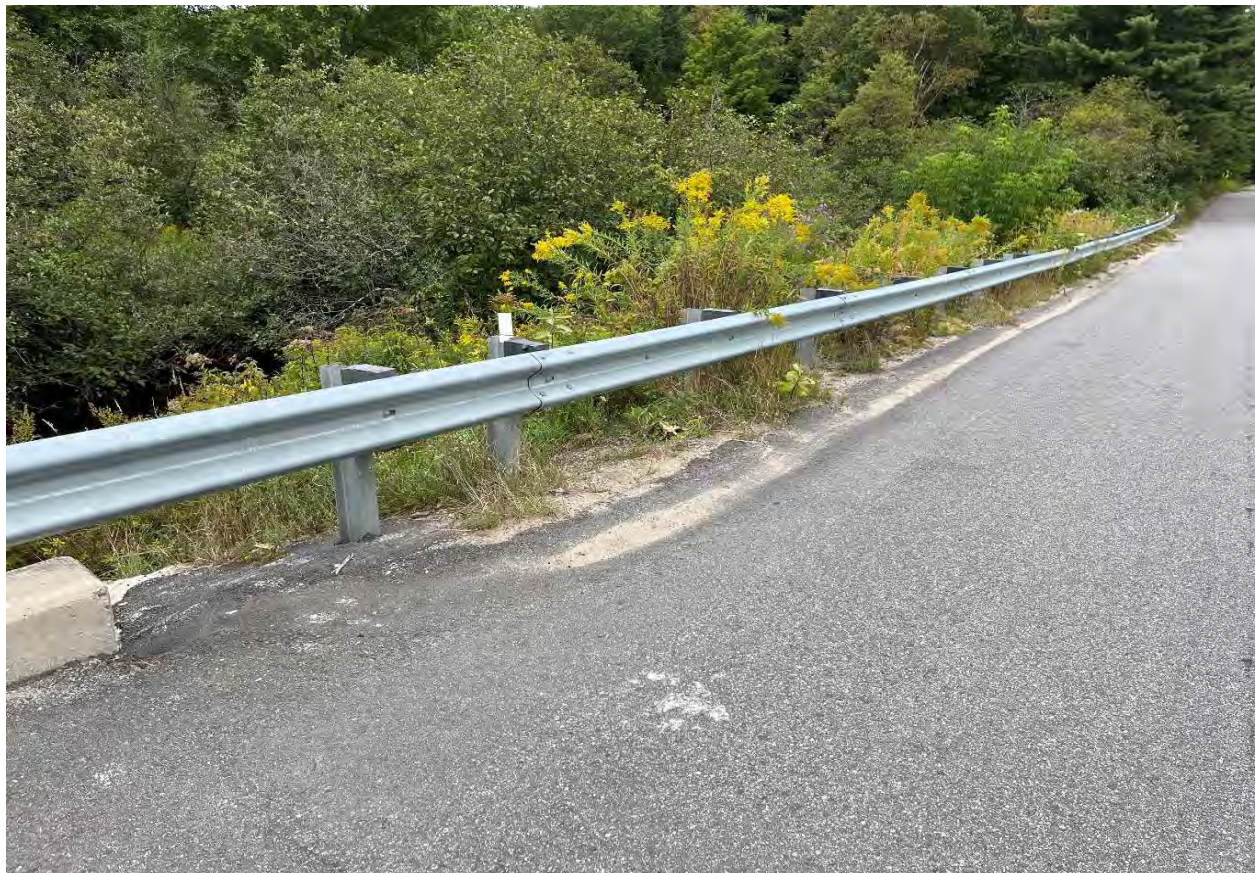
Description of Photo: Approach guide rail - northeast quadrant

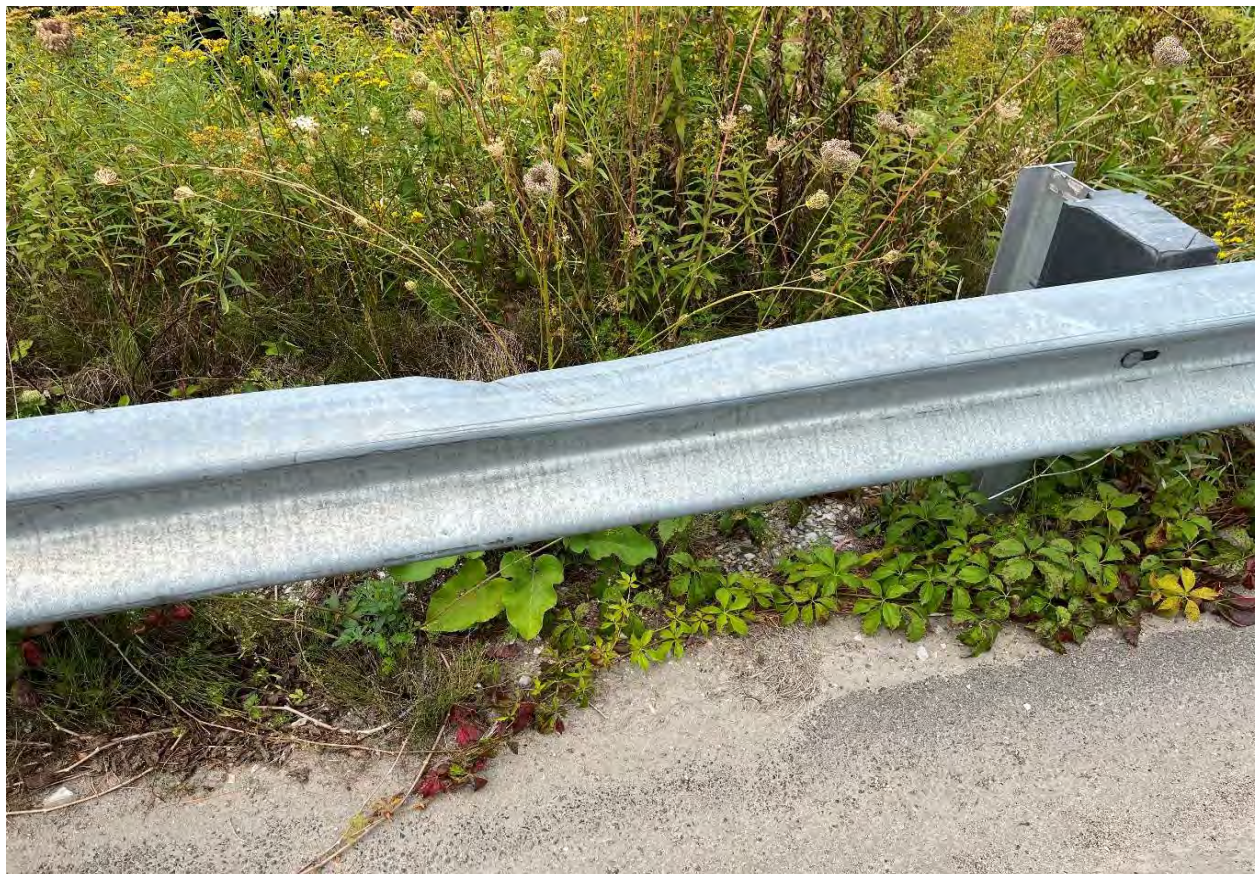
Comments: Recently installed barrier. One 300mm long deformation noted at the northwest approach. No other observed defects.

Description of Photo: Deformed section

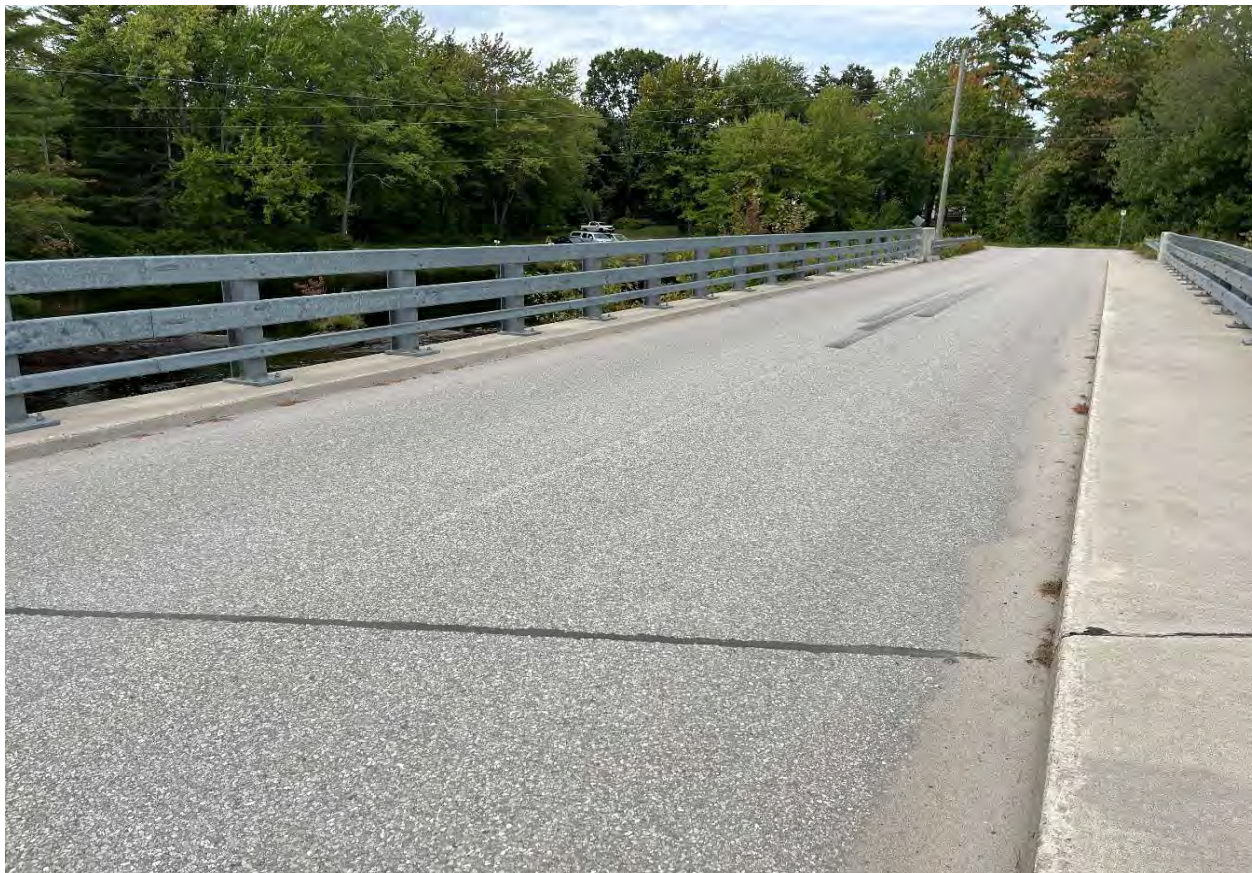
Description of Photo: Wearing surface

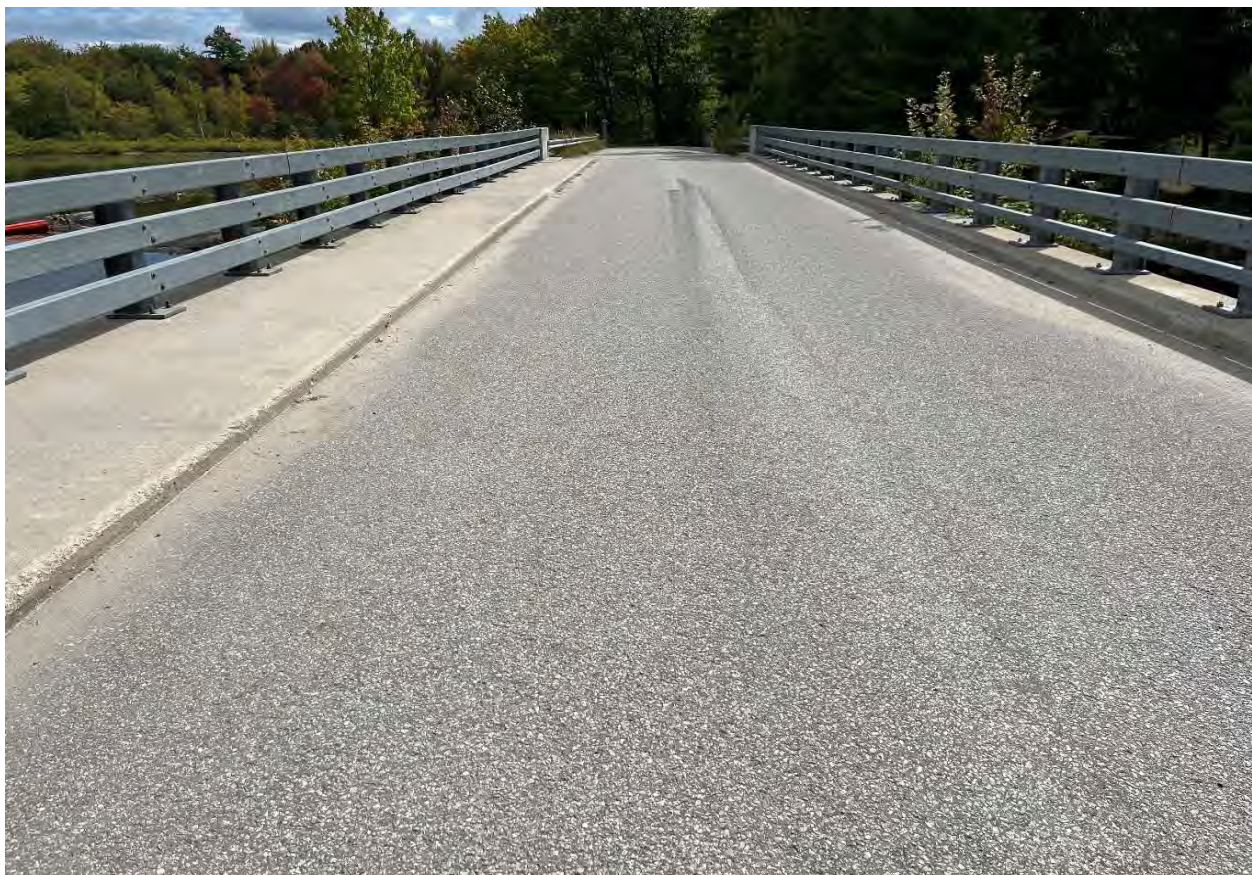
Comments: **Not visible for inspection. Assumed in good condition based on the condition of wearing surface and soffit.**

Description of Photo: Asphalt covered deck top

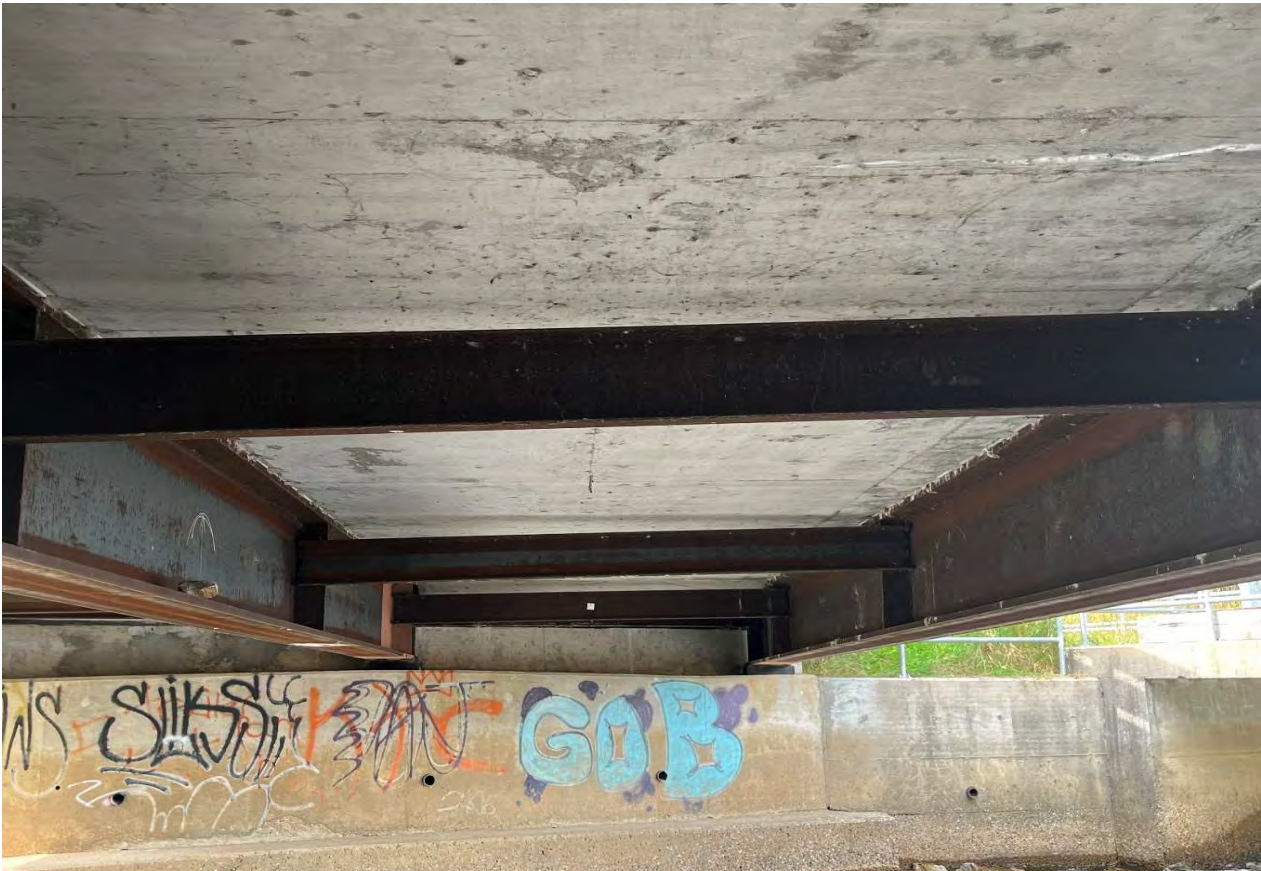
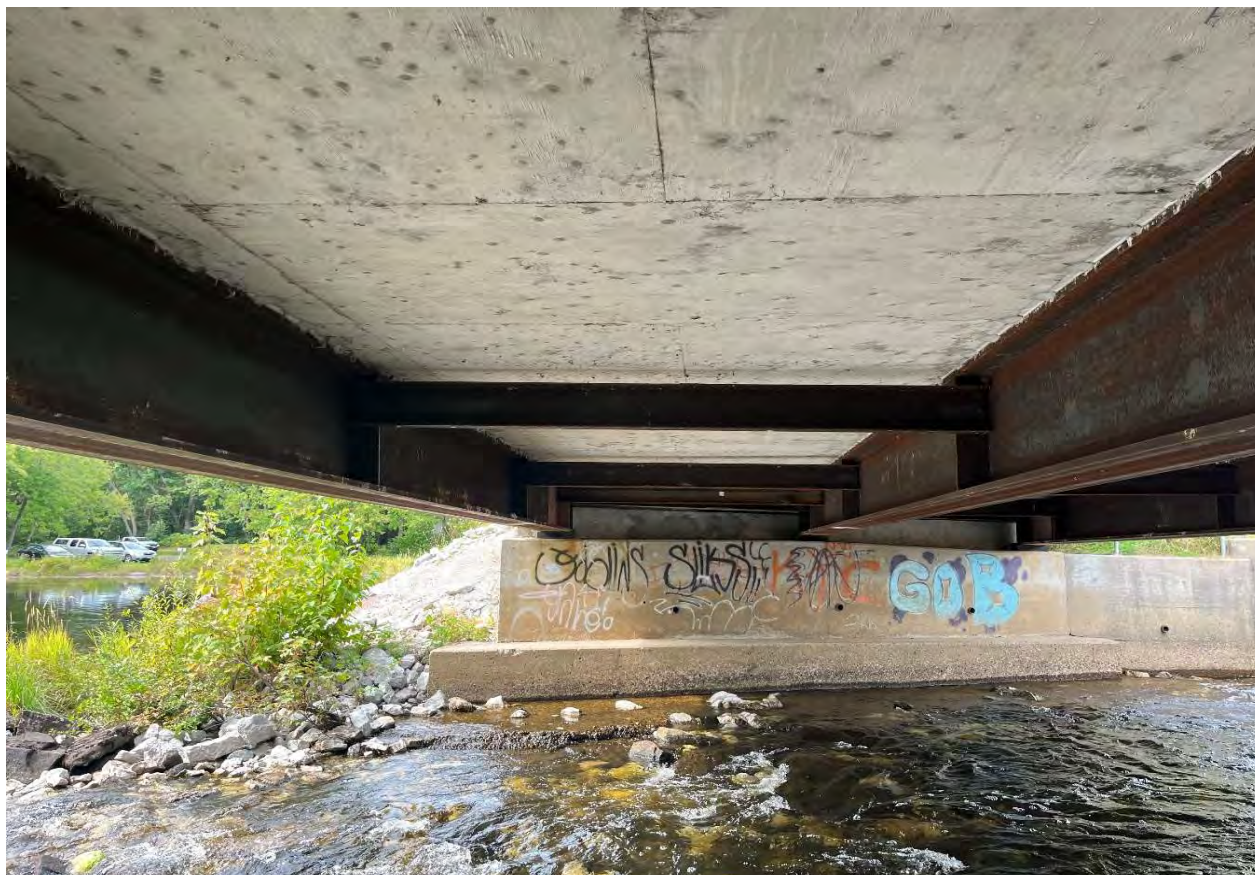
Comments: Light scaling, typ. Isolated narrow transverse cracks with efflorescence between girders. Regularly spaced narrow to medium transverse cracks with wet areas and efflorescence (stalactites) along exterior soffit.

Description of Photo: Deck - soffit

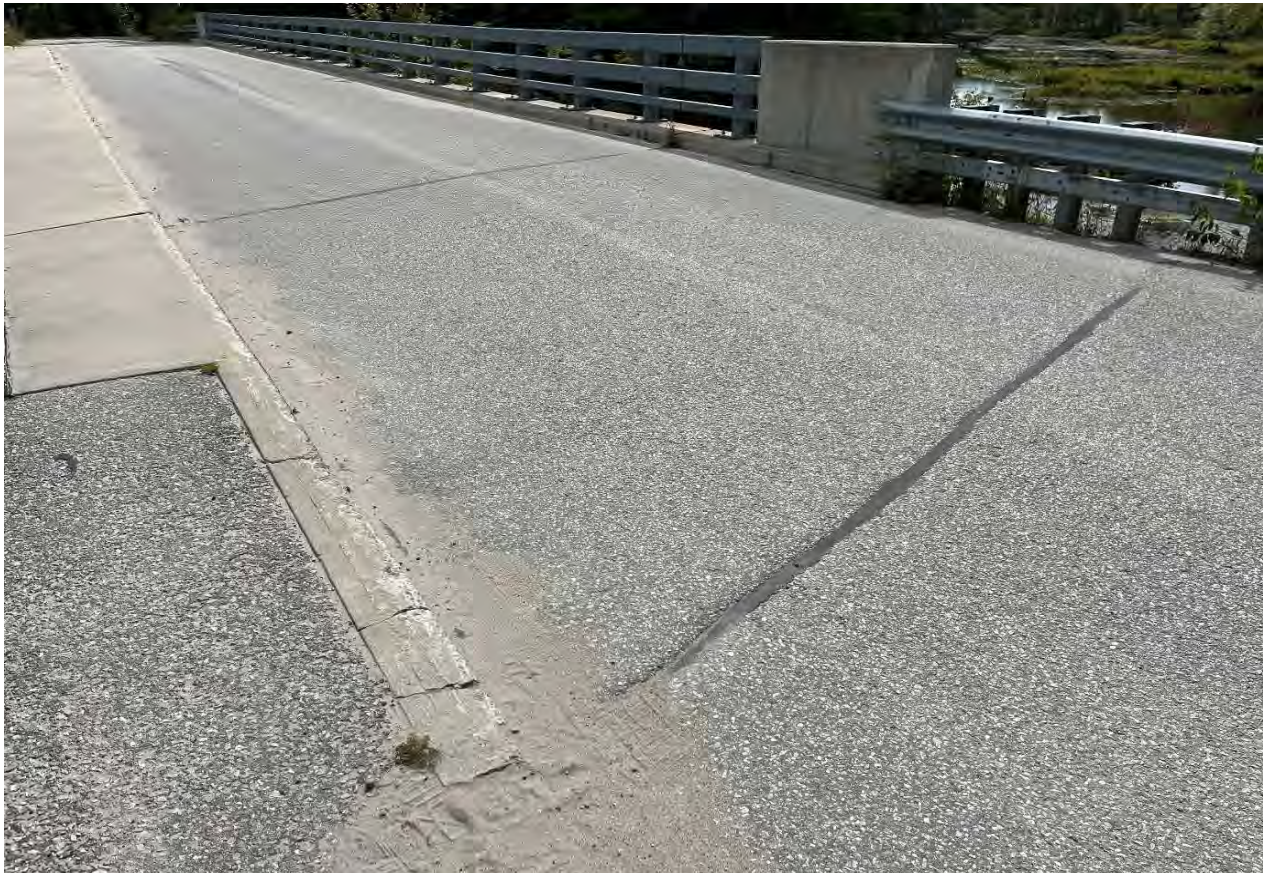
Description of Photo: Joint, typ.

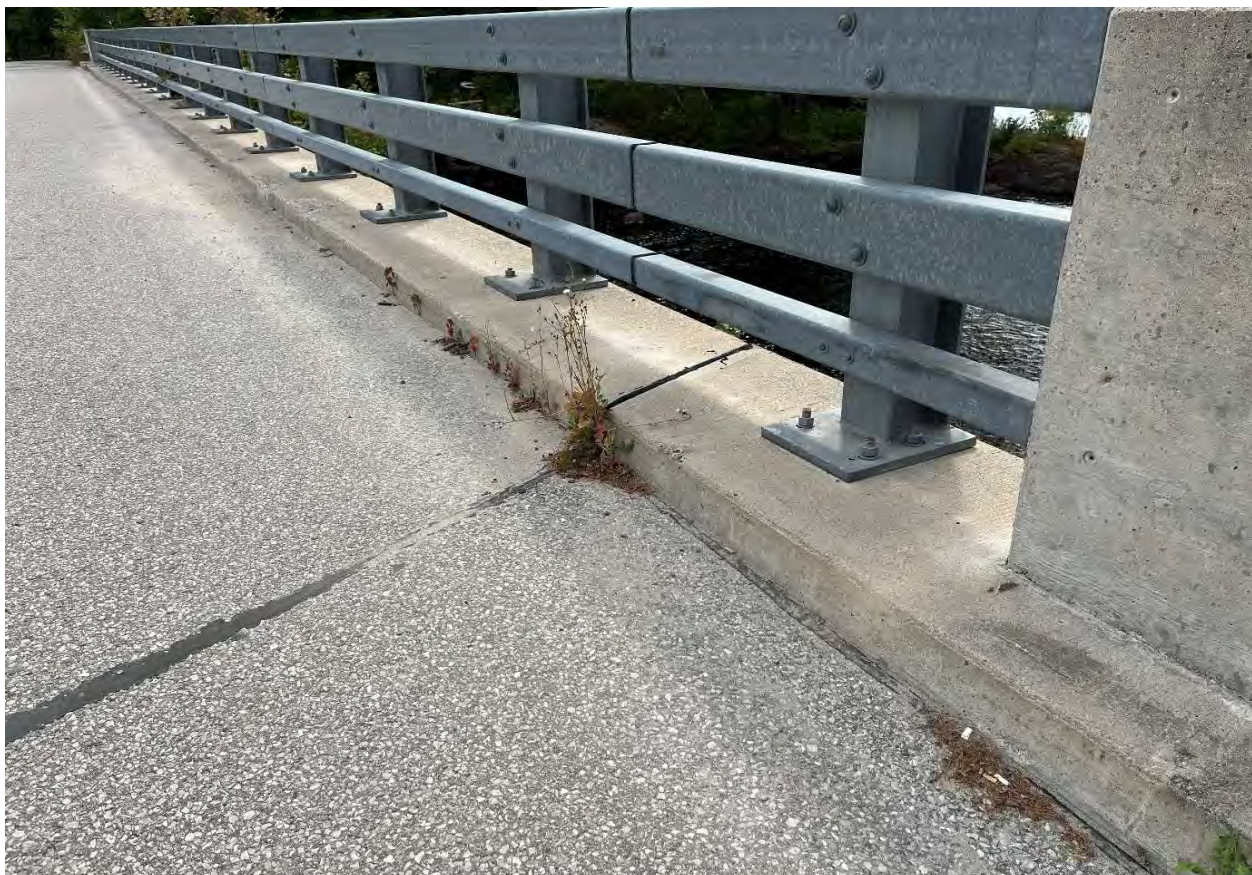
Description of Photo: Concrete sidewalk

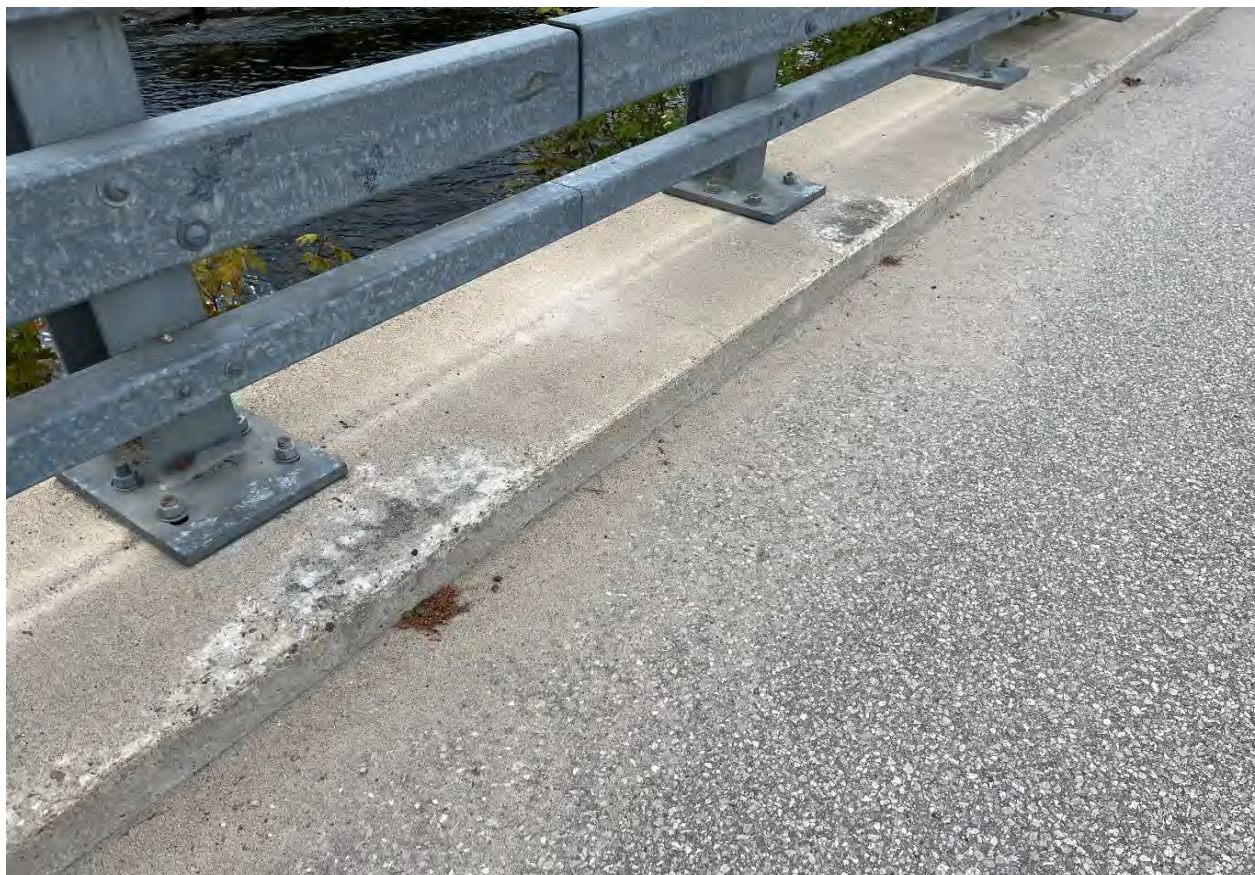
Description of Photo: Medium scaling

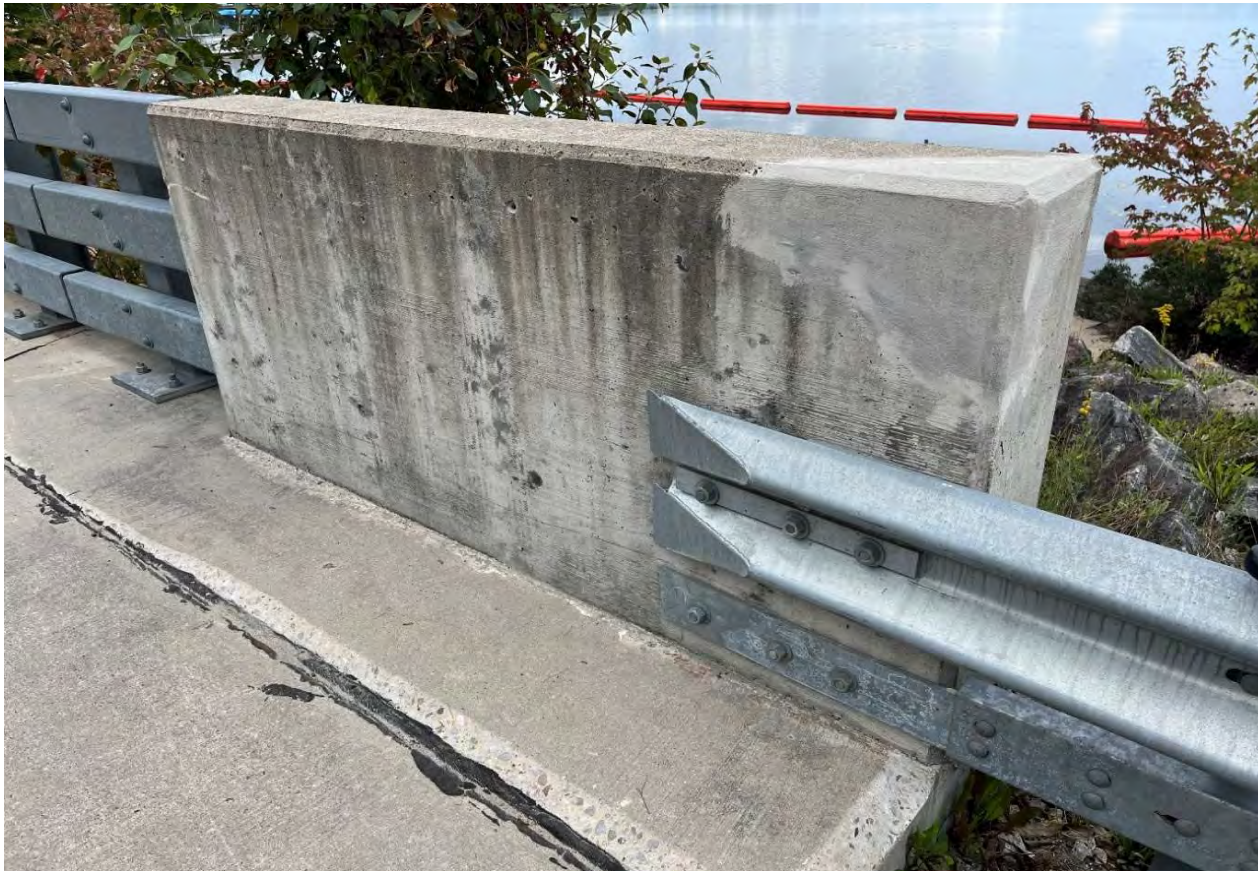
Description of Photo: Southeast end wall
