Bridge Needs Study

INSPECTION SUMMARY REPORT

Town of Gravenhurst

August
29, 2024

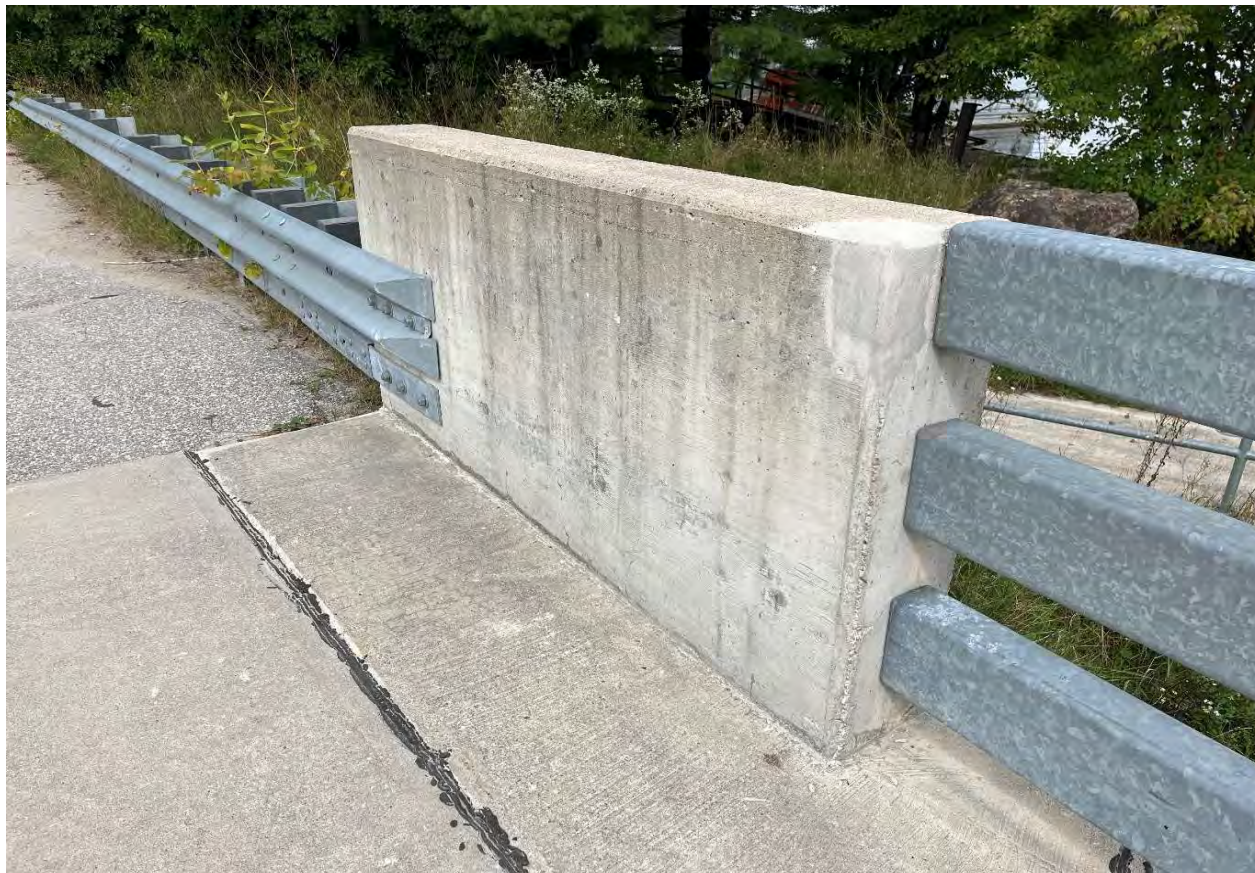
Description of Photo: Northeast end wall

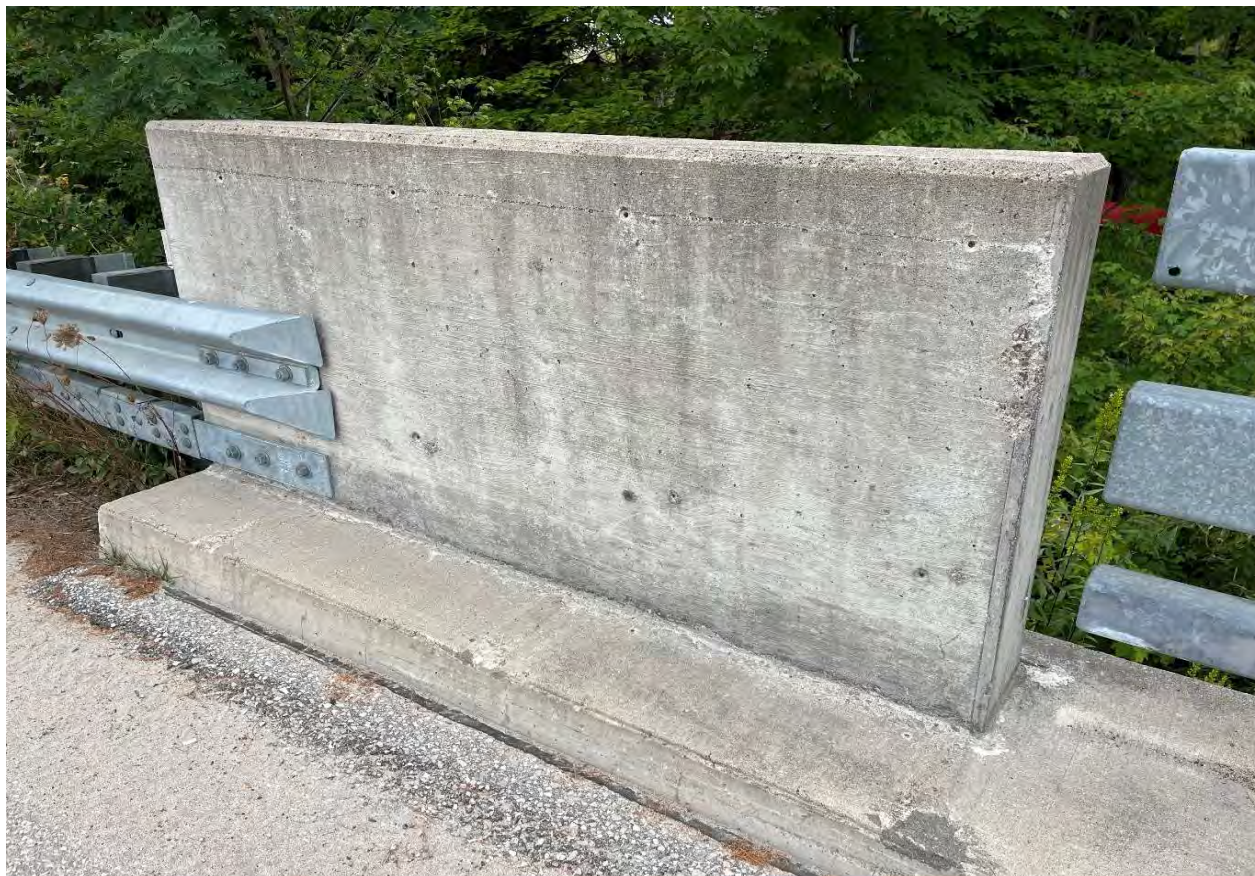
Description of Photo: Southwest end wall

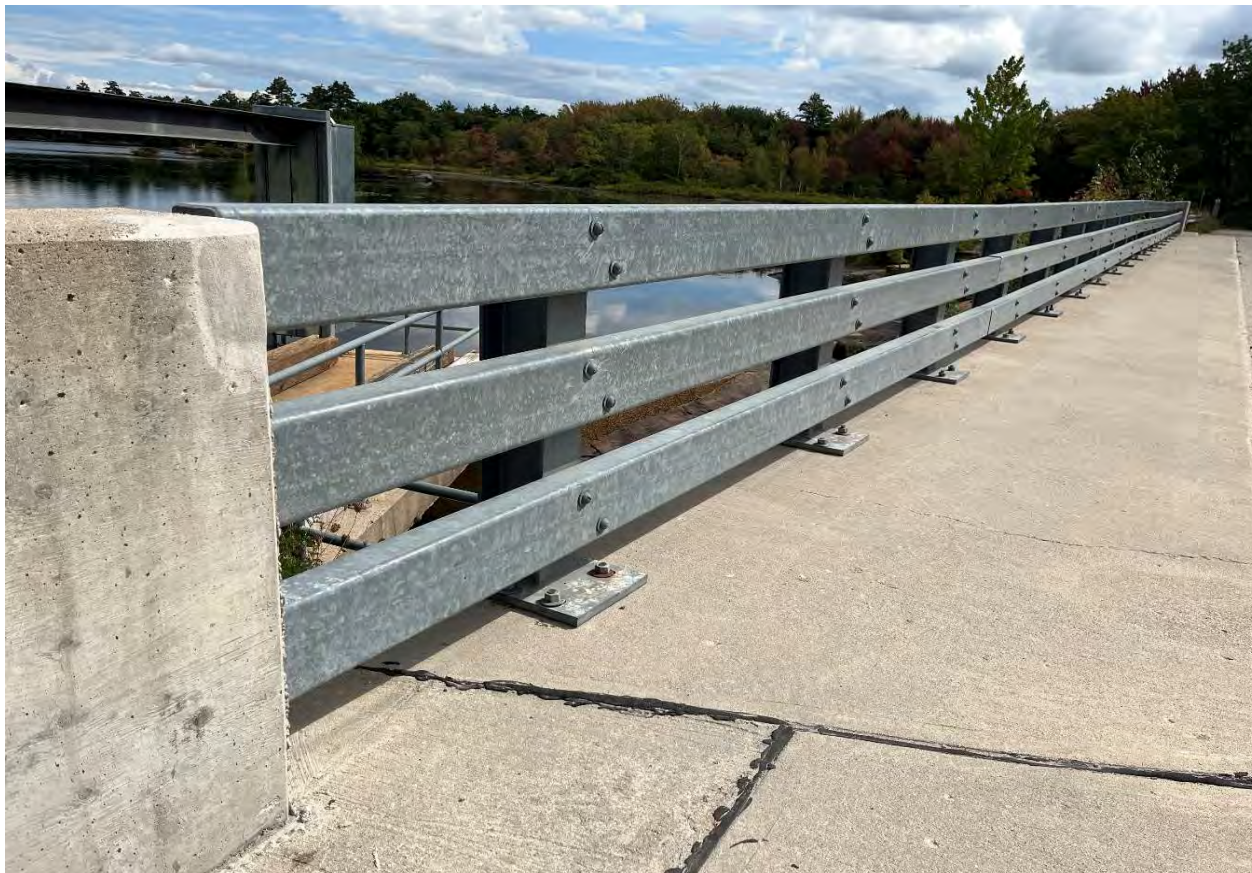
Description of Photo: East barrier

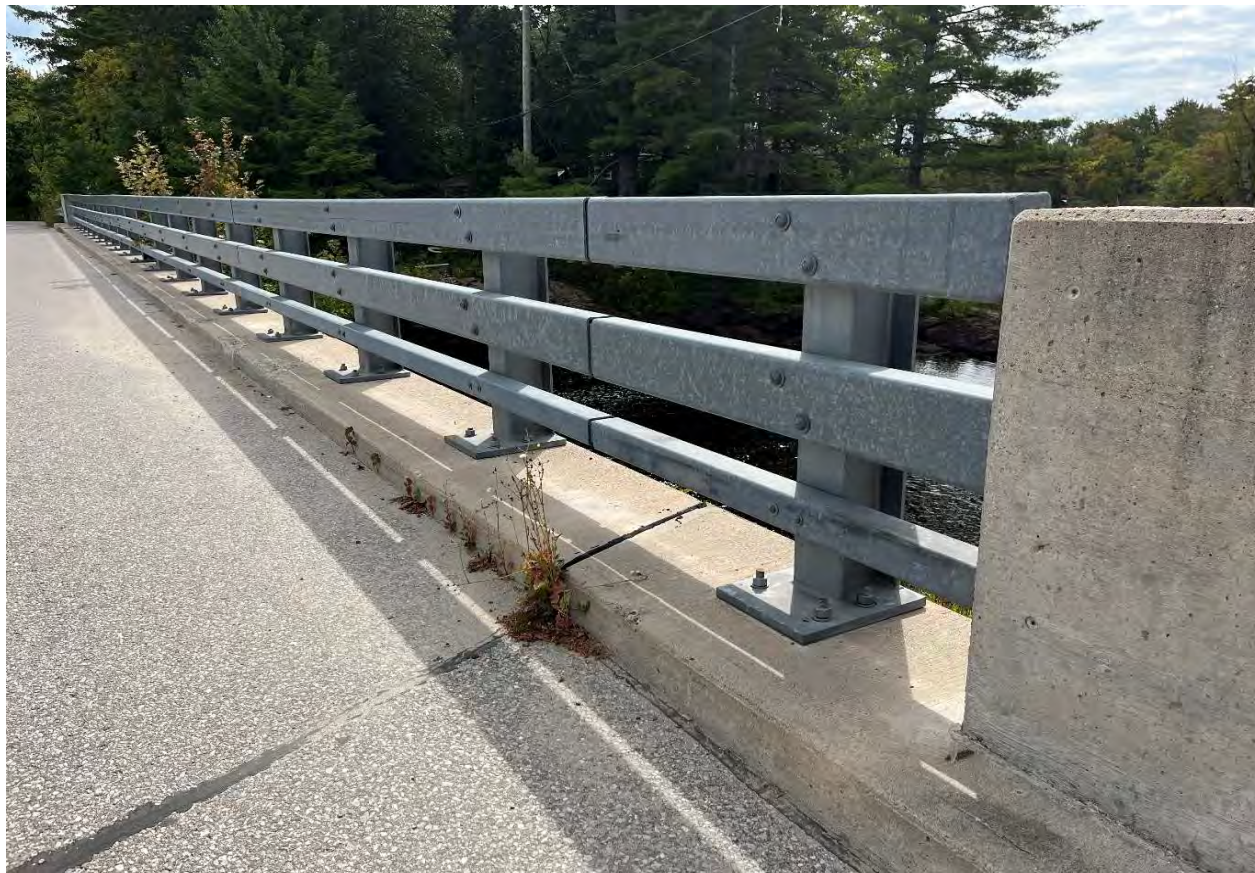
Description of Photo: West barrier

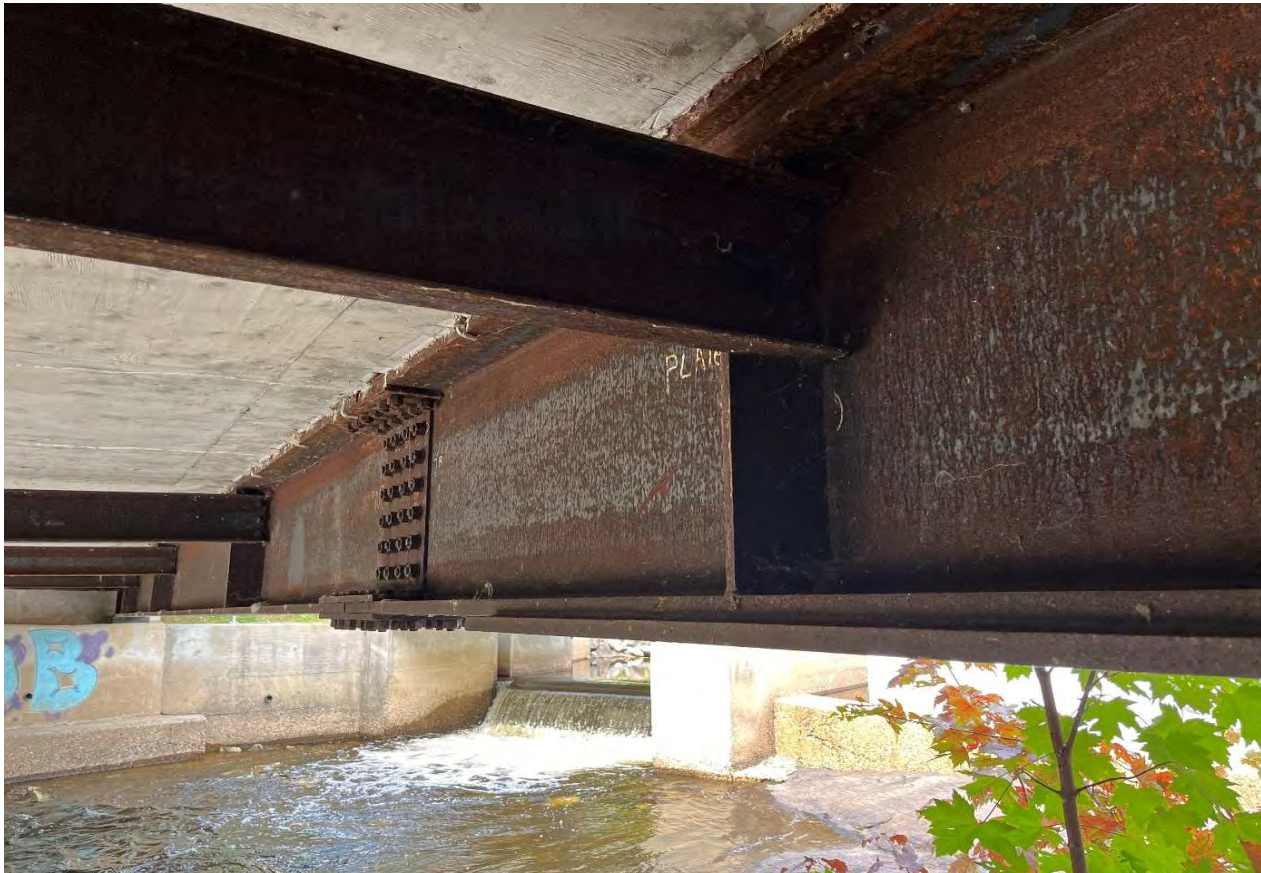
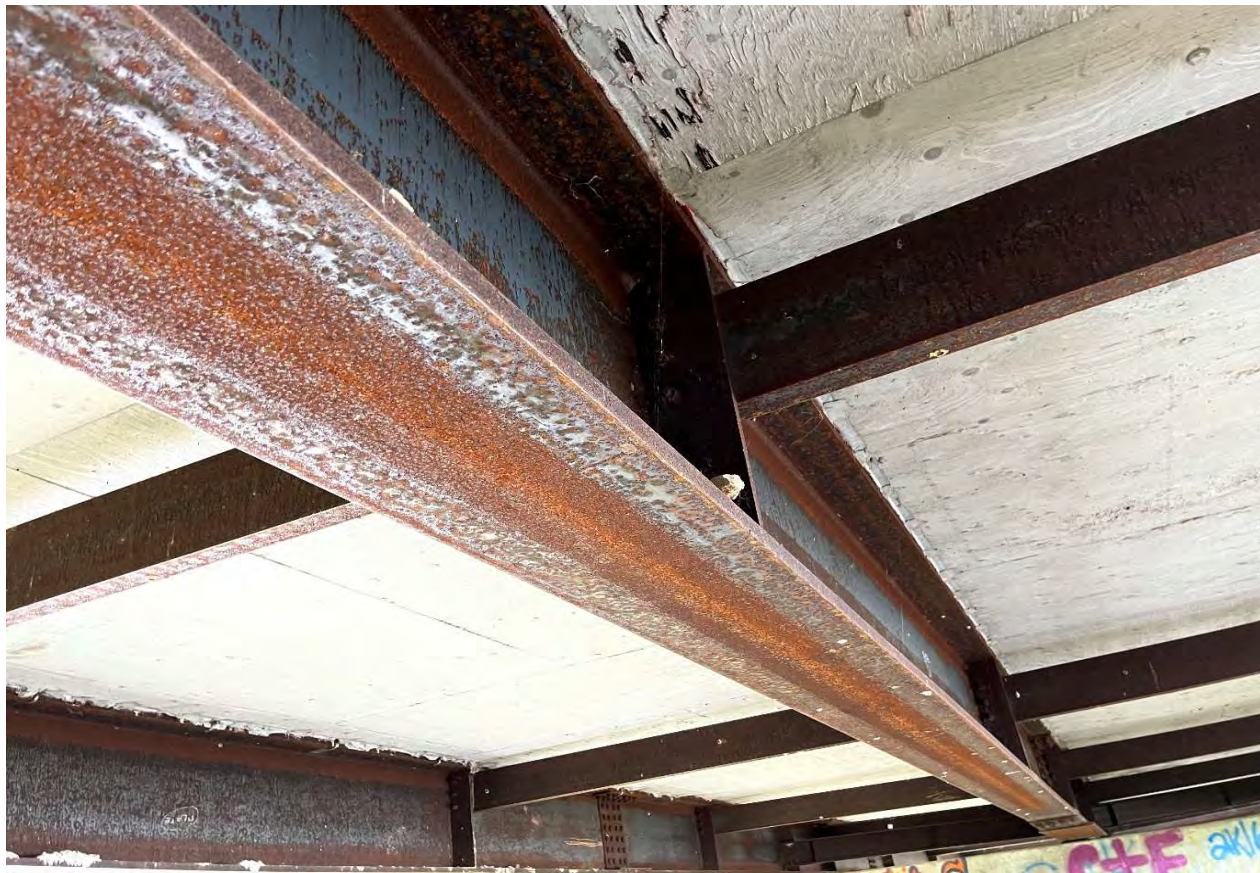
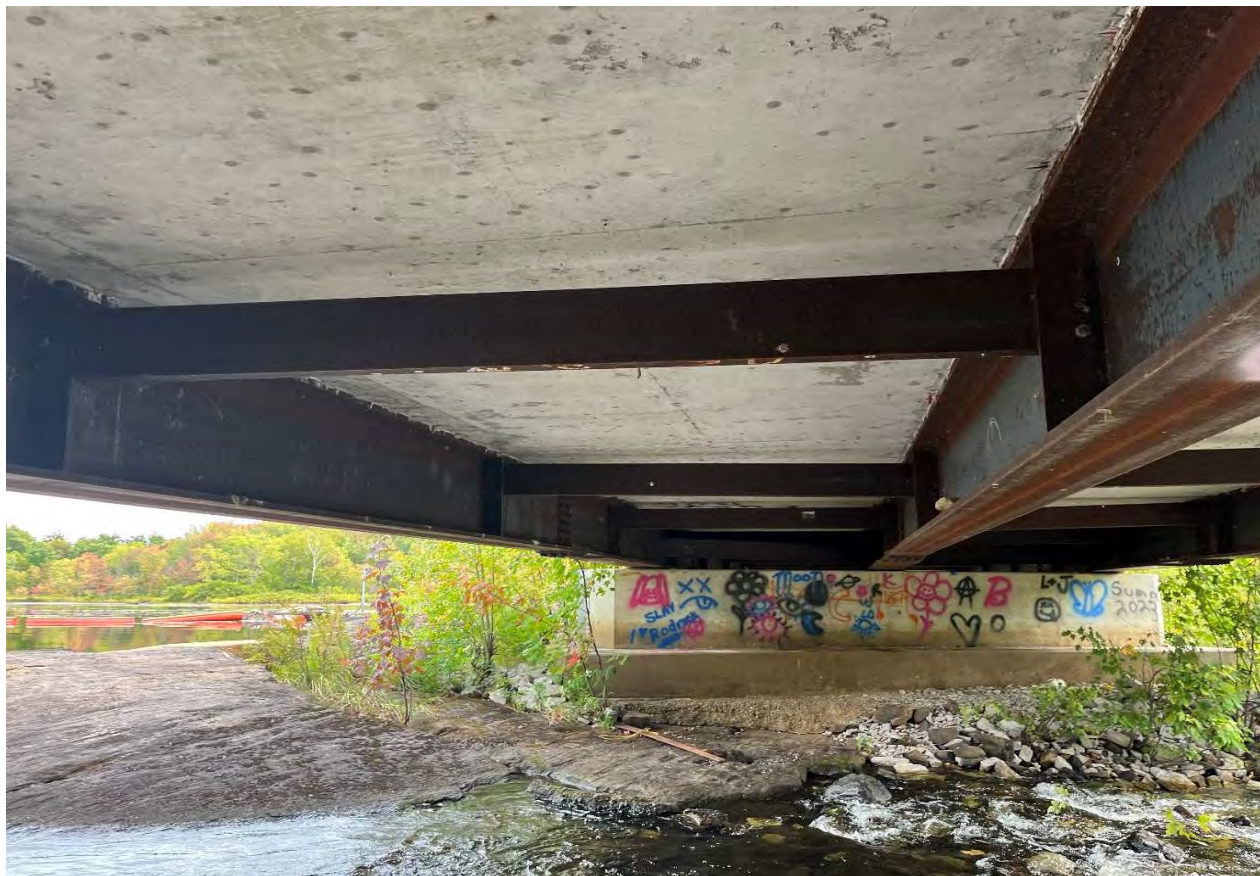
Comments: Light corrosion, typ. This may be atmospheric corrosion resistant steel (ACR) i.e. weathering steel, however unknown at this time.

Description of Photo: Girder, typ.

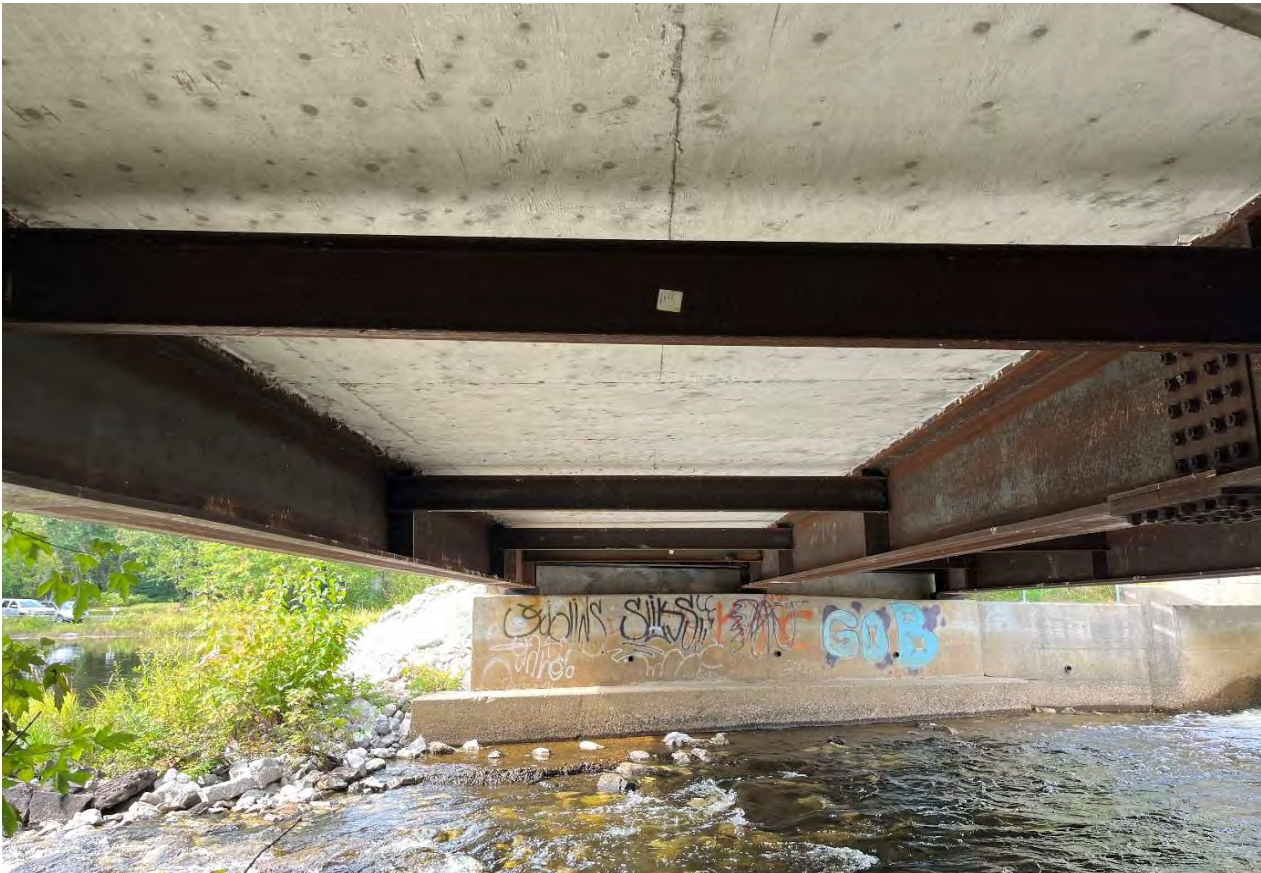
Comments: Light corrosion, typ. This may be atmospheric corrosion resistant steel (ACR) i.e. weathering steel, however unknown at this time.

Description of Photo: Diaphragm, typ.

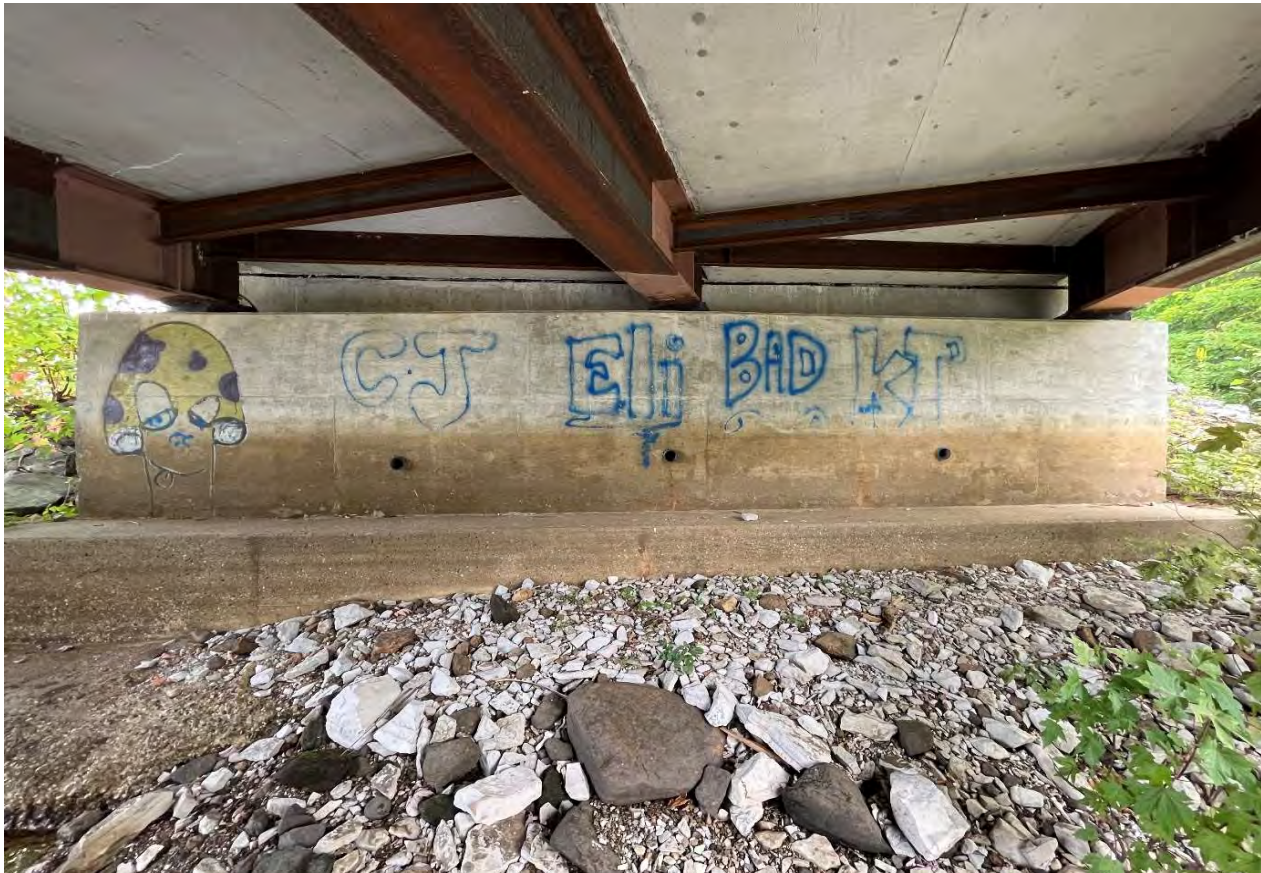
Comments: Light scaling, typ. Two narrow 1.2 m high vertical cracks. Medium scaling around base of walls.

Description of Photo: South abutment wall

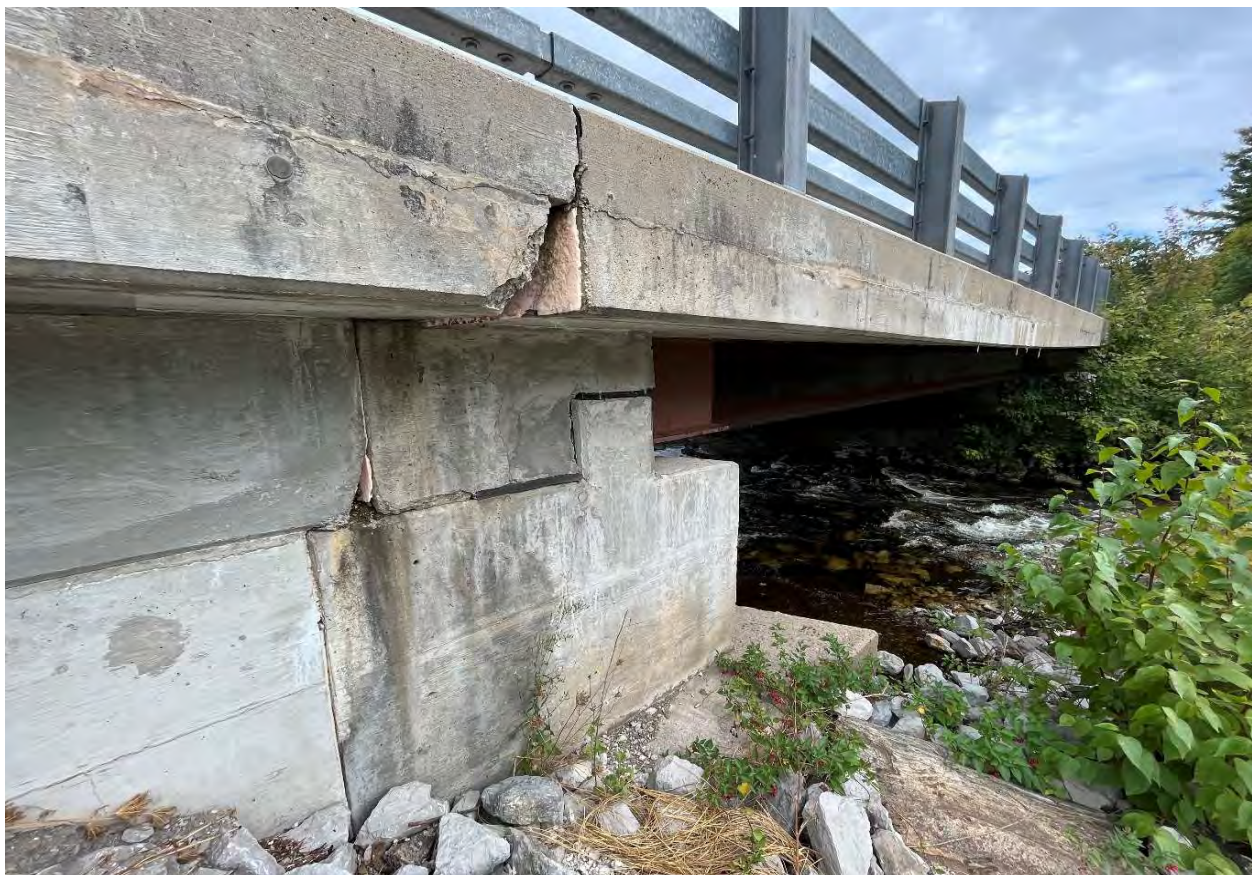
Comments: Light scaling, typ. Isolated delamination (0.6 x 0.15) at northwest wingwall, isolated spall (0.4 x 0.4 x 0.1) at southeast wingwall. Water leaking on face of Southeast wingwall.

Description of Photo: Southeast wingwall

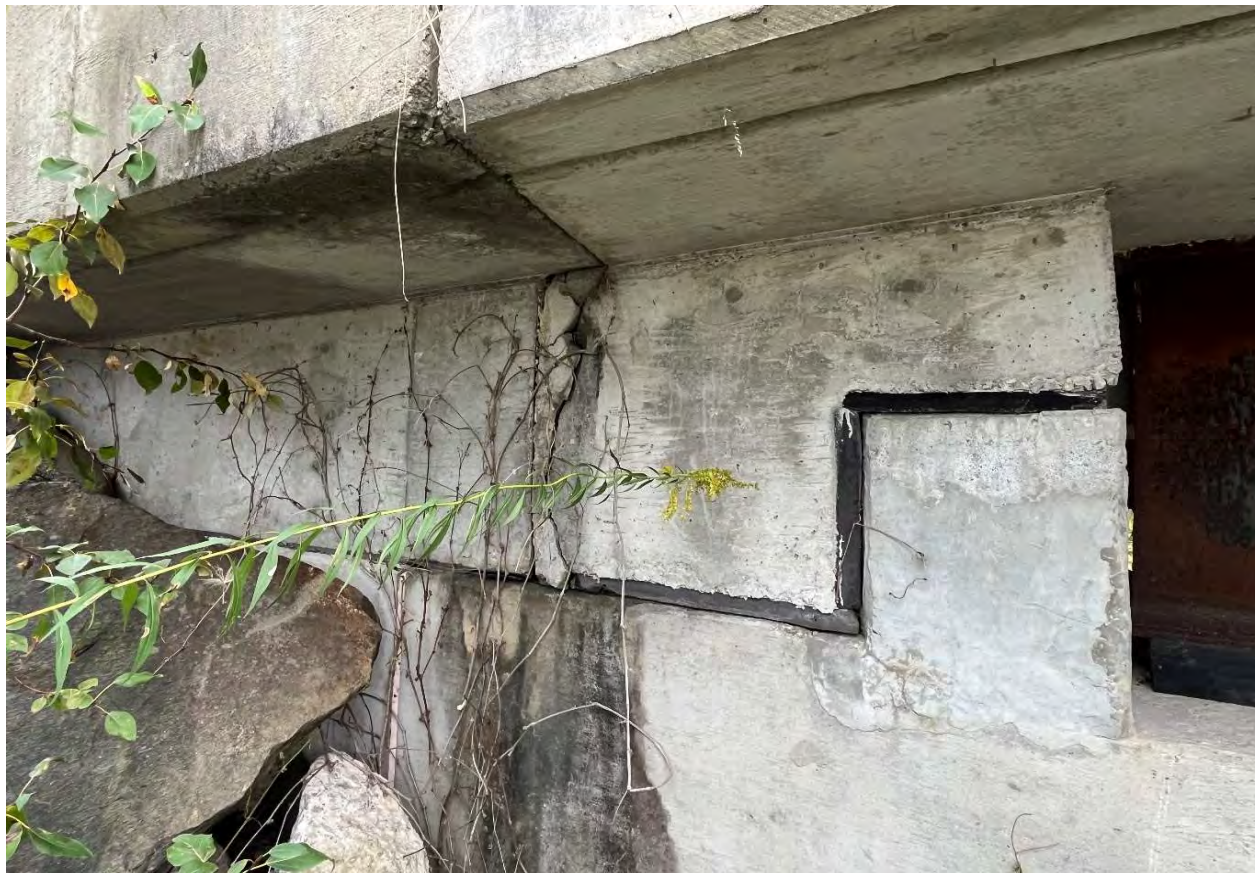
Description of Photo: Isolated delamination

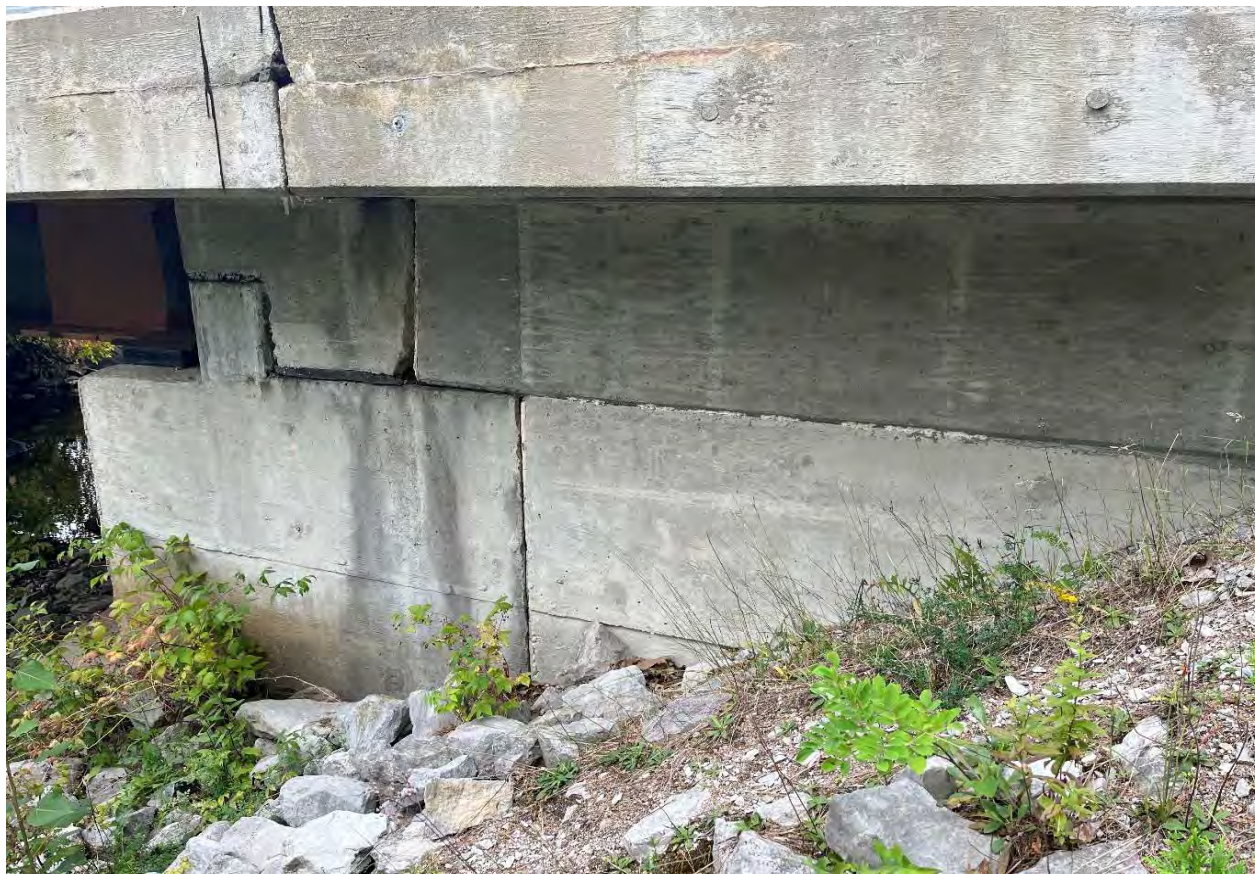
Description of Photo: Southwest wingwall

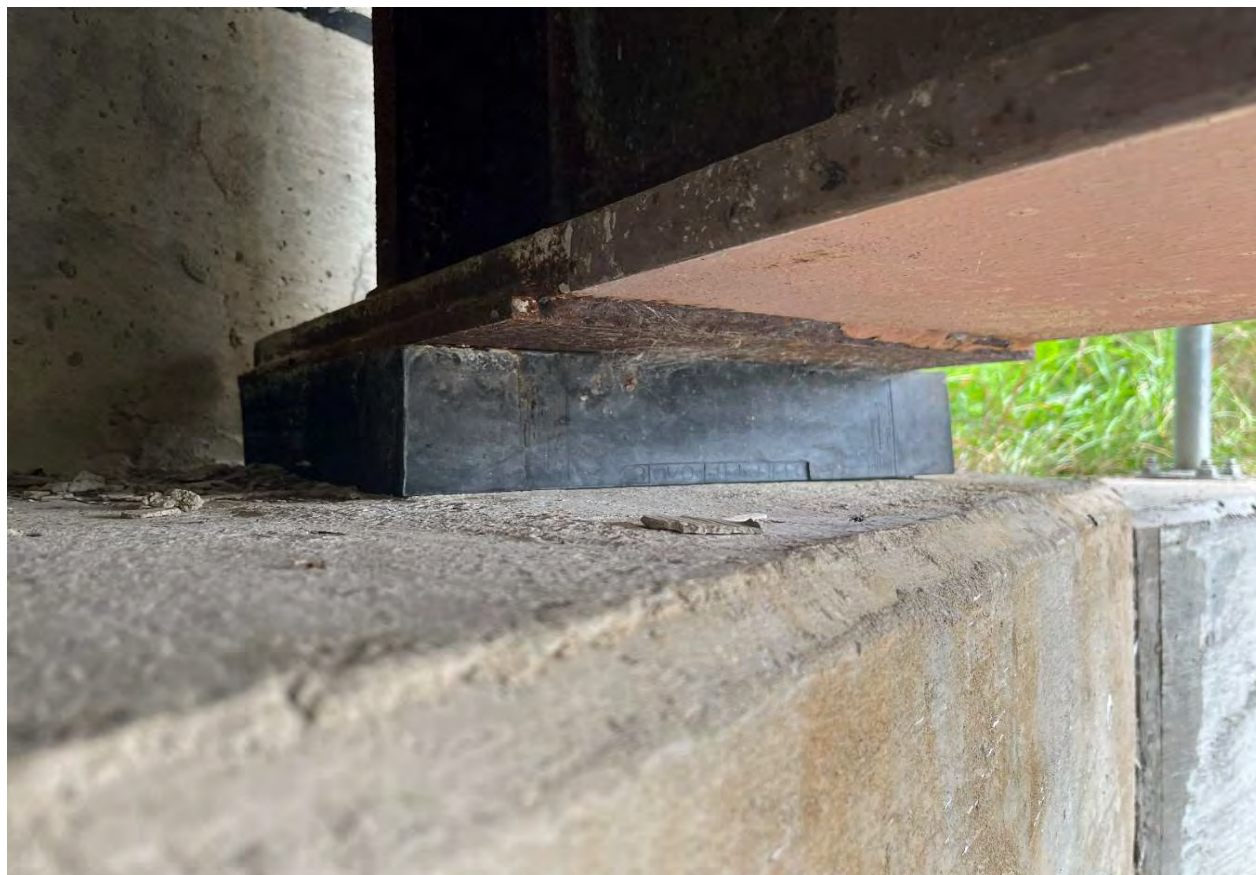
Description of Photo: Bearing, typ.

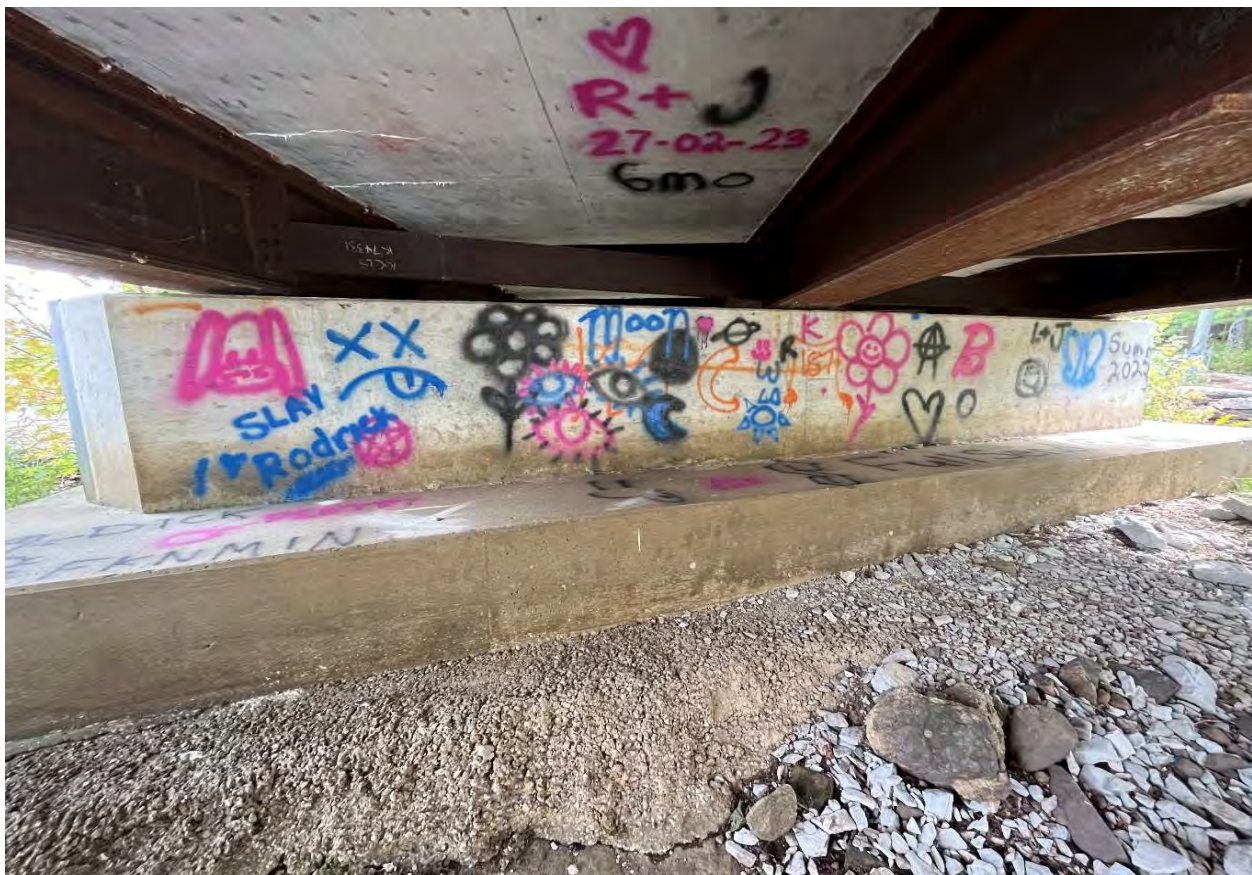
Comments: Light scaling, typ. Isolated medium scaling around base of pier wall. Two medium vertical cracks on the north face.

Description of Photo: Pier - north face

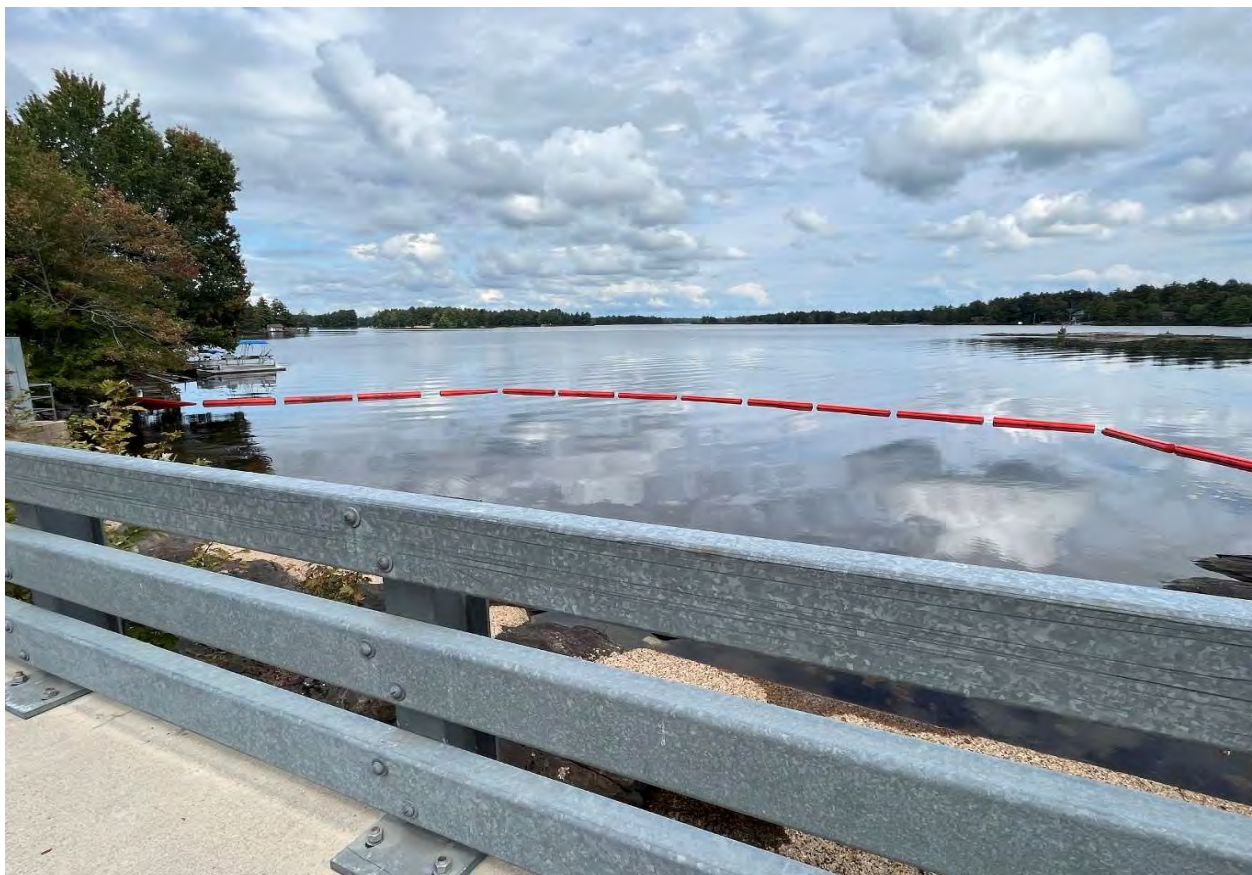
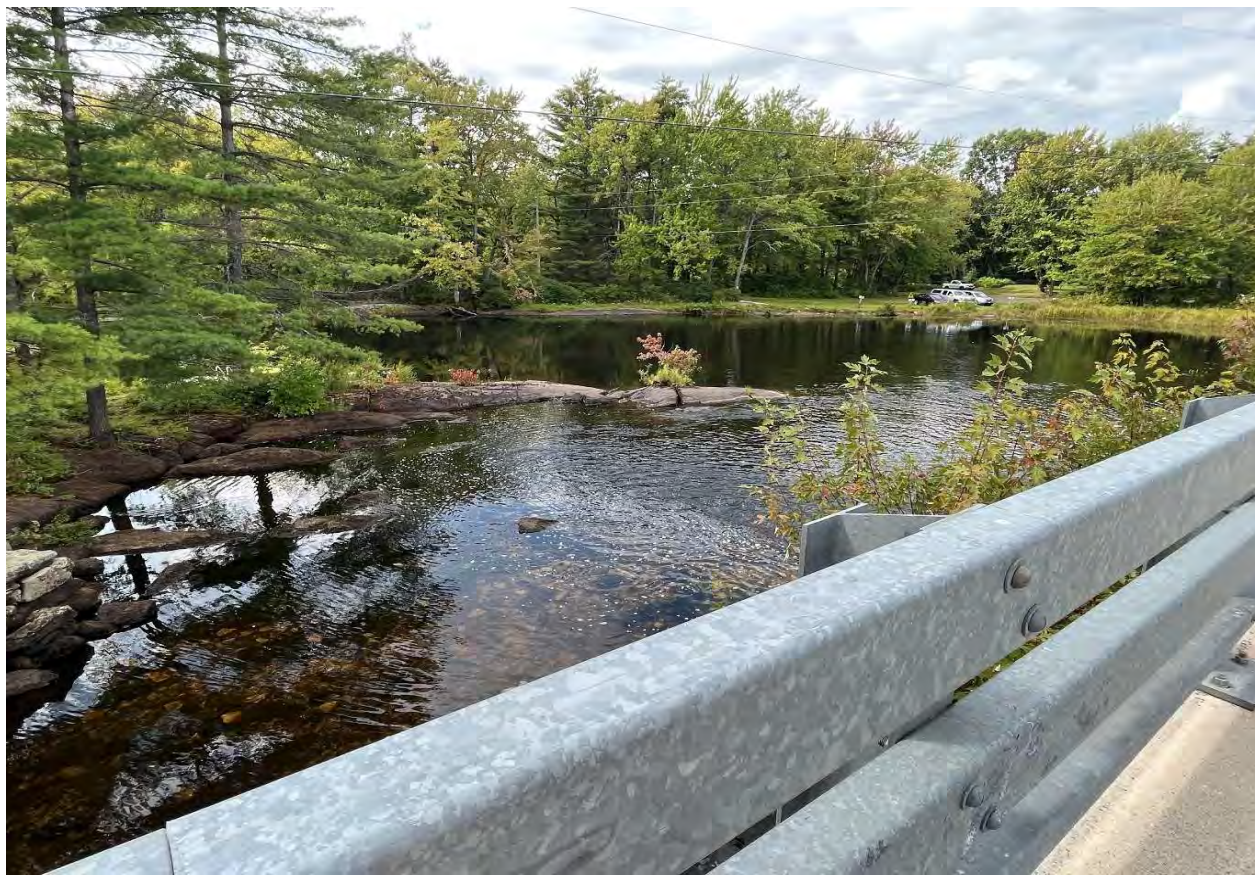
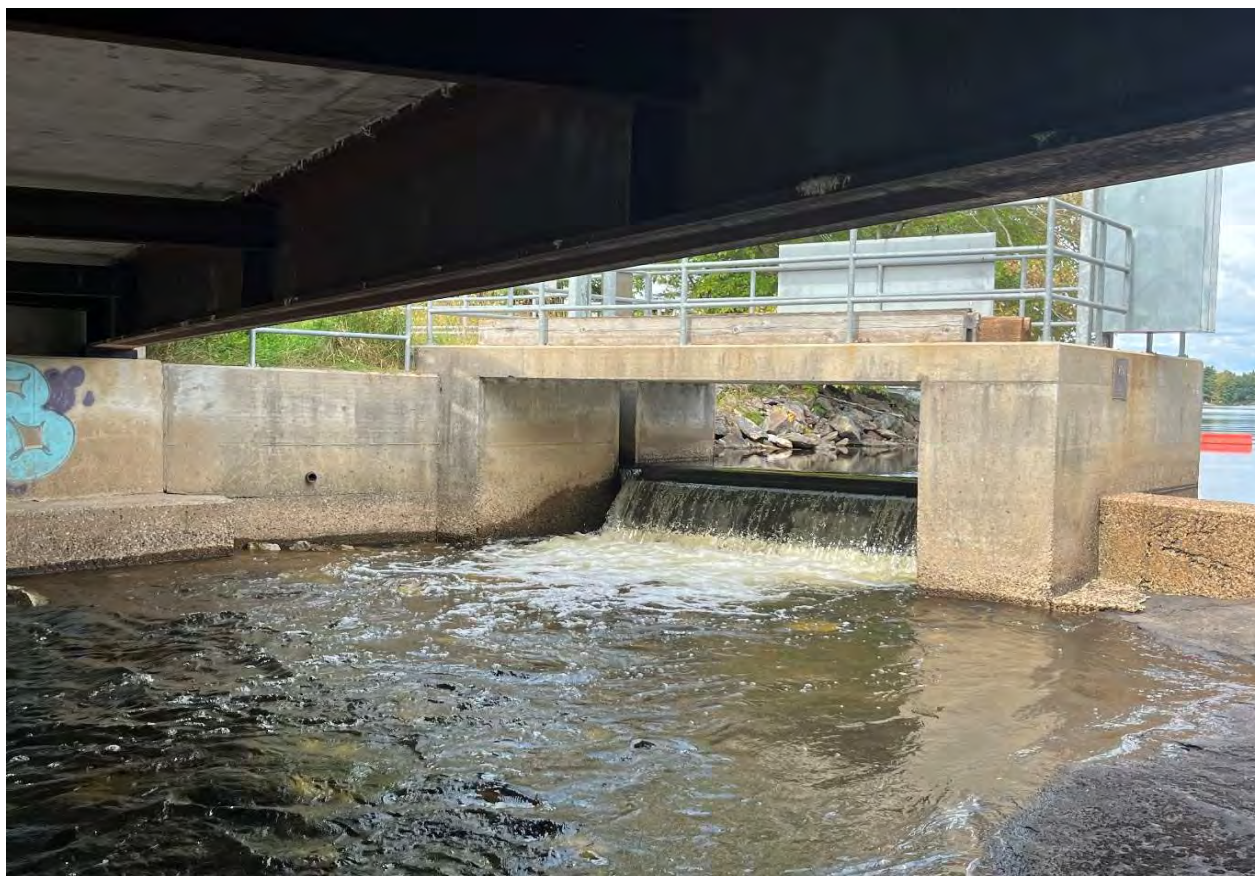
Comments: **No observed defects.**

Description of Photo: Upstream

Description of Photo: Downstream

Description of Photo: Dam on east side

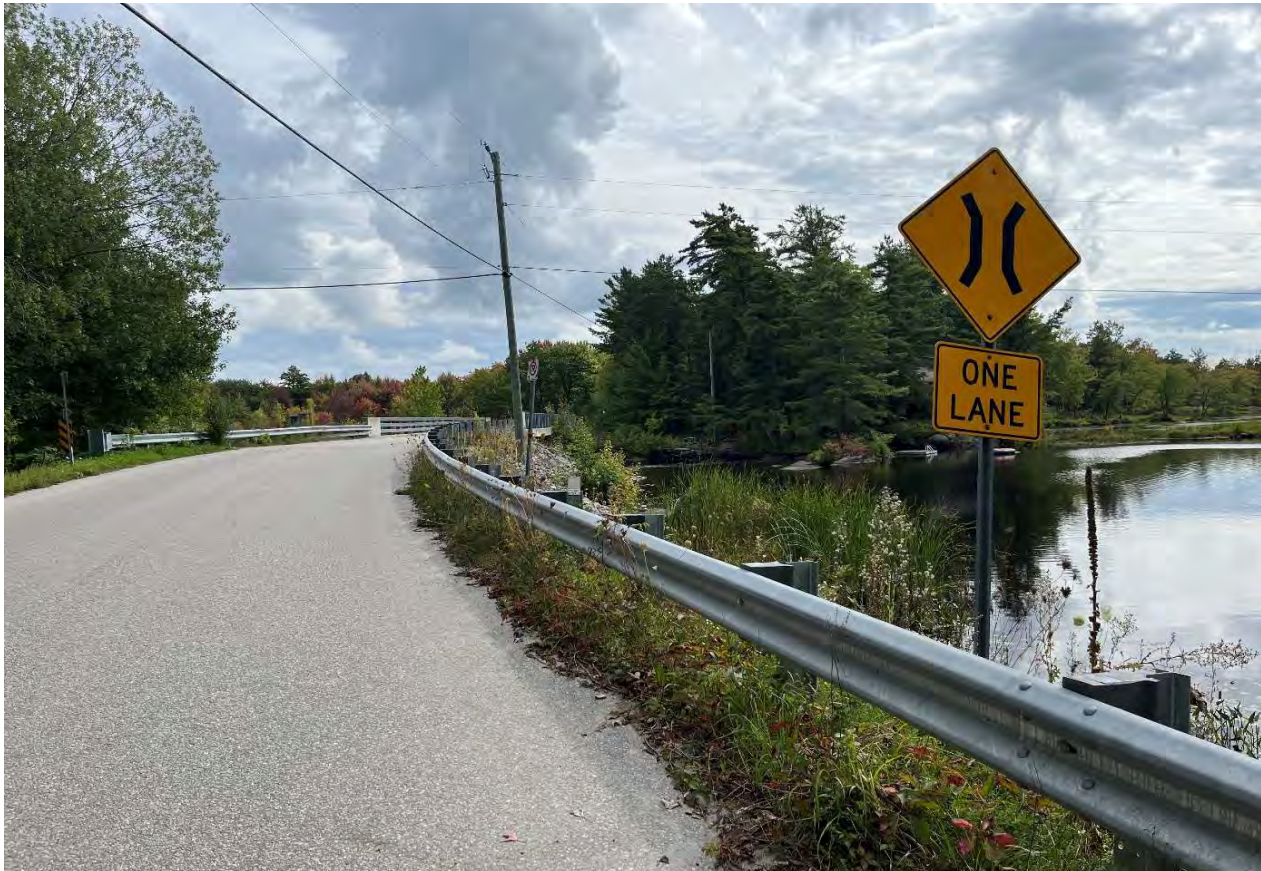
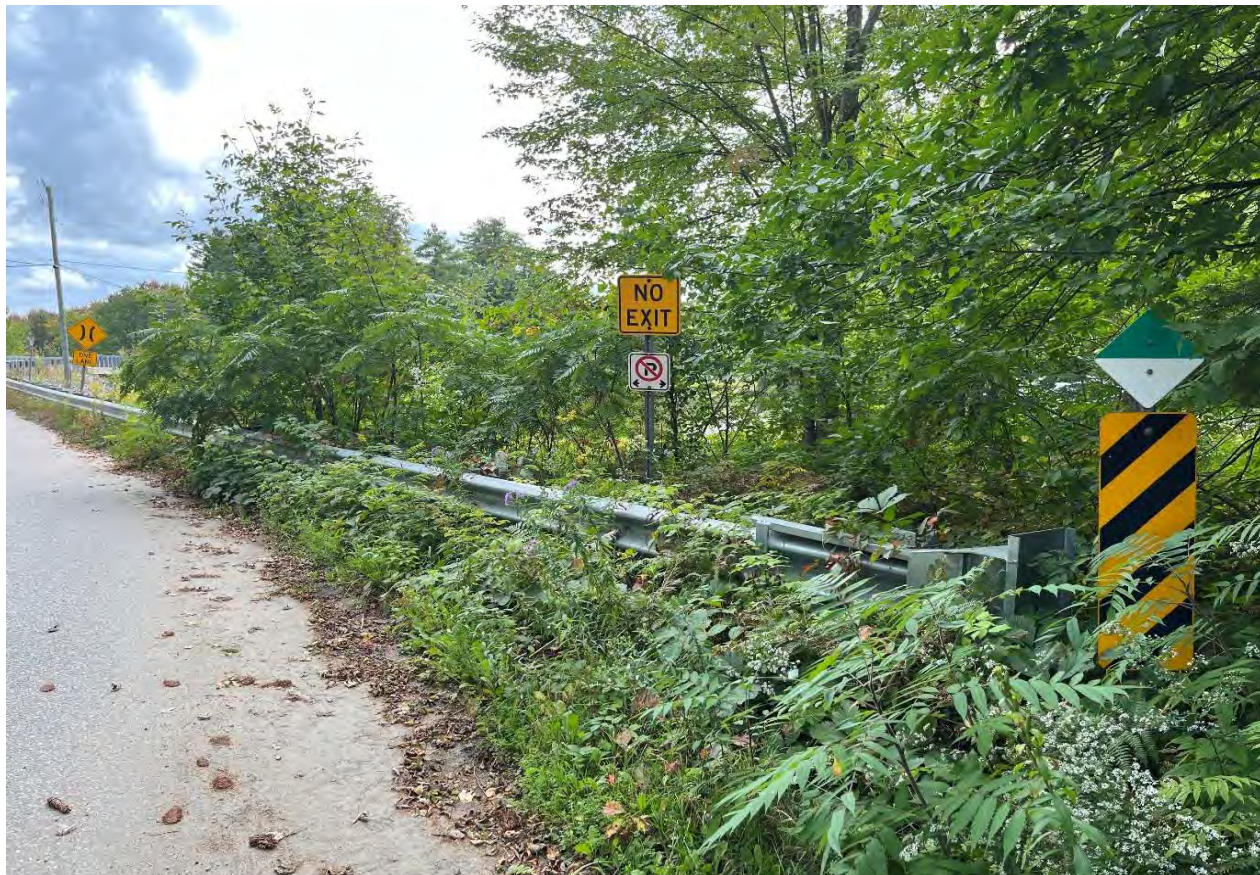
Comments: 4 - Hazard warning sign, 1 - narrow bridge ahead signs, and 1 - no exit sign. No observed defects.

Description of Photo: One lane sign

Description of Photo: Hazard warning sign
