Bridge Needs Study

INSPECTION SUMMARY REPORT

Town of Gravenhurst

August
29, 2024

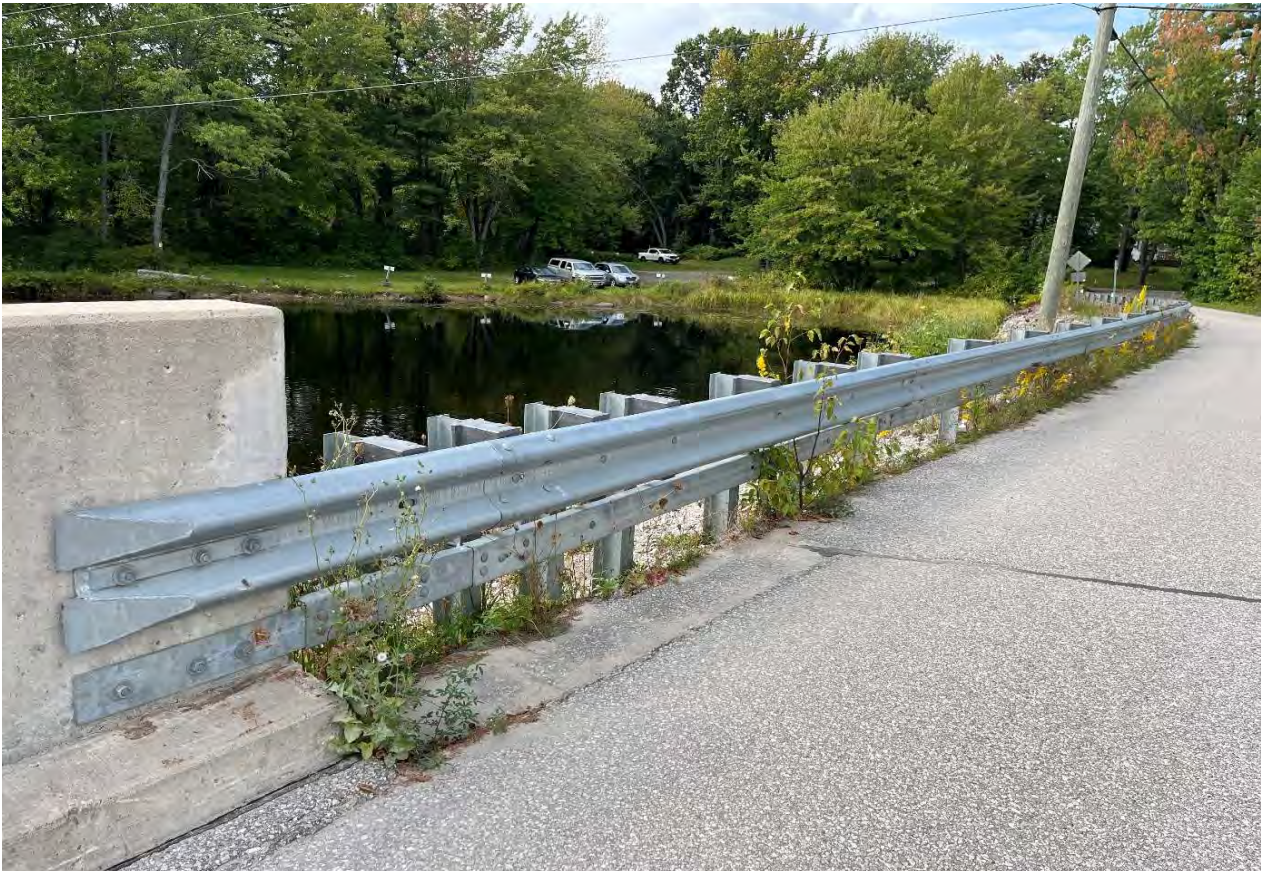
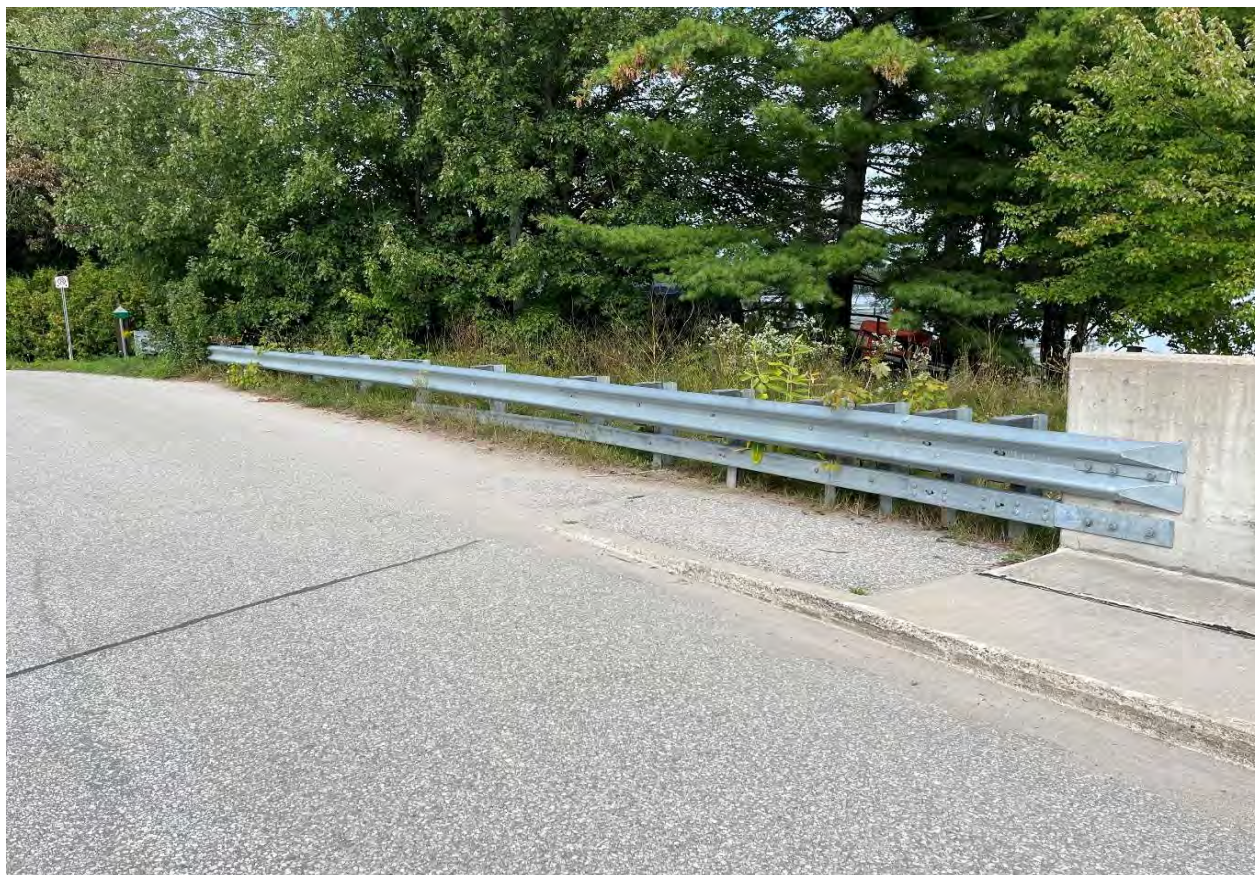
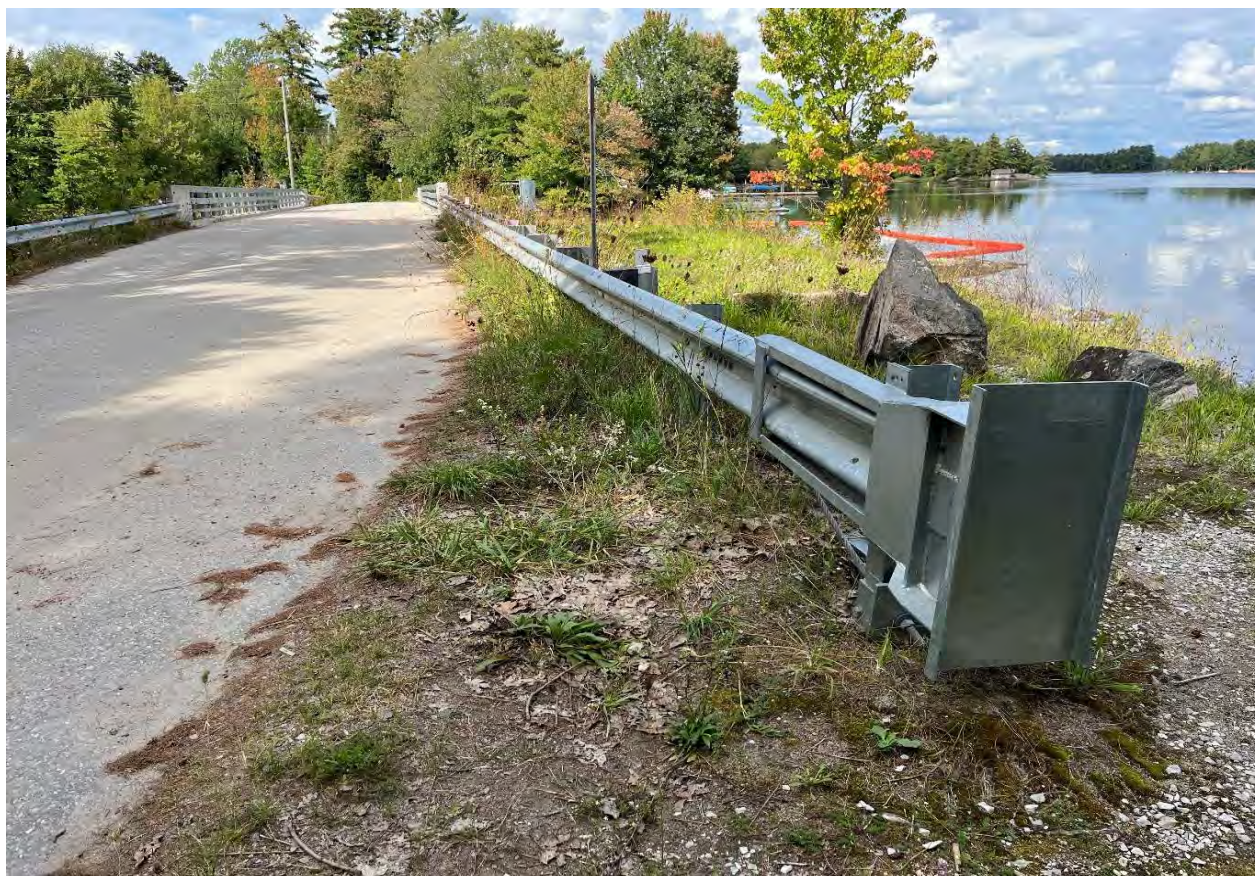
Comments: **No observed defects.**

Description of Photo: Northwest approach guide rail

Description of Photo: Northeast approach guide rail

Description of Photo: Southeast approach guide rail

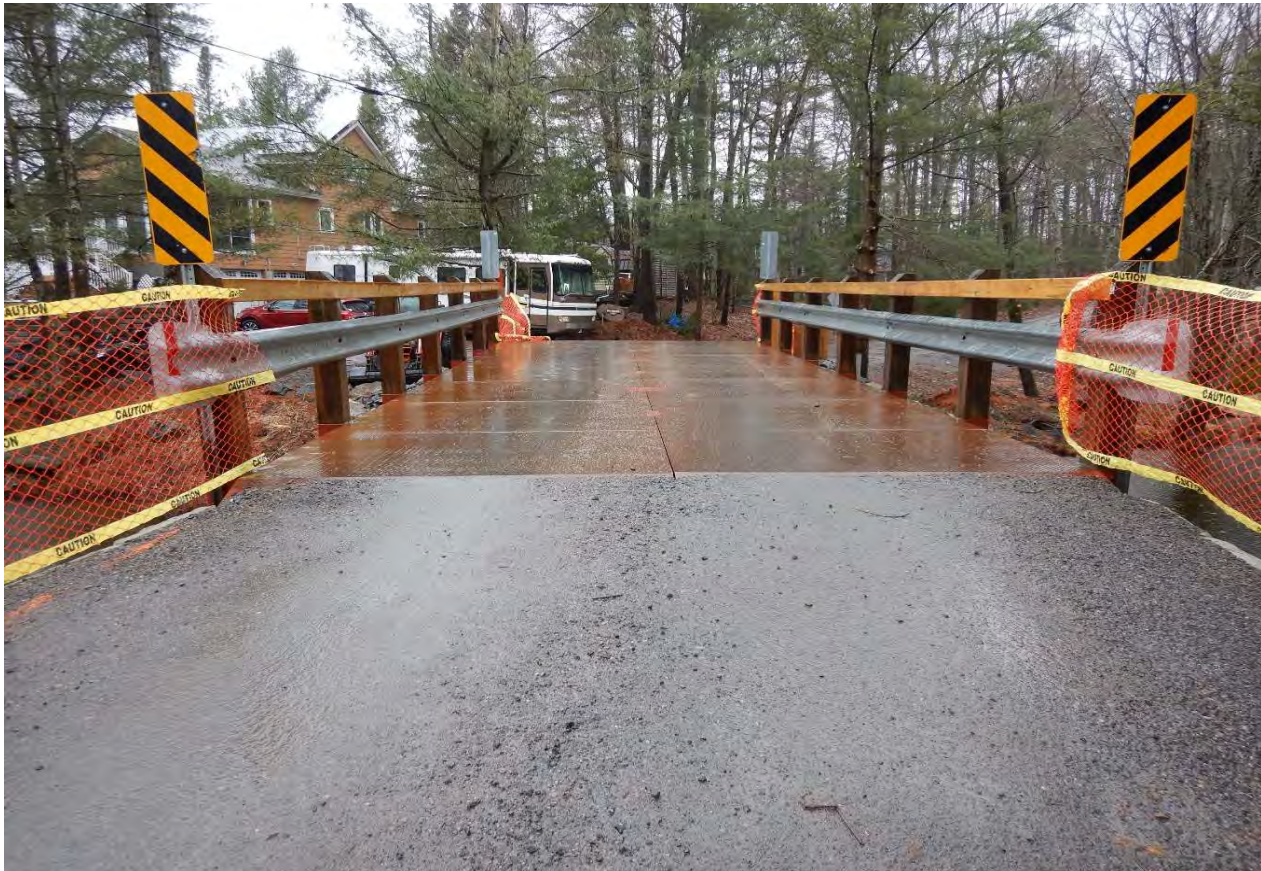
Comments: Light corrosion, typ.

Description of Photo: Wearing surface, typ.

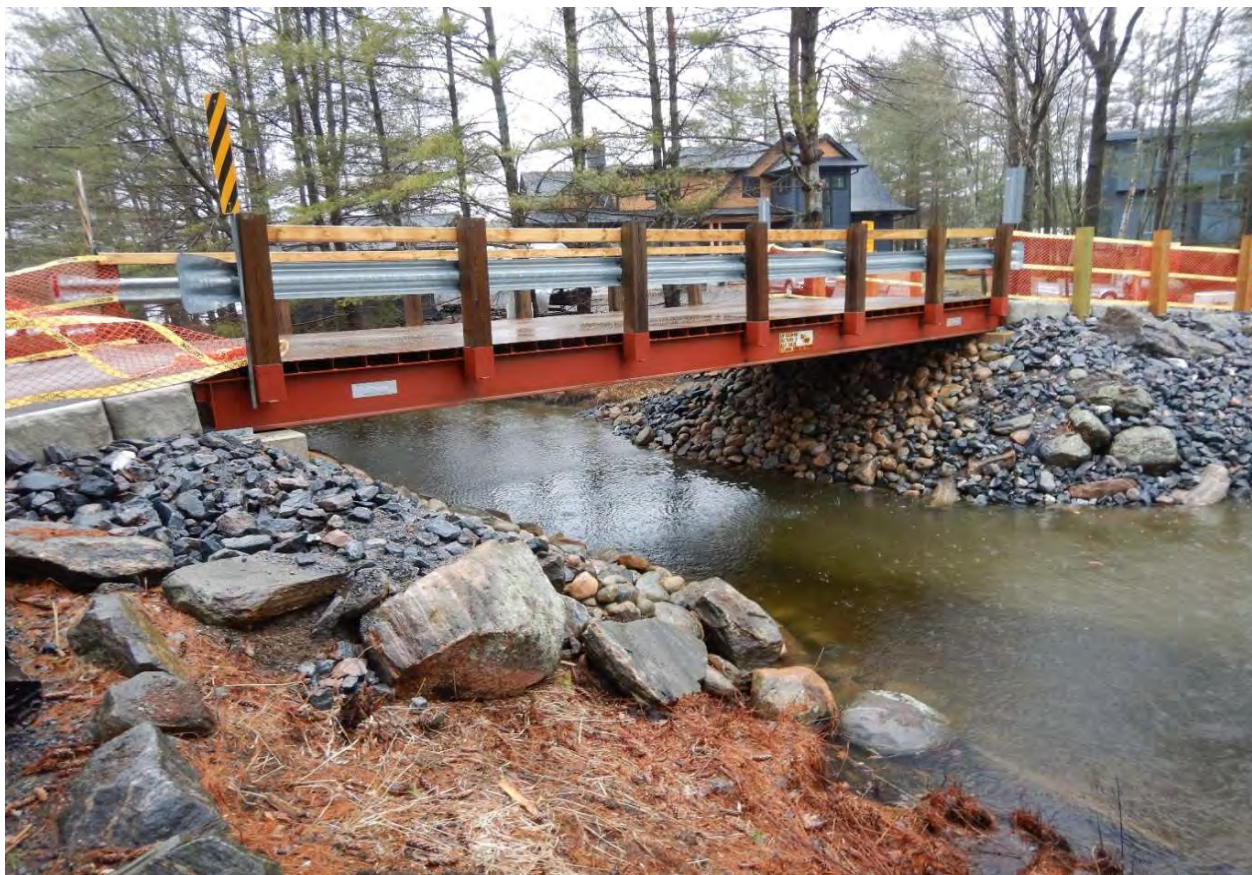
Comments: Light weathering, typ. Light to medium checks and splits noted on the posts with isolated rot on top of several posts. 2 m long abrasion/scrape, and 3 isolated deformations noted along the rail.

Description of Photo: Bridge barriers

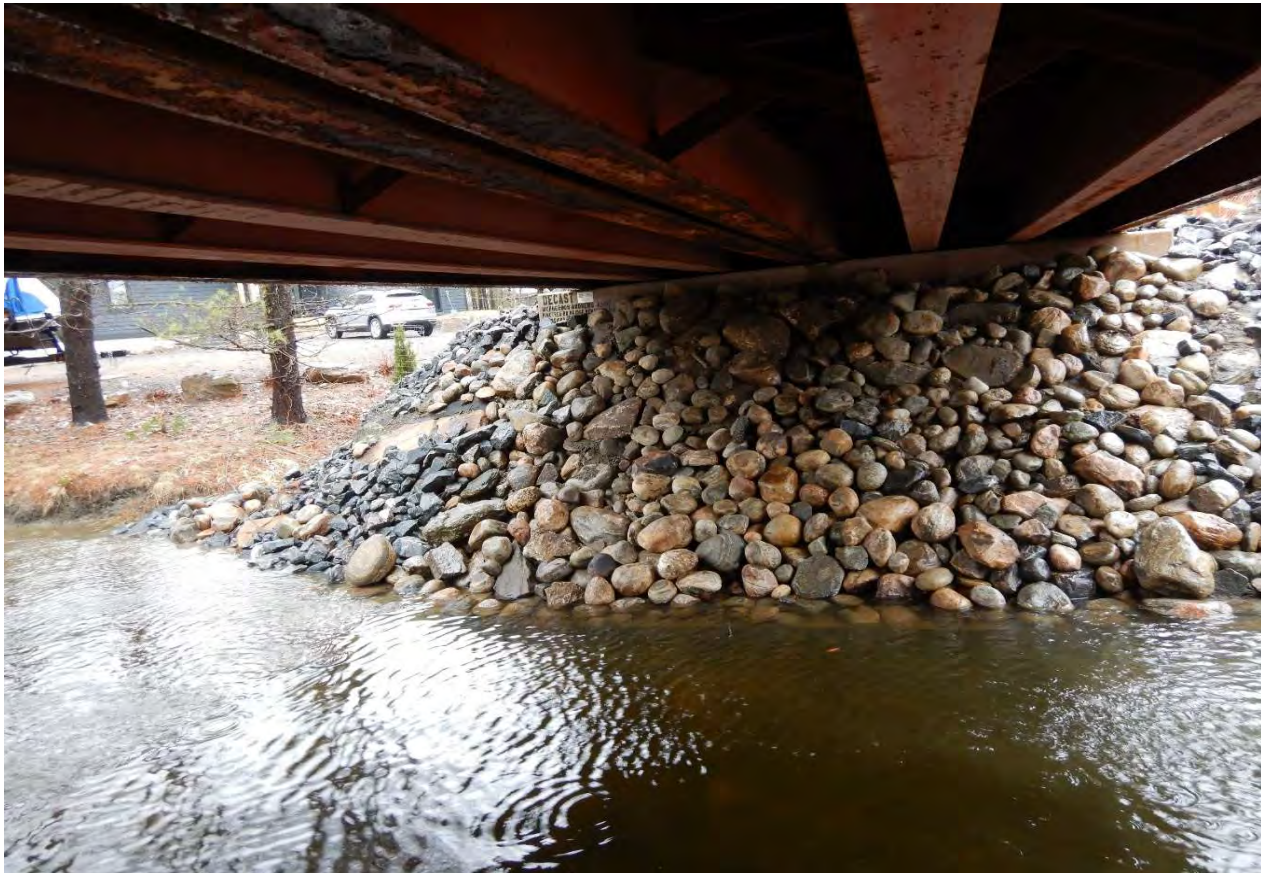
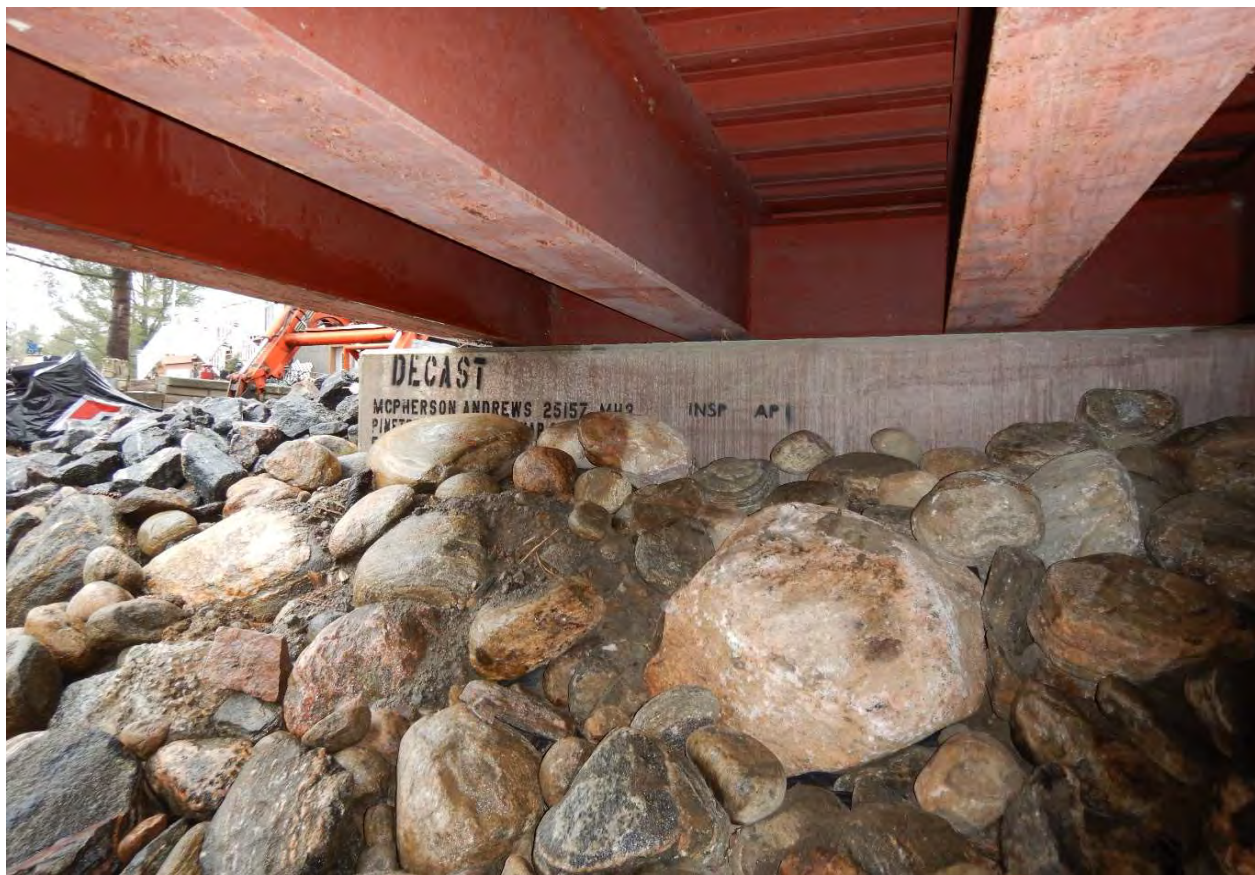
Comments: Light corrosion, typ. Isolated loss of coating on bottom of bottom flanges, generally along the full length. Limited inspection due to water level.

Description of Photo: Girders, typ.

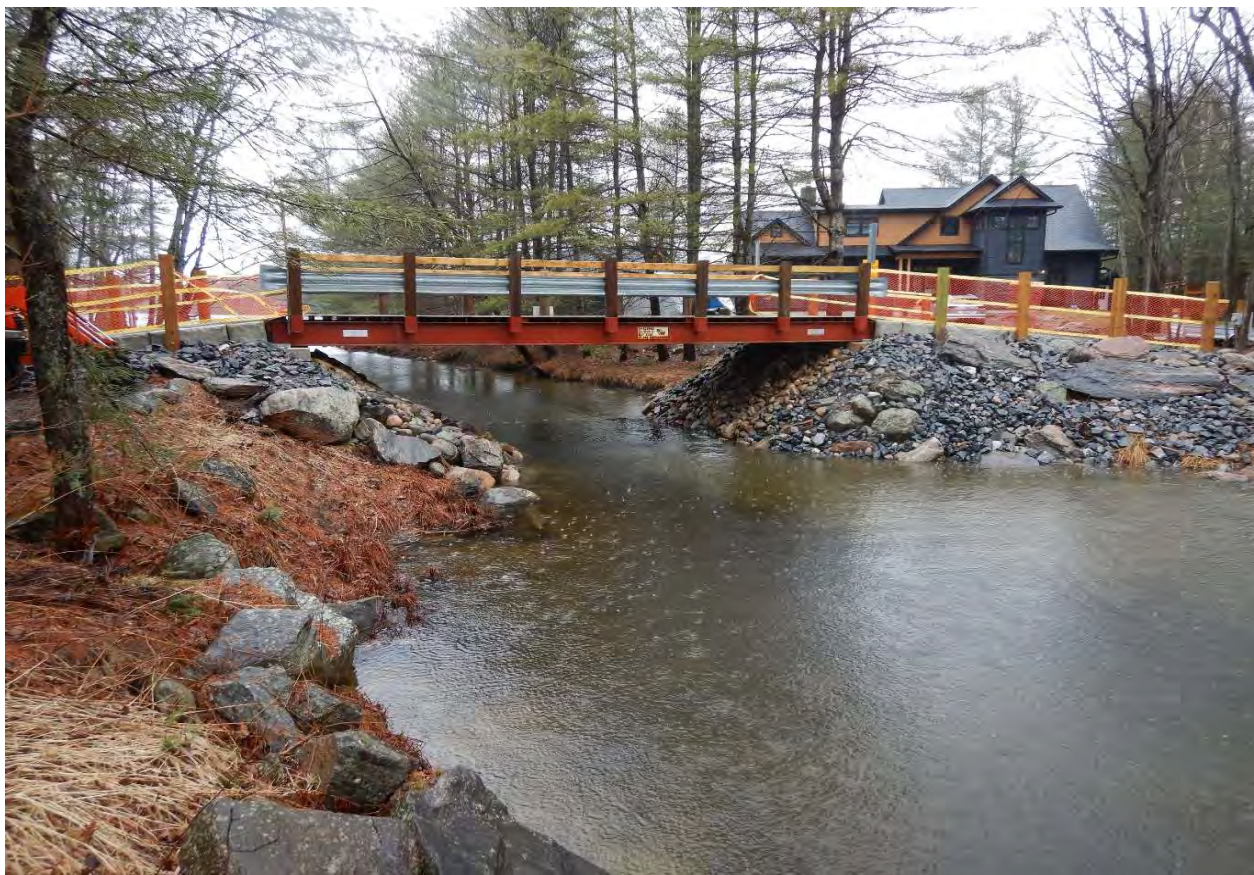
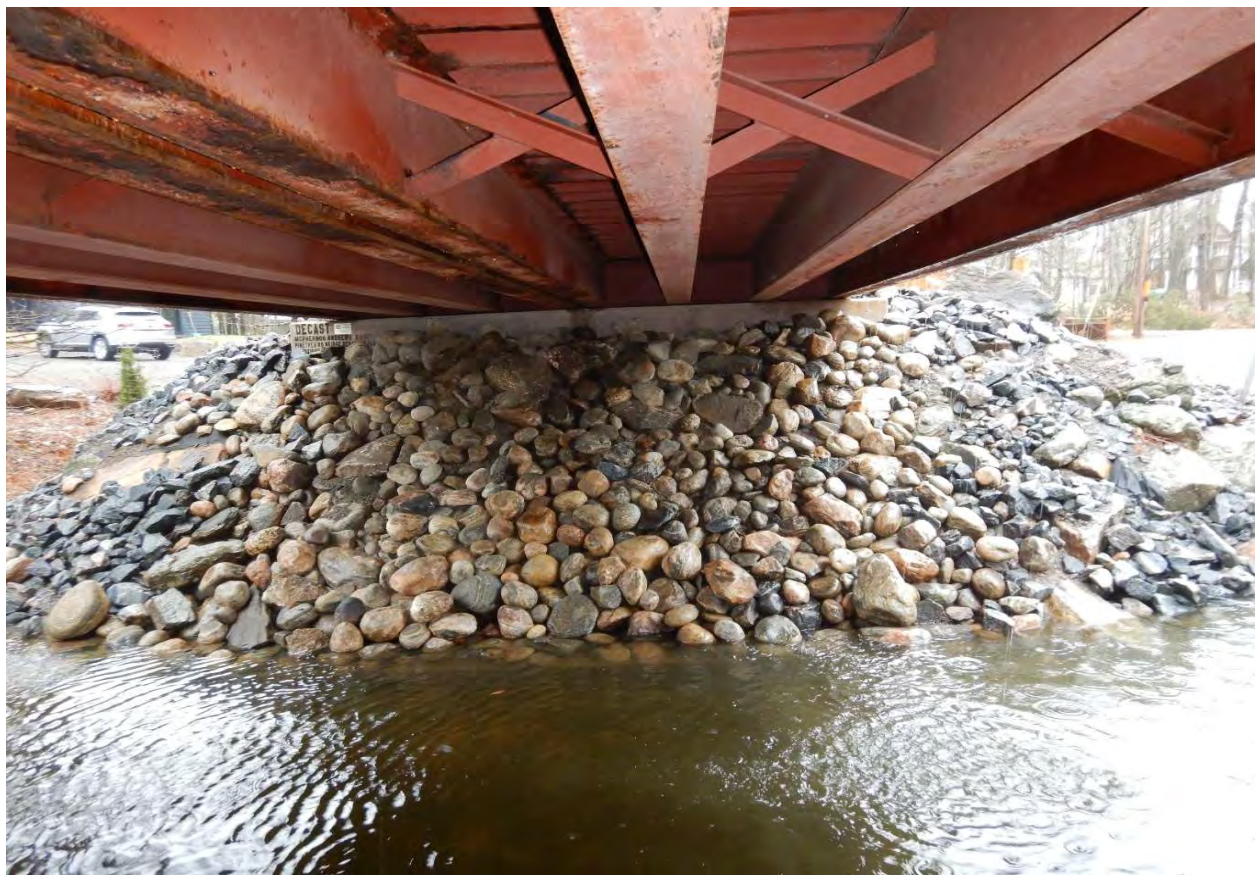
Comments: **No observed defects.**

Description of Photo: Watercourse

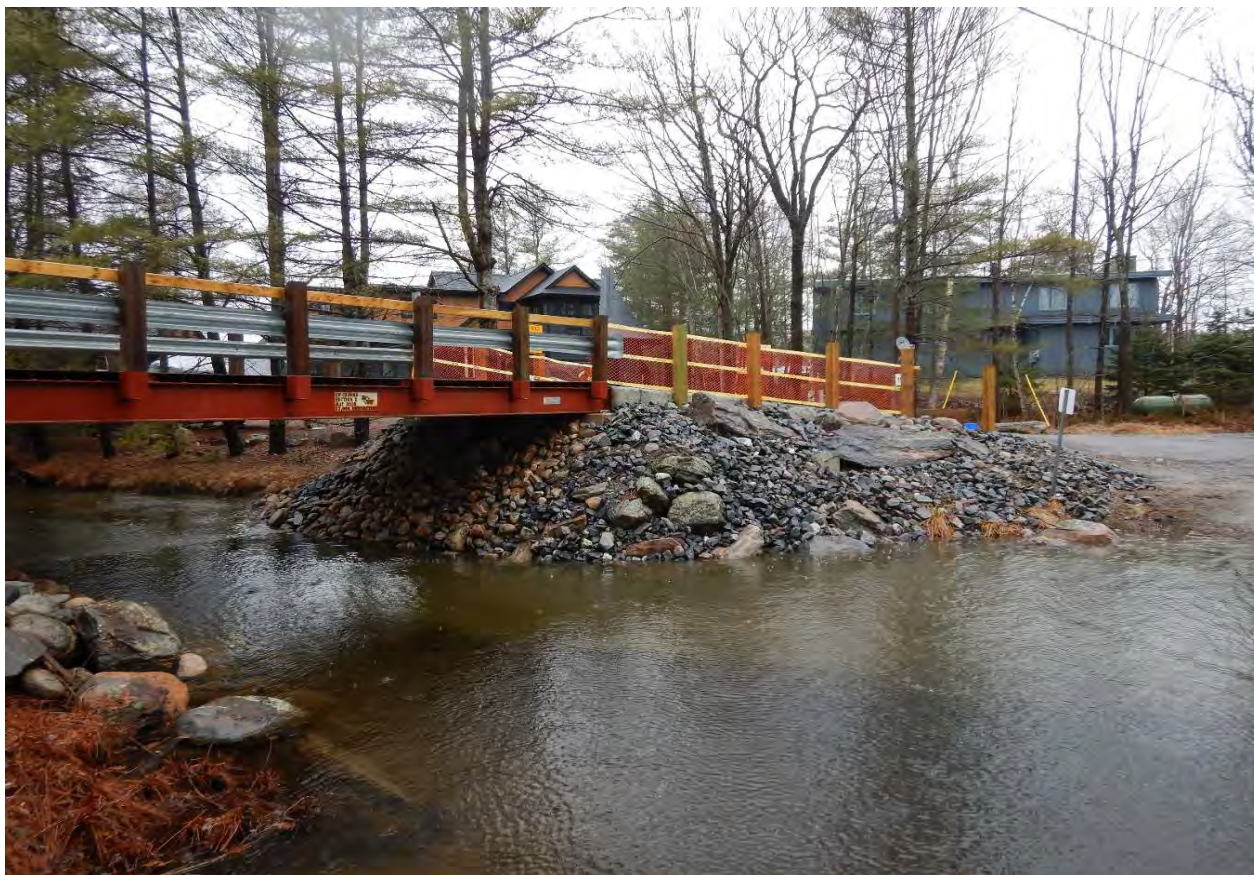
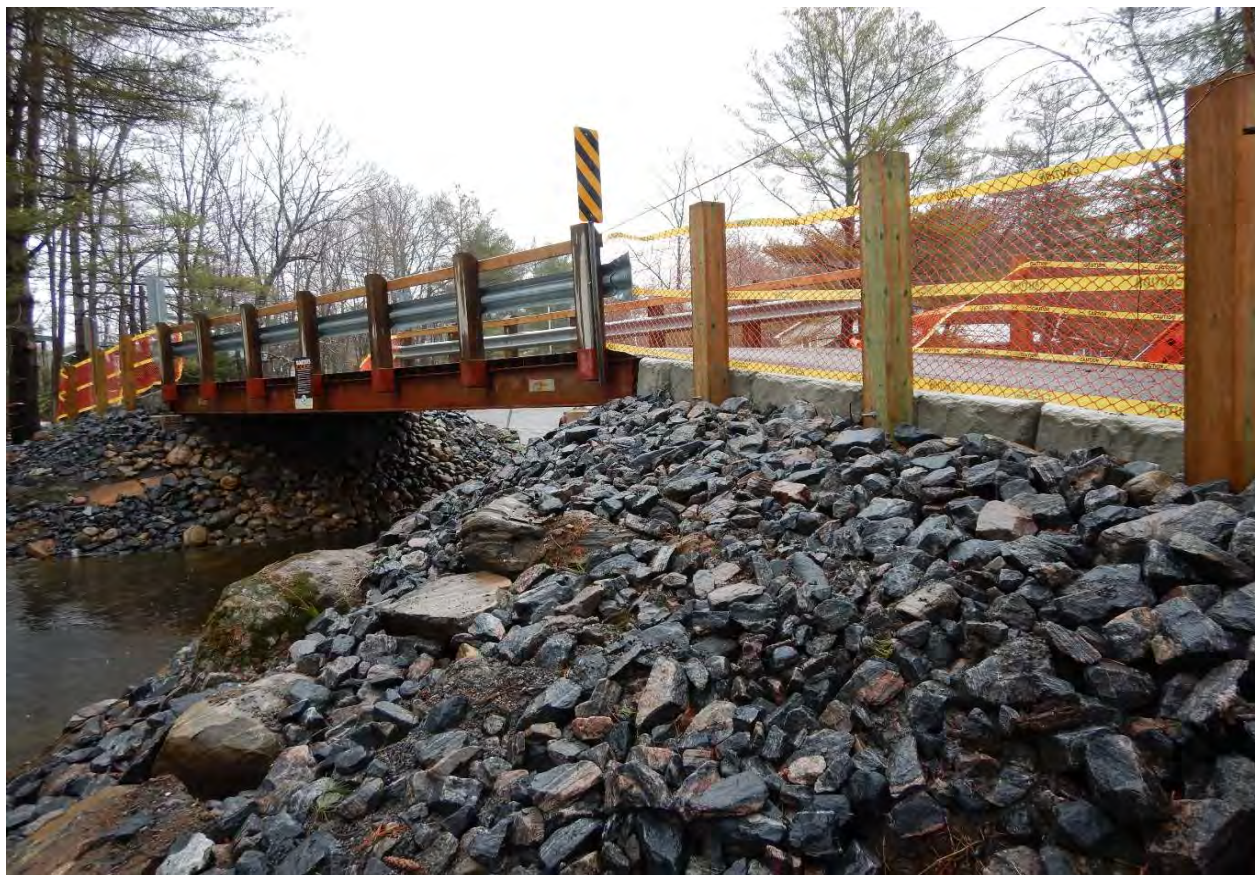
Comments: **No observed defects.**

Description of Photo: Embankment, typ.

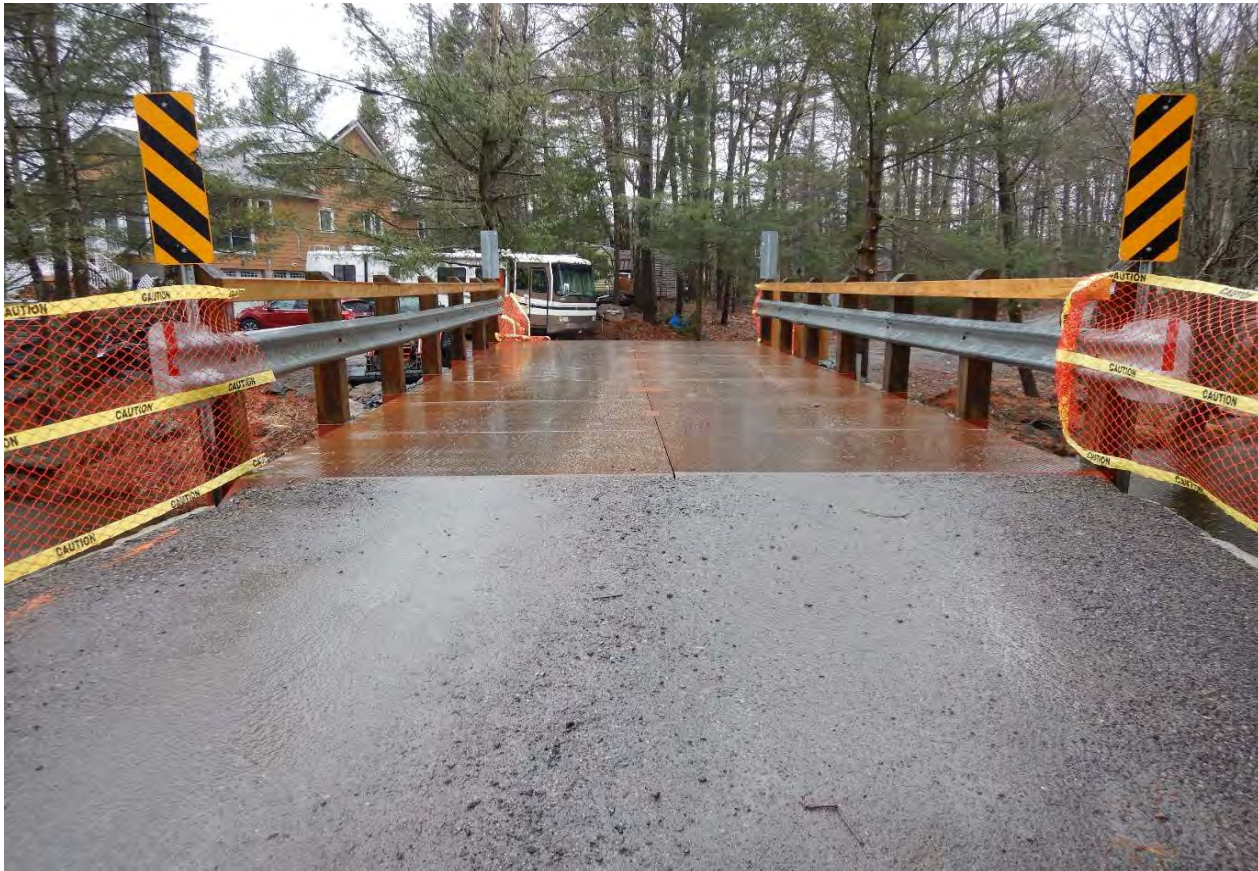
Comments: **No observed defects. Recommend installing narrow bridge warning signs on approaches.**

Description of Photo: Hazard warning sign, typ.

Recommended Work:	Rehab: <input type="checkbox"/>	Replace: <input type="checkbox"/>	Maintenance Needs:	18 - Other Maintenance
Urgent: <input type="checkbox"/>	1-5 Years: <input type="checkbox"/>	6-10 Years: <input type="checkbox"/>	None: <input checked="" type="checkbox"/>	Urgent: <input type="checkbox"/> 1 Year: <input checked="" type="checkbox"/> 2 Year: <input type="checkbox"/>
			Install narrow bridge signage

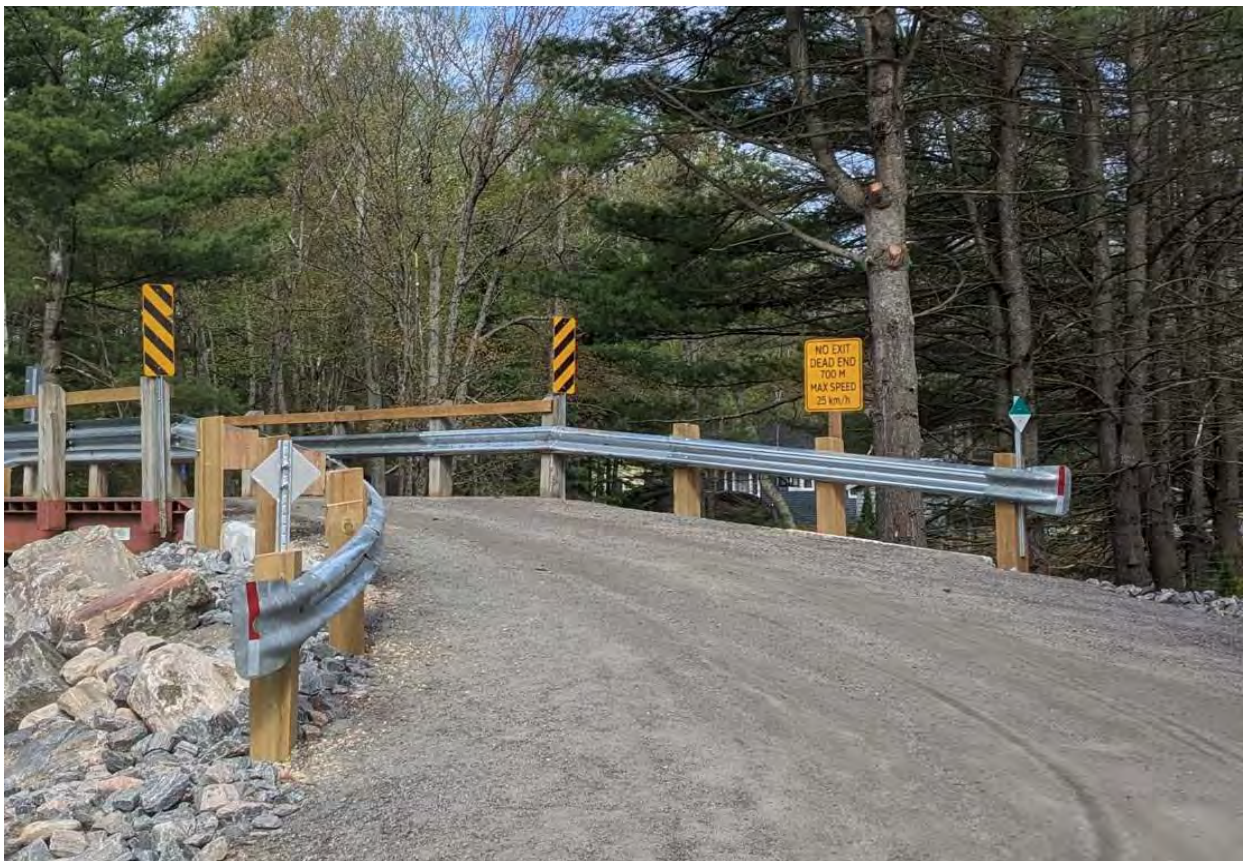
Description of Photo: Approach guide rail, typ.

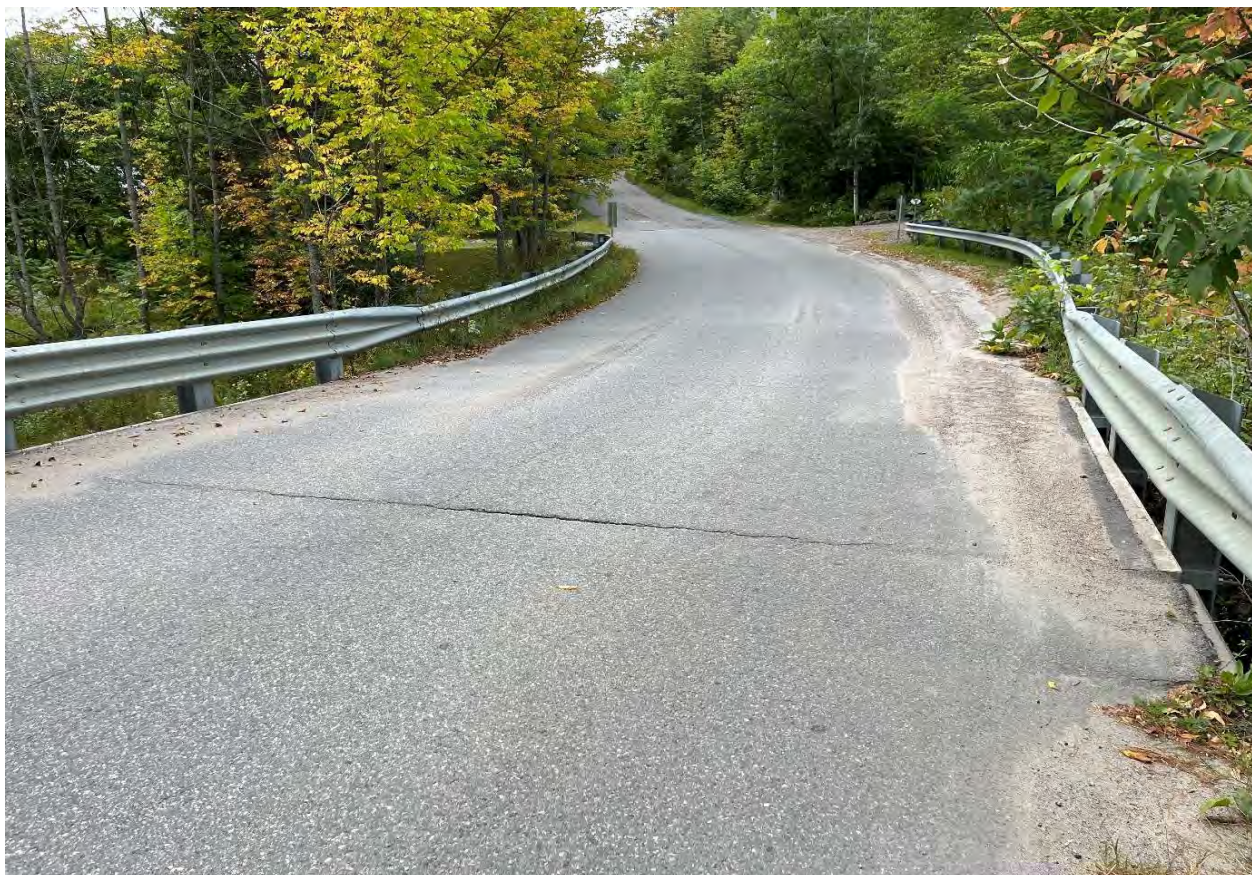
Comments: Light ravelling, typ. Narrow crack along road centerline.

Description of Photo: Wearing surface - looking south

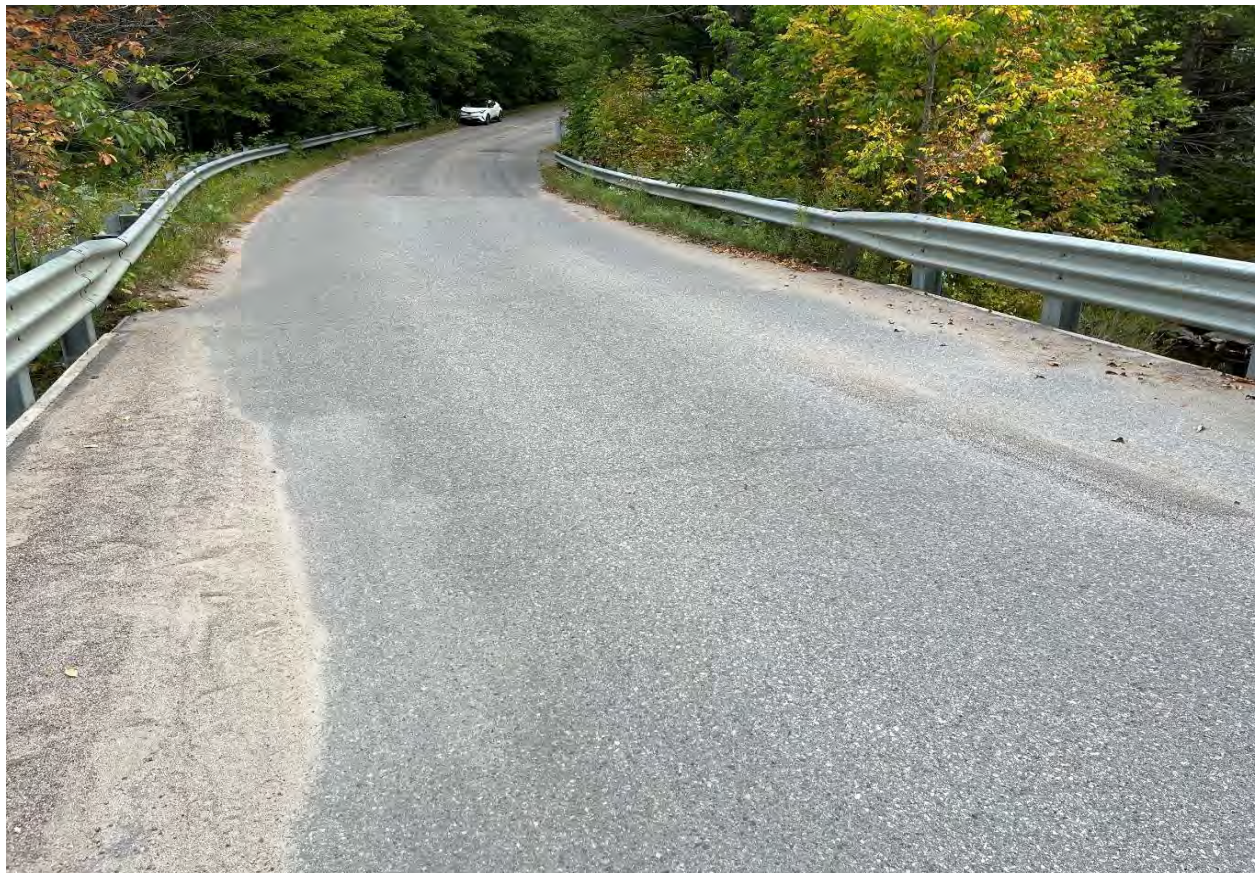
Description of Photo: Wearing surface - looking north

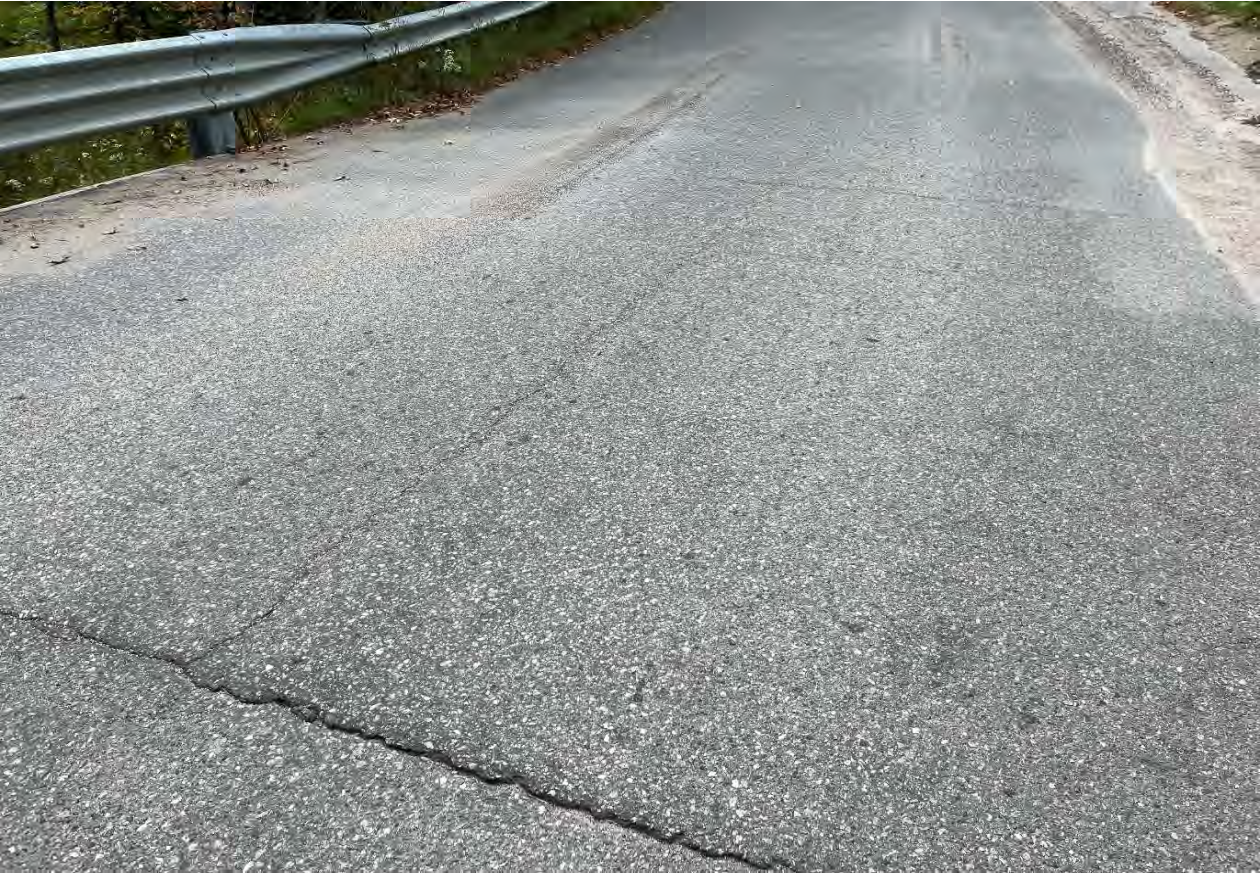
Description of Photo: Asphalt covered concrete deck

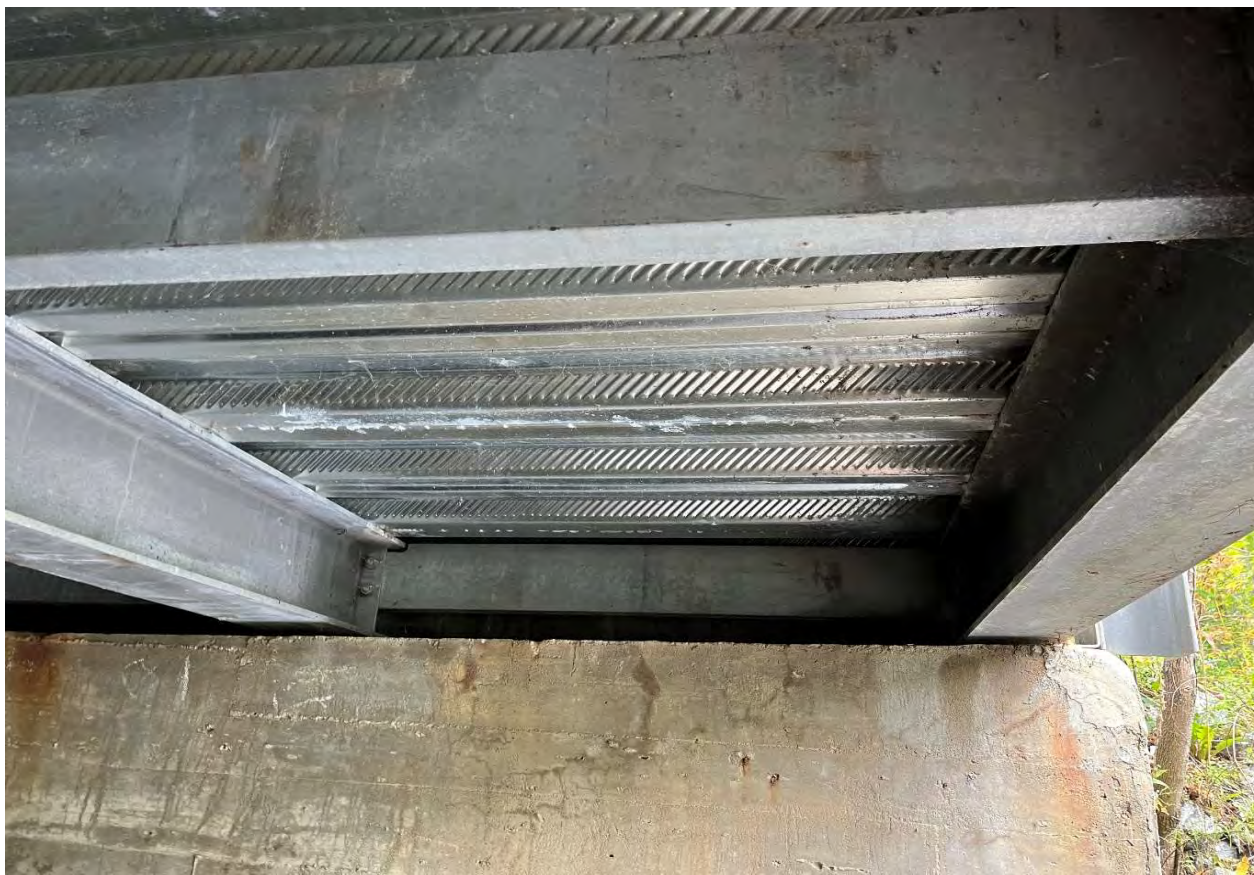
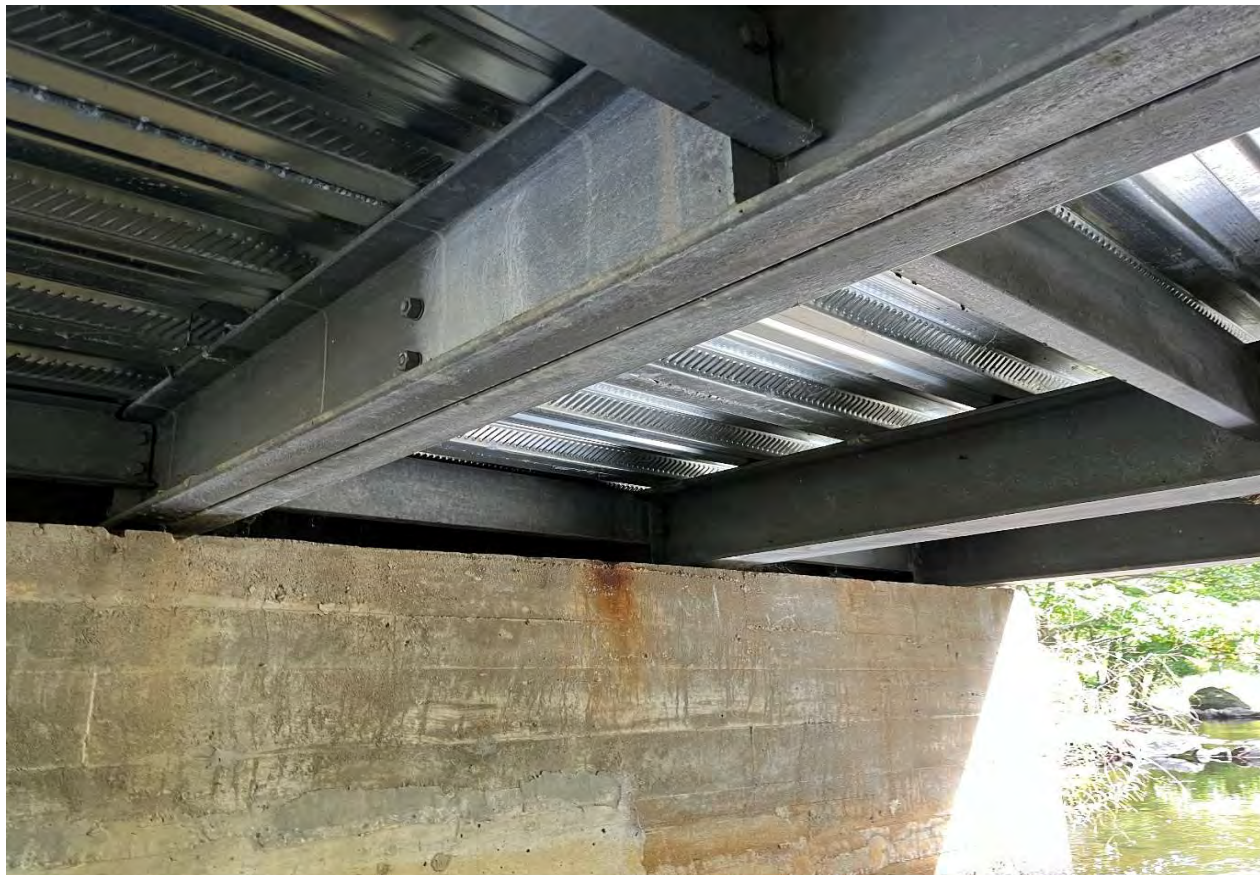
Comments: No observed defects. Note the steel decking were forms for the concrete deck.

Description of Photo: Deck - soffit

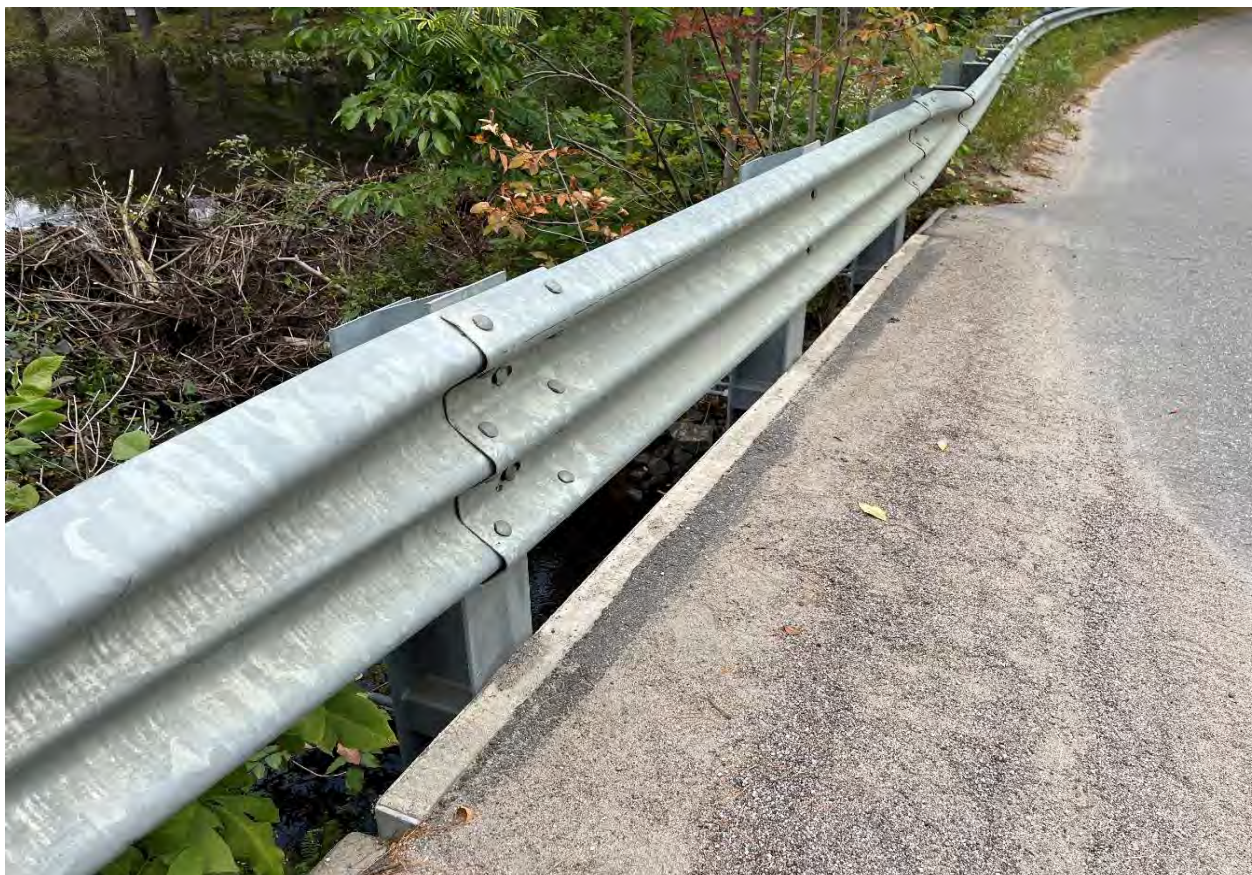
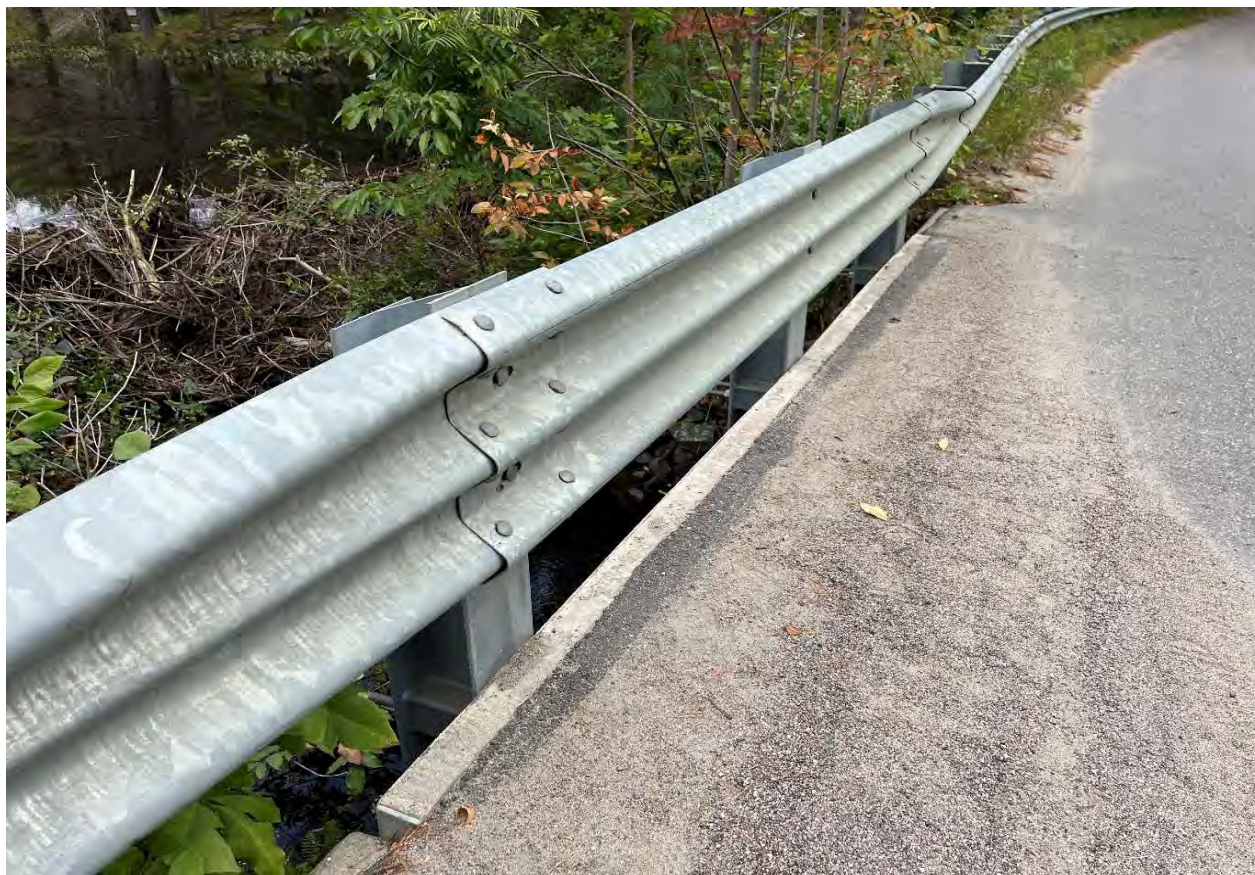
Description of Photo: Railing system

Description of Photo: Railing system, typ.
