Bridge Needs Study

INSPECTION SUMMARY REPORT

Town of Gravenhurst

August
29, 2024

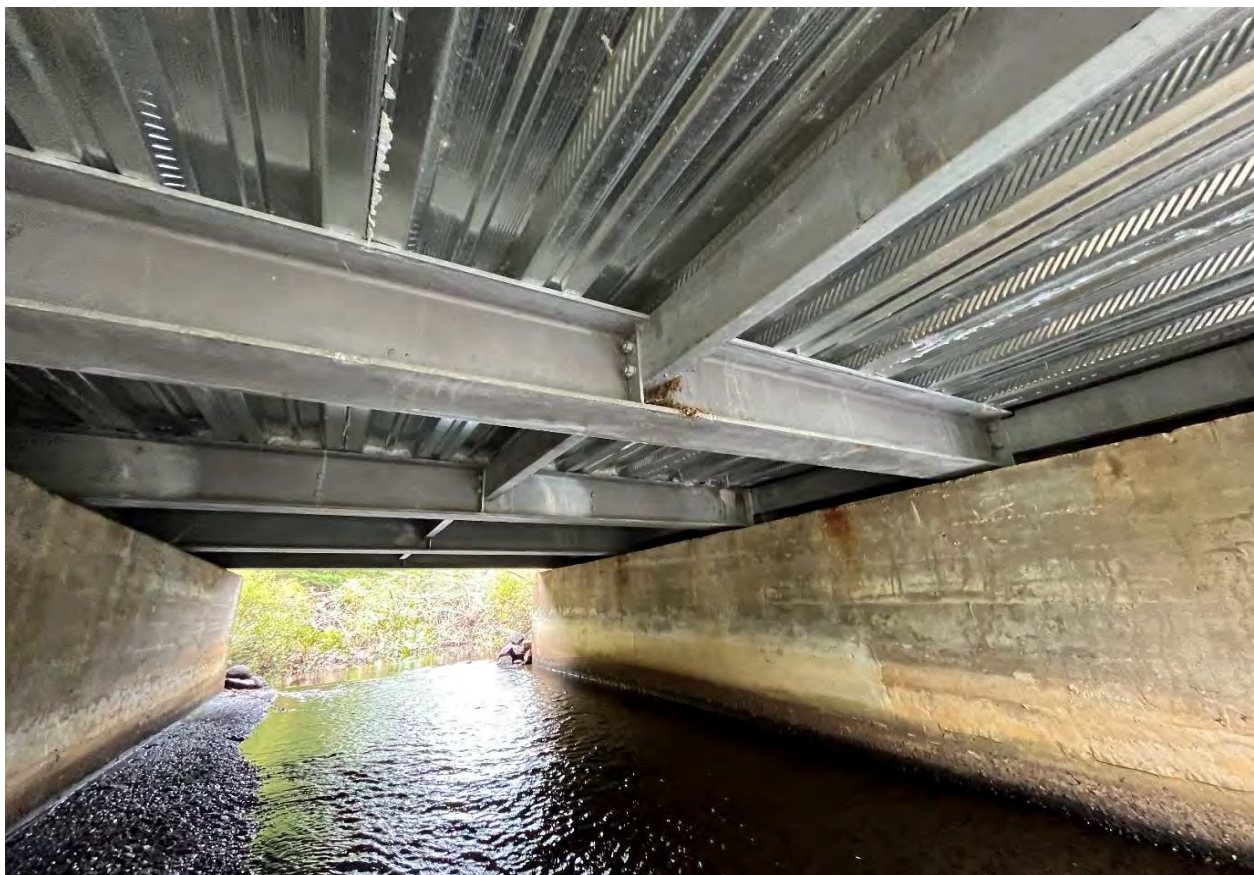
Comments: **No observed defects. 4 - I-Beam and 2 - Bolted channel sections.**

Description of Photo: Girder, typ.

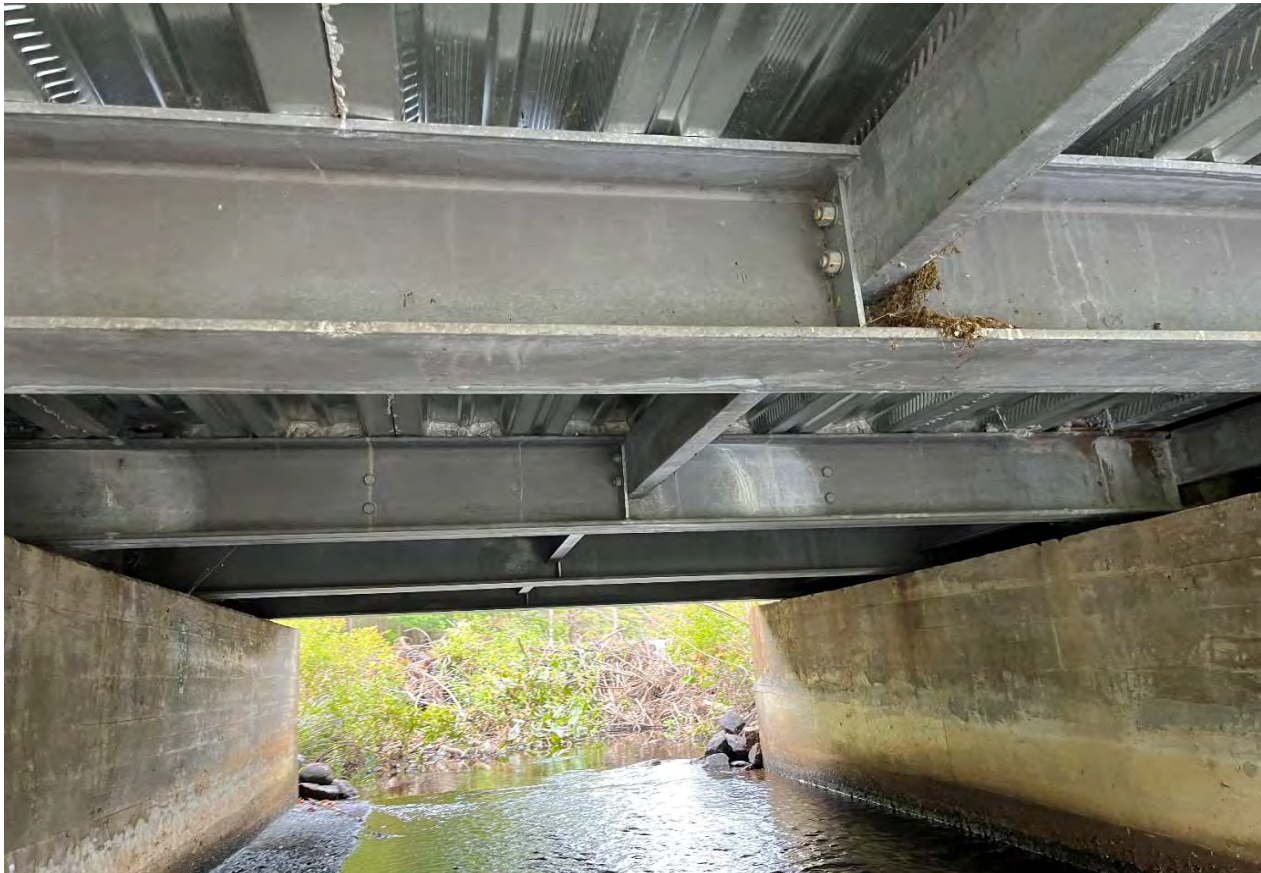
Comments: **No observed defects.**

Description of Photo: Diaphragm

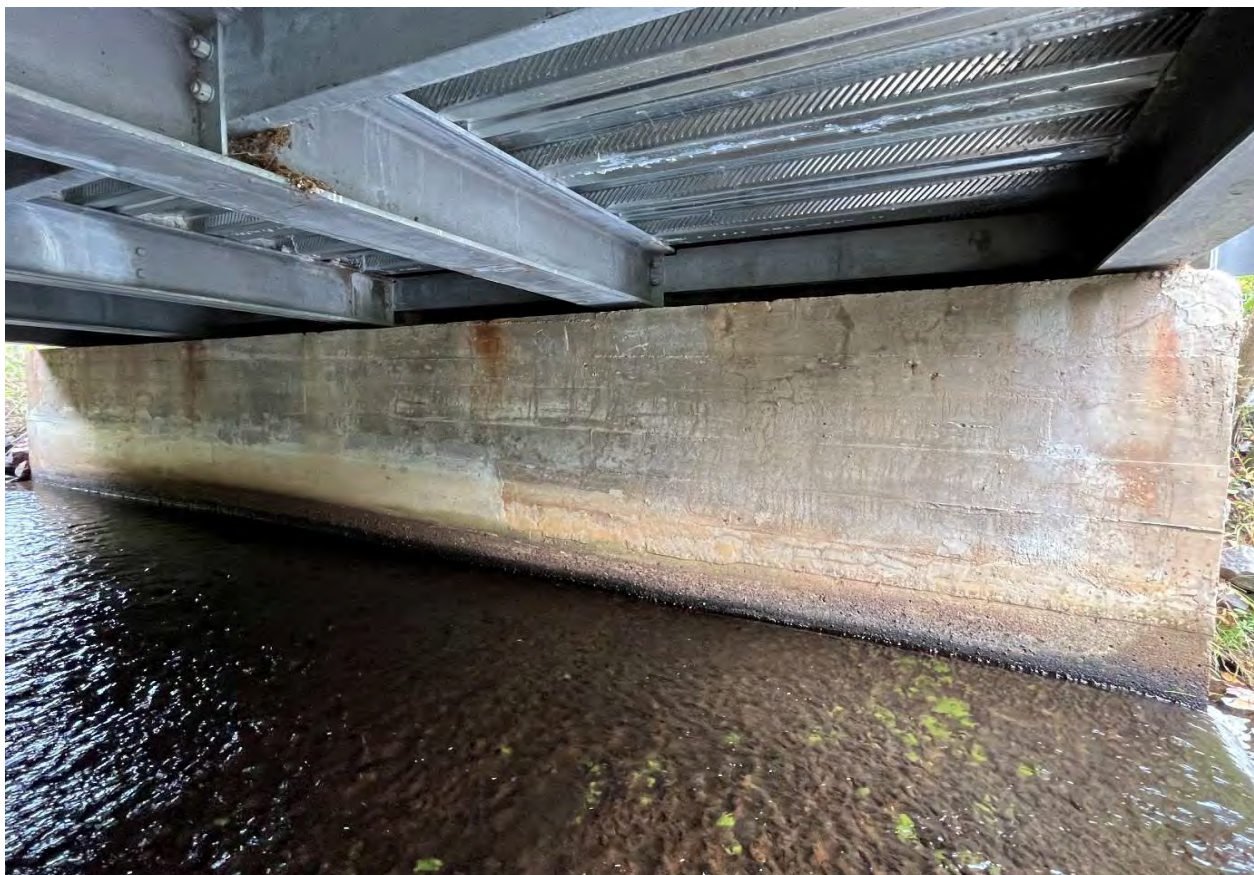
Comments: Light scaling, typ. Staining and light erosion along the waterline.

Description of Photo: North abutment wall

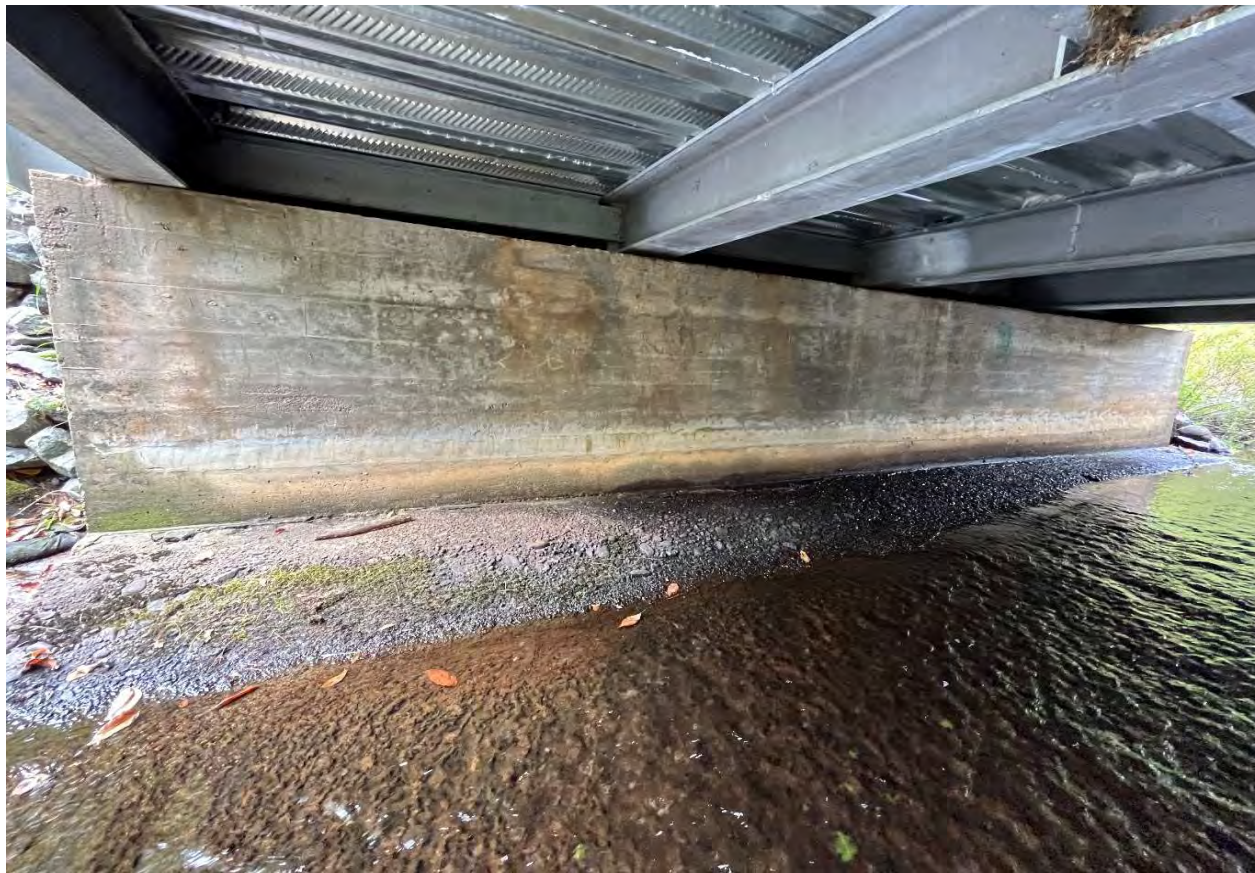
Description of Photo: South abutment wall

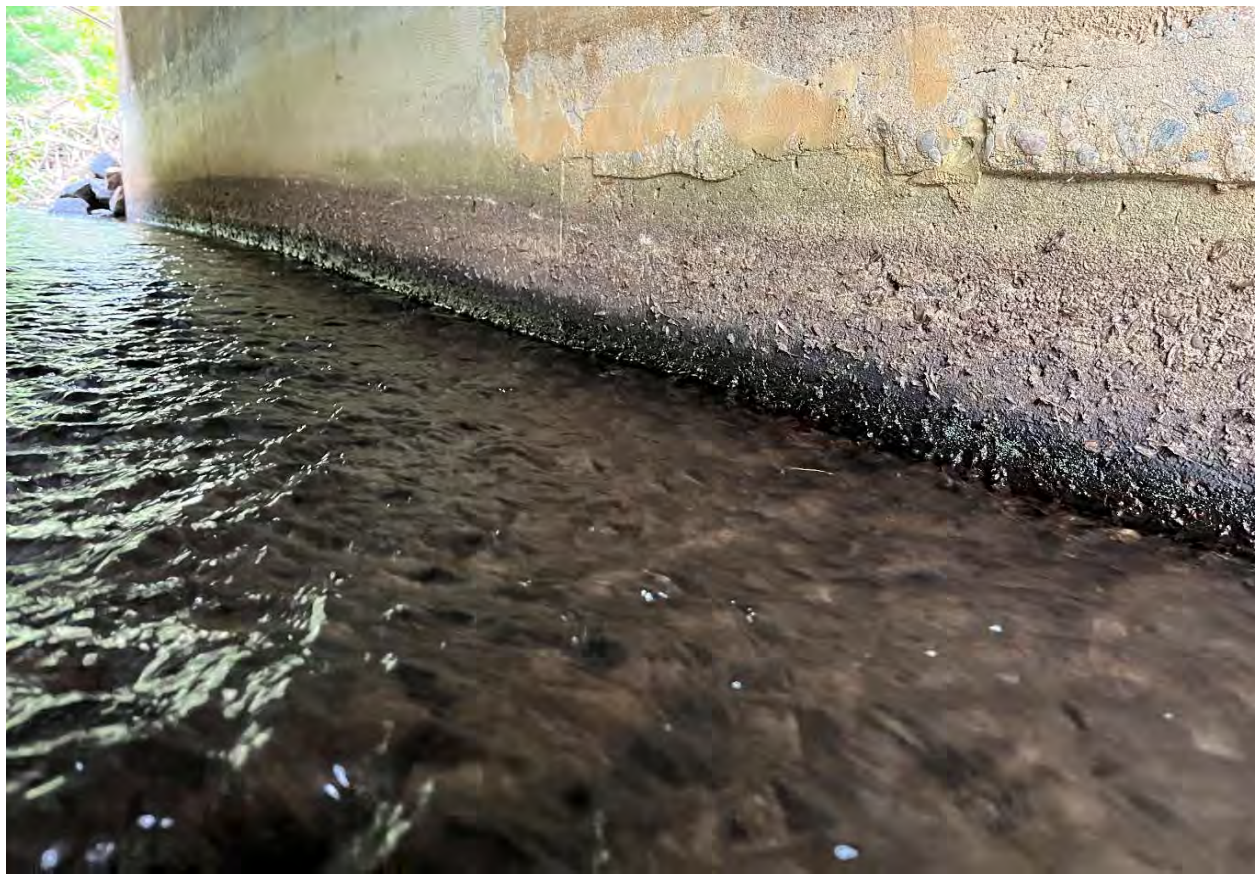
Description of Photo: Erosion along waterline

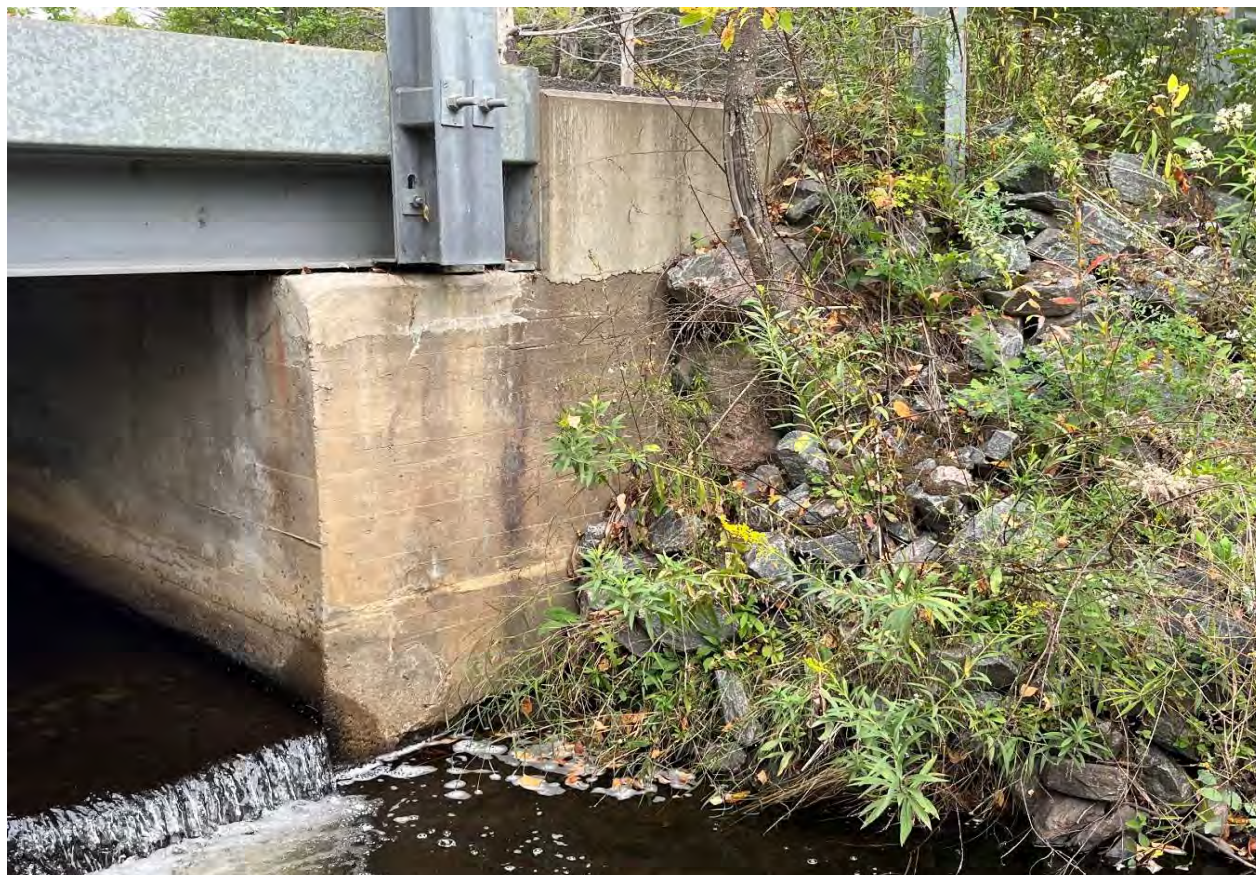
Description of Photo: Northeast wing wall

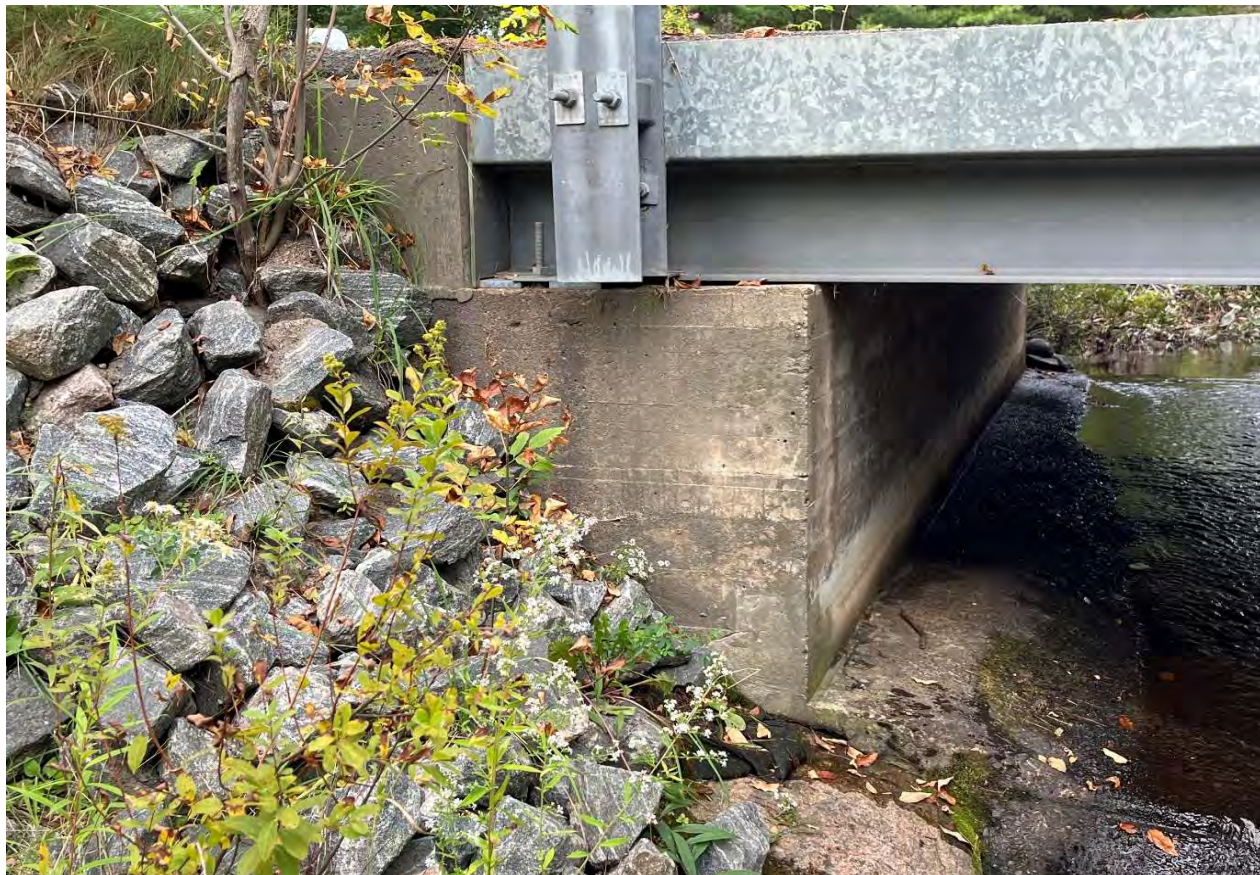
Description of Photo: Southeast wing wall

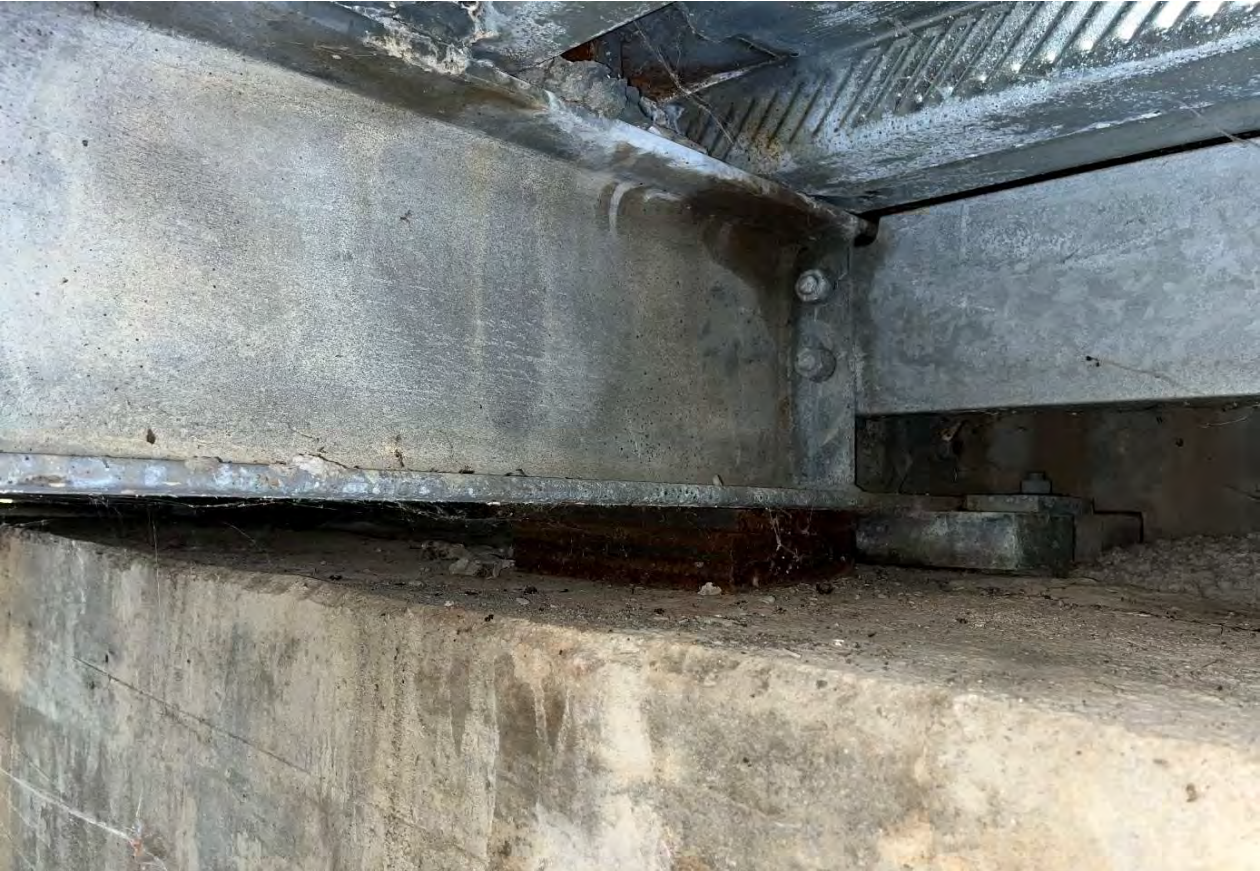
Description of Photo: Bearings, typ.

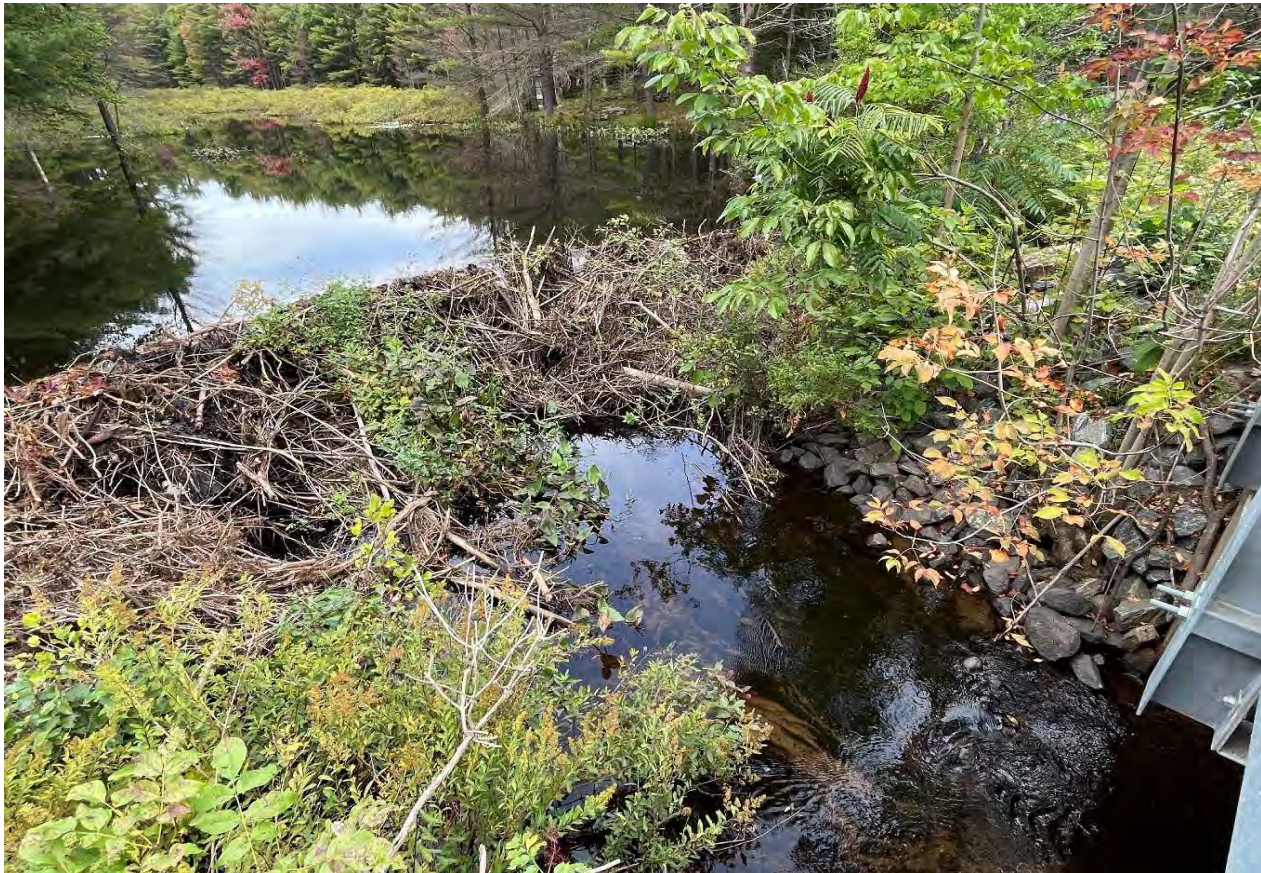
Description of Photo: Upstream

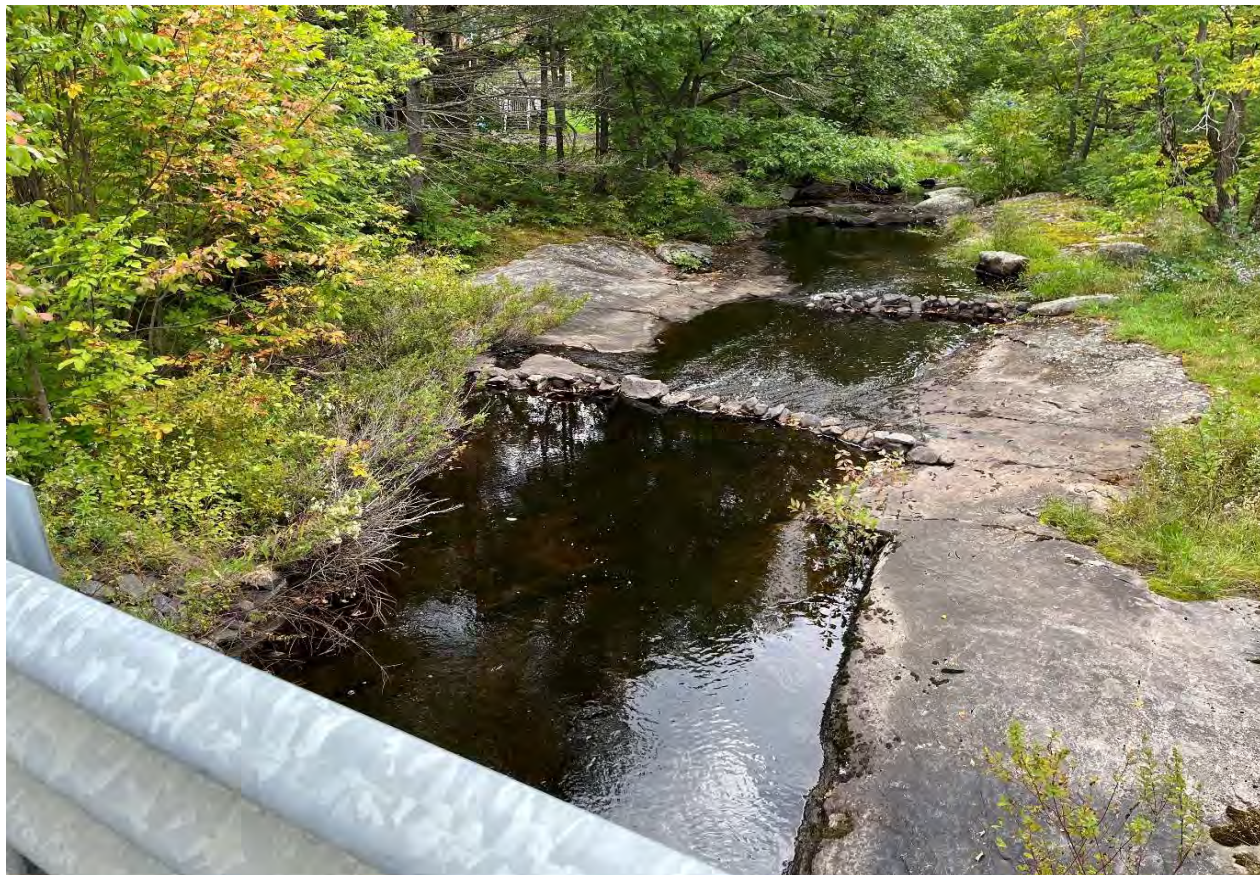
Description of Photo: Downstream

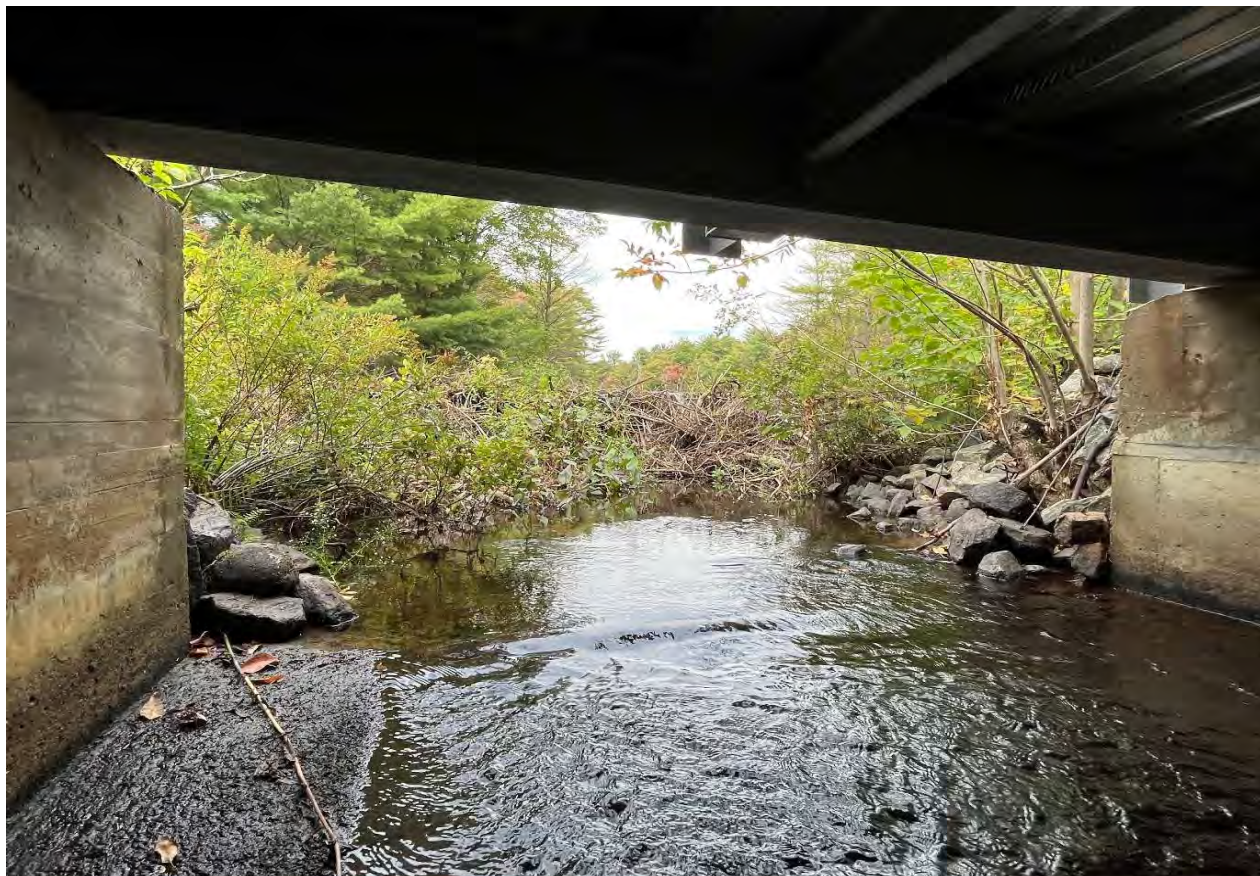
Comments: Beaver dam buildup on upstream. No other observed defects.

Description of Photo: Beaver dam on upstream

Recommended Work:	Rehab: <input type="checkbox"/>	Replace: <input type="checkbox"/>	Maintenance Needs:	11 - Animal / Pest Control
Urgent: <input type="checkbox"/>	1-5 Years: <input type="checkbox"/>	6-10 Years: <input type="checkbox"/>	None: <input checked="" type="checkbox"/>	Urgent: <input type="checkbox"/> 1 Year: <input checked="" type="checkbox"/> 2 Year: <input type="checkbox"/>
			Clearing the beaver dam

Justification:
The structure is generally in excellent to good condition. Maintenance: the beaver dam is affecting the flow and should be cleared within 1 year.

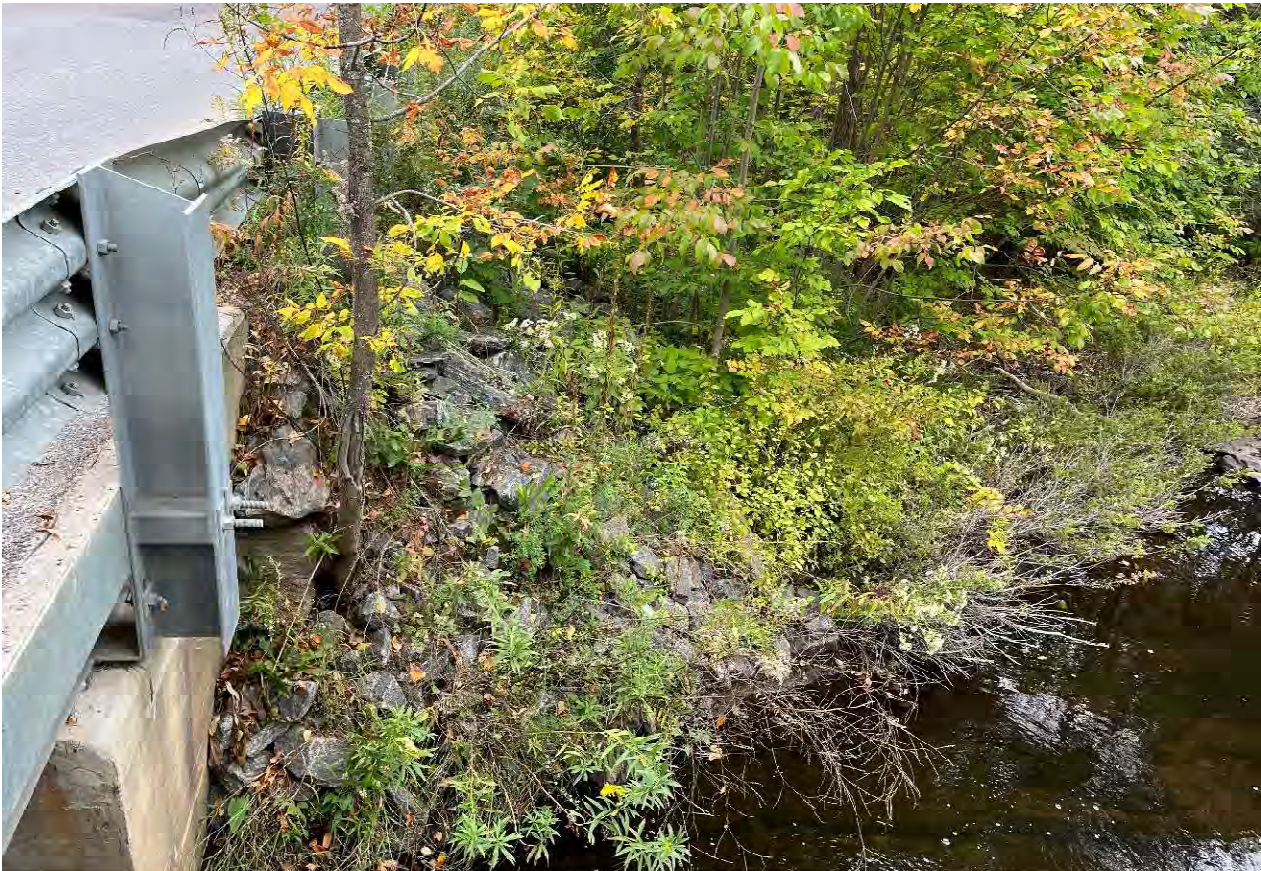
Comments: **No observed defects.**

Description of Photo: Northeast embankment

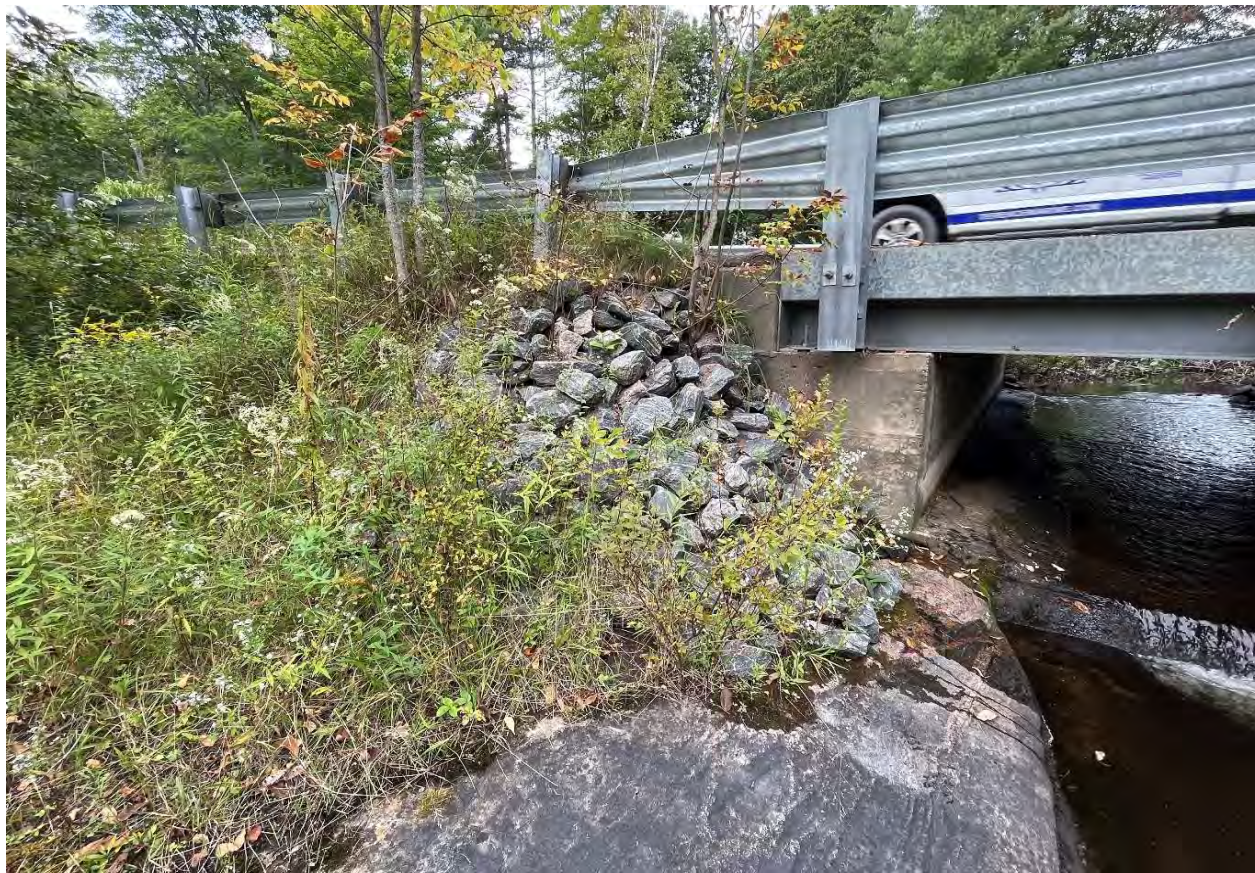
Description of Photo: Southeast embankment

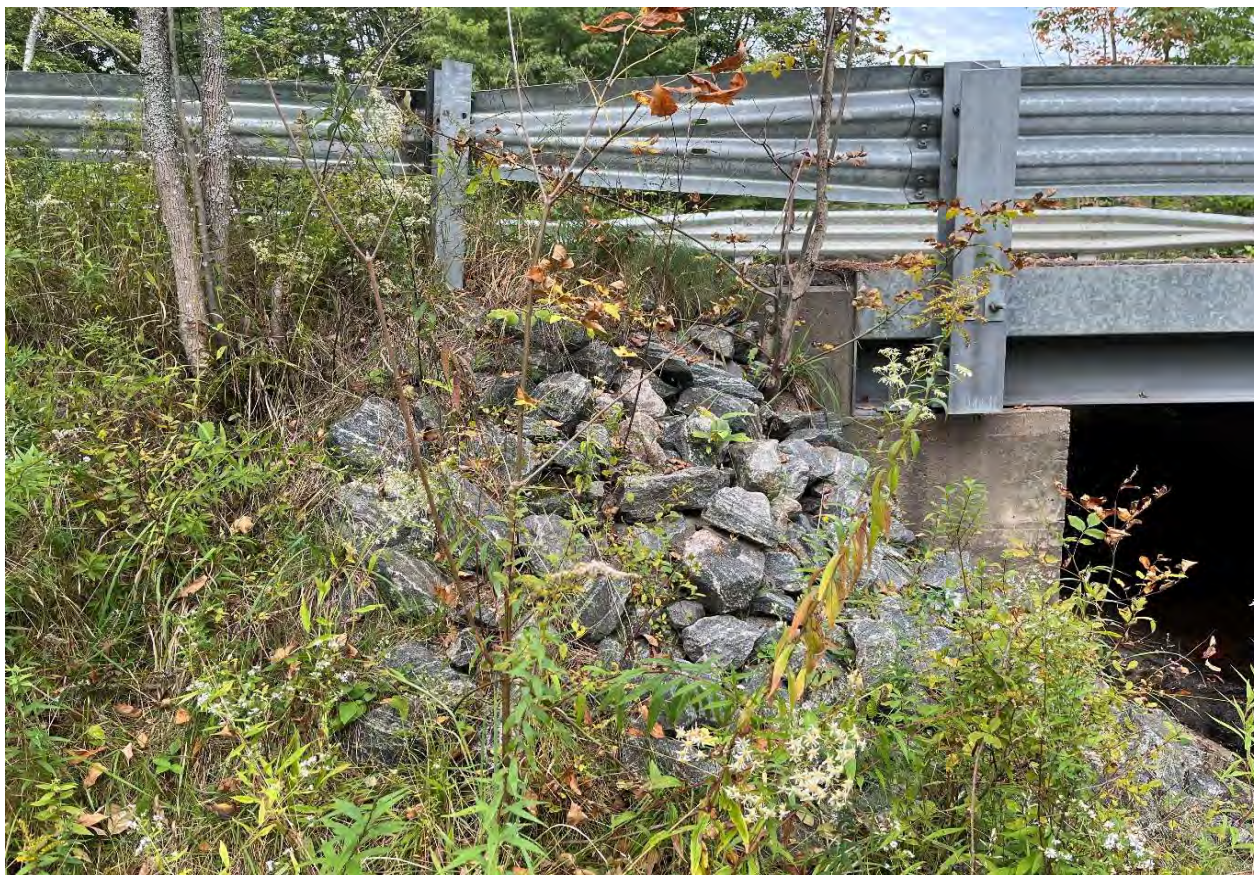
Comments: **No observed defects.**

**Description of Photo:** Southeast slope protection

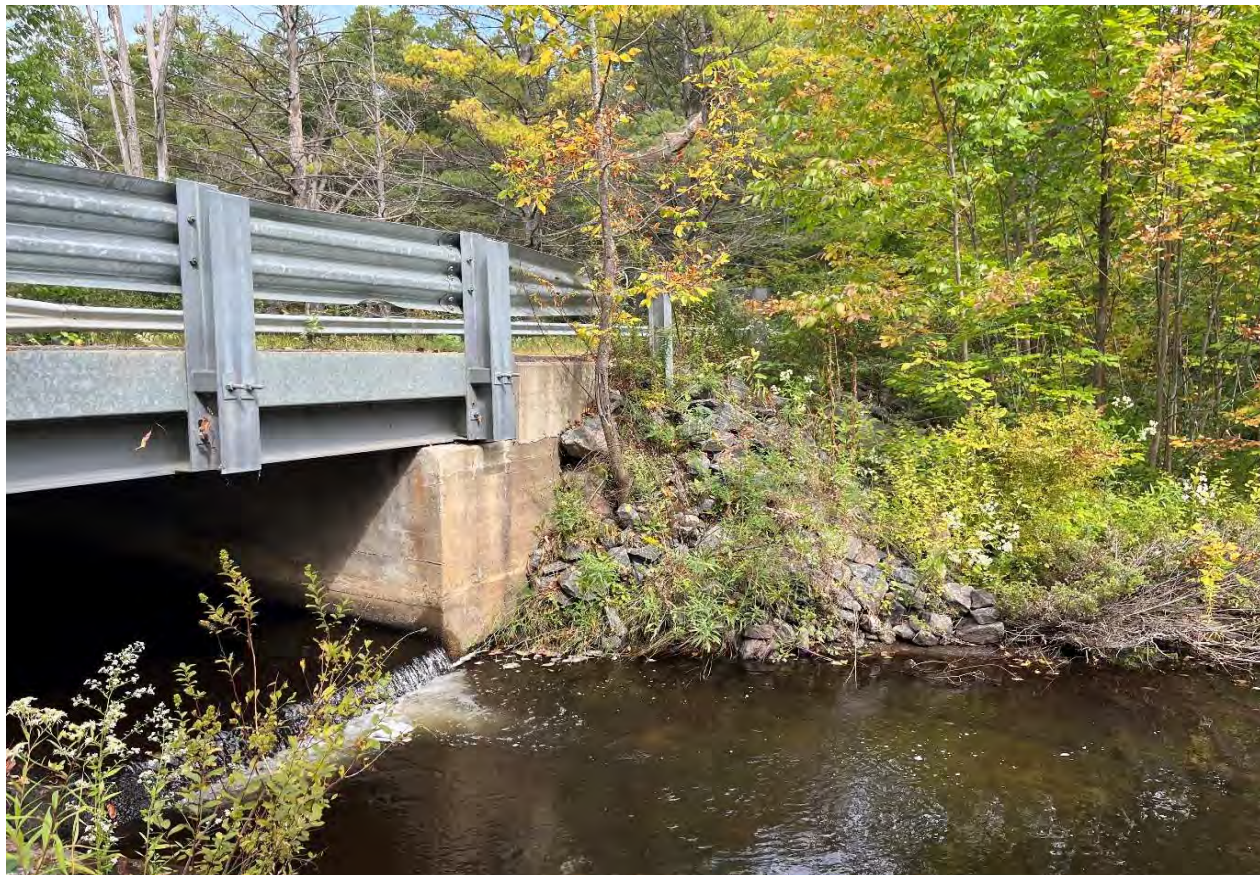
Description of Photo: Northeast slope protection

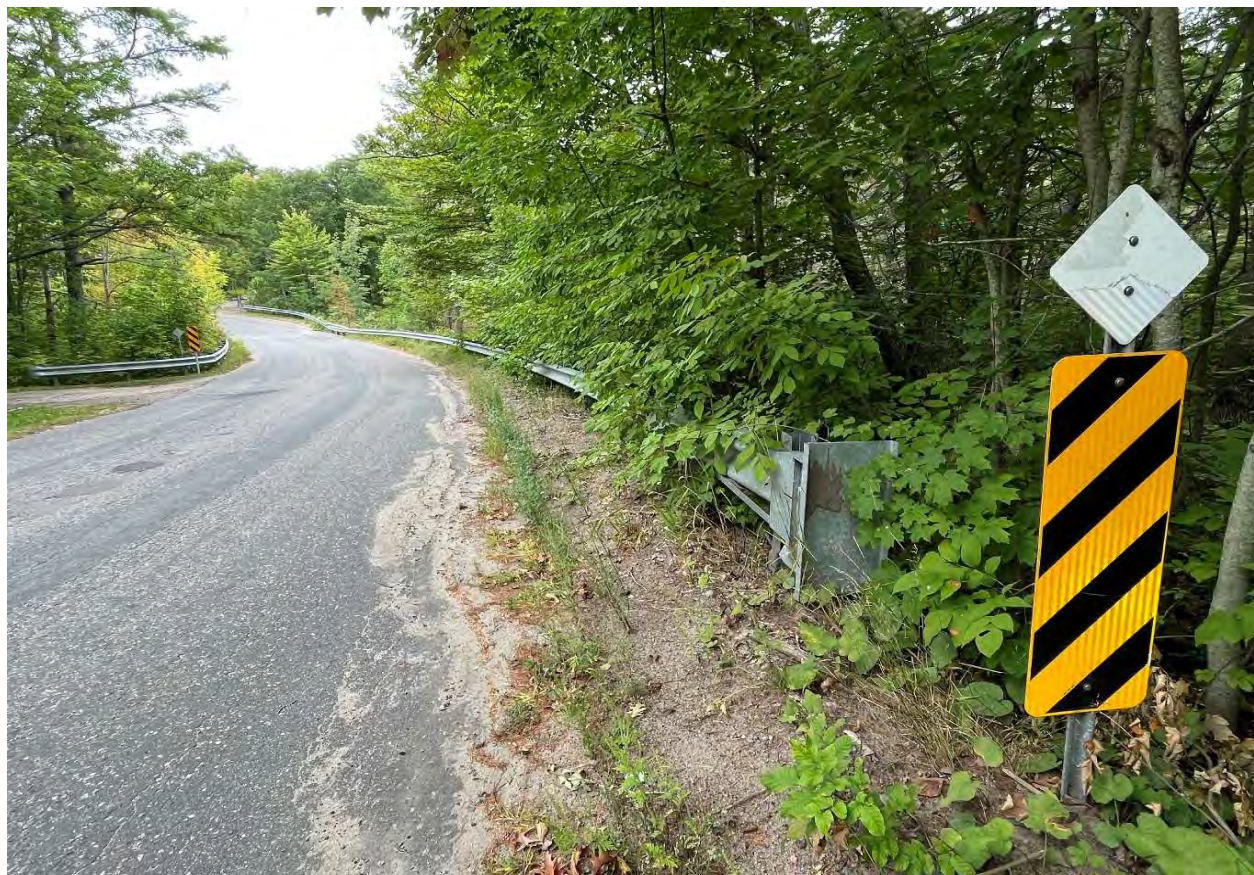
Comments: **No observed defects.**

Description of Photo: Hazard warning sign, typ.

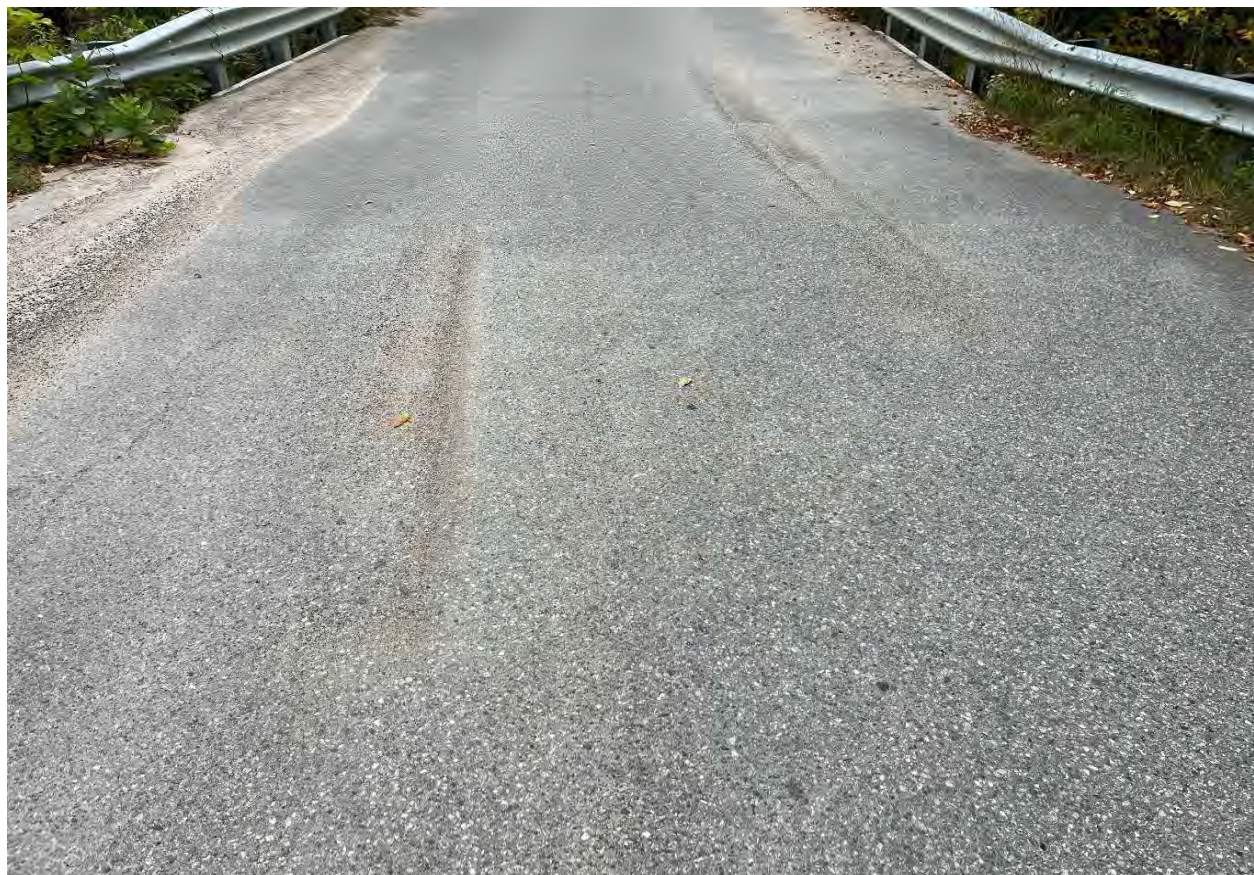
Comments: Light ravelling, typ. Medium transverse cracks at west ends of bridge.

Description of Photo: South approach wearing surface

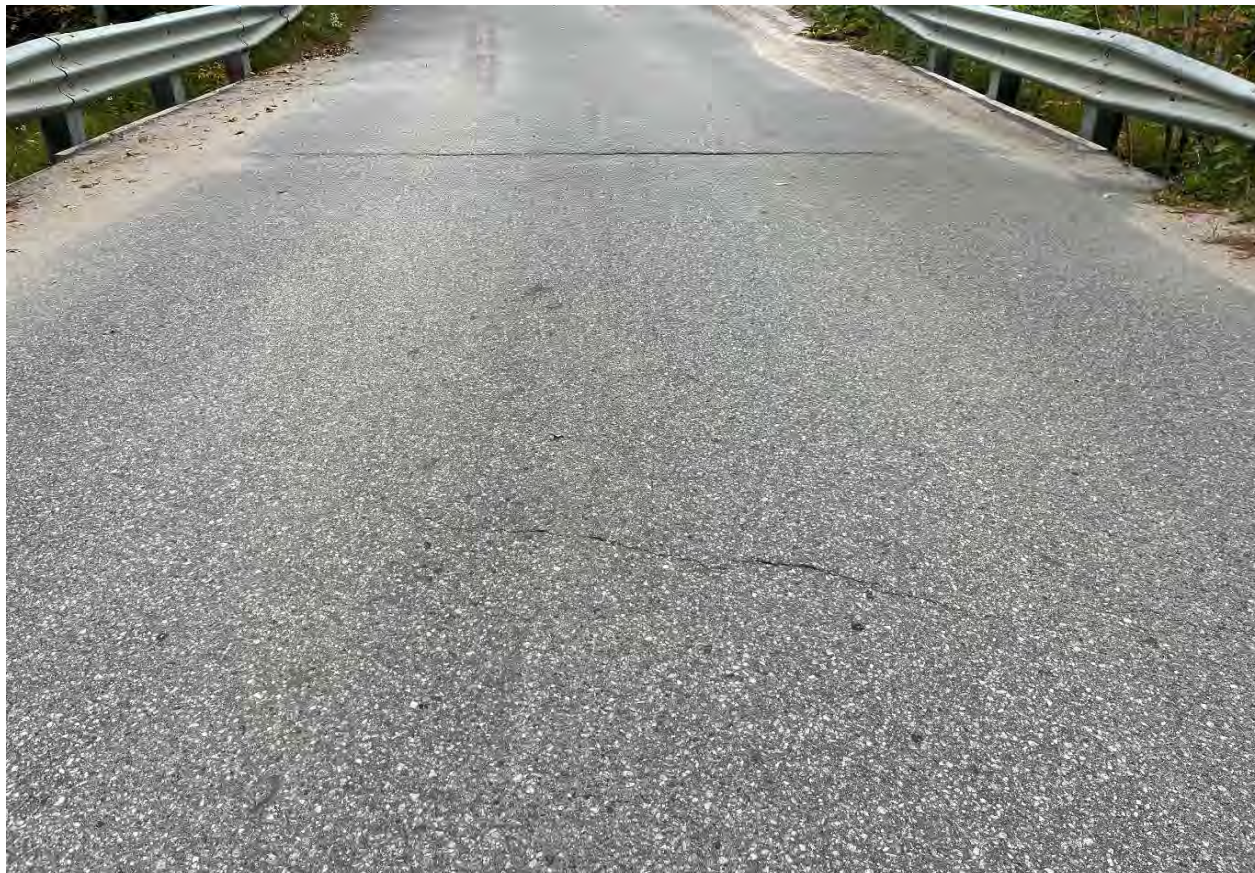
Description of Photo: North approach wearing surface

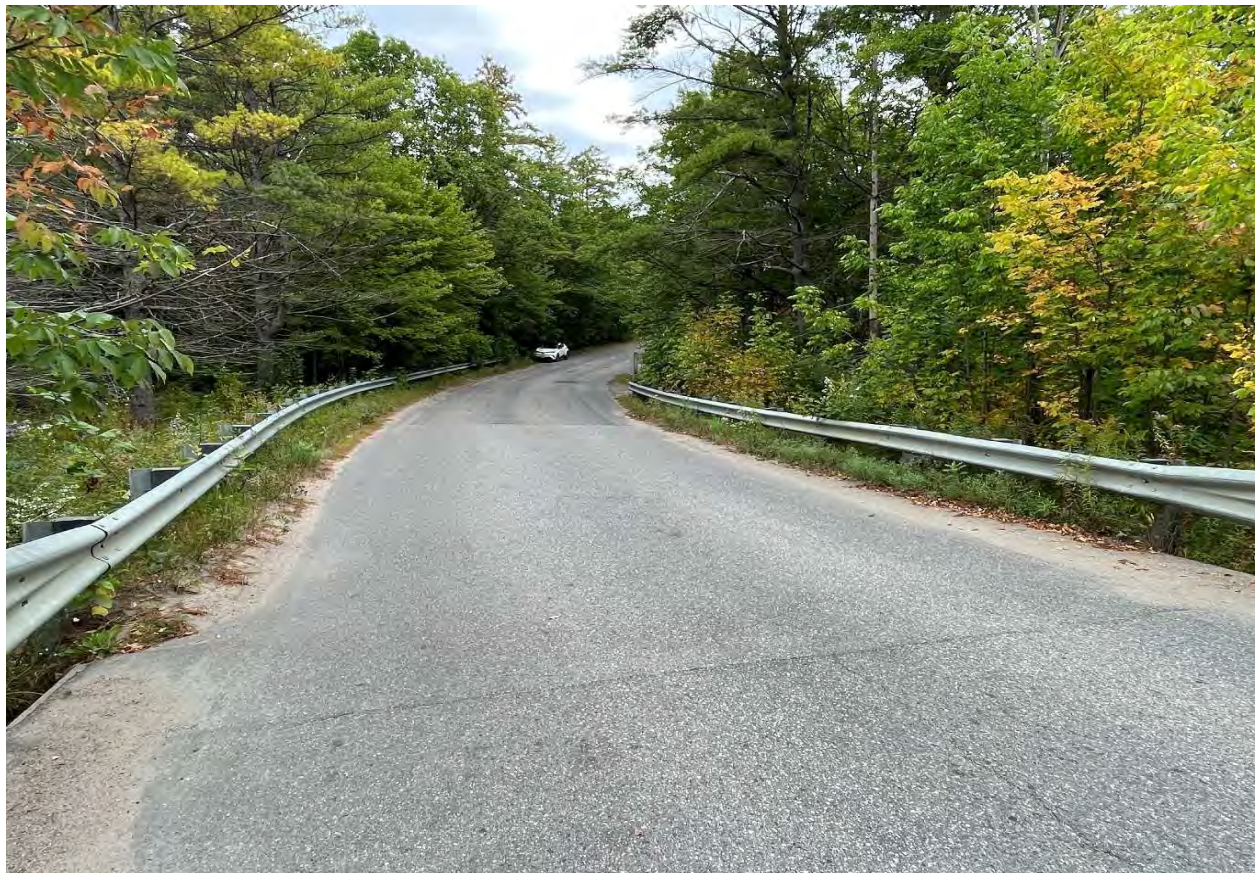
Description of Photo: North approach guide rail
