Bridge Needs Study

INSPECTION SUMMARY REPORT

Town of Gravenhurst

August
29, 2024

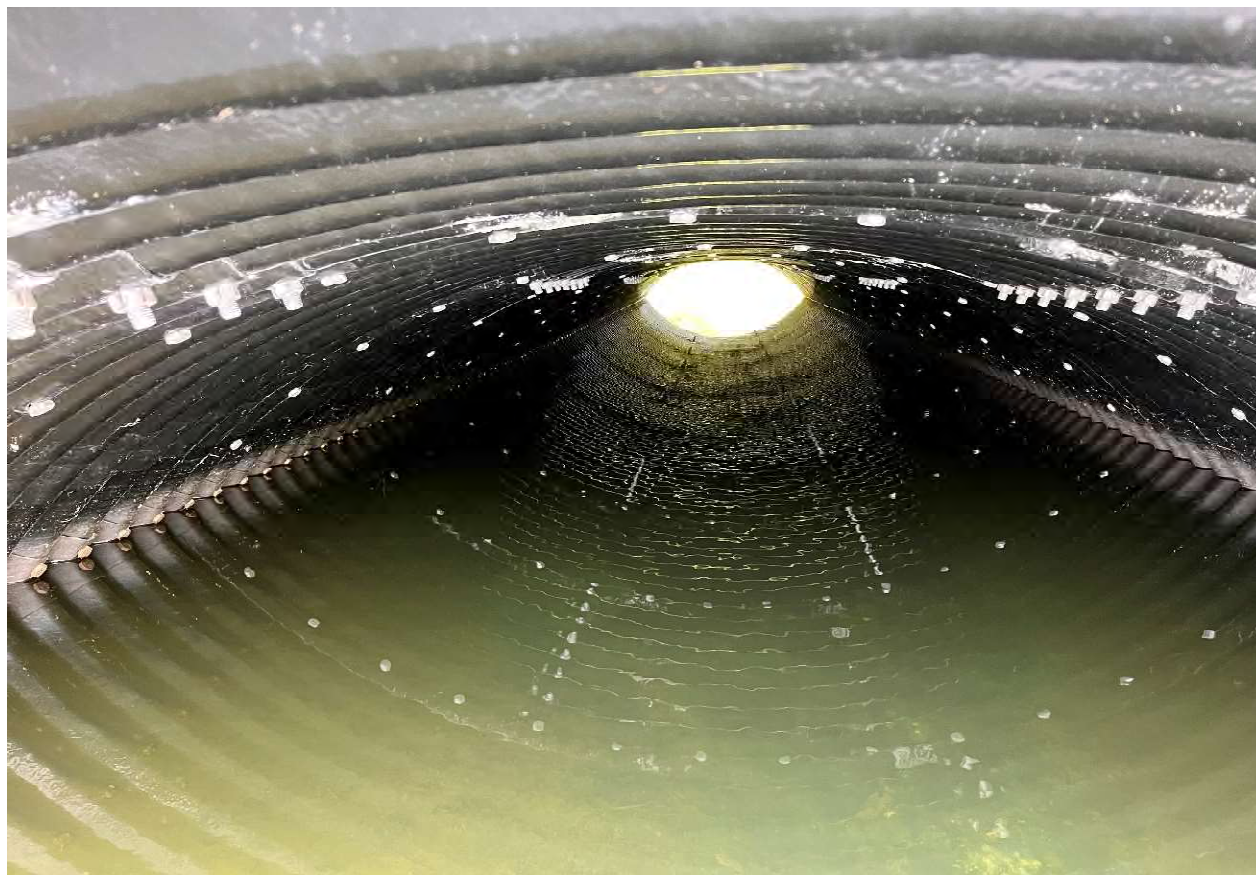
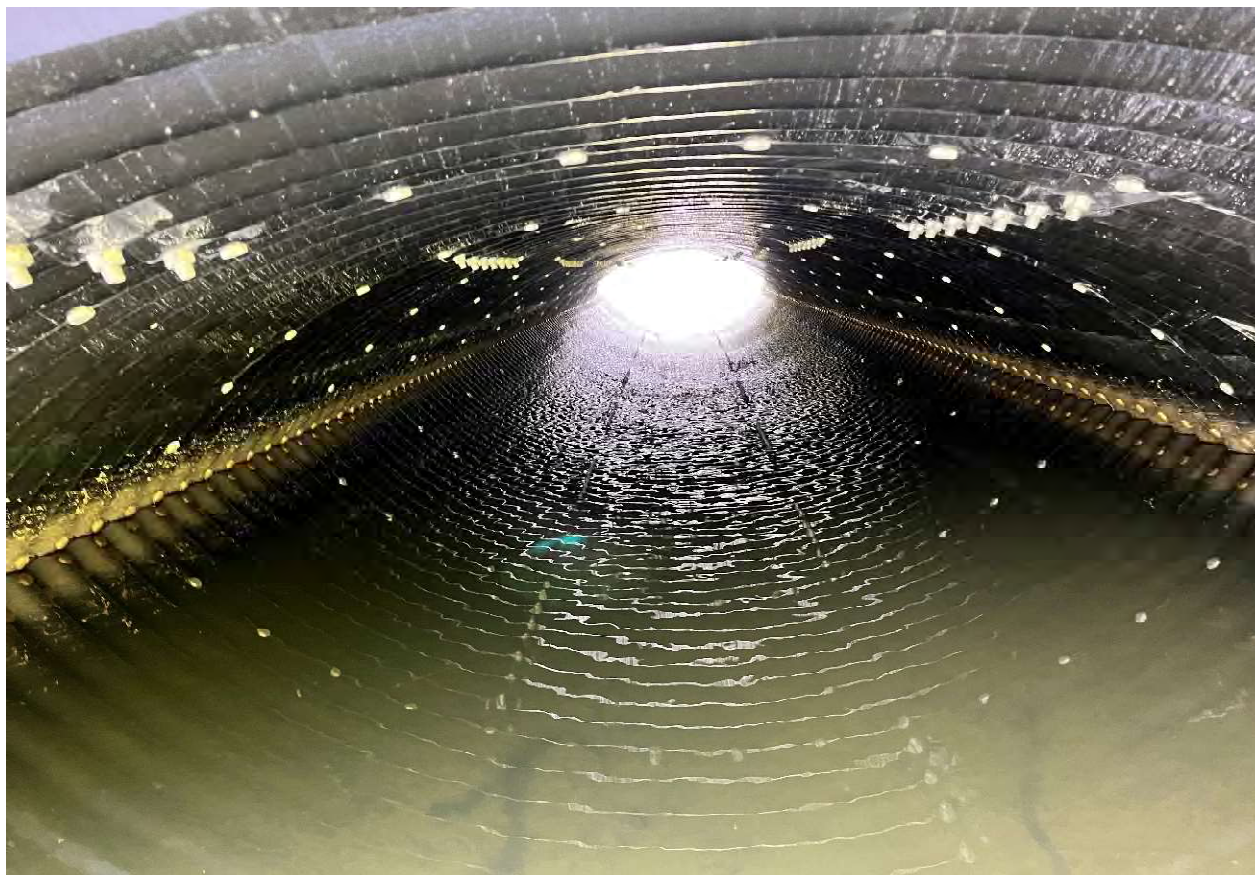
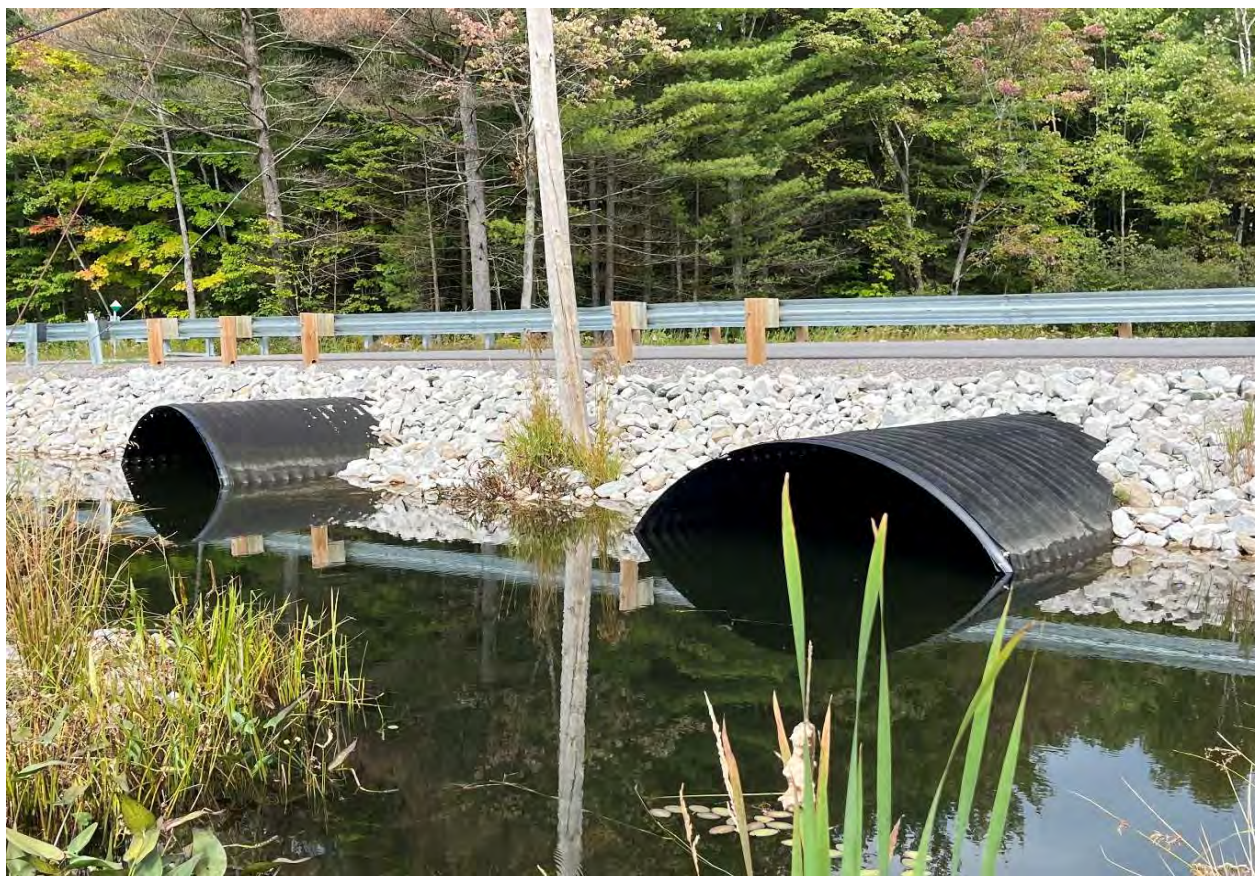
Comments: Inside of pipe and below water level were not inspected due to water depth. No observed defects from visible areas.

Description of Photo: Culvert barrel, typ.

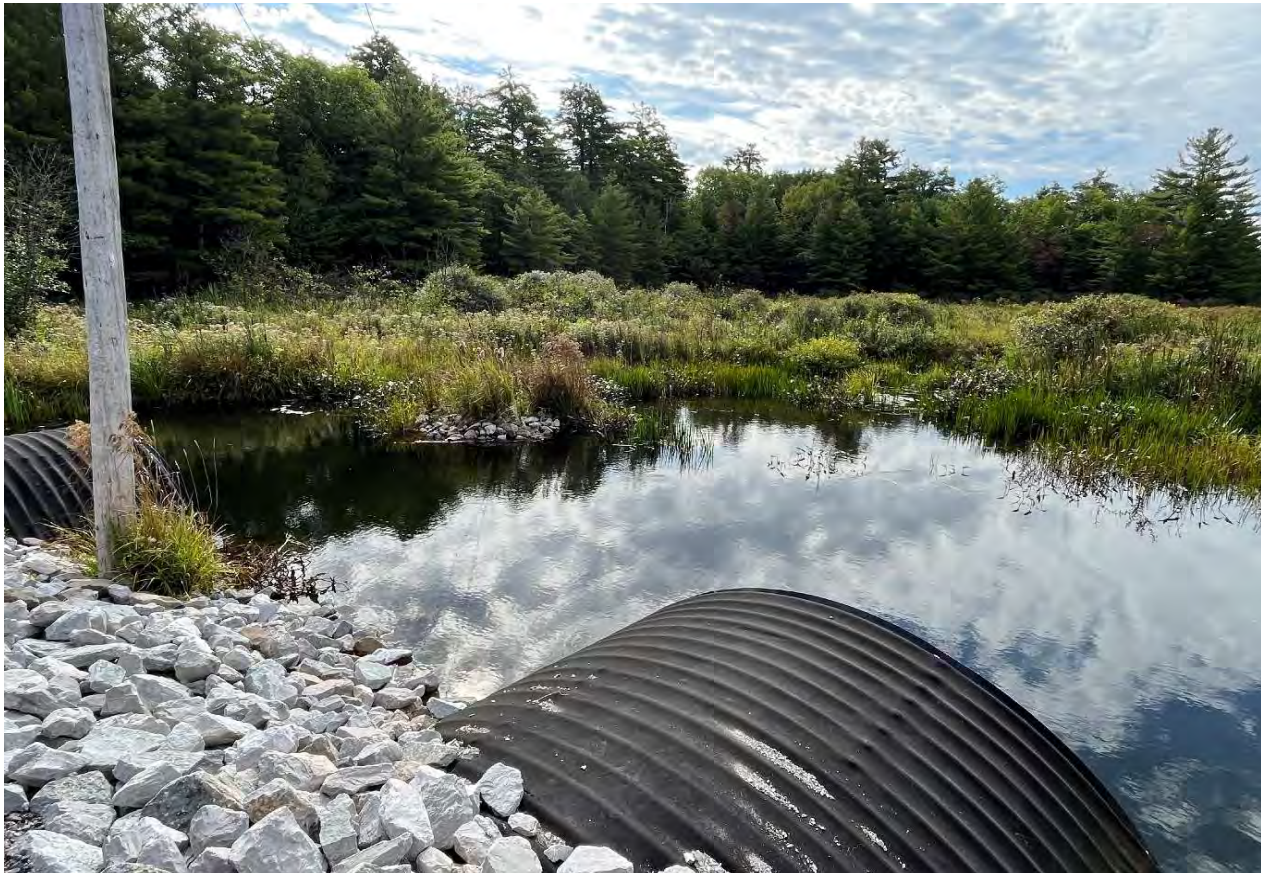
Comments: **No observed defects.**

Description of Photo: Watercourse

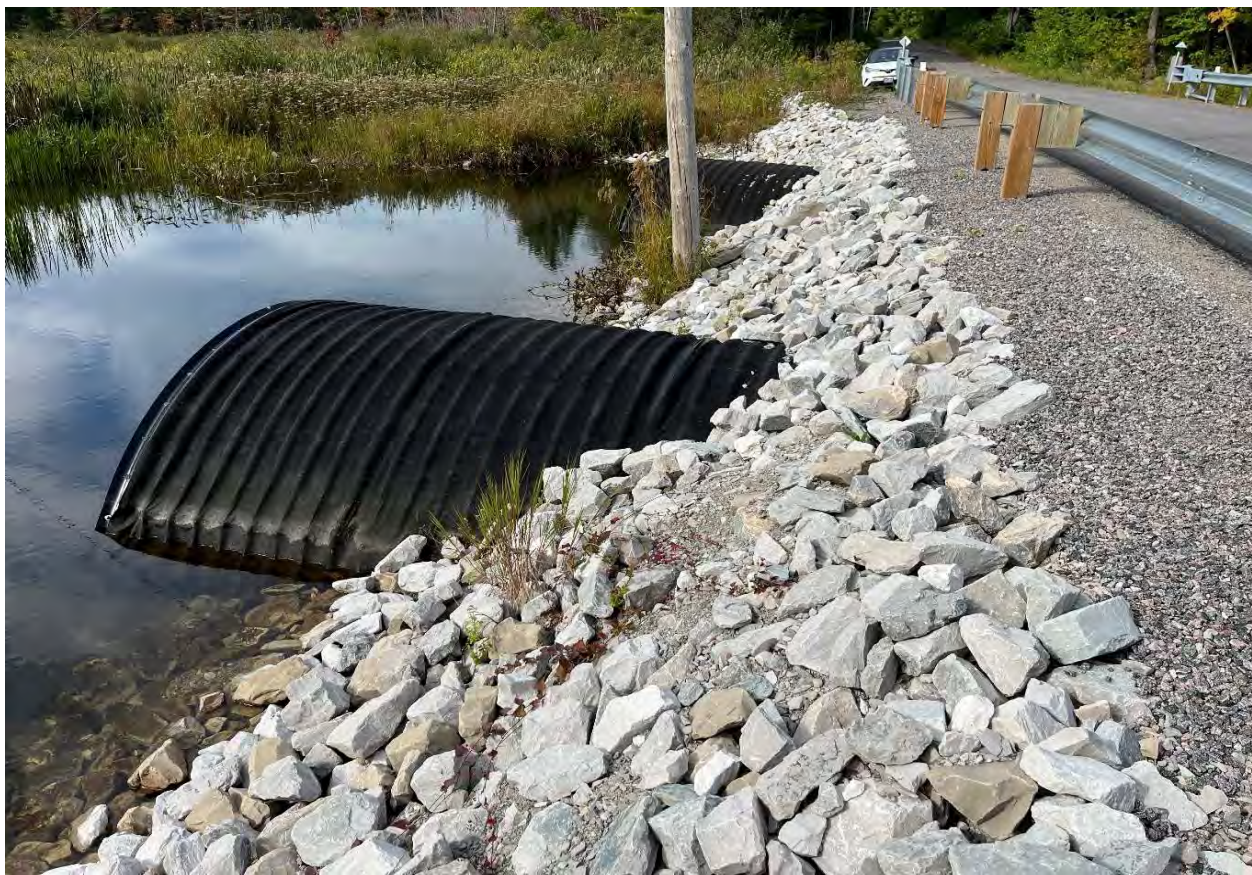
Comments: **No observed defects.**

Description of Photo: Embankment, typ.

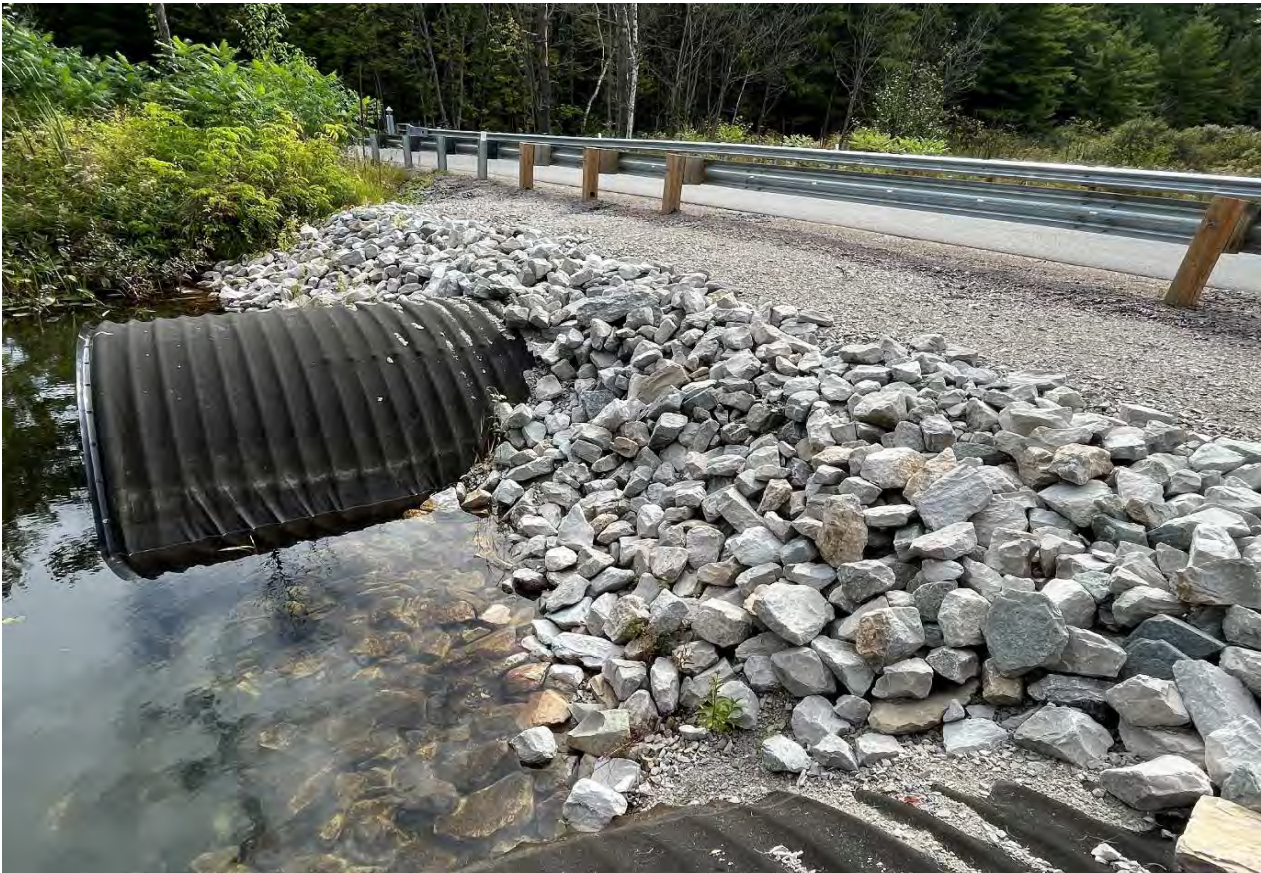
Description of Photo: Slope protection, typ.

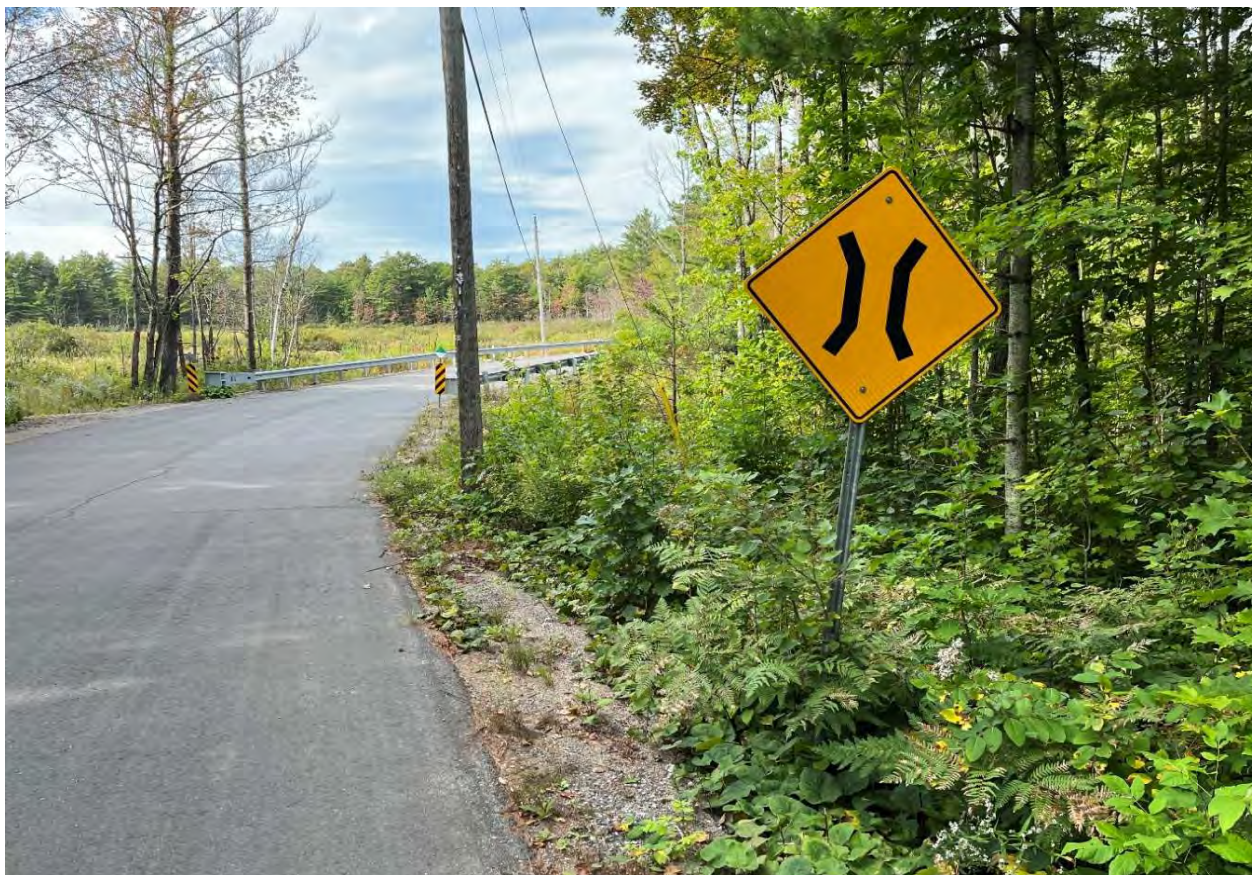
Comments: 4 - hazard warning sign, 1 narrow bridge sign. No observed defects.

Description of Photo: Narrow bridge sign

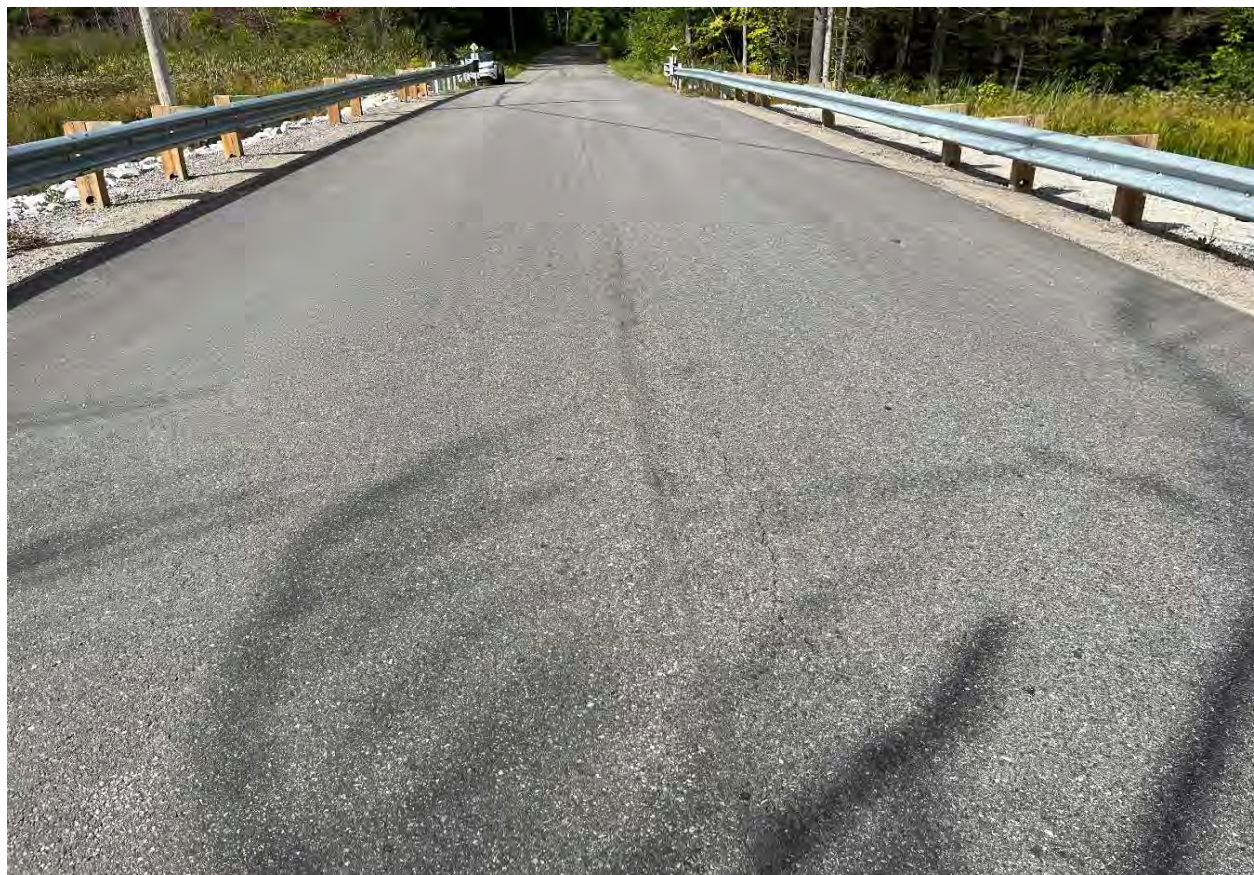
Comments: **No observed defects.**

**Description of Photo:** Approach wearing surface - looking west

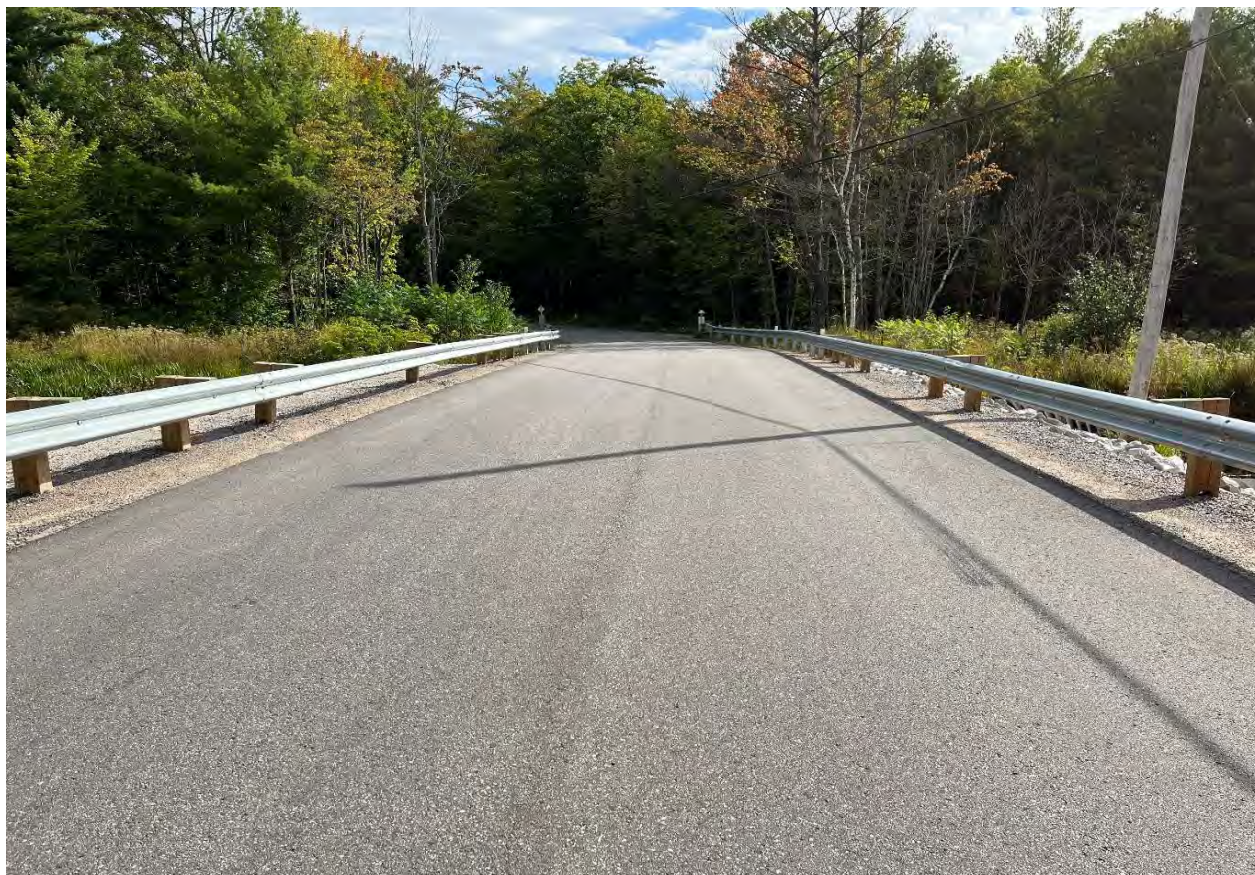
Description of Photo: Approach wearing surface - looking east

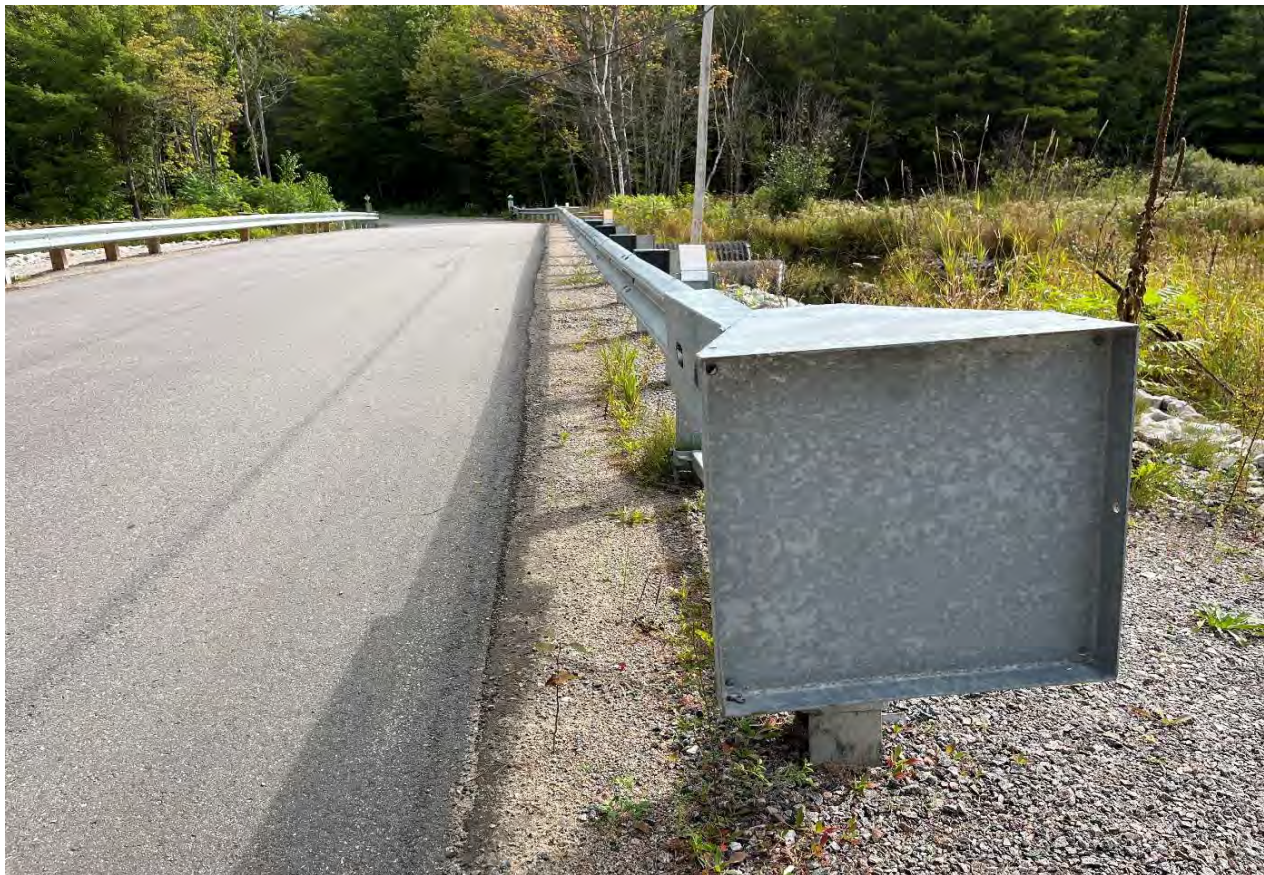
Description of Photo: Approach guide rail - looking east

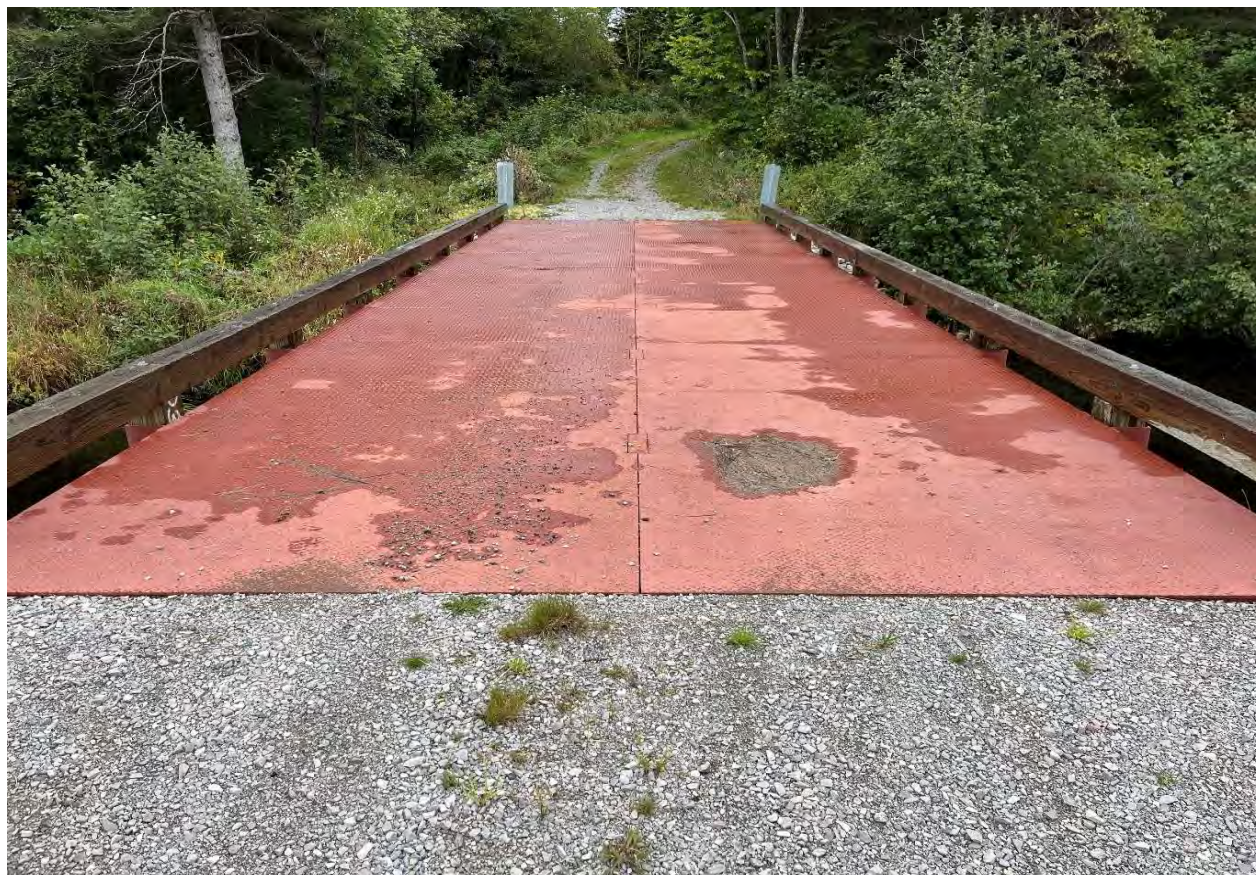
Description of Photo: Deck top

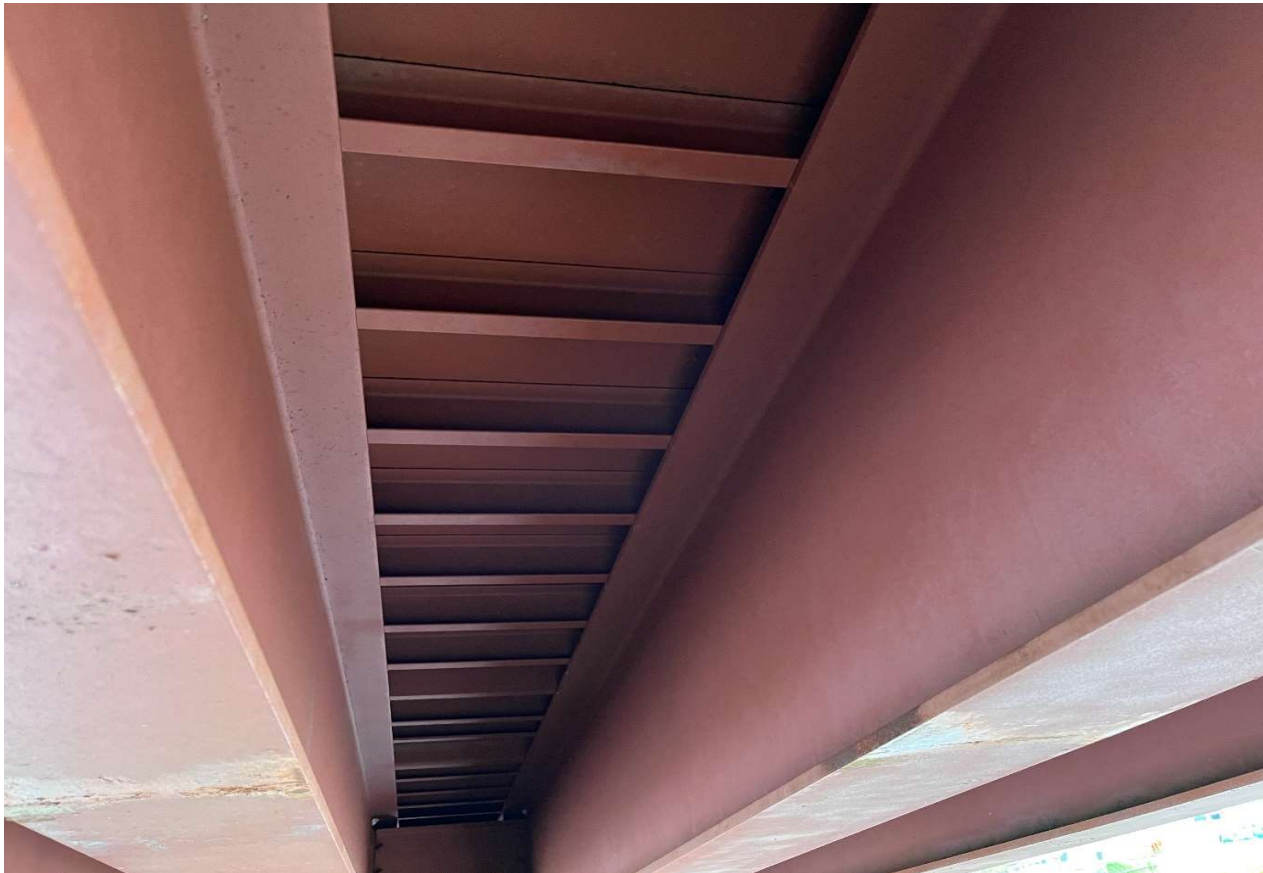
Description of Photo: Deck - soffit

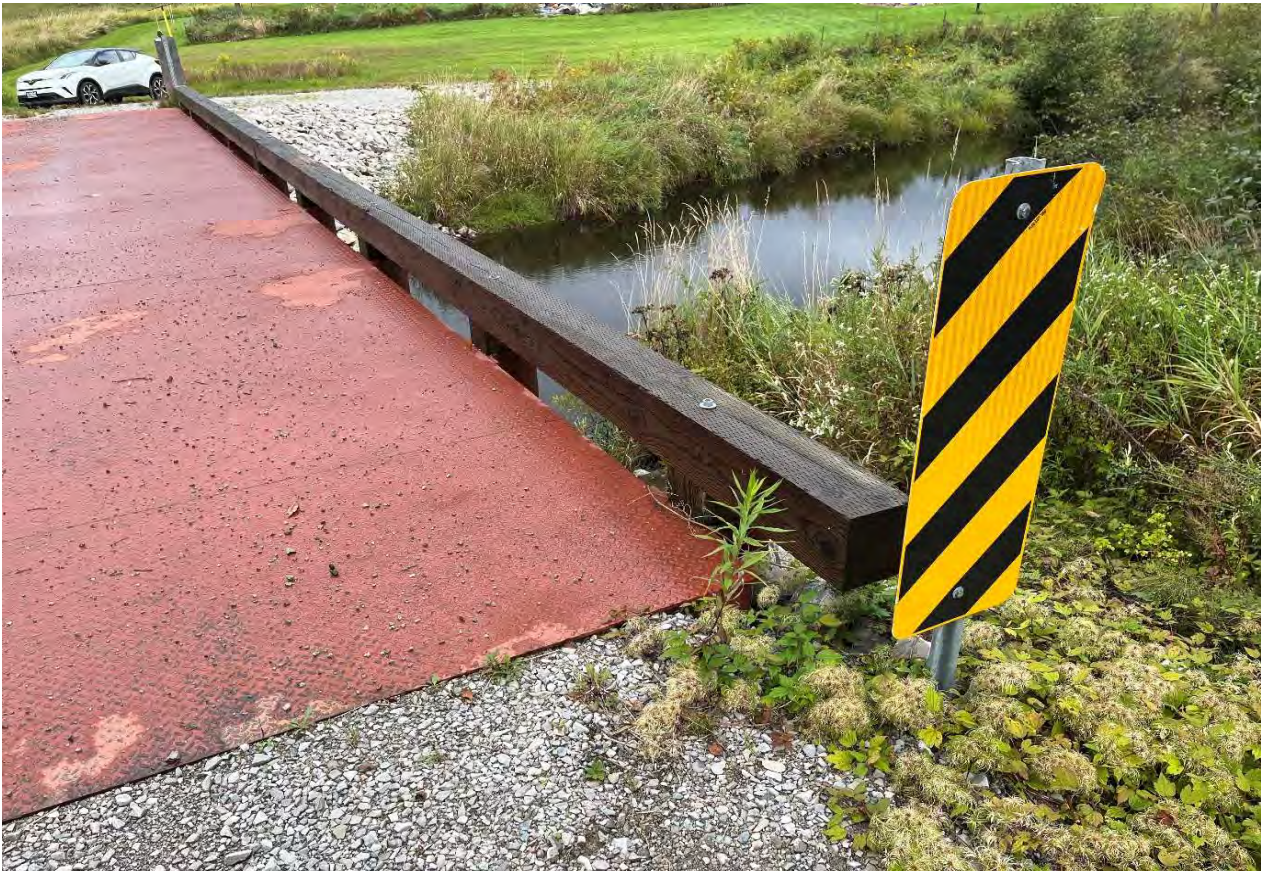
Comments: No observed defects.

Description of Photo: Raised curb

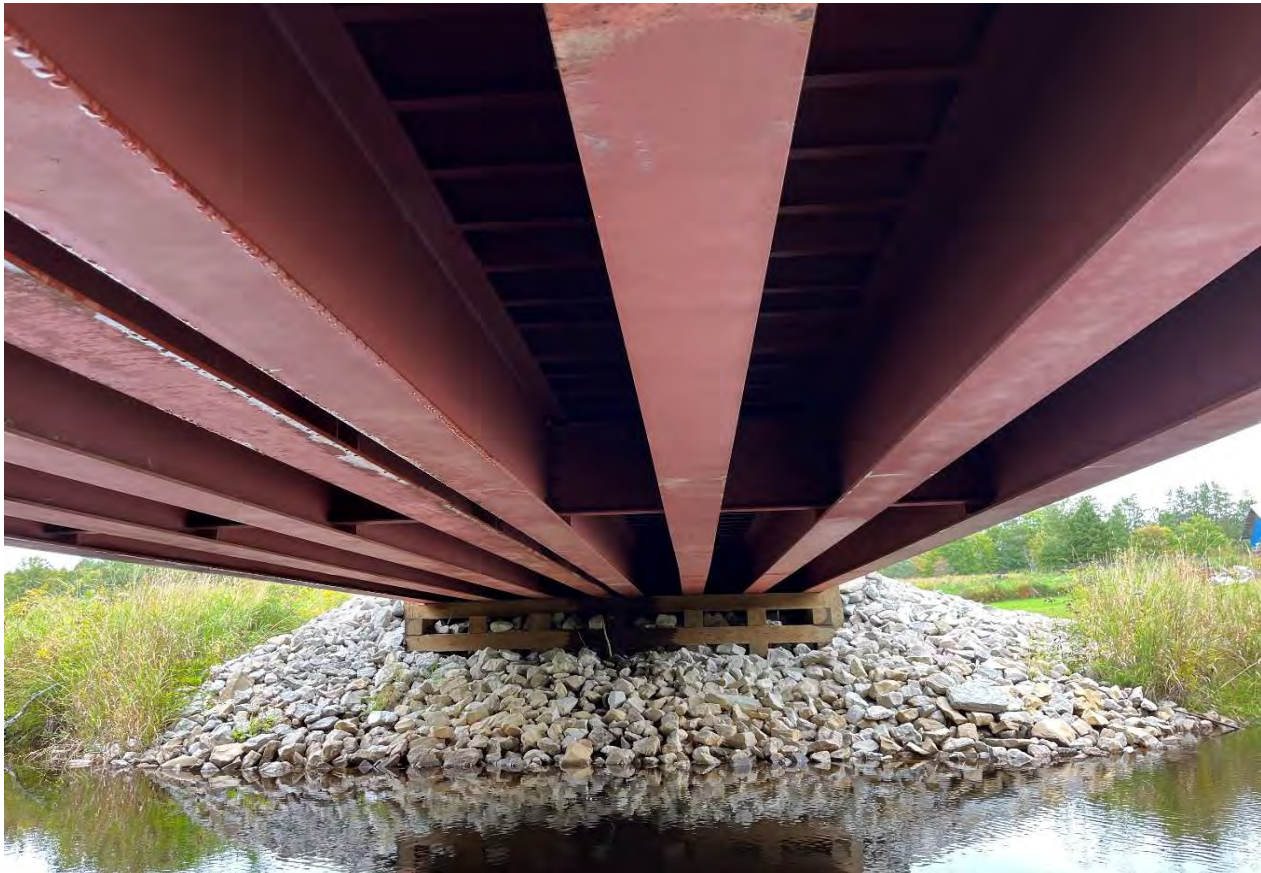
Comments: Isolated light corrosion along bottom flange. No other observed defects.

Description of Photo: Girder, typ.

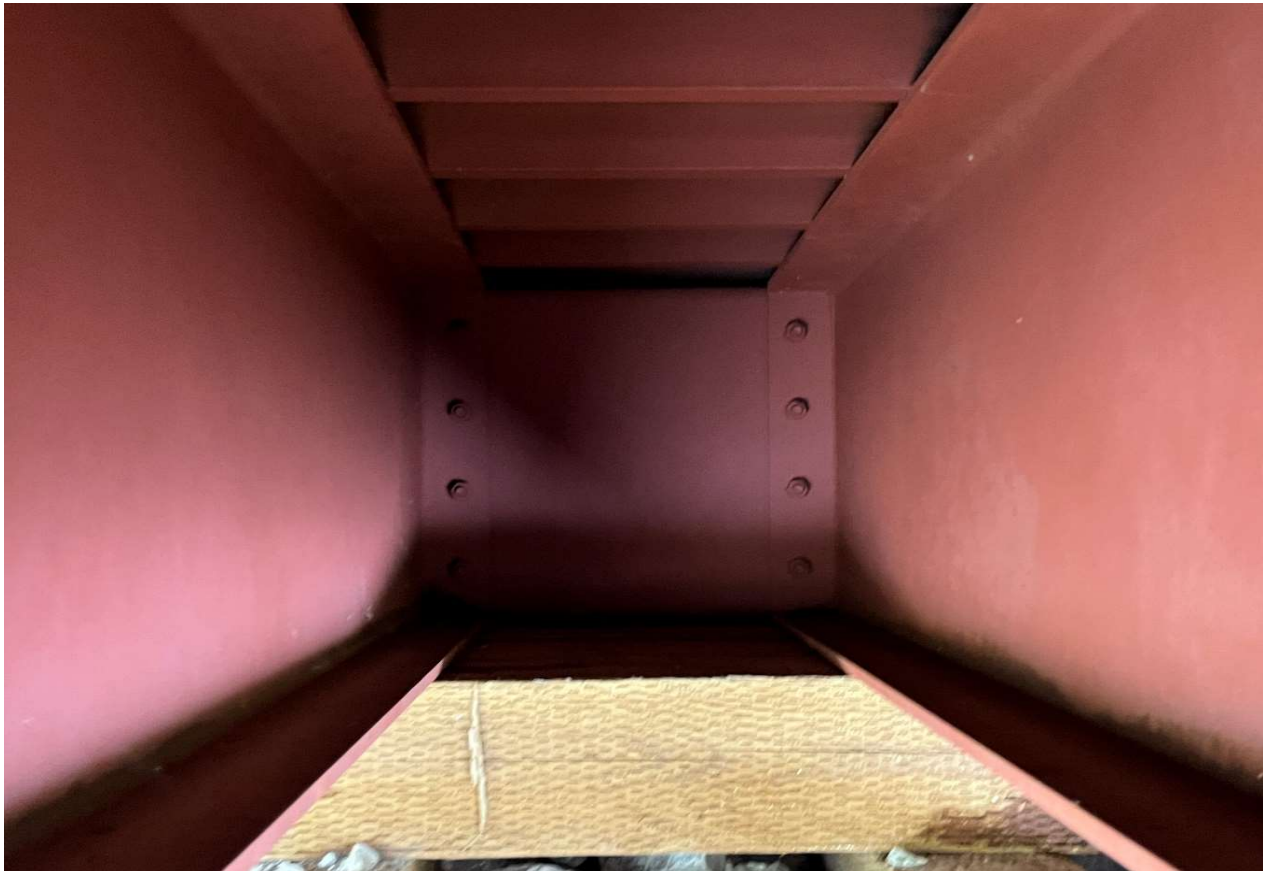
Comments: **No observed defects.**

Description of Photo: End diaphragm

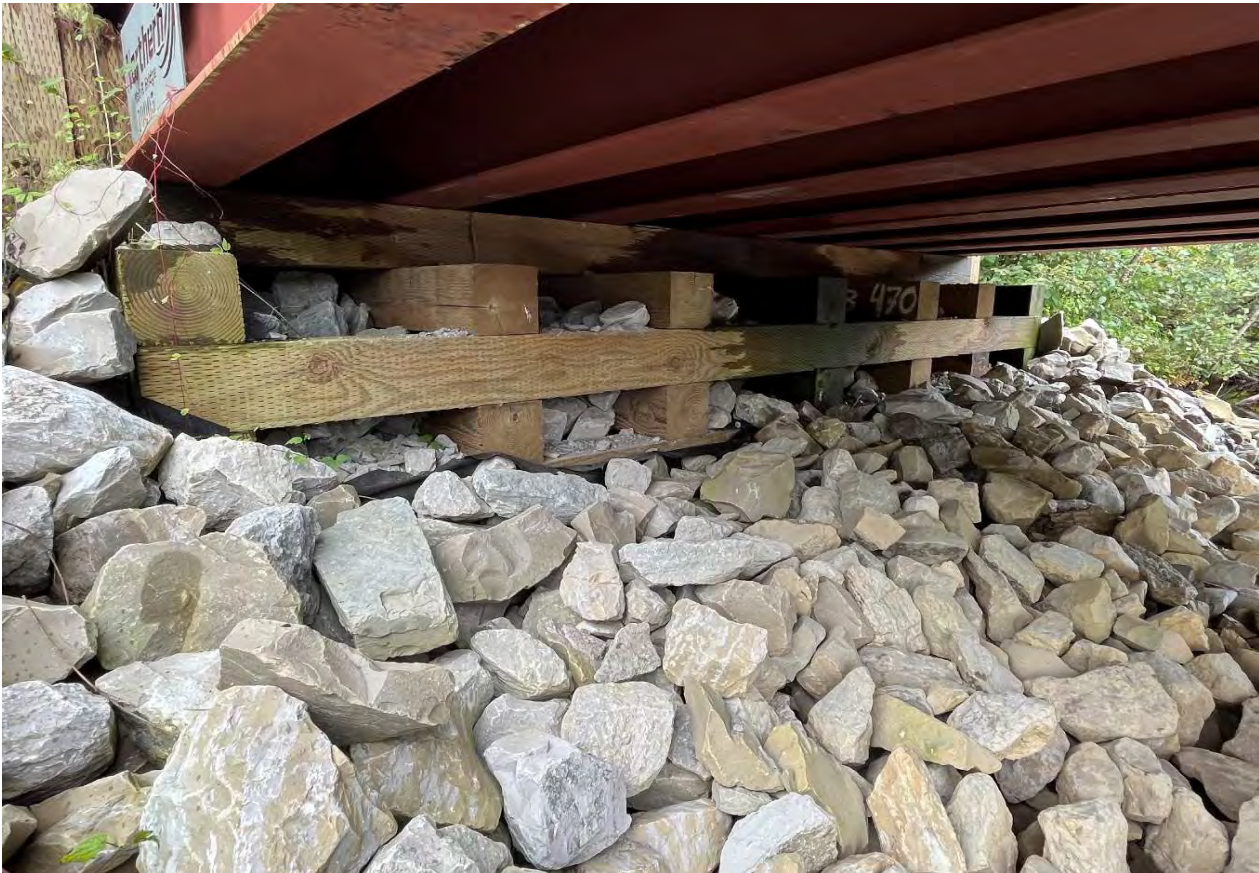
Comments: **No observed defects.**

Description of Photo: Timber crib abutment

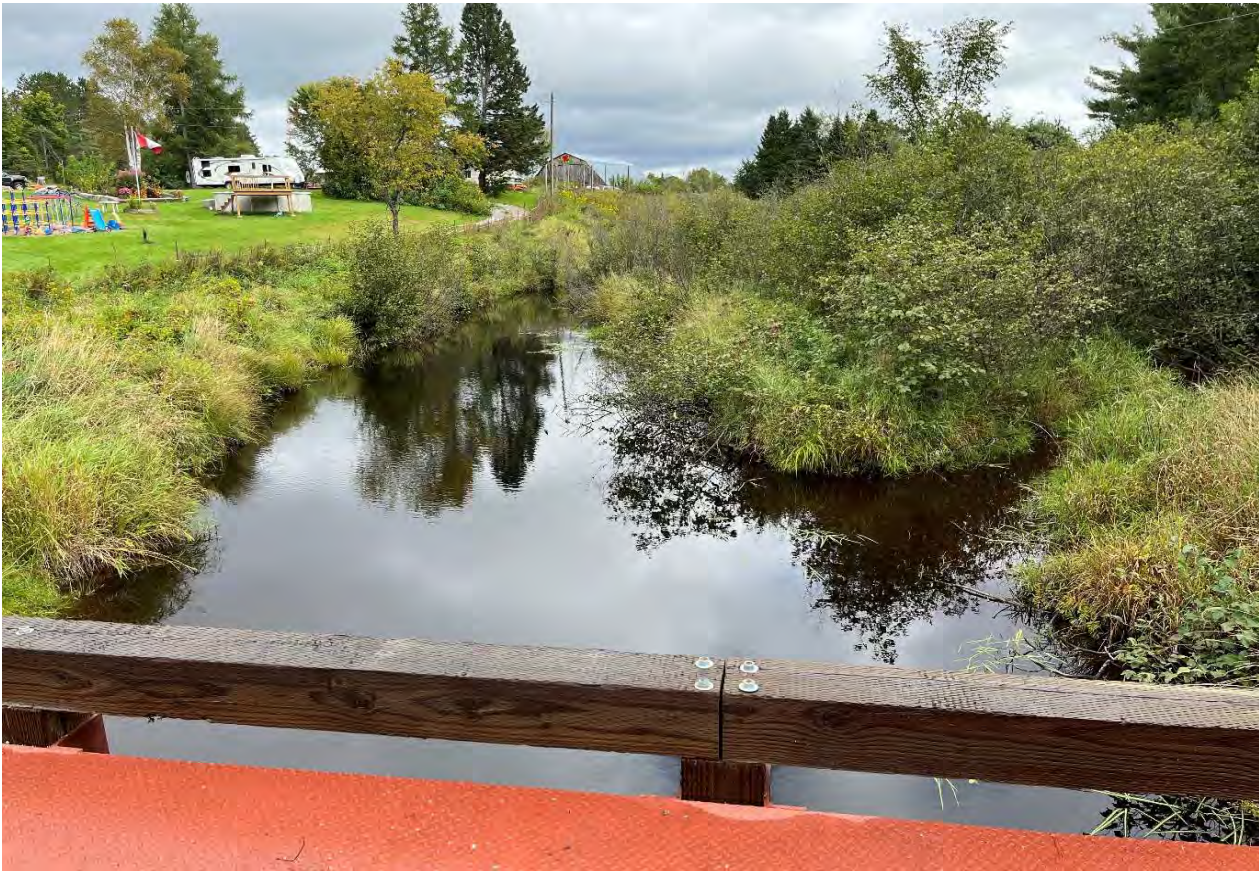
Comments: **No observed defects.**

Description of Photo: Watercourse

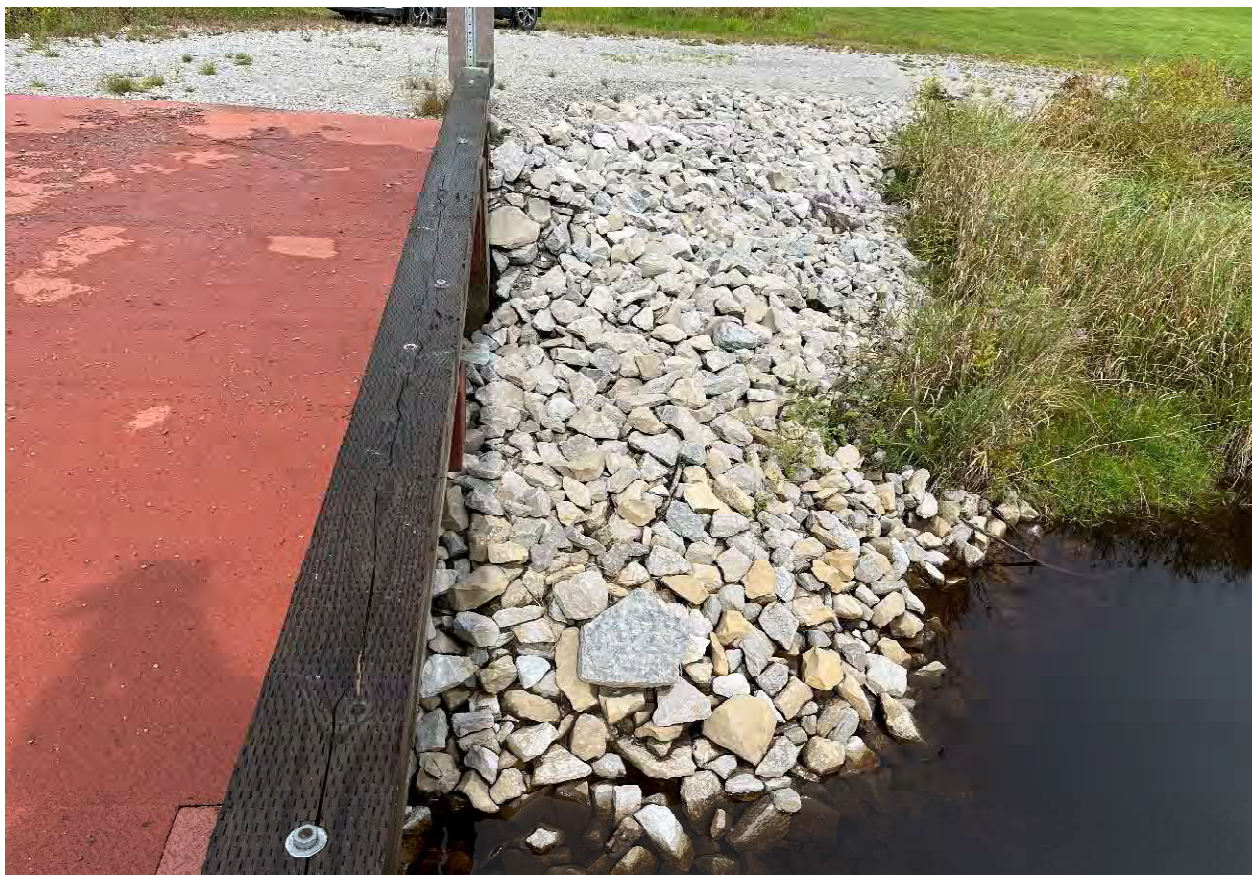
Comments: No observed defects.

Description of Photo: Embankment, typ.

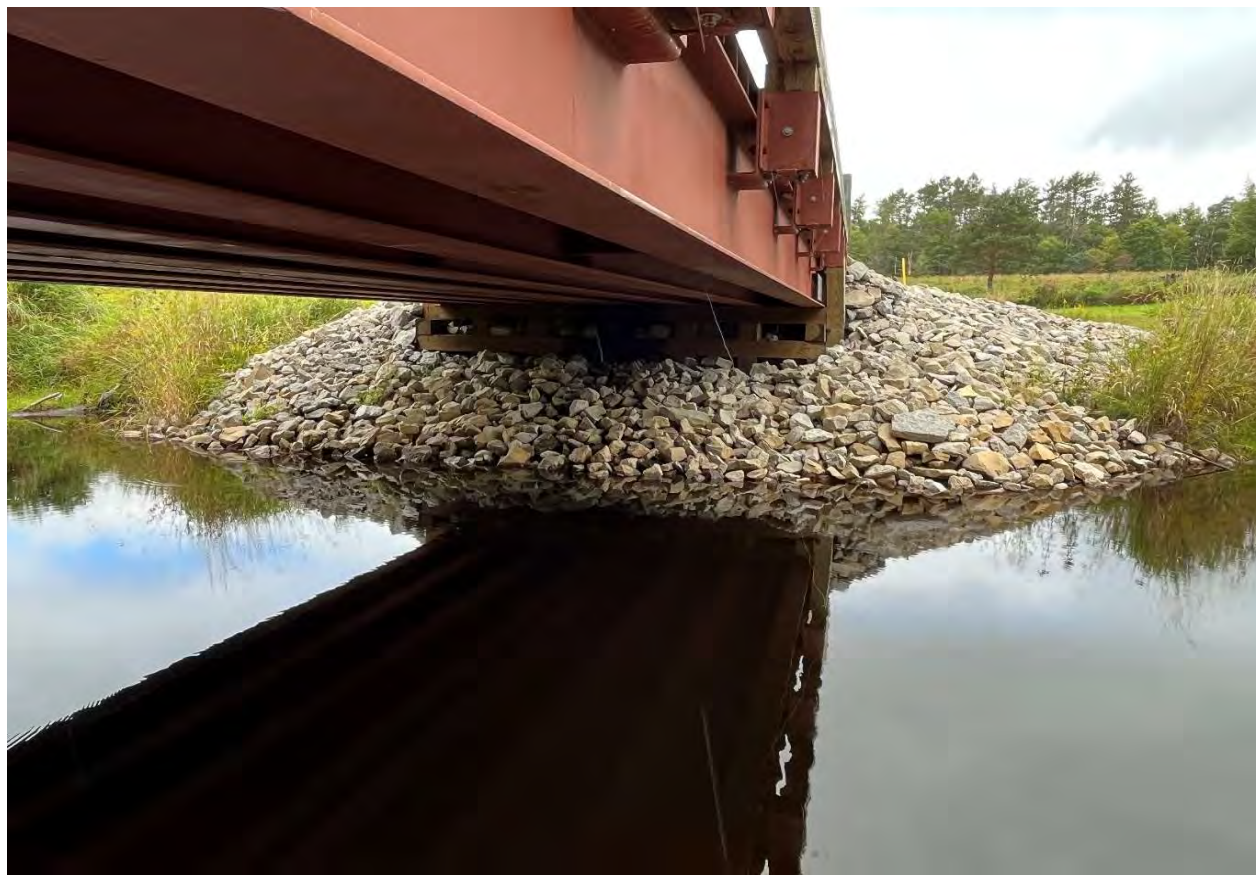
Comments: **No observed defects.**

Description of Photo: Slope protection, typ.

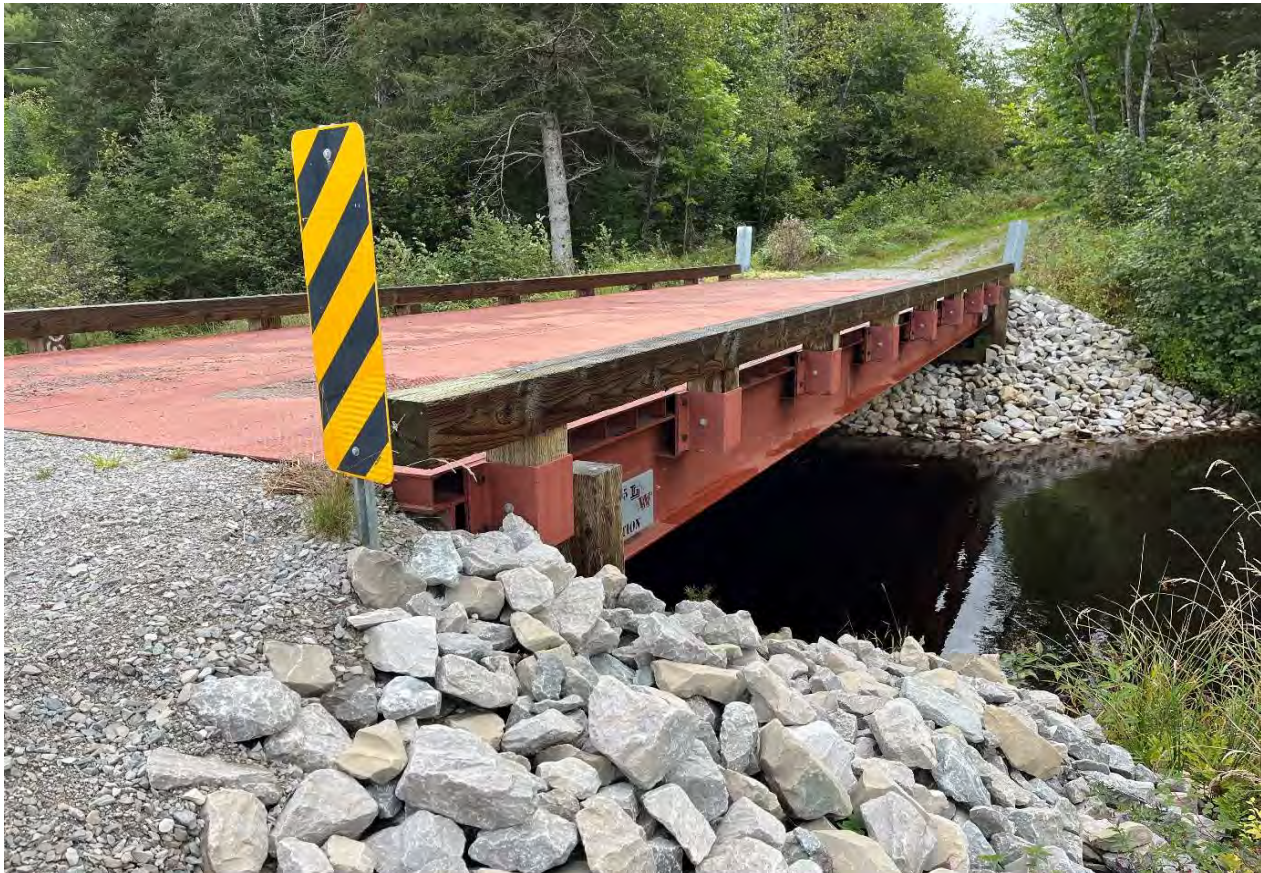
Comments: **No observed defects.**

Description of Photo: Hazard warning sign, typ.
