Bridge Needs Study

INSPECTION SUMMARY REPORT

Town of Gravenhurst

August
29, 2024

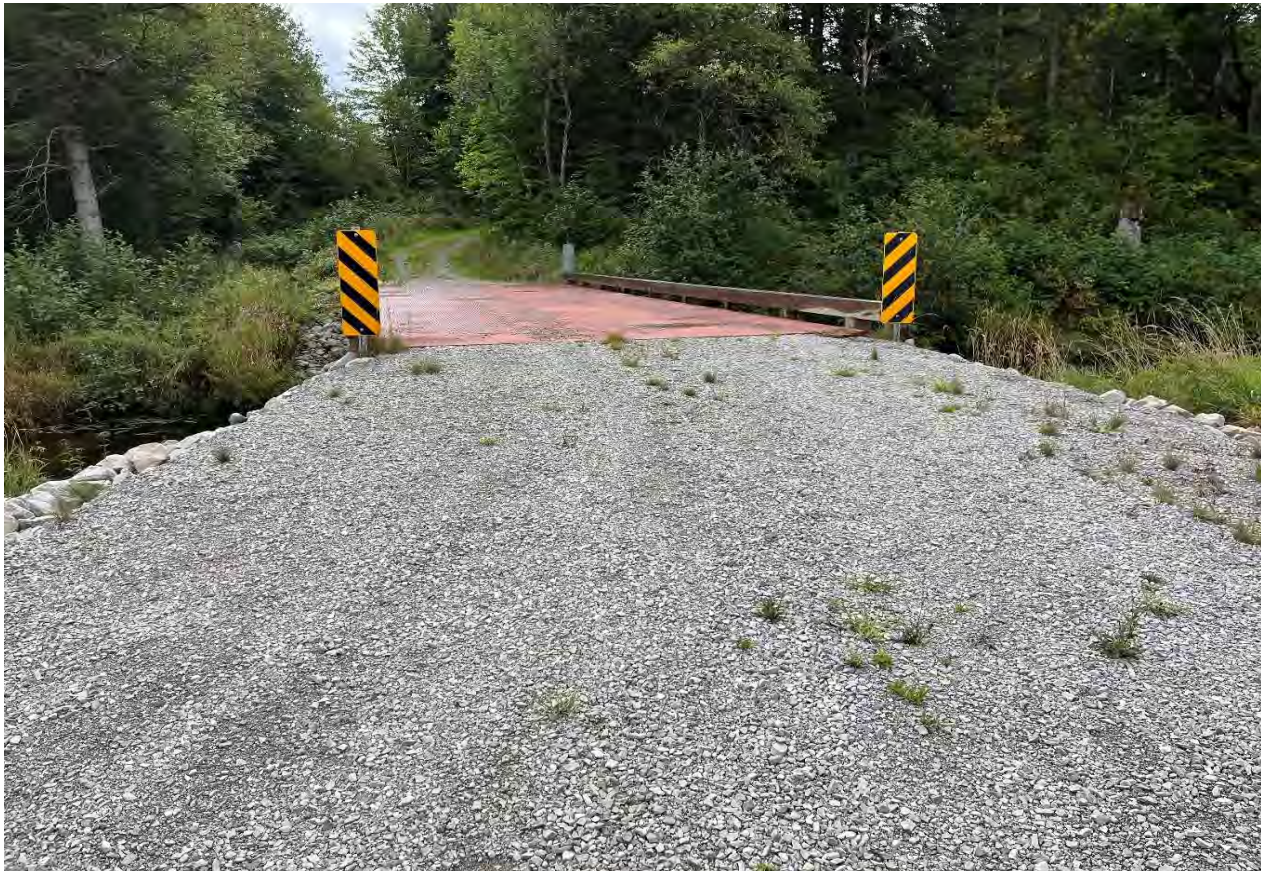
Comments: **No observed defects.**

Description of Photo: Approach wearing surface

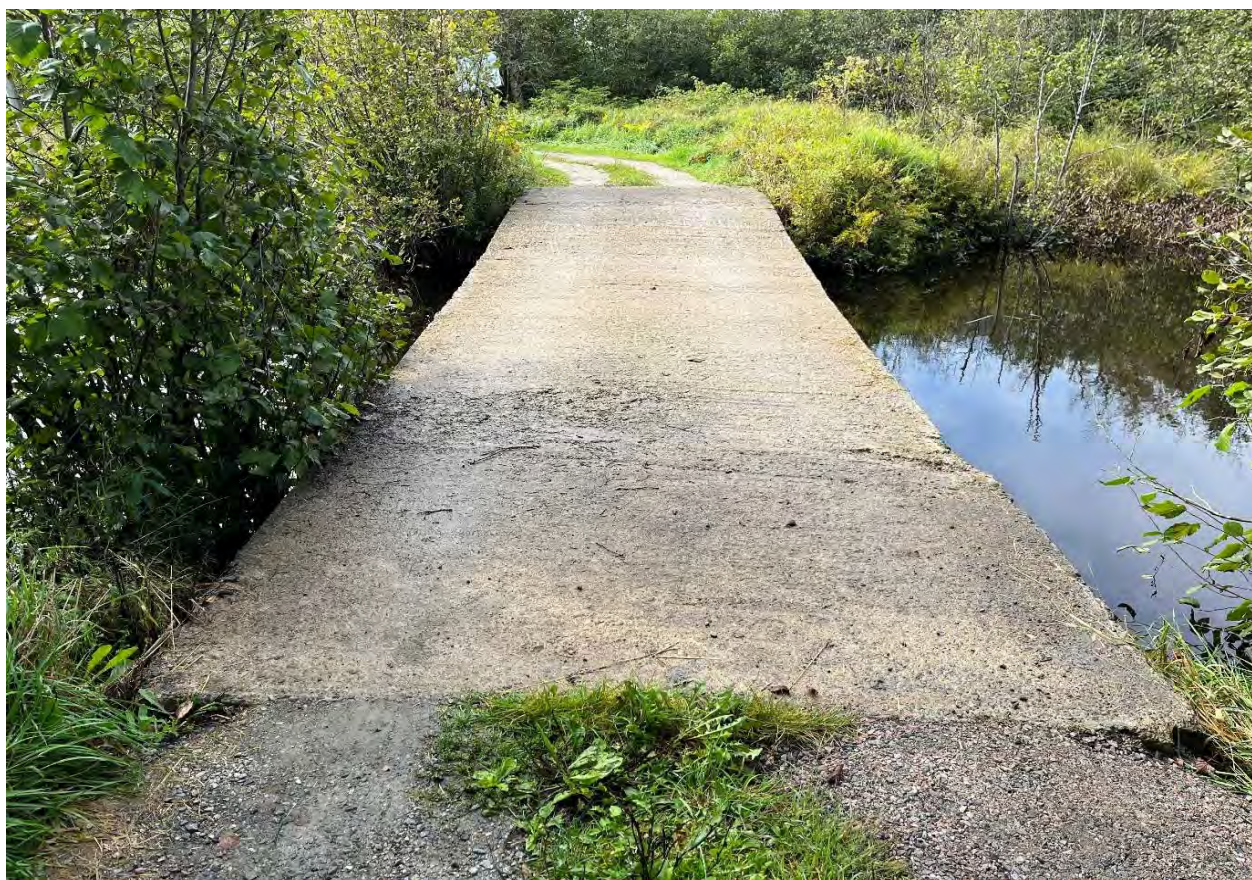
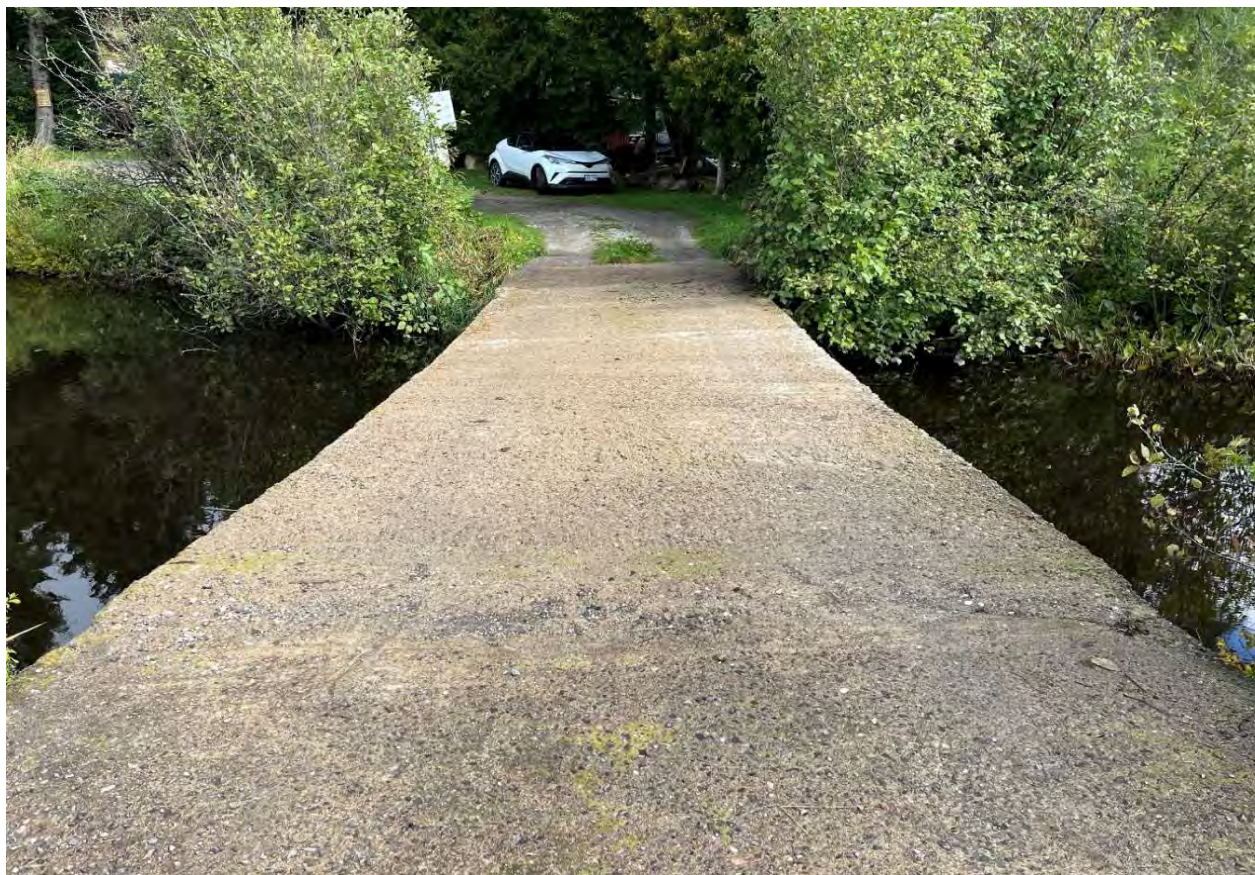
Comments: Light to severe scaling typ. (2 sq.m in severe, 4 sq.m in medium). 3 - 300 x 300mm spalls. Full width medium crack at west abutment. Crack continues around side of deck.

Description of Photo: Concrete deck top

Replace the bridge

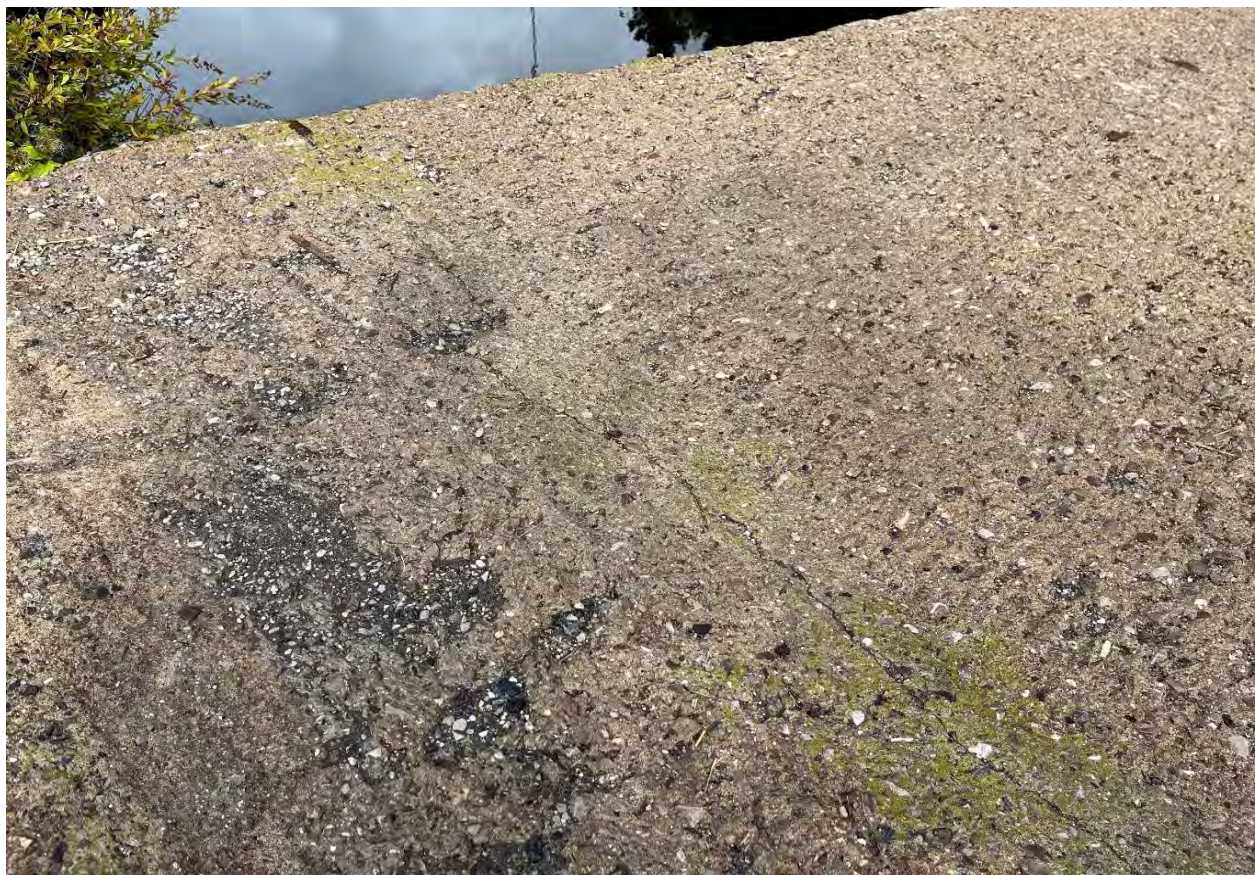
Description of Photo: Transverse crack

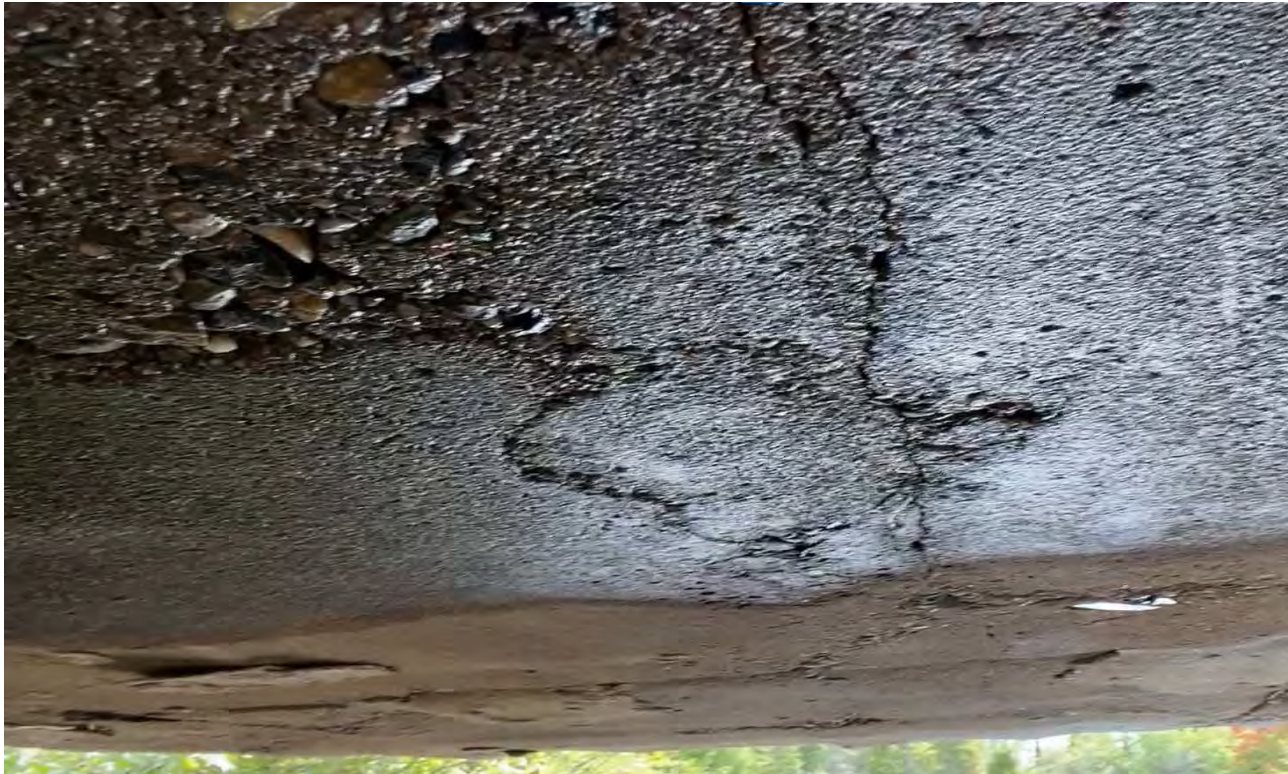
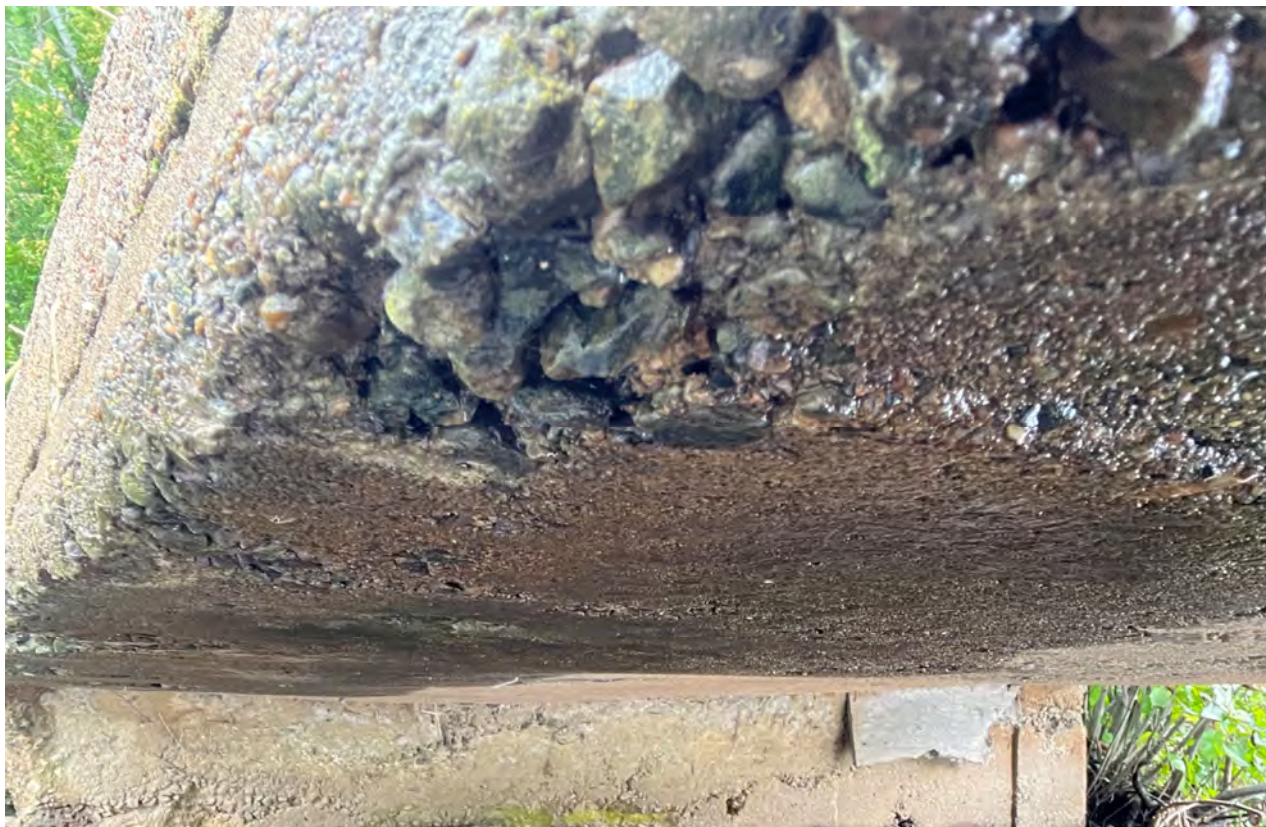
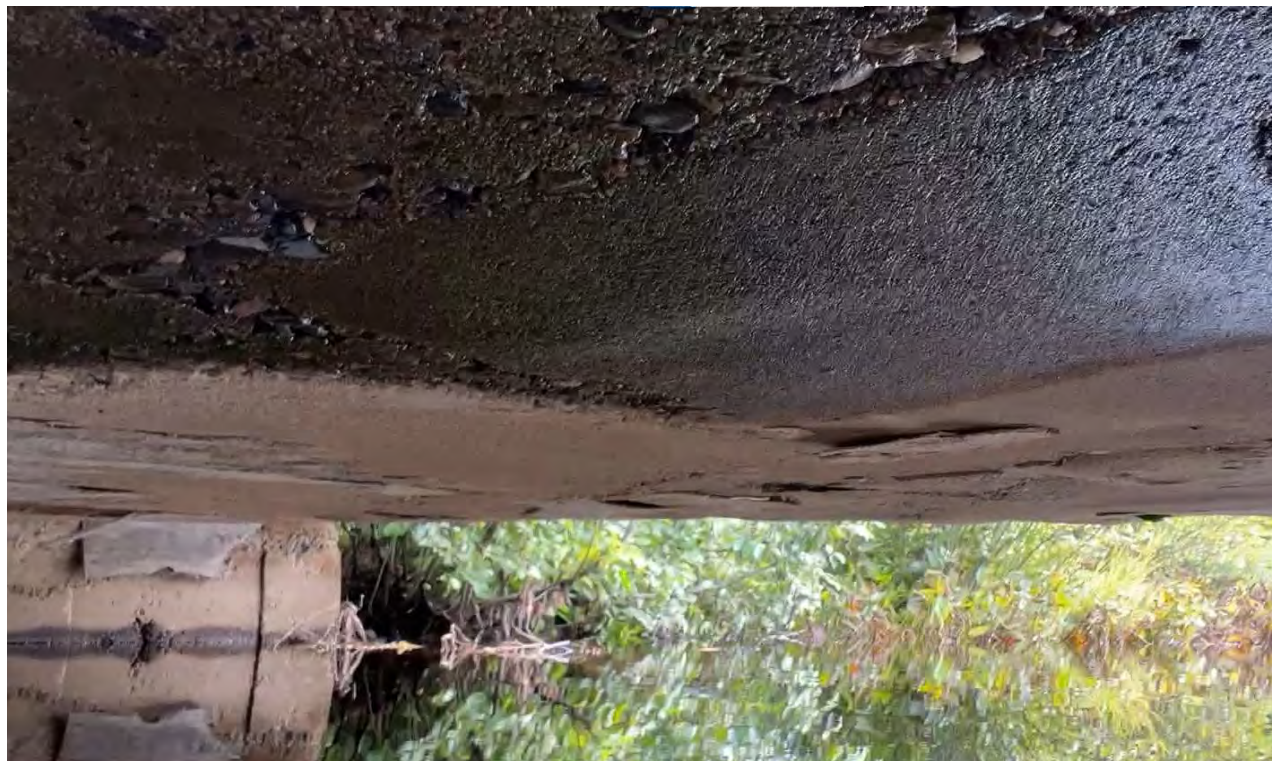
Description of Photo: Deck - soffit

Element Data:						
Element Group:	Decks		Length:	7.1		
Element Name:	Soffit		Width:	2.9		
Location:			Height:			
Material:	Concrete		Count:	1		
Element Type:			Total Quantity:	20.6		
Environment:	Benign		Inspected	Yes <input type="checkbox"/> No <input type="checkbox"/> limited <input checked="" type="checkbox"/>		
Protection System:						Performance Deficiencies
Condition Data:	Units	Excellent	Good	Fair	Poor*	
	sq.m		10.6	8.0	2.0	
Comments: Light to medium scaling, typ. Isolated medium to severe honeycombing.						
Recommended Work:		Rehab: <input type="checkbox"/>	Replace: <input checked="" type="checkbox"/>	Maintenance Needs:		
Urgent: <input type="checkbox"/>		1-5 Years: <input type="checkbox"/>	6-10 Years: <input checked="" type="checkbox"/>	None: <input type="checkbox"/>	Urgent: <input type="checkbox"/>	1 Year: <input type="checkbox"/> 2 Year: <input type="checkbox"/>
Replace the bridge.

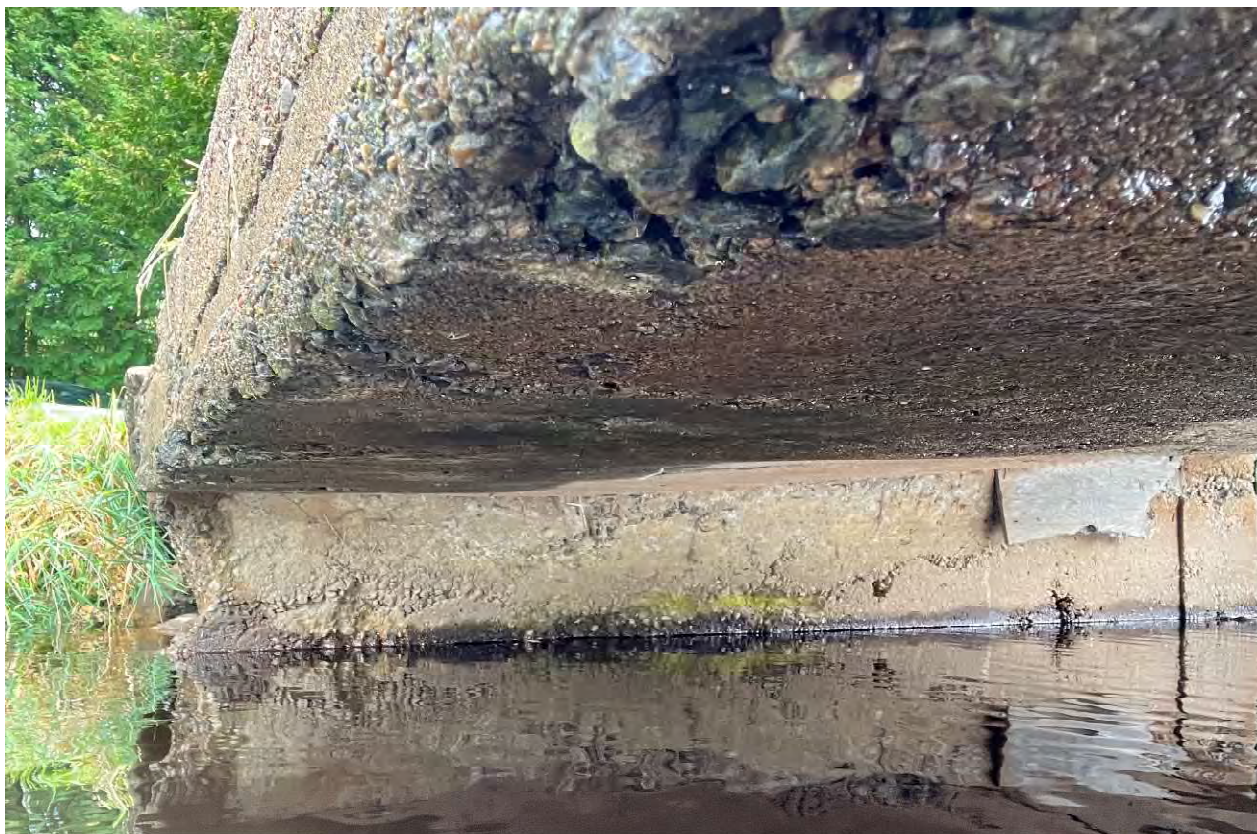
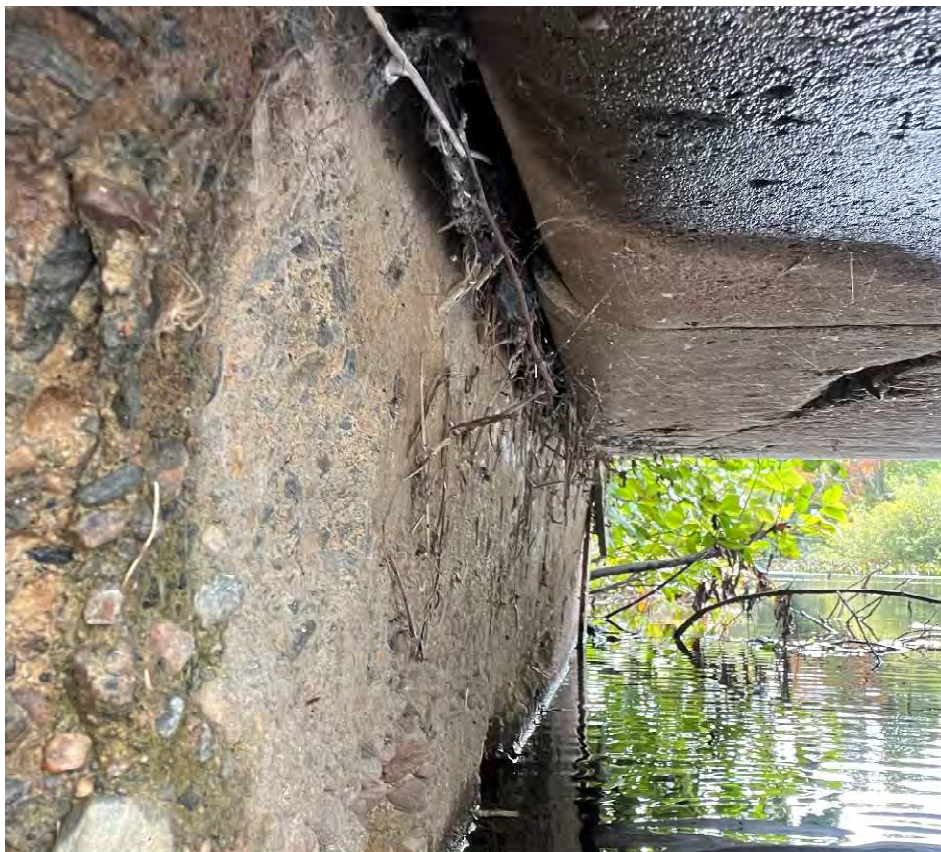
Comments: Below water level not inspected due to water depth. Light to medium scaling, typ. Severe 600x600x600mm spall and concrete disintegration at north abutment.

Description of Photo: North abutment wall

Recommended Work:	Rehab: <input type="checkbox"/>	Replace: <input checked="" type="checkbox"/>	Maintenance Needs:
Urgent: <input type="checkbox"/>	1-5 Years: <input type="checkbox"/>	6-10 Years: <input checked="" type="checkbox"/>	None: <input type="checkbox"/>
Urgent: <input type="checkbox"/>	1 Year: <input type="checkbox"/>	2 Year: <input type="checkbox"/>	
Concrete repair

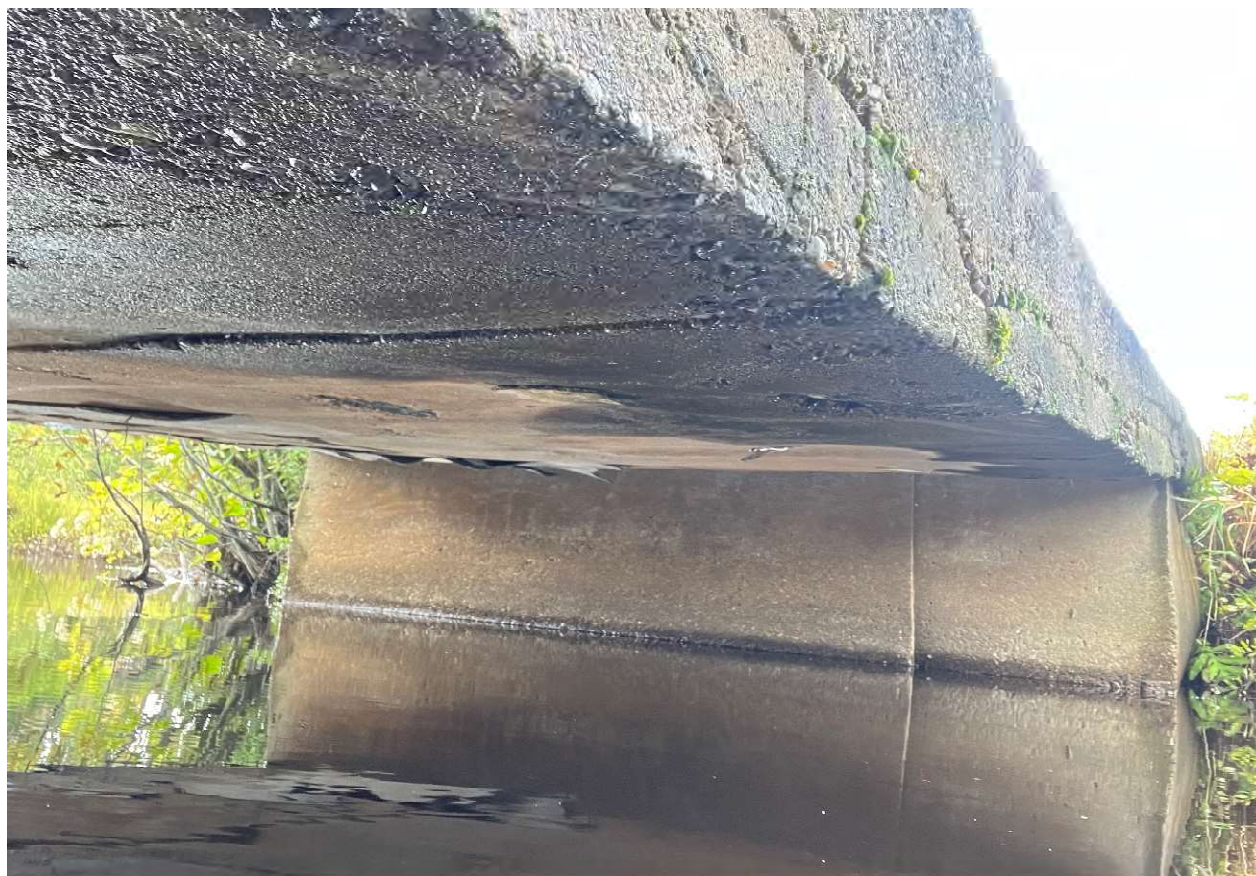
Description of Photo: South abutment wall

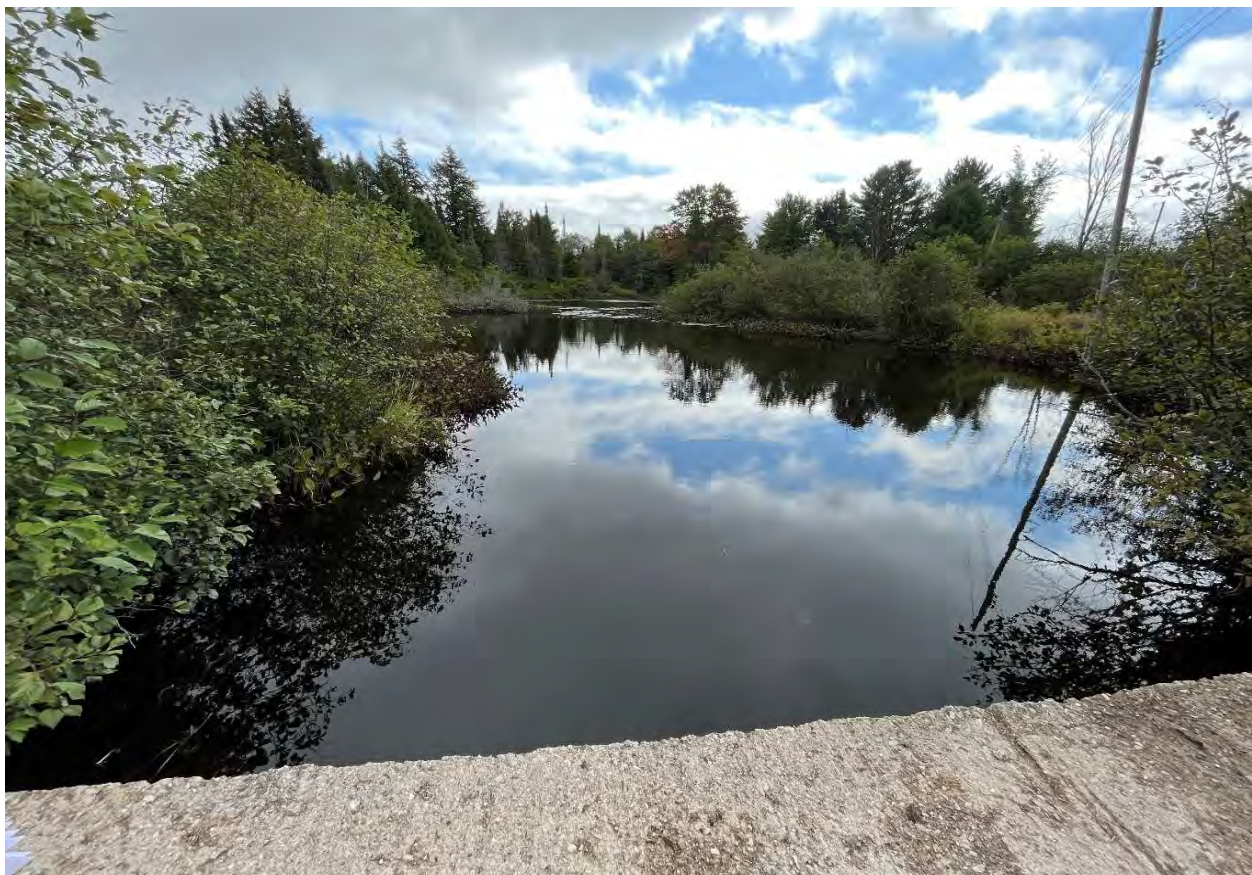
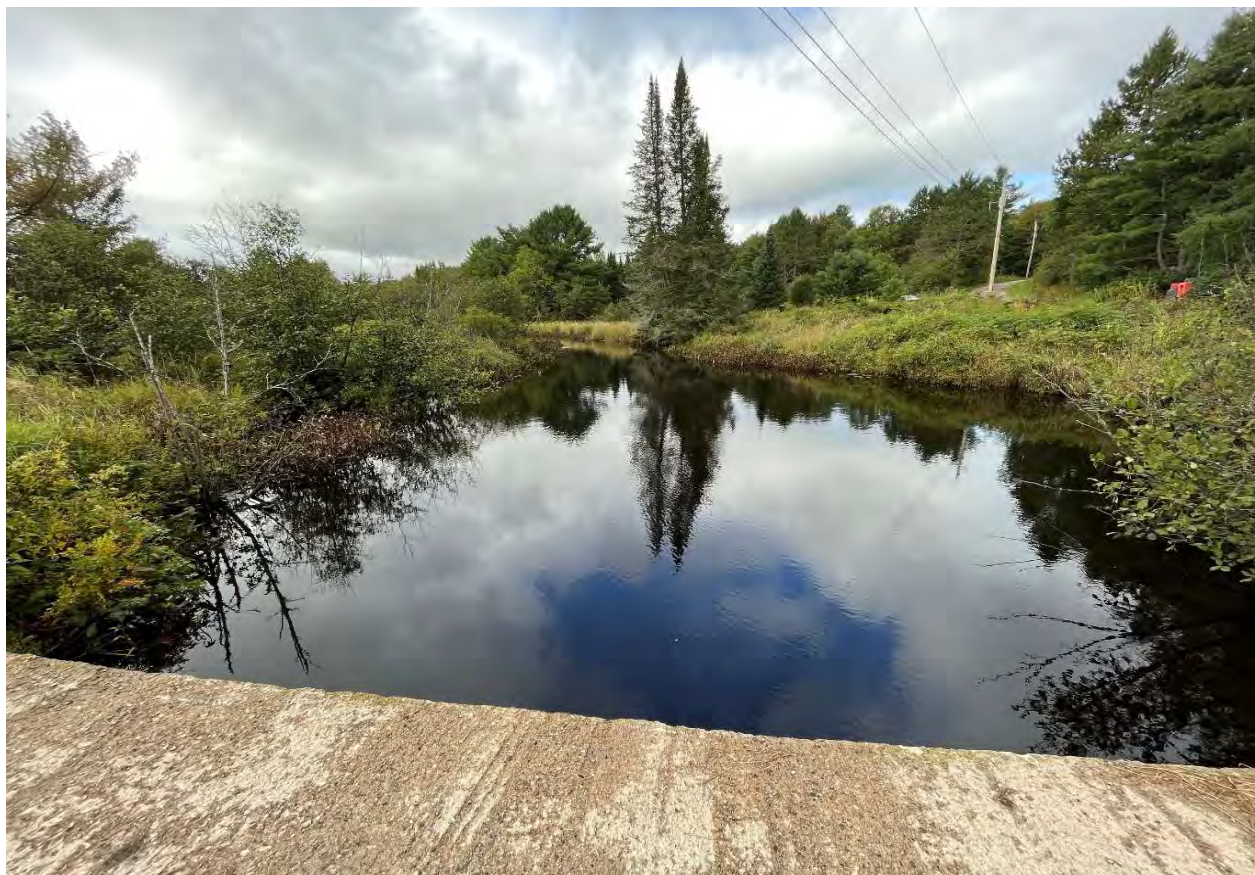
Comments: No observed defects. Water depth over 2.4 m.

Description of Photo: Watercourse

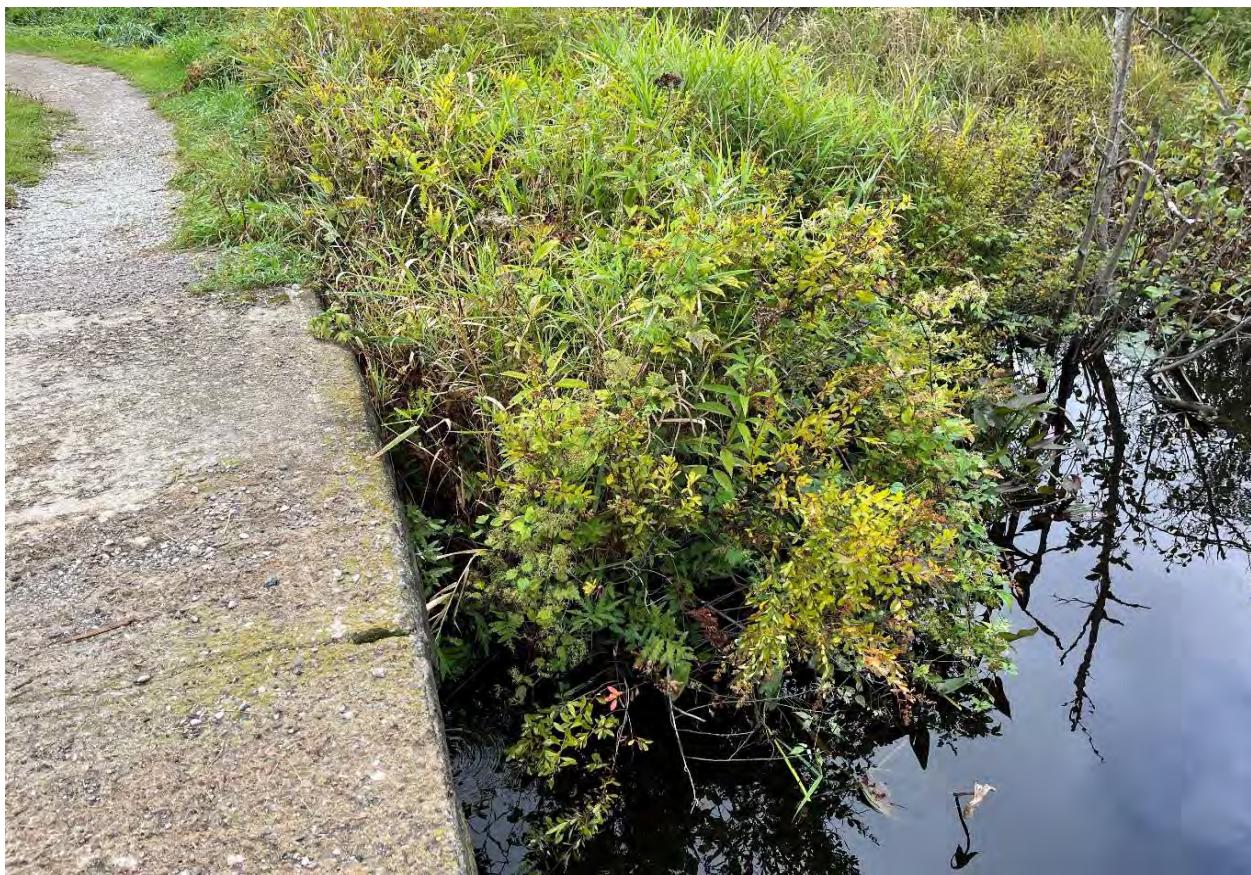
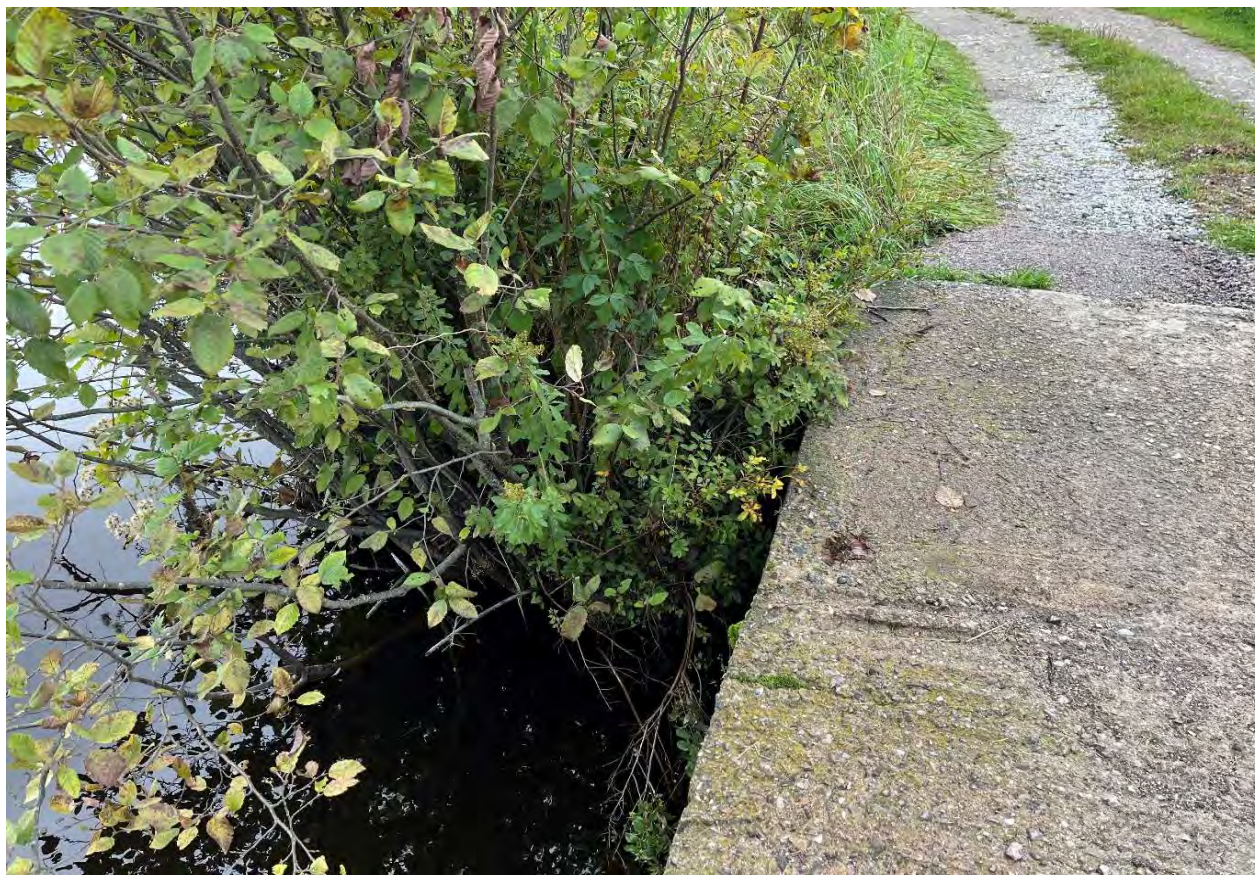
Comments: **Very steep and heavily vegetated. No other observed defects.**

Description of Photo: Embankment, typ.

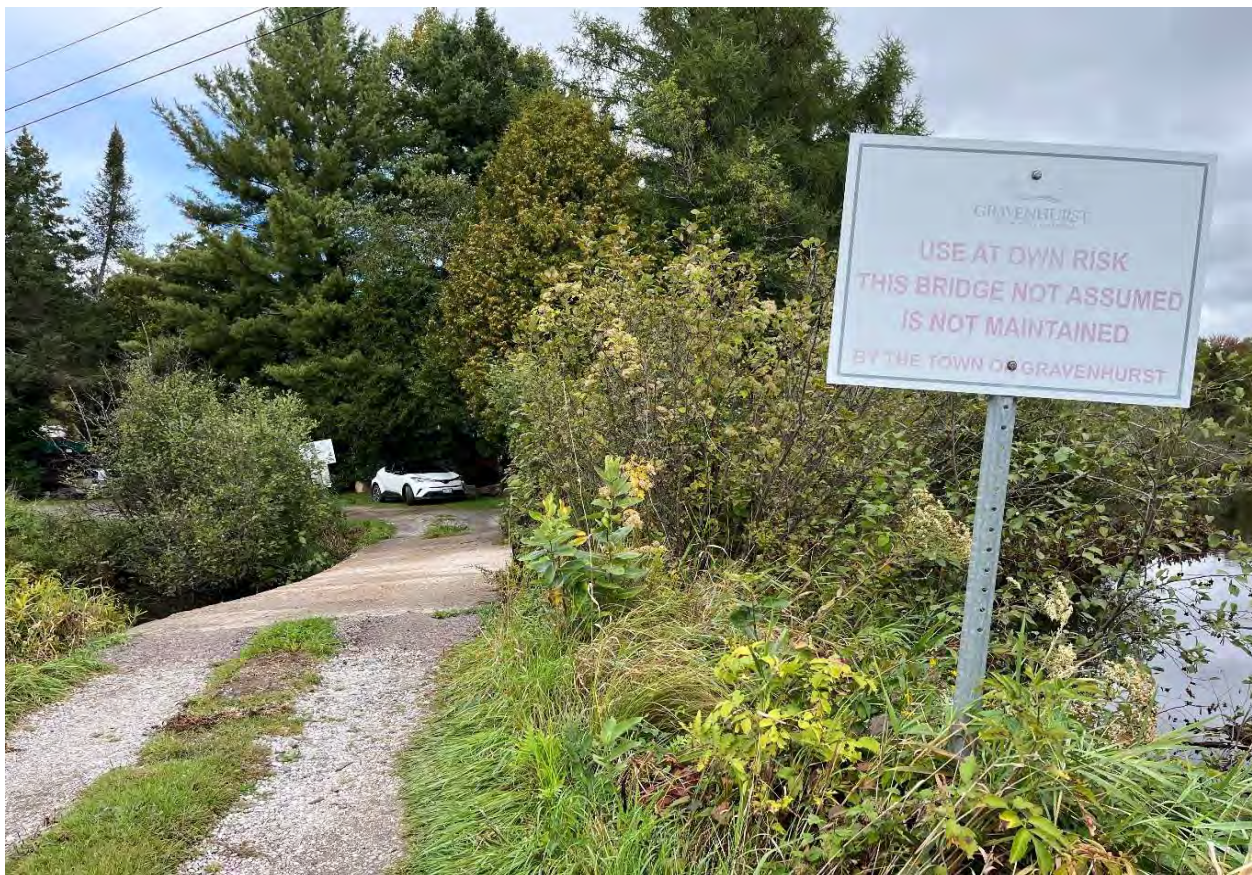
Description of Photo: Sign

Element Data:						
Element Group:	Accessories		Length:			
Element Name:	Signs		Width:			
Location:			Height:			
Material:	Steel		Count:			
Element Type:			Total Quantity:	2		
Environment:	Benign		Inspected	Yes <input checked="" type="checkbox"/>	No <input type="checkbox"/>	limited <input type="checkbox"/>
Protection System:						Performance Deficiencies
Condition Data:	Units	Excellent	Good	Fair	Poor*	
	each		2			
Comments: Light weathering, typ.						
Recommended Work:		Rehab: <input type="checkbox"/>	Replace: <input type="checkbox"/>	Maintenance Needs:	18 - Other Maintenance	
Urgent: <input type="checkbox"/>	1-5 Years: <input type="checkbox"/>	6-10 Years: <input type="checkbox"/>	None: <input checked="" type="checkbox"/>	Urgent: <input checked="" type="checkbox"/>	1 Year: <input type="checkbox"/>	2 Year: <input type="checkbox"/>
				Install a 3 Tonne load post sign.

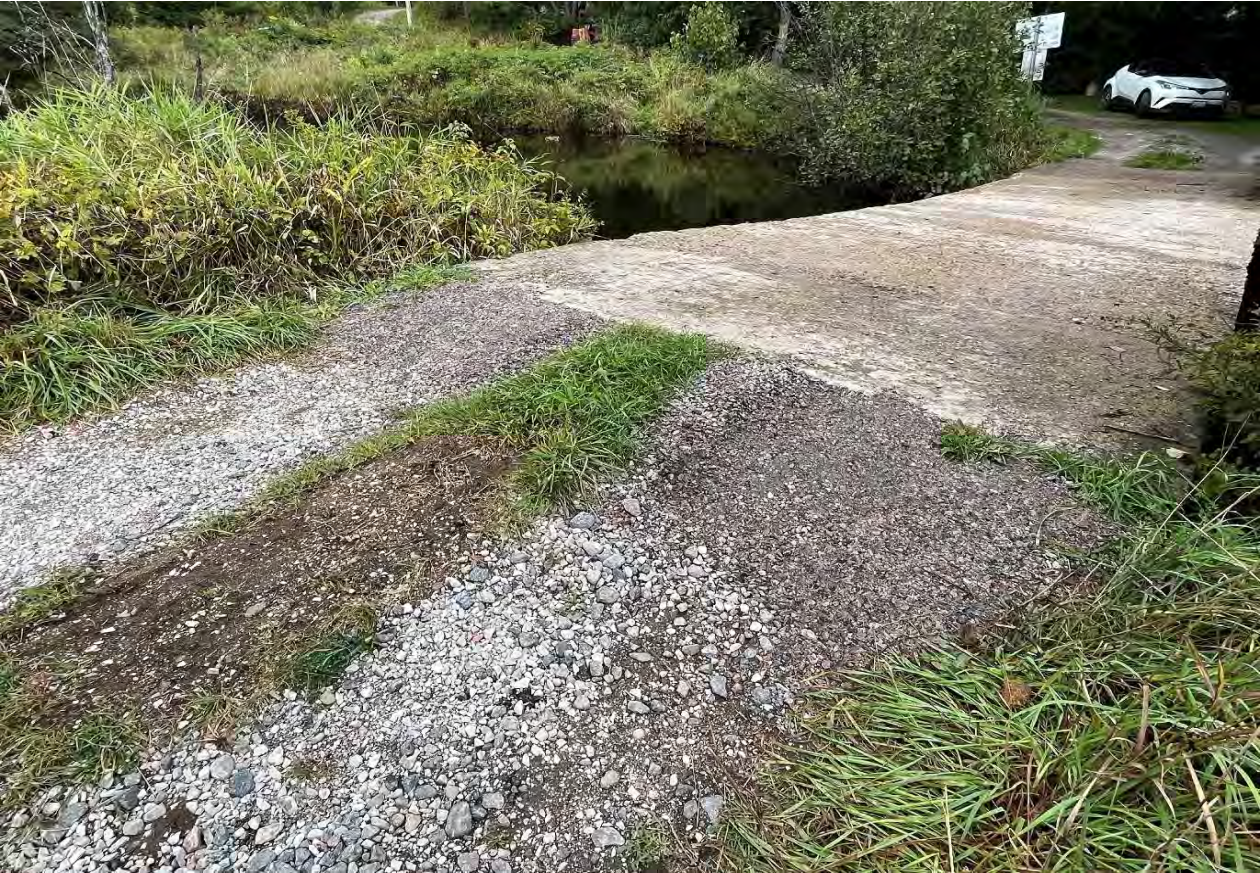
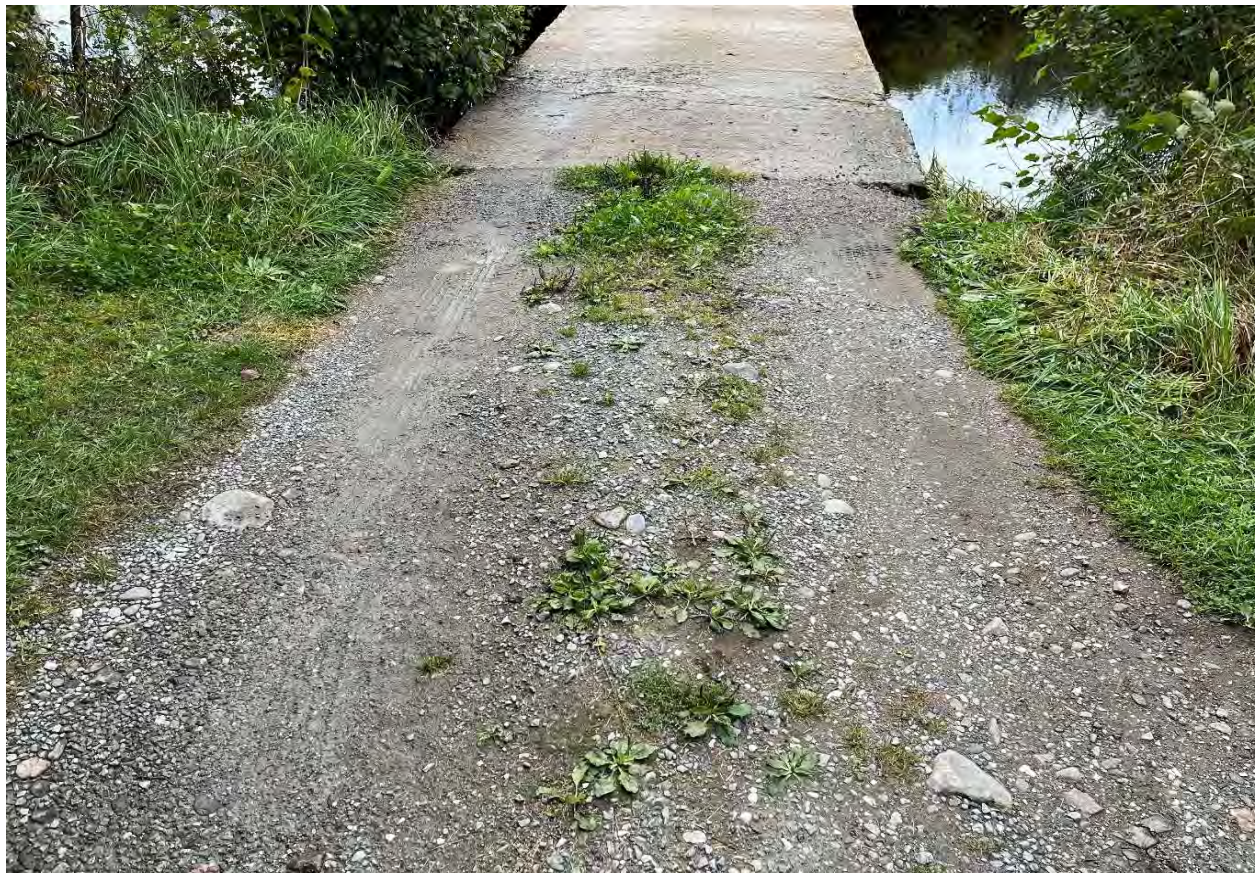
Description of Photo: Approach wearing surface

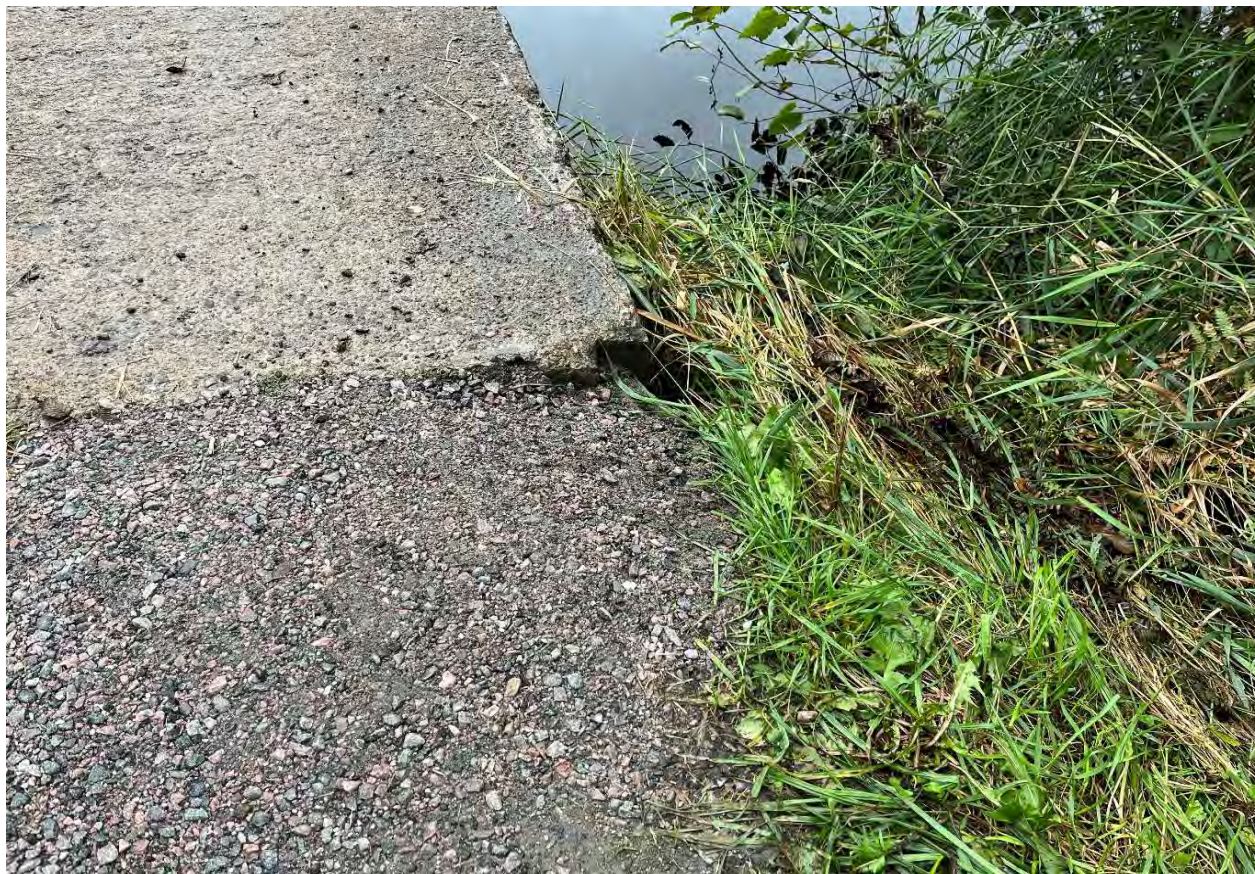
Description of Photo: Erosion at approach wearing surface

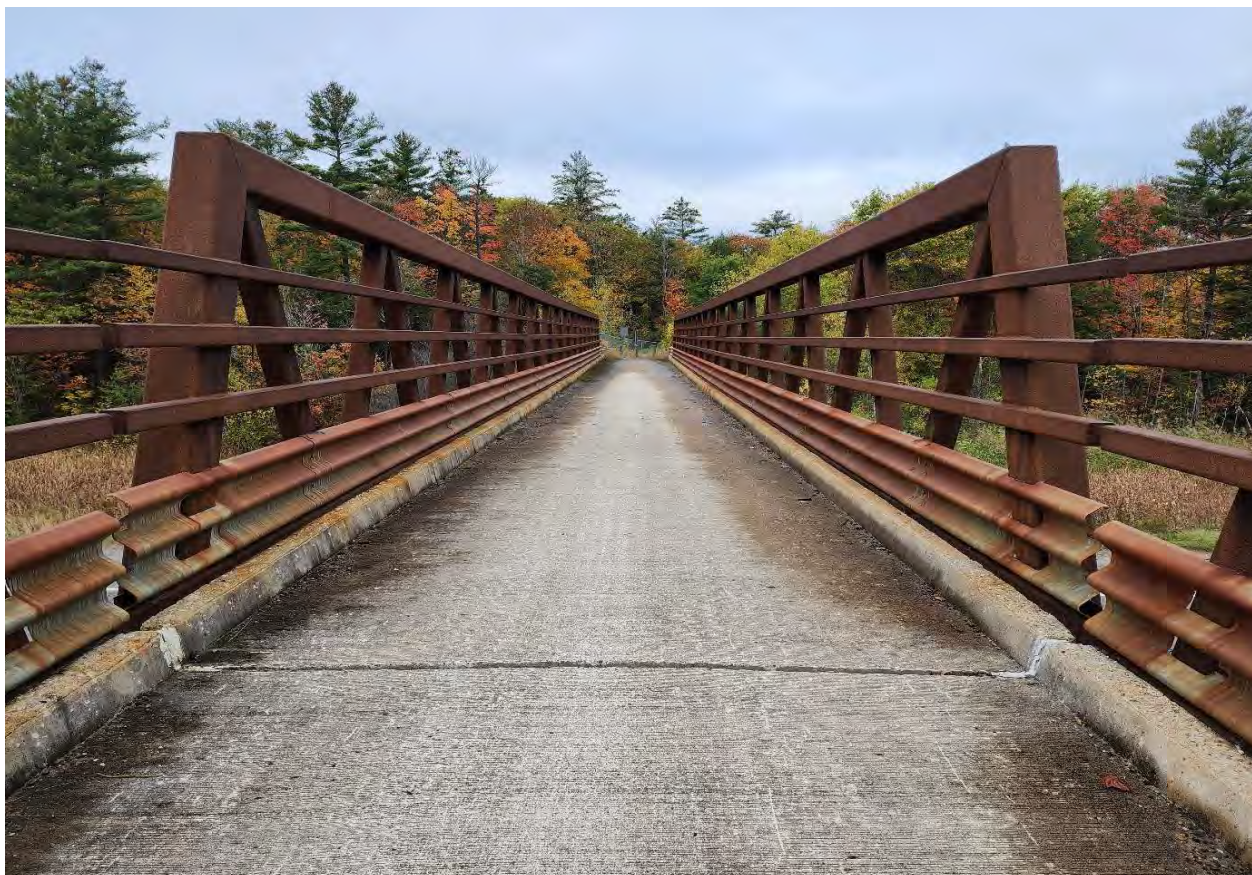
Description of Photo: Deck top

Recommended Work:	Rehab: <input type="checkbox"/>	Replace: <input type="checkbox"/>	Maintenance Needs:	2 - Bridge Cleaning
Urgent: <input type="checkbox"/>	1-5 Years: <input type="checkbox"/>	6-10 Years: <input type="checkbox"/>	None: <input checked="" type="checkbox"/>	Urgent: <input type="checkbox"/> 1 Year: <input type="checkbox"/> 2 Year: <input checked="" type="checkbox"/>
				Bridge Cleaning
