Bridge Needs Study

INSPECTION SUMMARY REPORT

Town of Gravenhurst

August
29, 2024

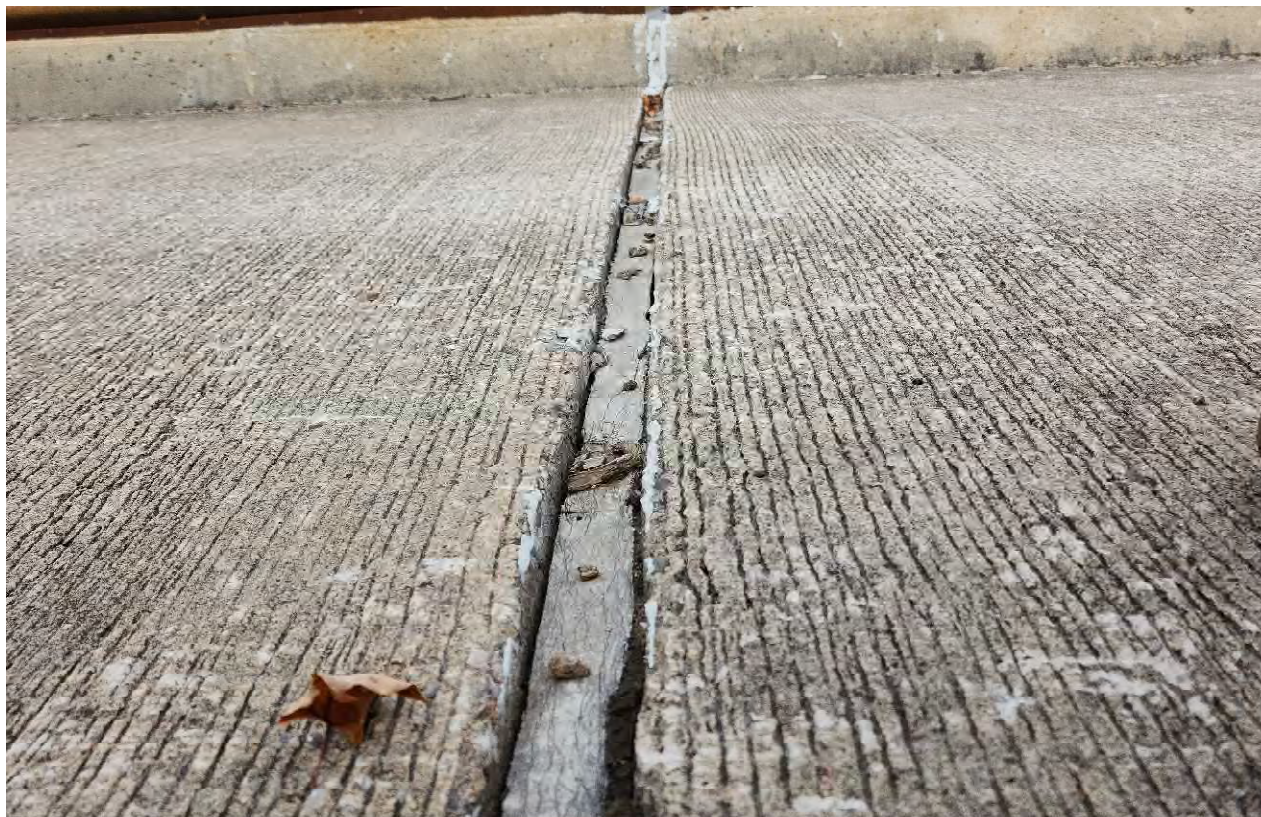
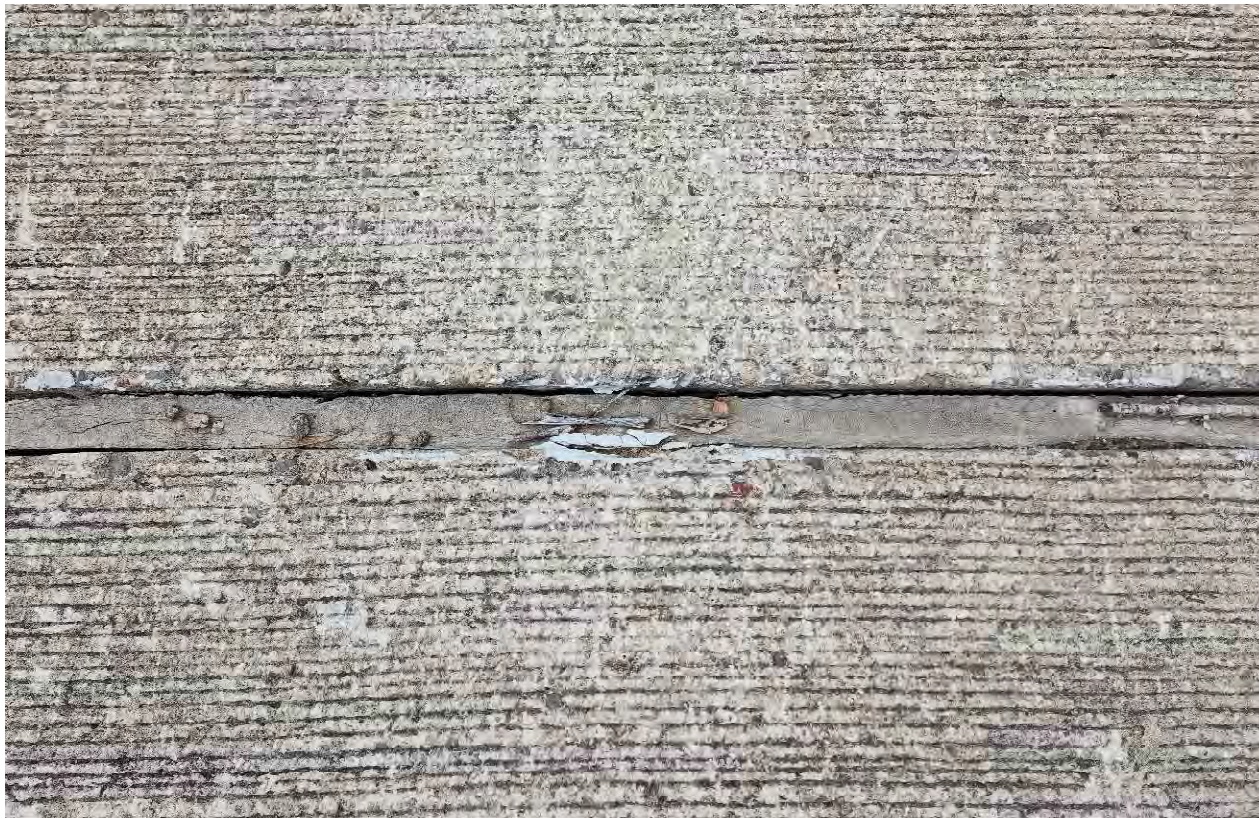
Description of Photo: Seal joint, typ.

Recommended Work:	Rehab: <input type="checkbox"/>	Replace: <input type="checkbox"/>	Maintenance Needs:	18 - Other Maintenance
Urgent: <input type="checkbox"/>	1-5 Years: <input type="checkbox"/>	6-10 Years: <input type="checkbox"/>	None: <input checked="" type="checkbox"/>	Urgent: <input type="checkbox"/> 1 Year: <input type="checkbox"/> 2 Year: <input checked="" type="checkbox"/>
				Replace centre seal

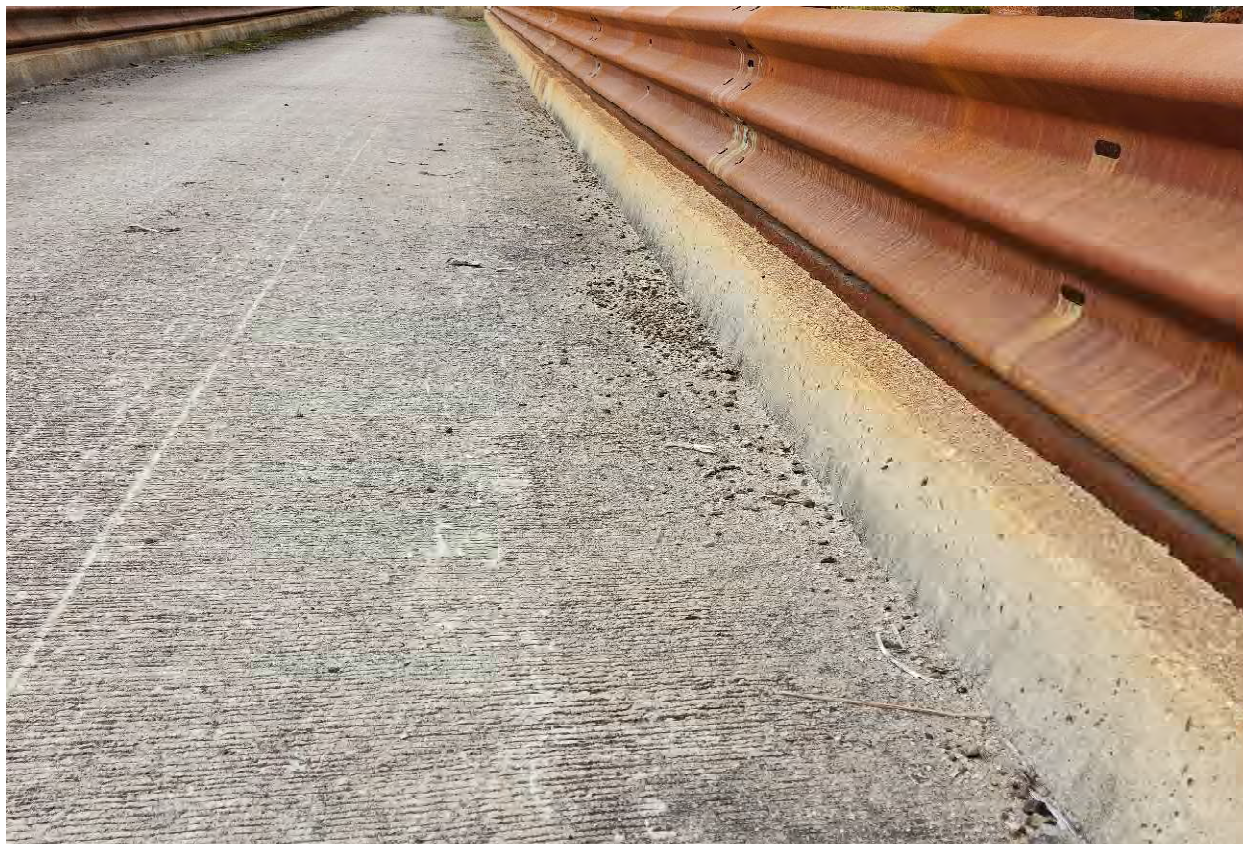
Description of Photo: Curb, typ.

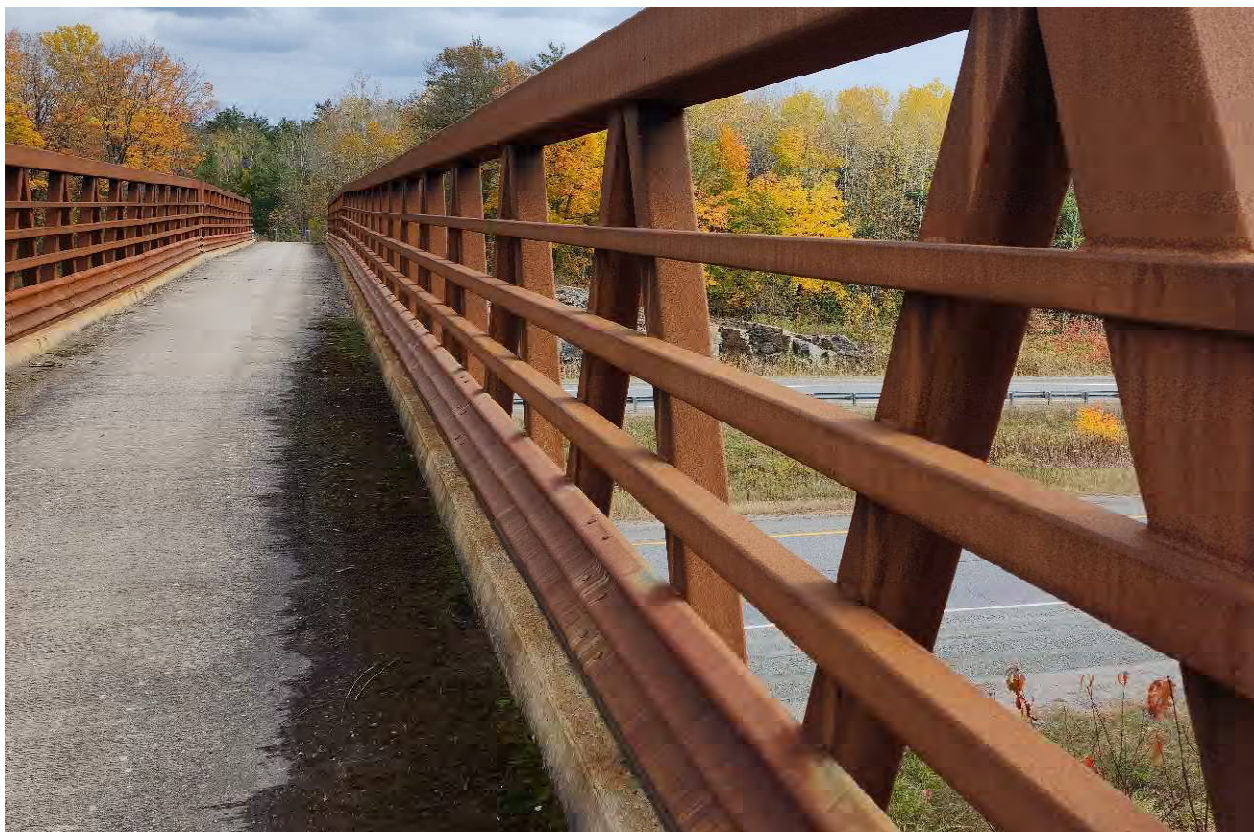
Description of Photo: Railing, typ.

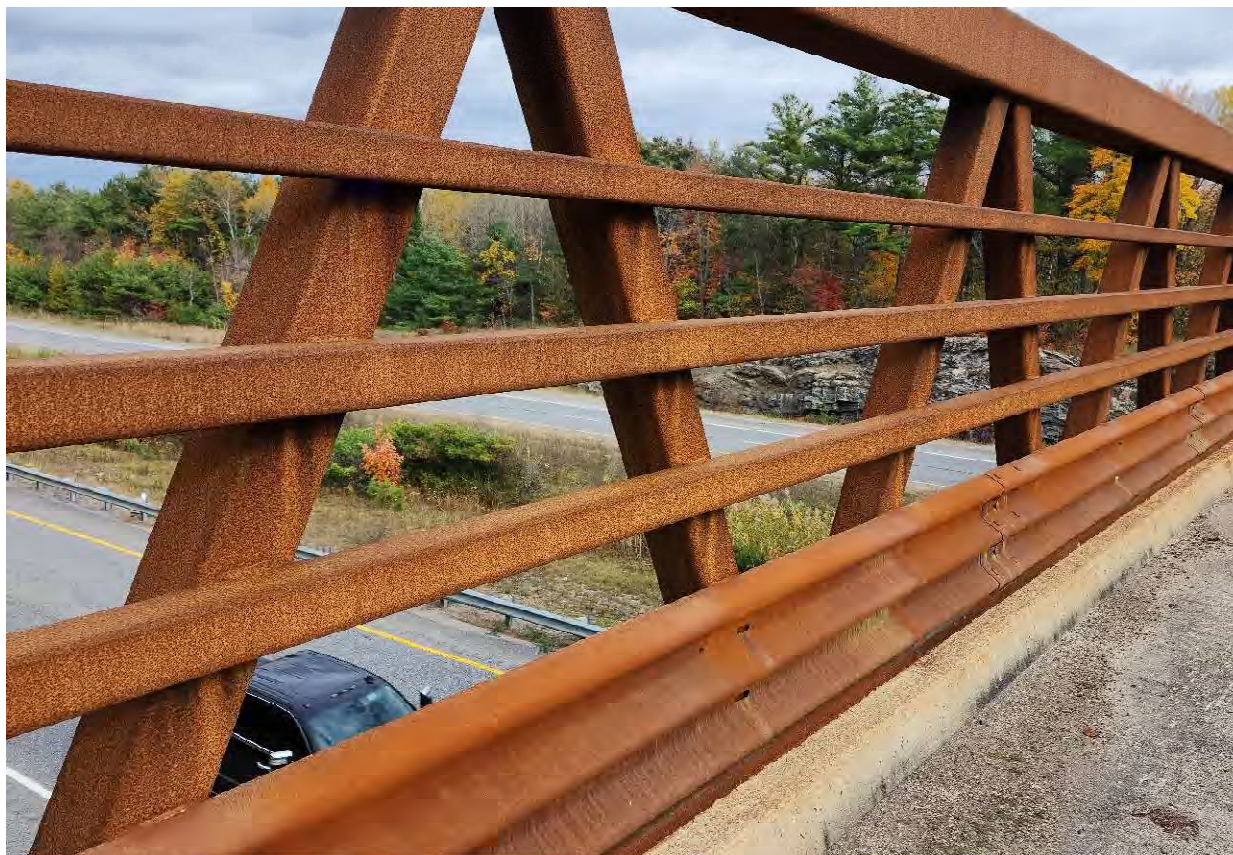
Description of Photo: Railing, typ.

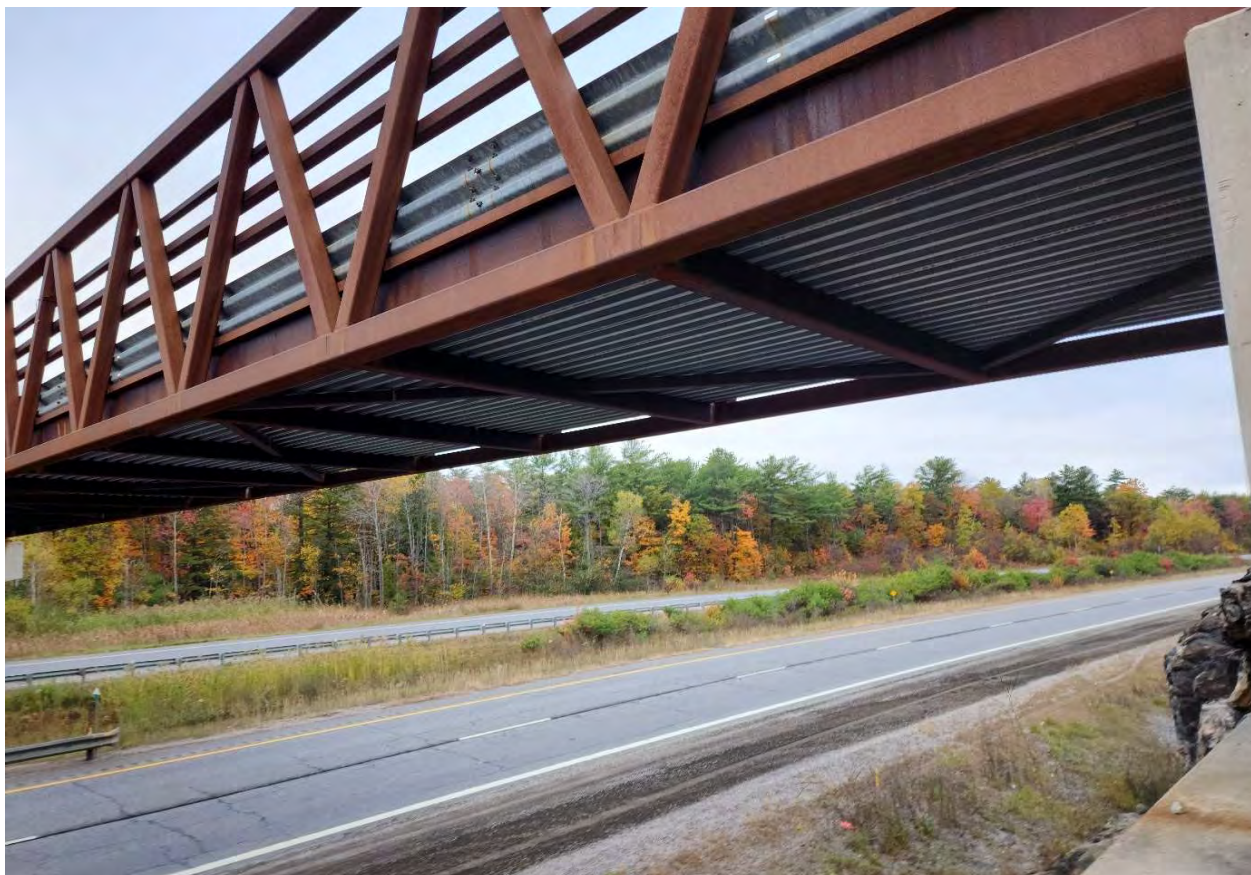
Description of Photo: Floor beam, typ.

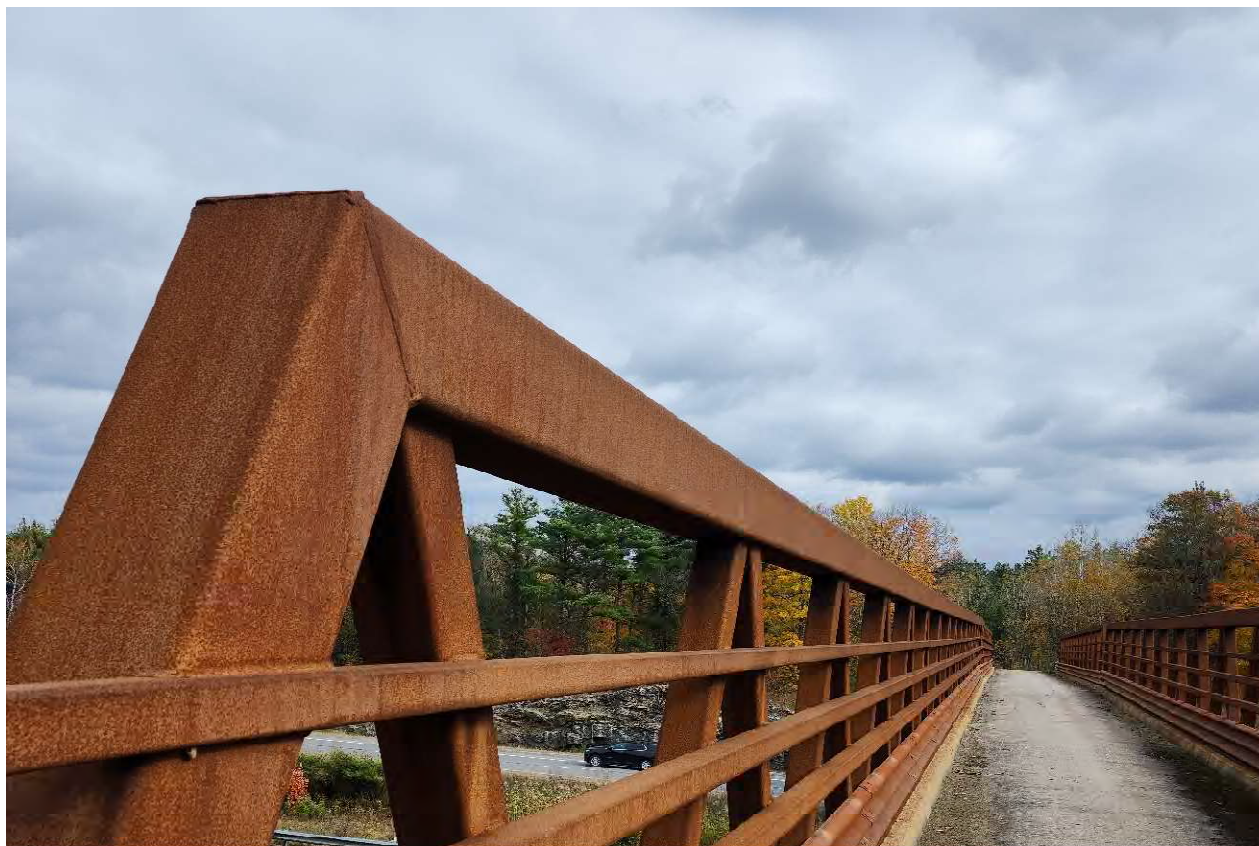
**Description of Photo:** Truss - top chord

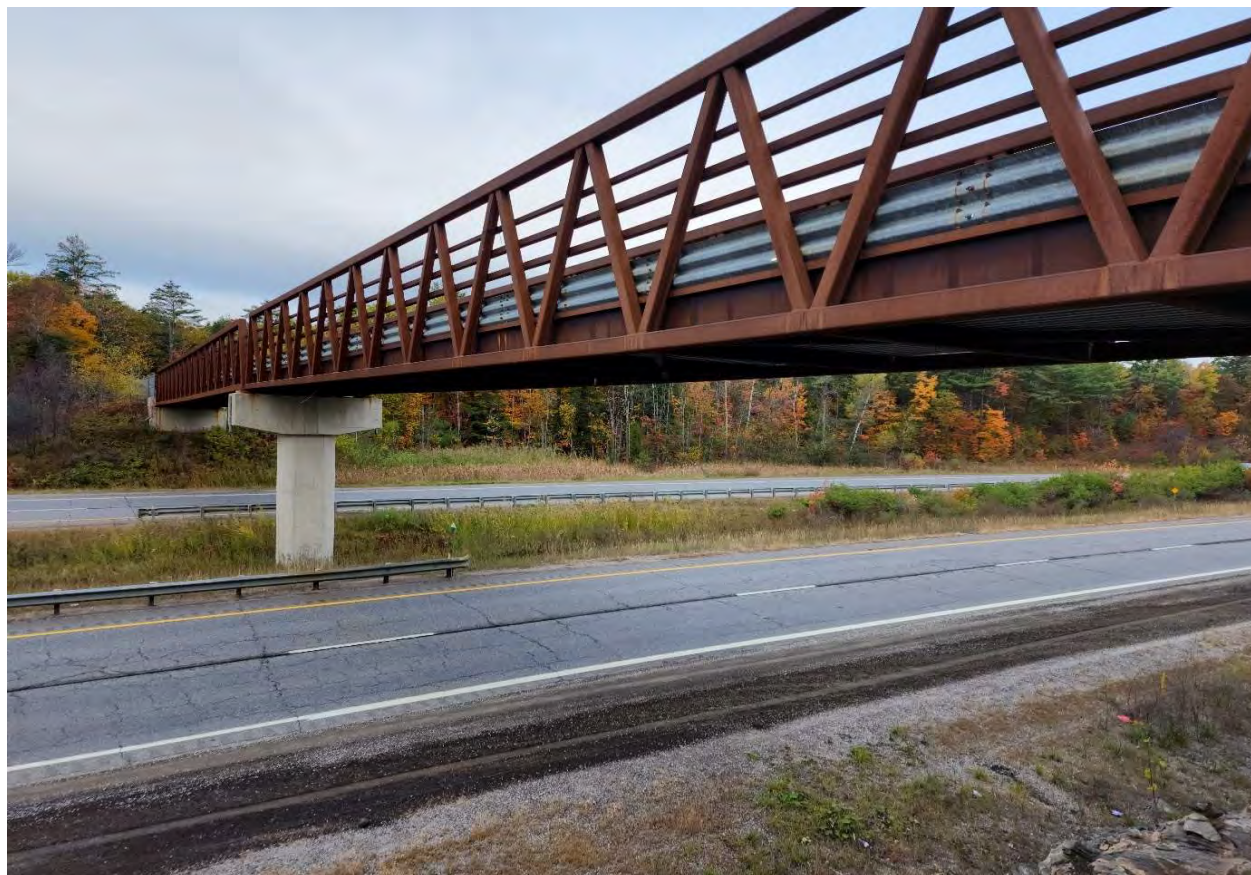
Description of Photo: Truss - bottom chord

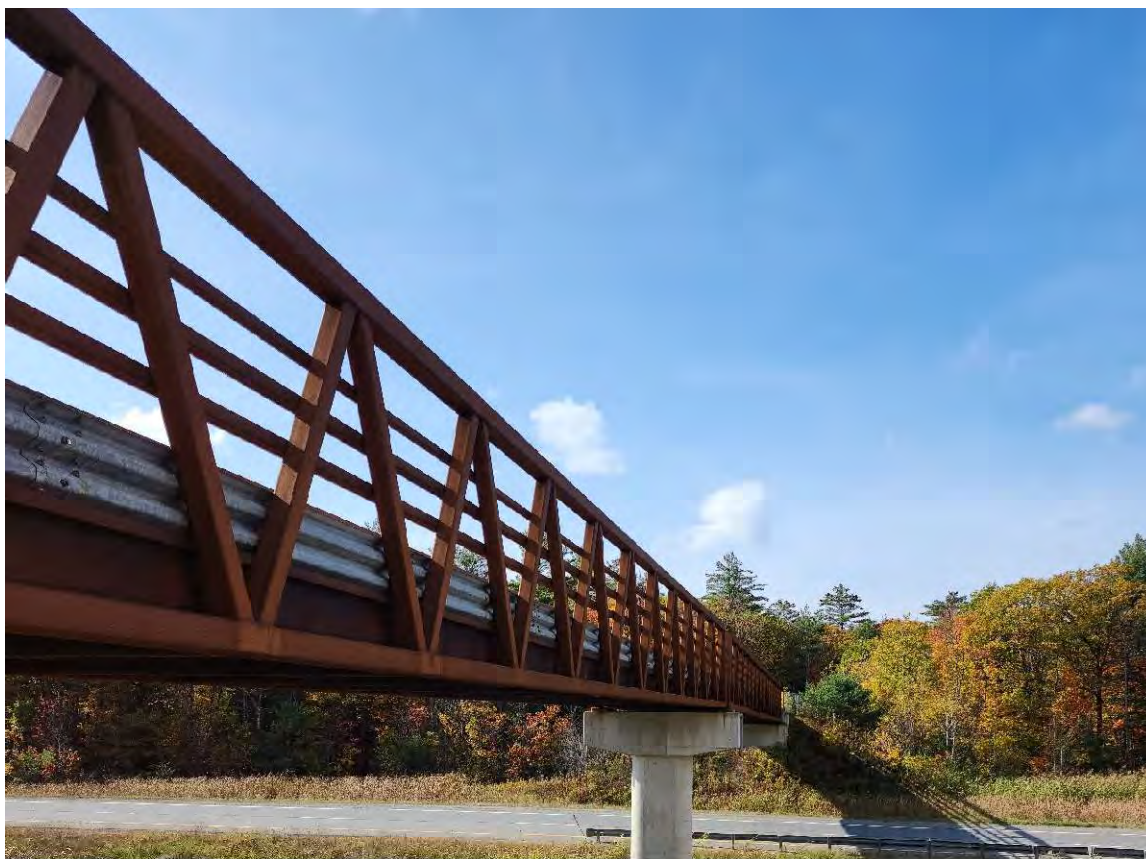
**Description of Photo:** Truss - vertical / diagonal member

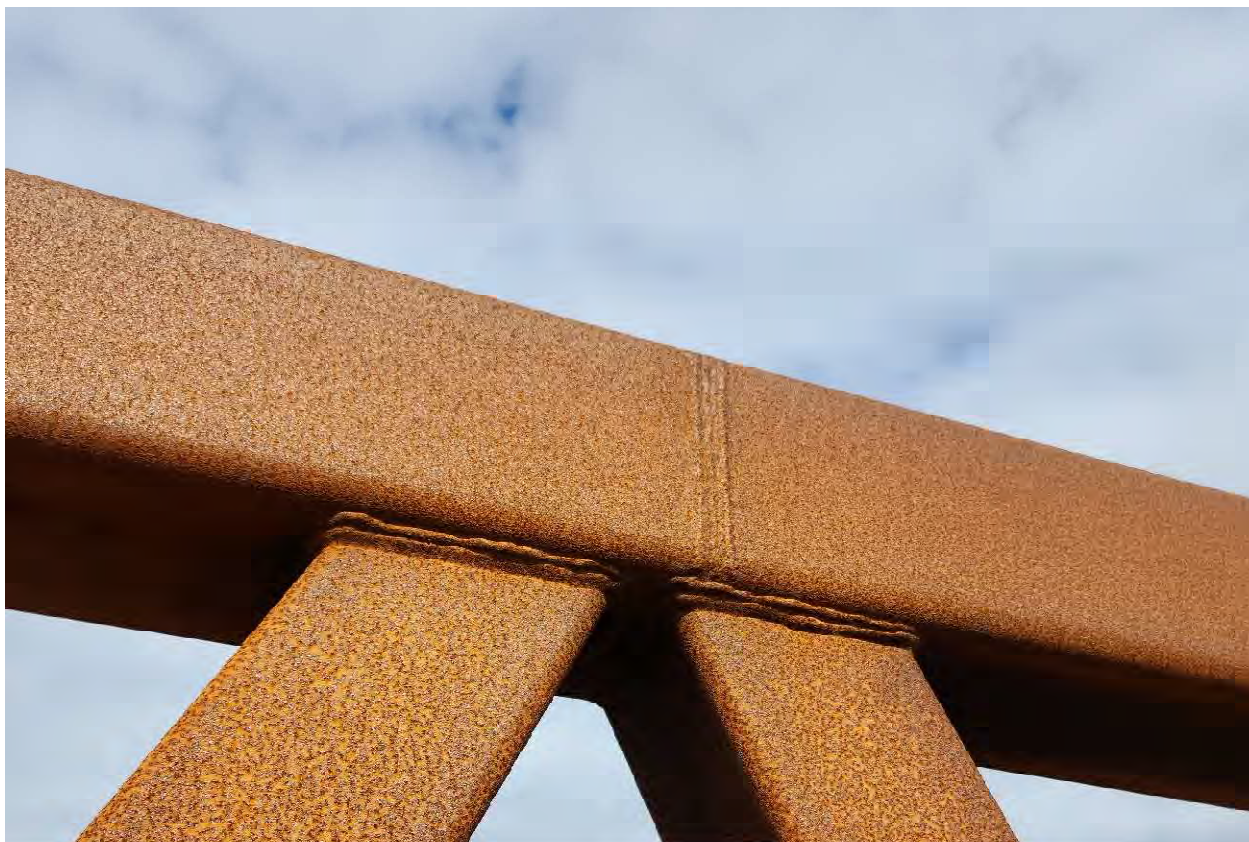
Comments: **No observed defects.**

Description of Photo: Weld Connections

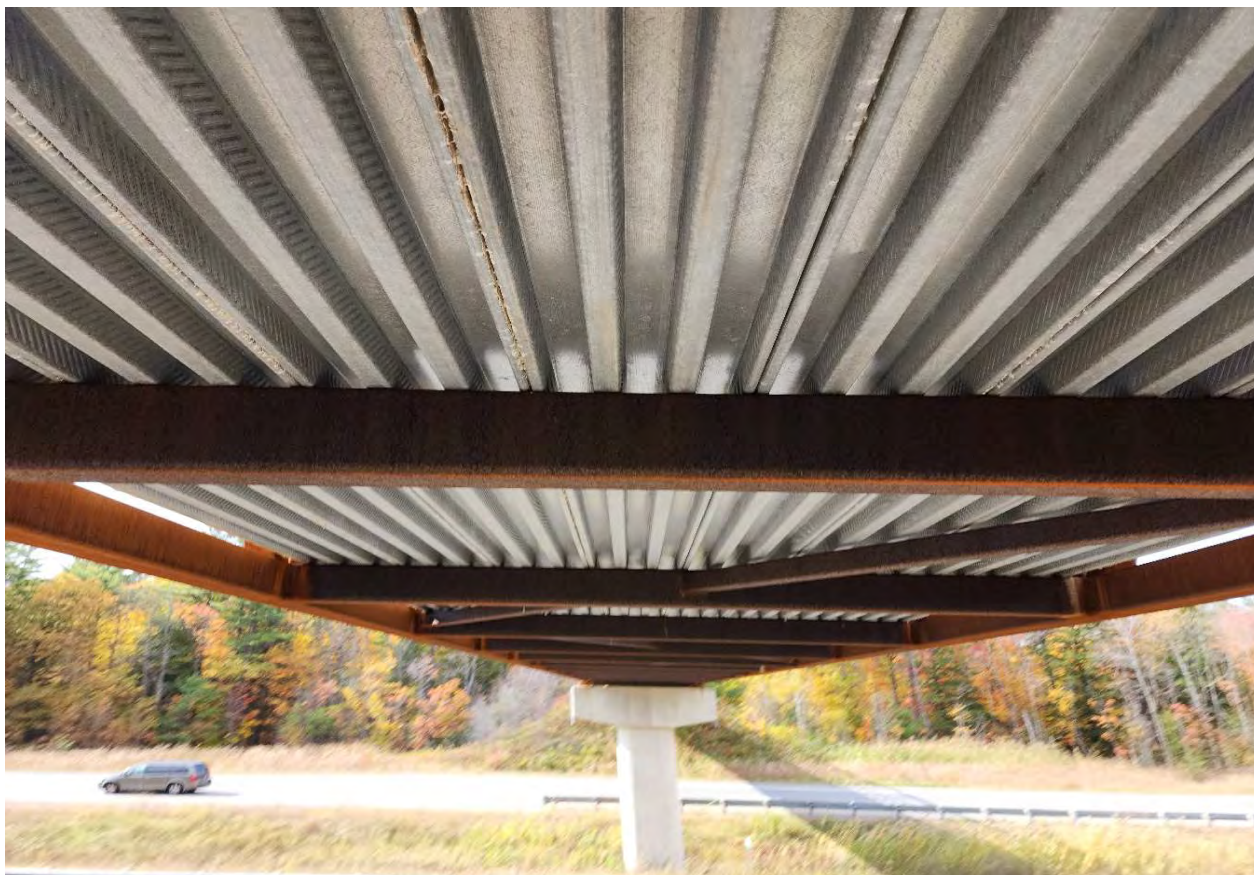
Comments: Relatively uniform patina. Some discolouration at welded connections. No other observed defects. No access for inspection due to height and traffic volume: Condition data, comments, and photos carried over from the 2021 inspection.

Description of Photo: Bracing

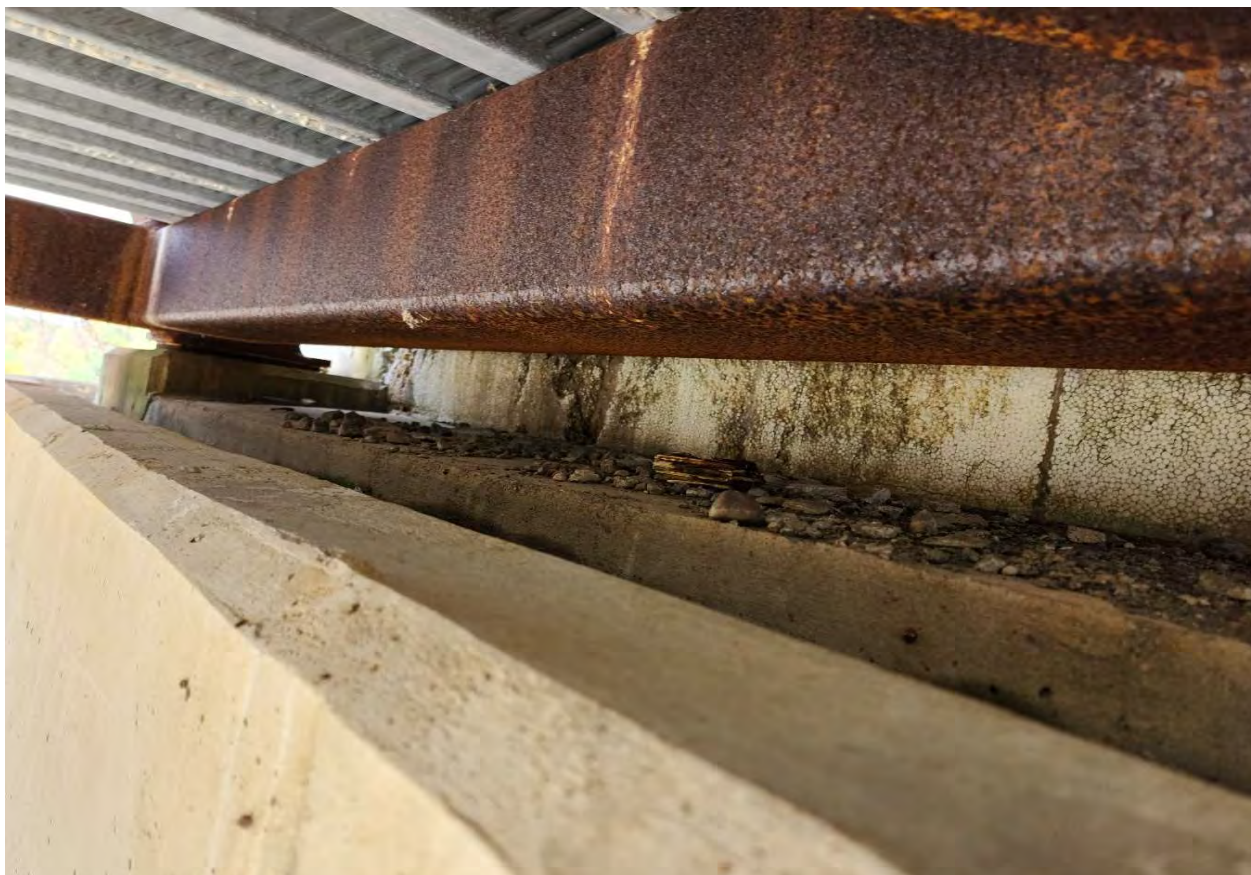
Comments: Light scaling, typ. Isolated efflorescence build-up, and light staining.

Description of Photo: Ballast wall, typ.

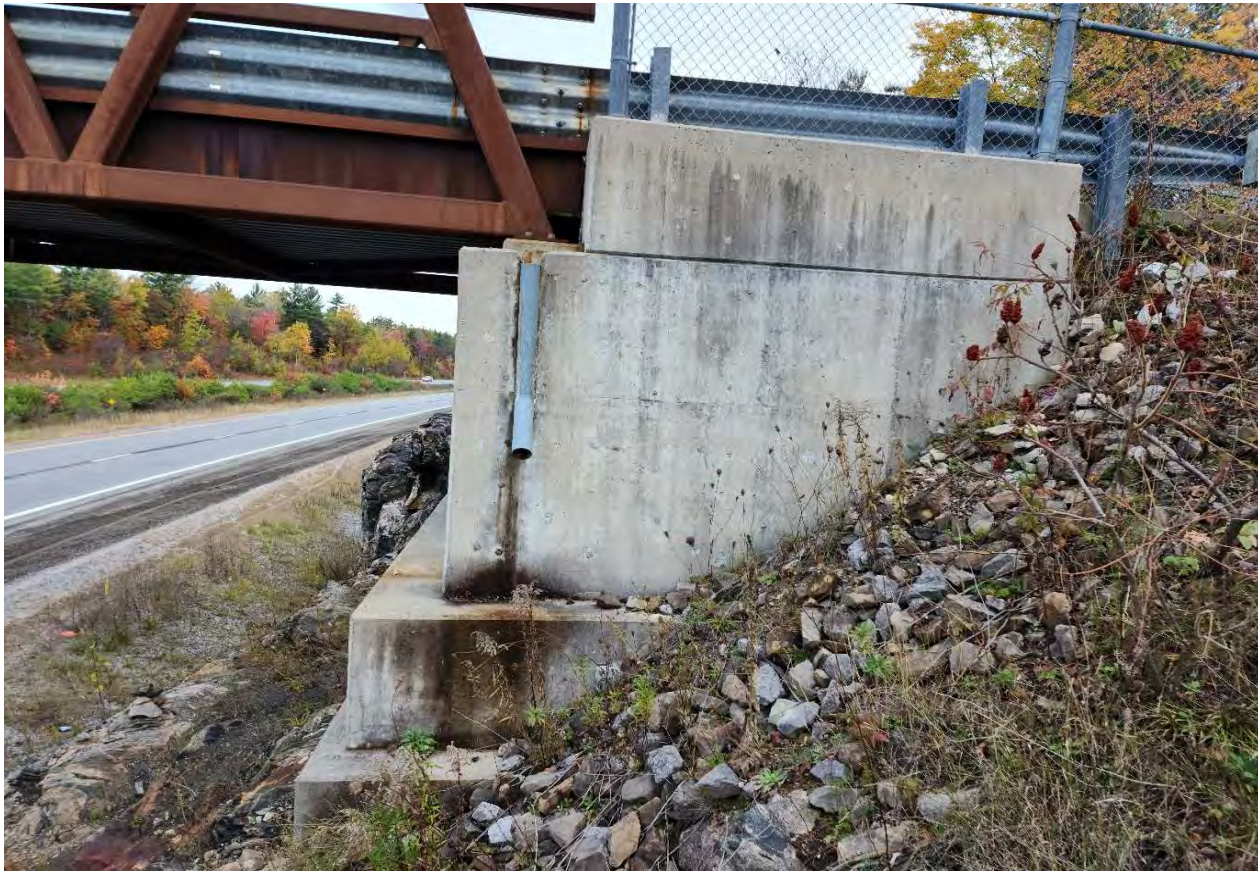
Description of Photo: Wing wall, typ.

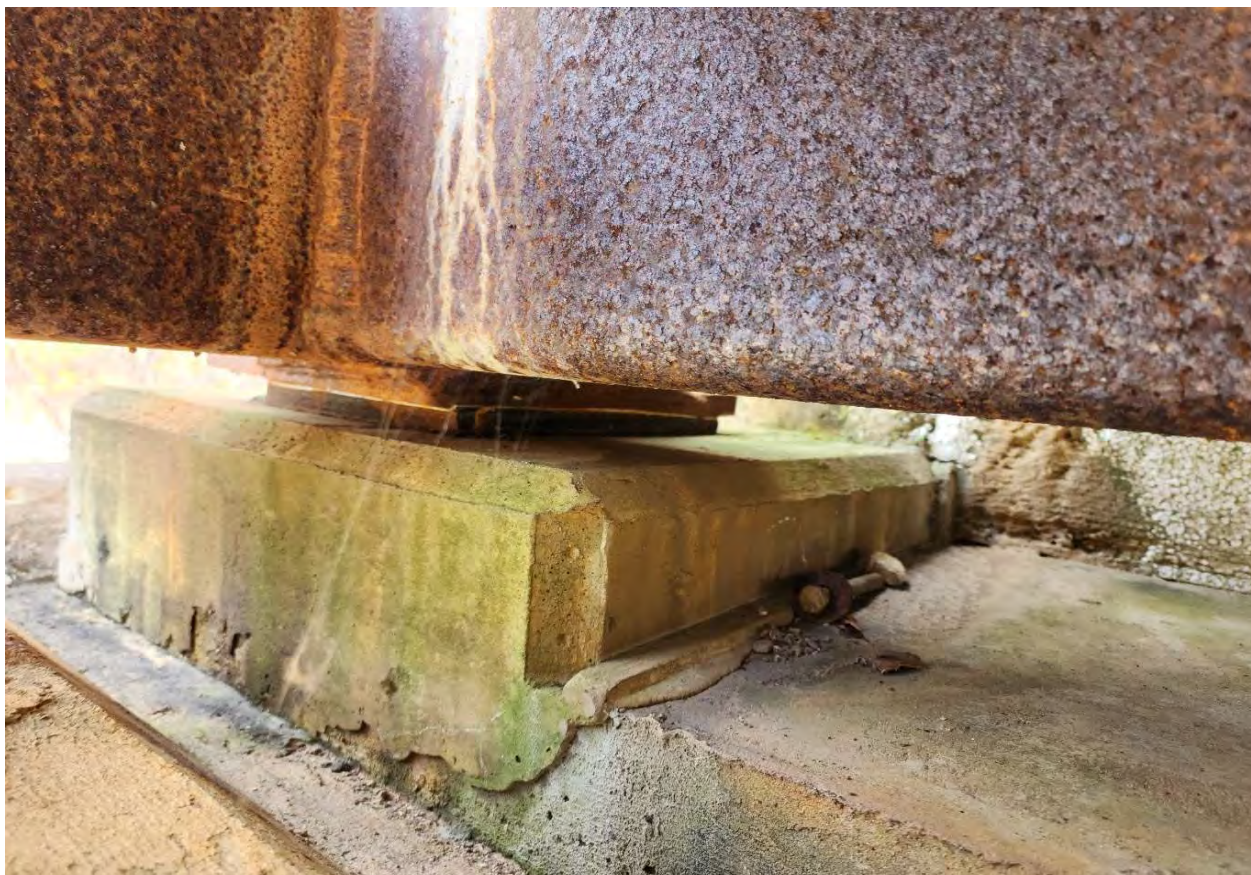
Comments: **Some debris build-up around bearing seat. Light weathering of the elastomer. No other observed defects.**

Description of Photo: Bearing pad, typ.

Recommended Work:	Rehab: <input type="checkbox"/> Replace: <input type="checkbox"/>	Maintenance Needs:	2 - Bridge Cleaning
Urgent: <input type="checkbox"/>	1-5 Years: <input type="checkbox"/>	6-10 Years: <input type="checkbox"/>	None: <input checked="" type="checkbox"/>
			Clean bearing seat.

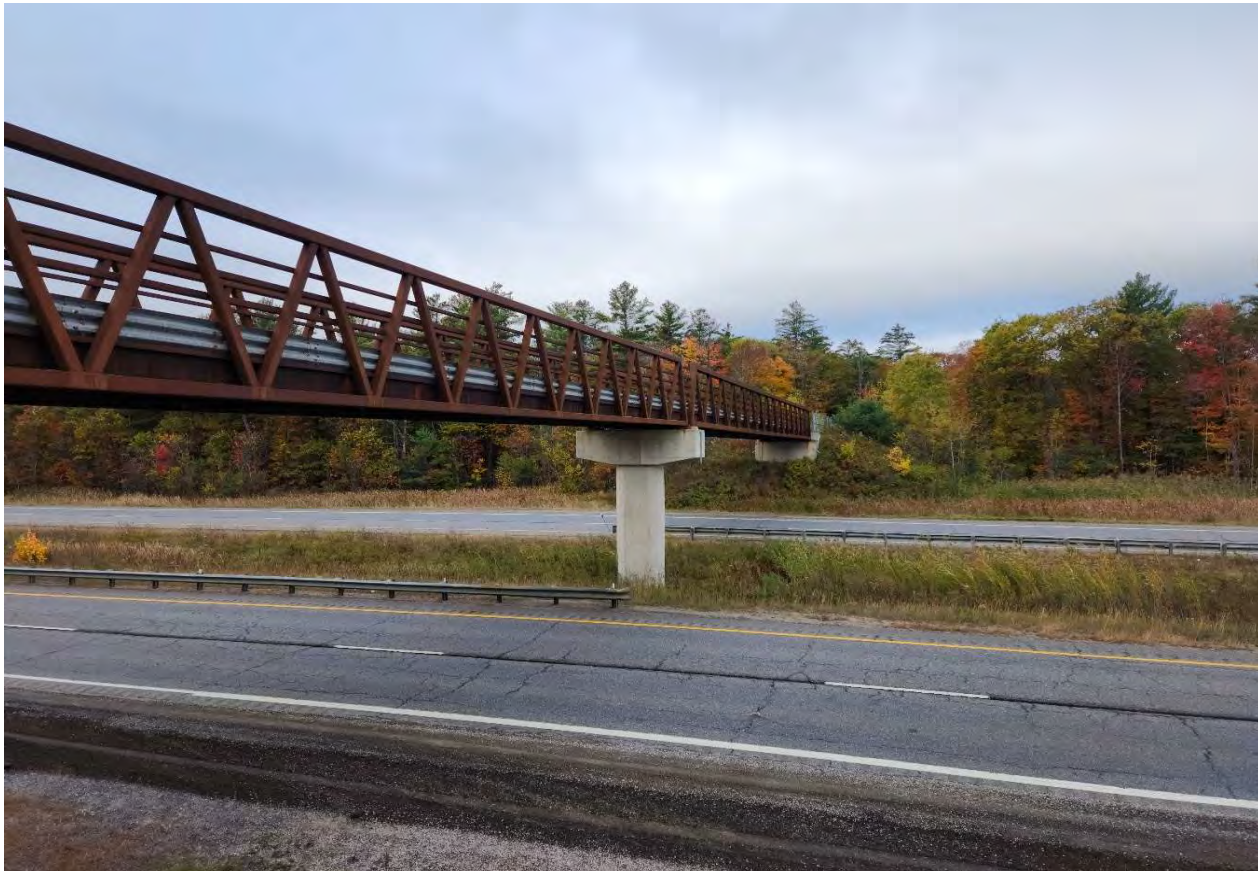
Comments: Light scaling, typ. No access for inspection due to height and traffic volume. 2019 concrete repair to bearing seat. Condition data, comments, and photos carried over from the 2021 inspection.

Description of Photo: Concrete Pier

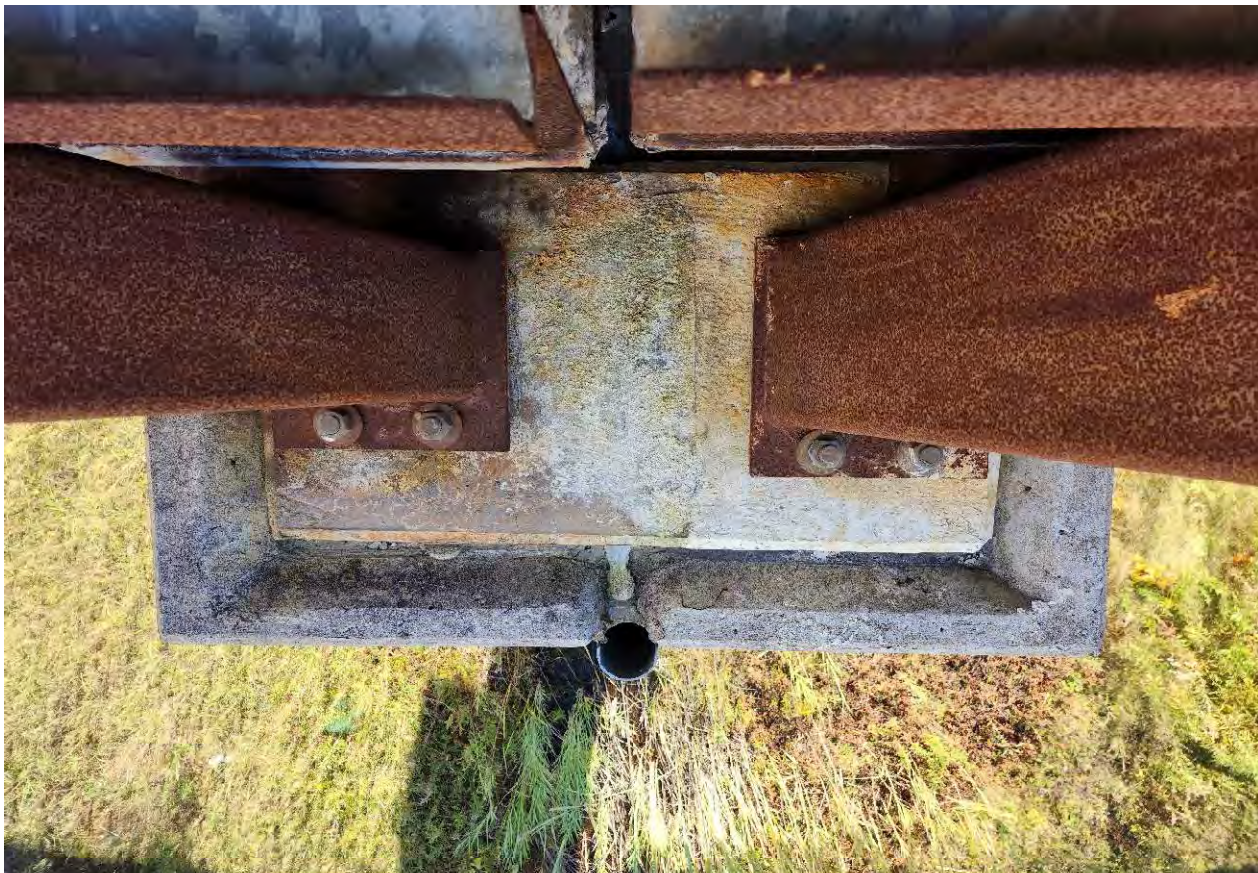
Description of Photo: Pier cap, typ.

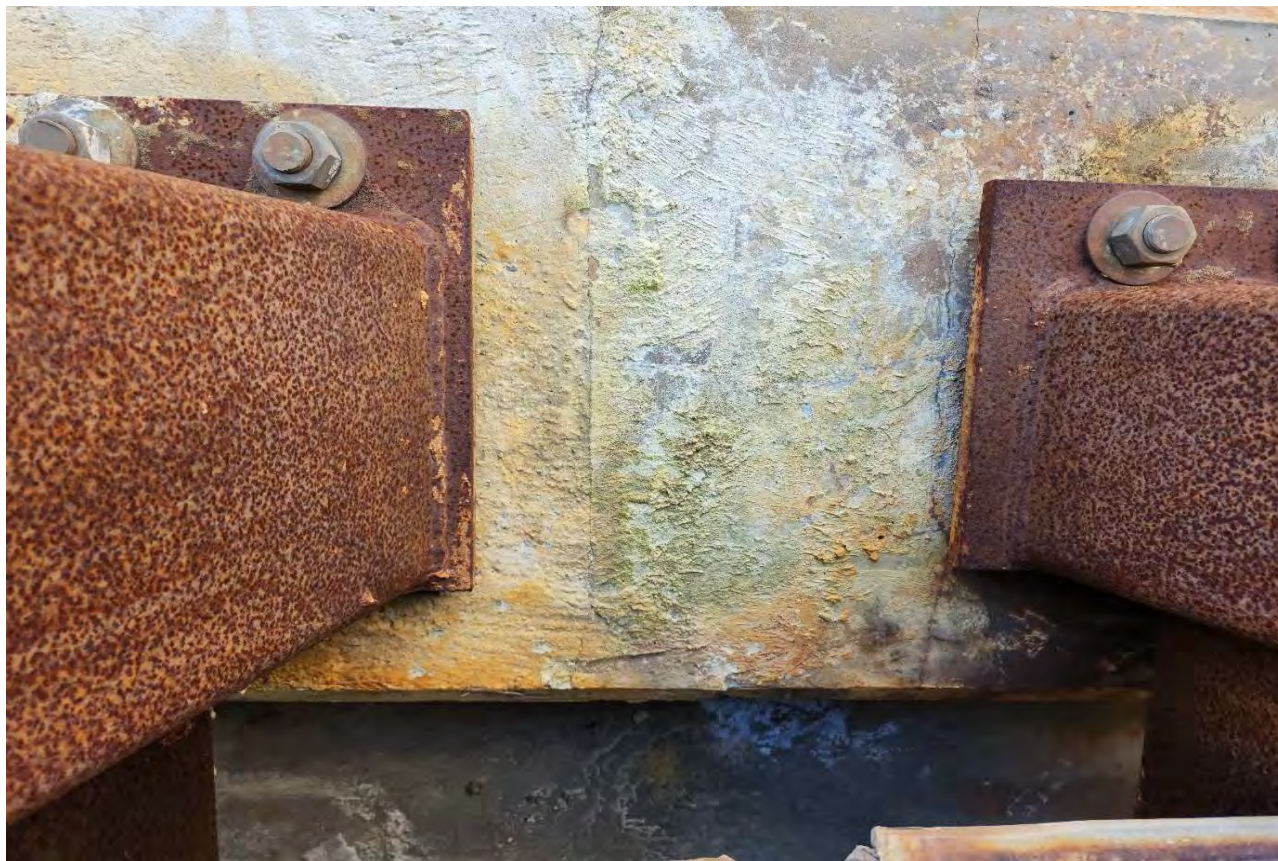
Comments: **Assumed light weathering, typ. No access for inspection due to height and traffic volume: Condition data, comments, and photos carried over from the 2021 inspection.**

Description of Photo: Bearing, typ.

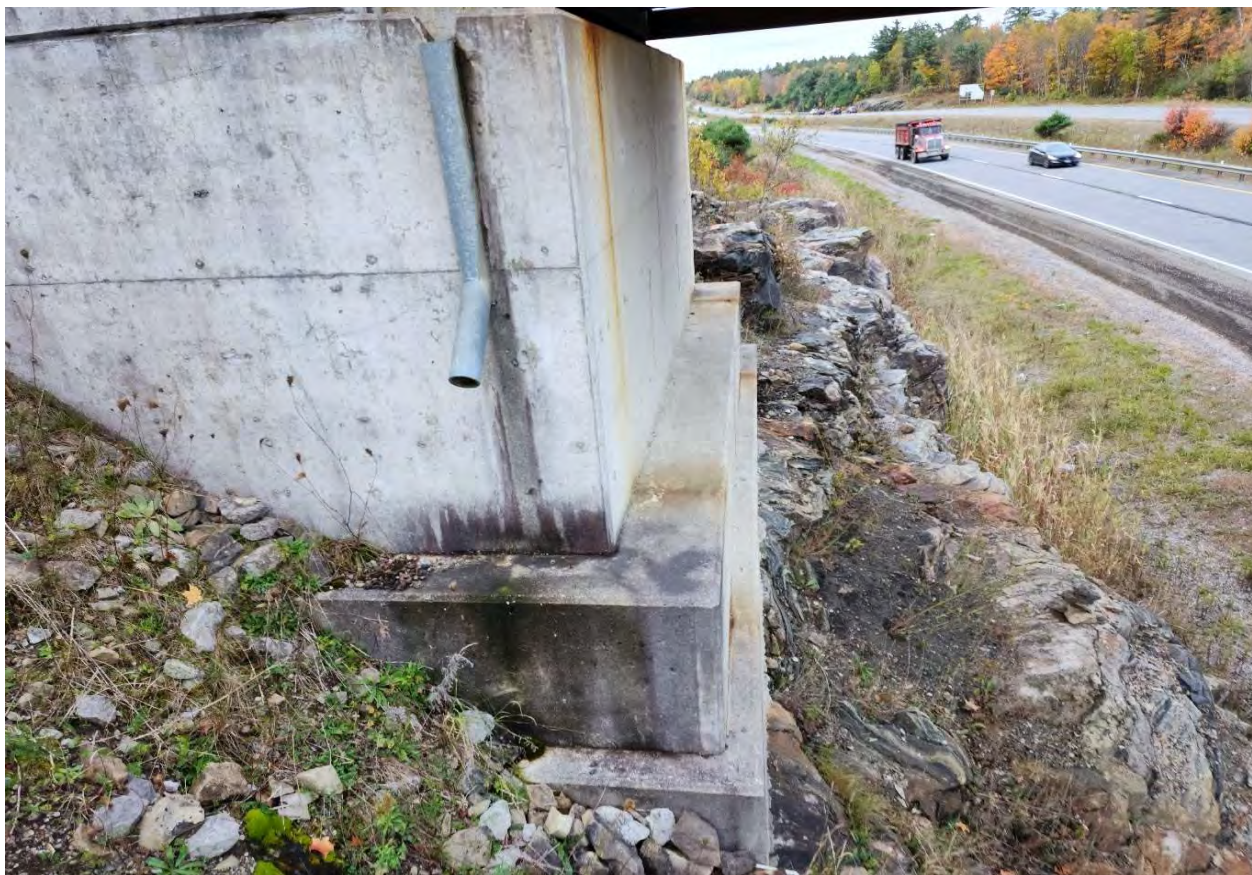
**Description of Photo:** Embankment, typ.

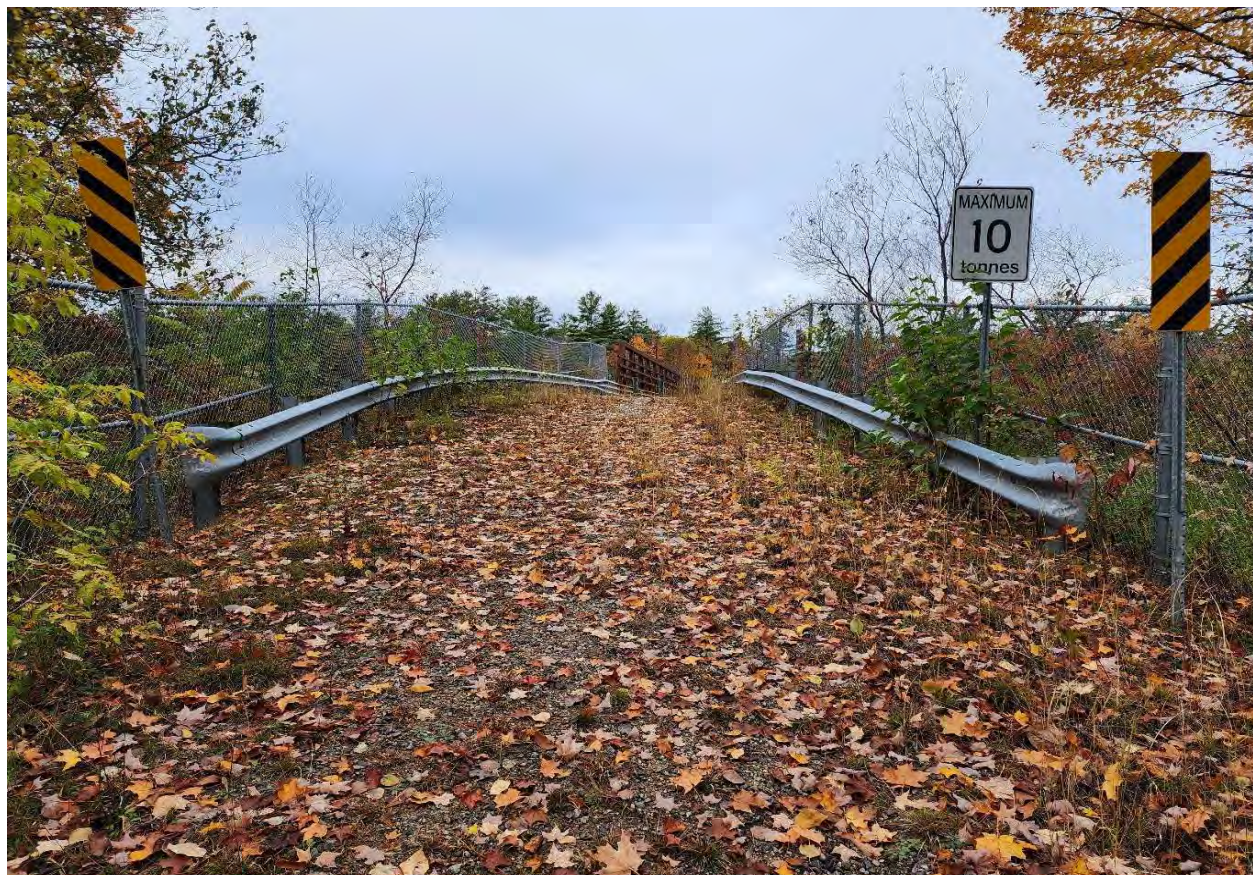
Comments: 4 hazard markers present, 2-10 tonne load limit signs. No observed defects.

Description of Photo: Load post sign and hazard warning sign

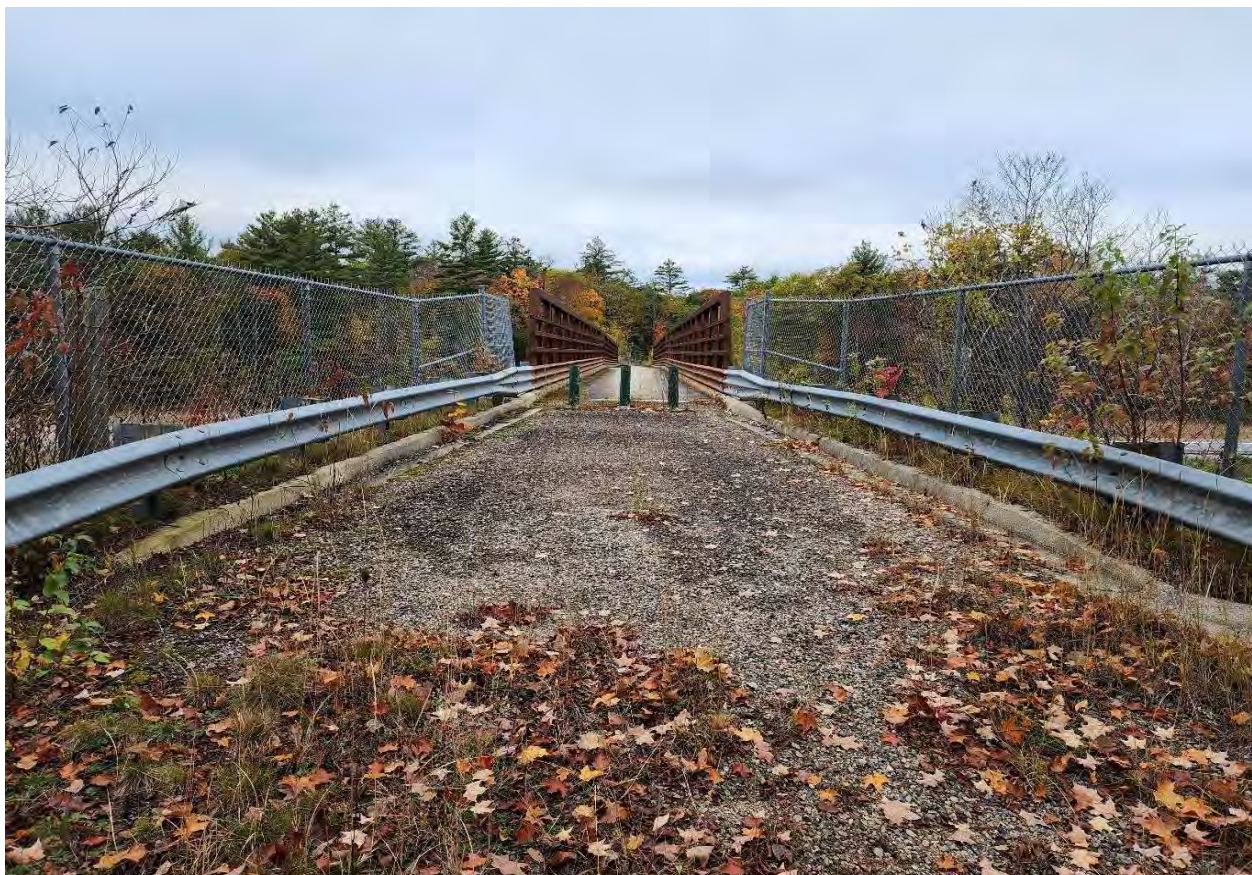
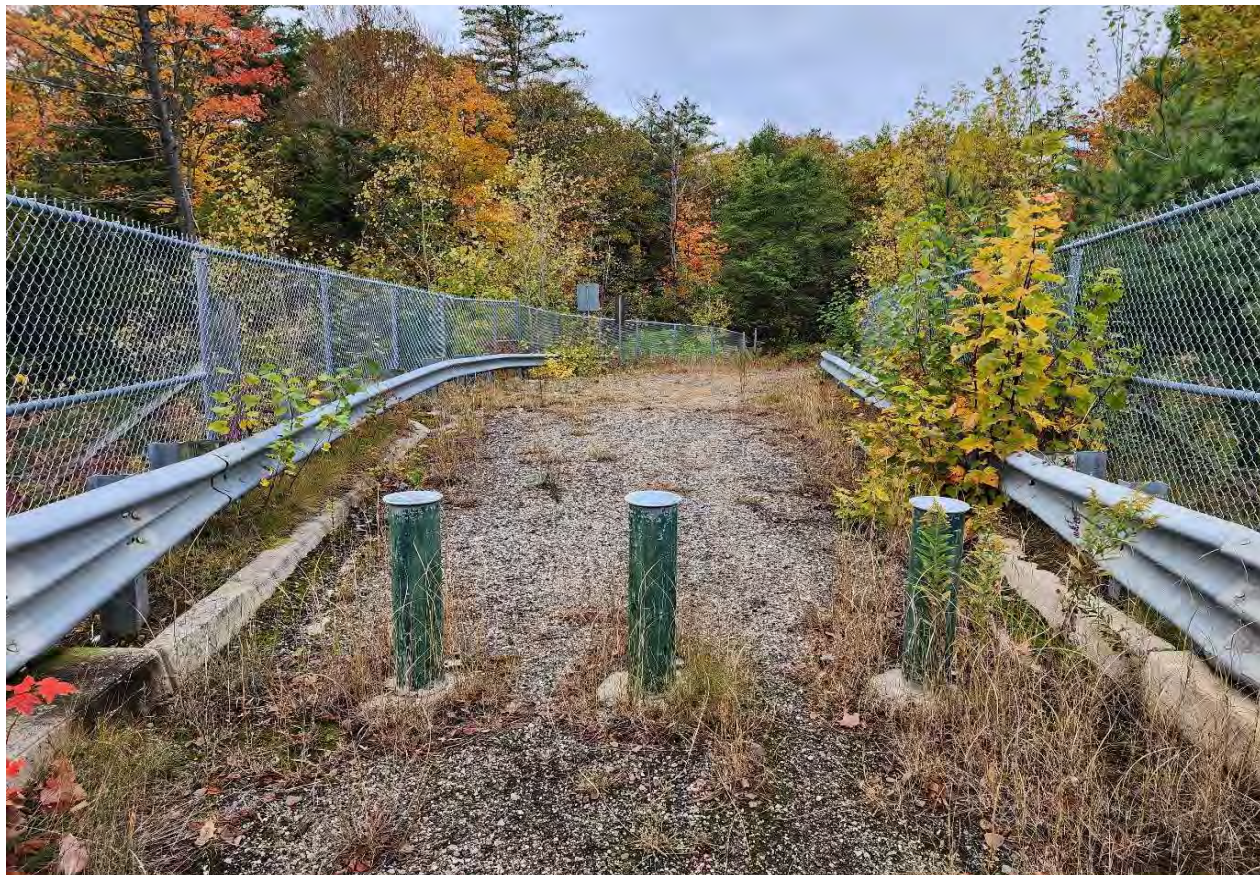
Comments: **No observed defects.**

Description of Photo: Approach wearing surface

Description of Photo: Approach wearing surface, typ.
