Bridge Needs Study

INSPECTION SUMMARY REPORT

Town of Gravenhurst

August
29, 2024

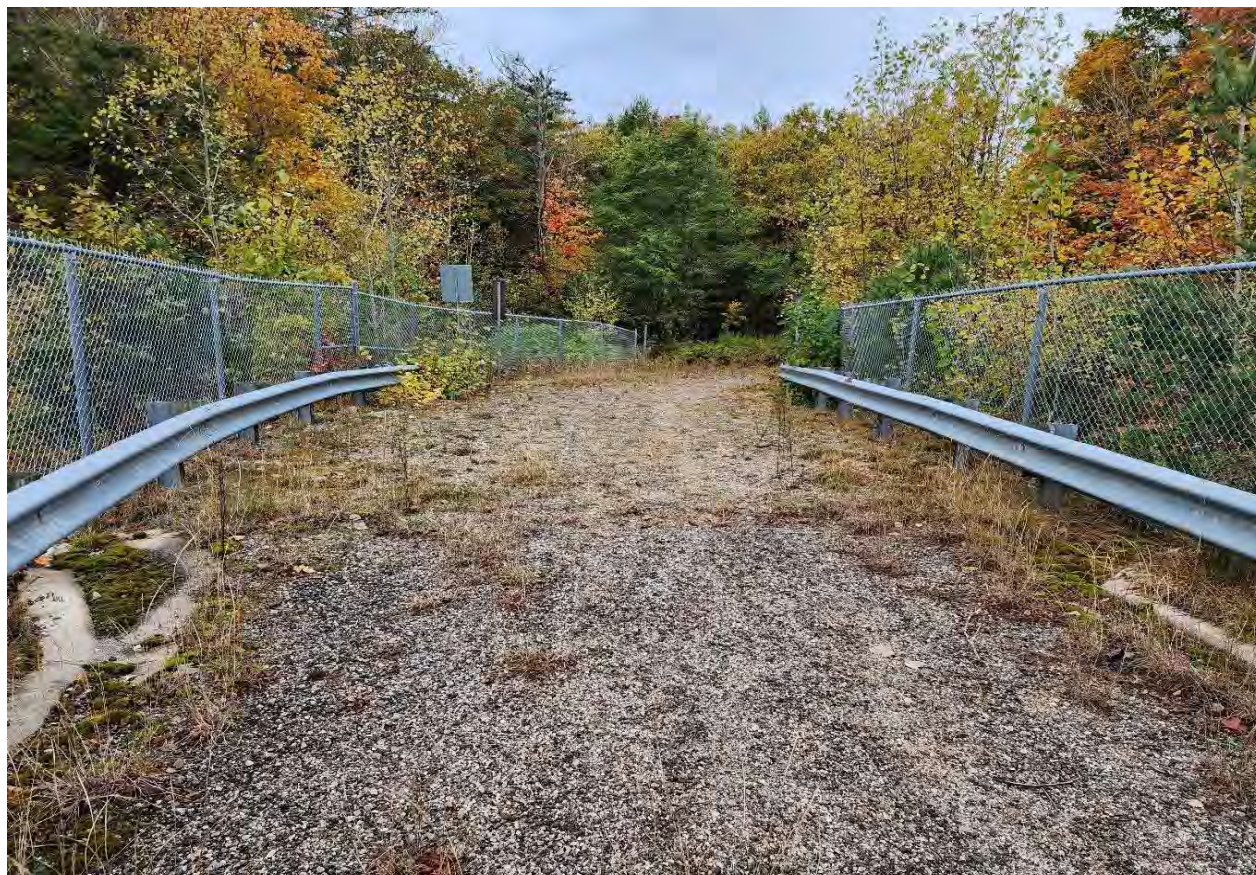
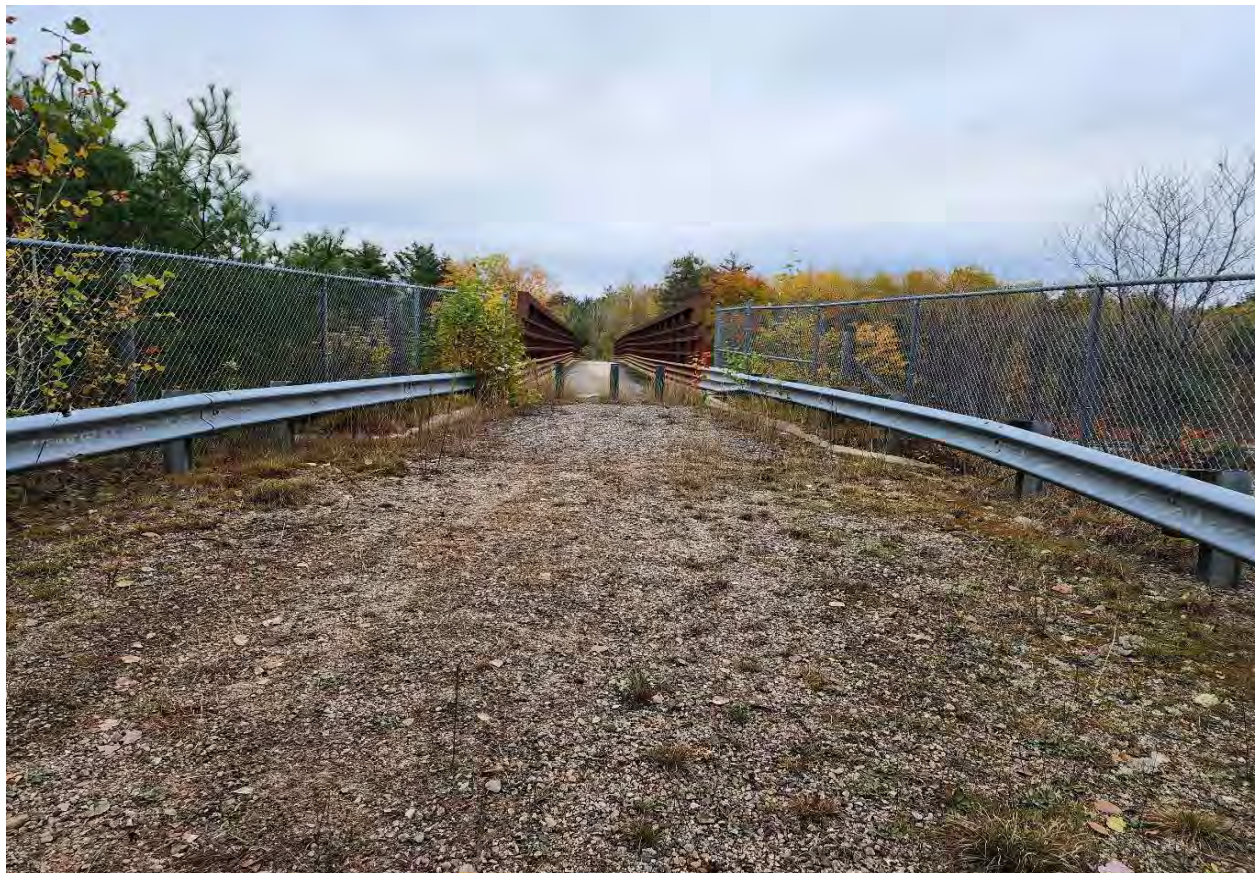
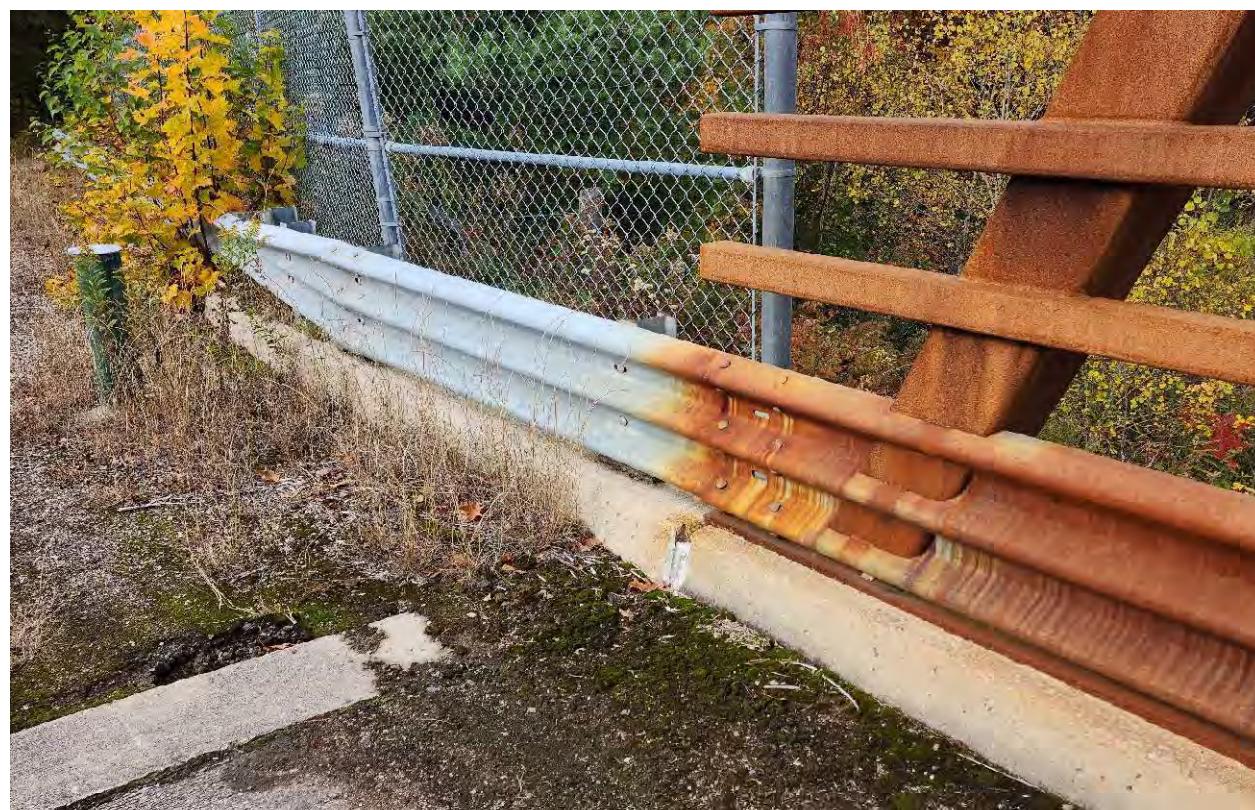
Comments: Transitions from thrie-beam on the bridge to W-beam. Several missing bolts noted on the east approach post connections. No other observed defects.

Description of Photo: Approach guide rail, typ.

Description of Photo: Approach guide rail transition

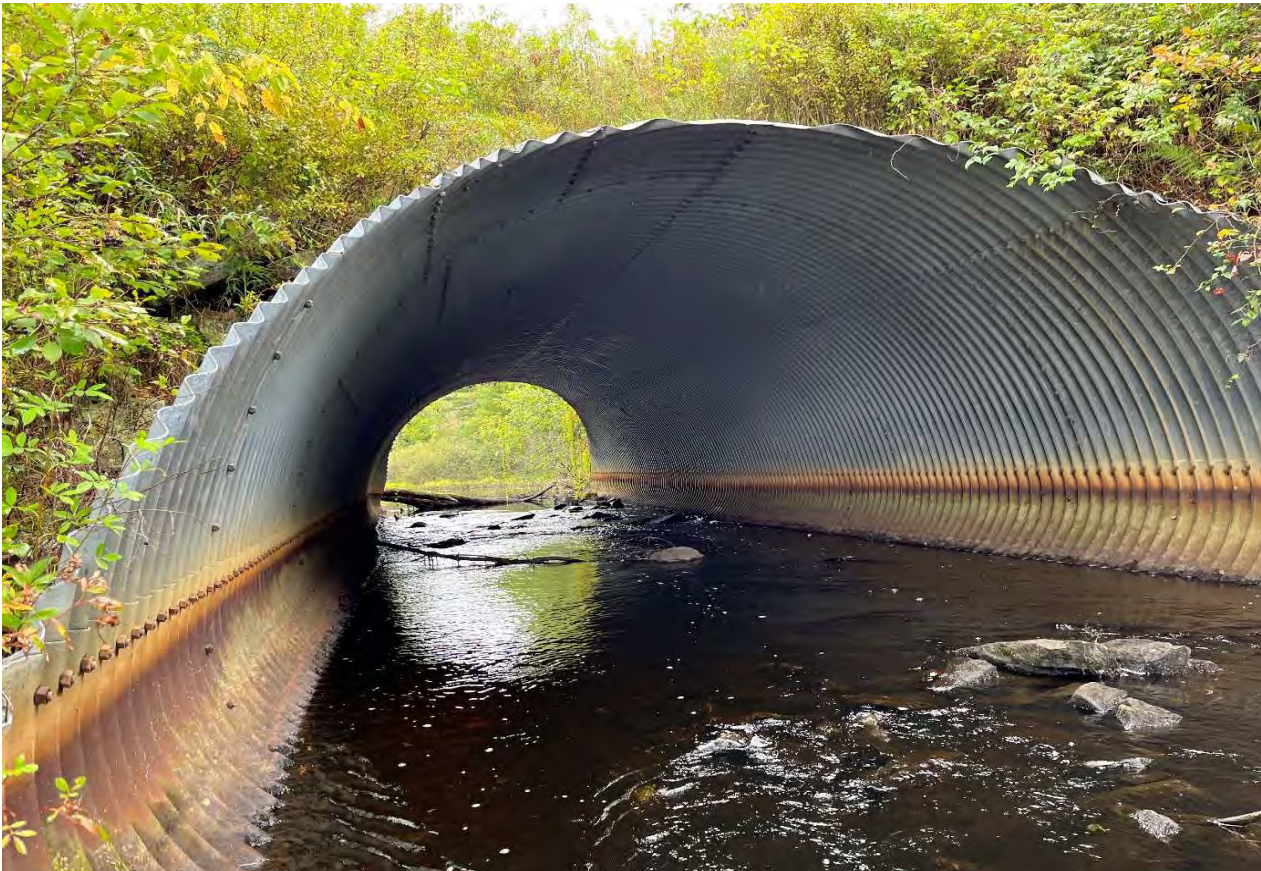
Description of Photo: Culvert barrel outlet

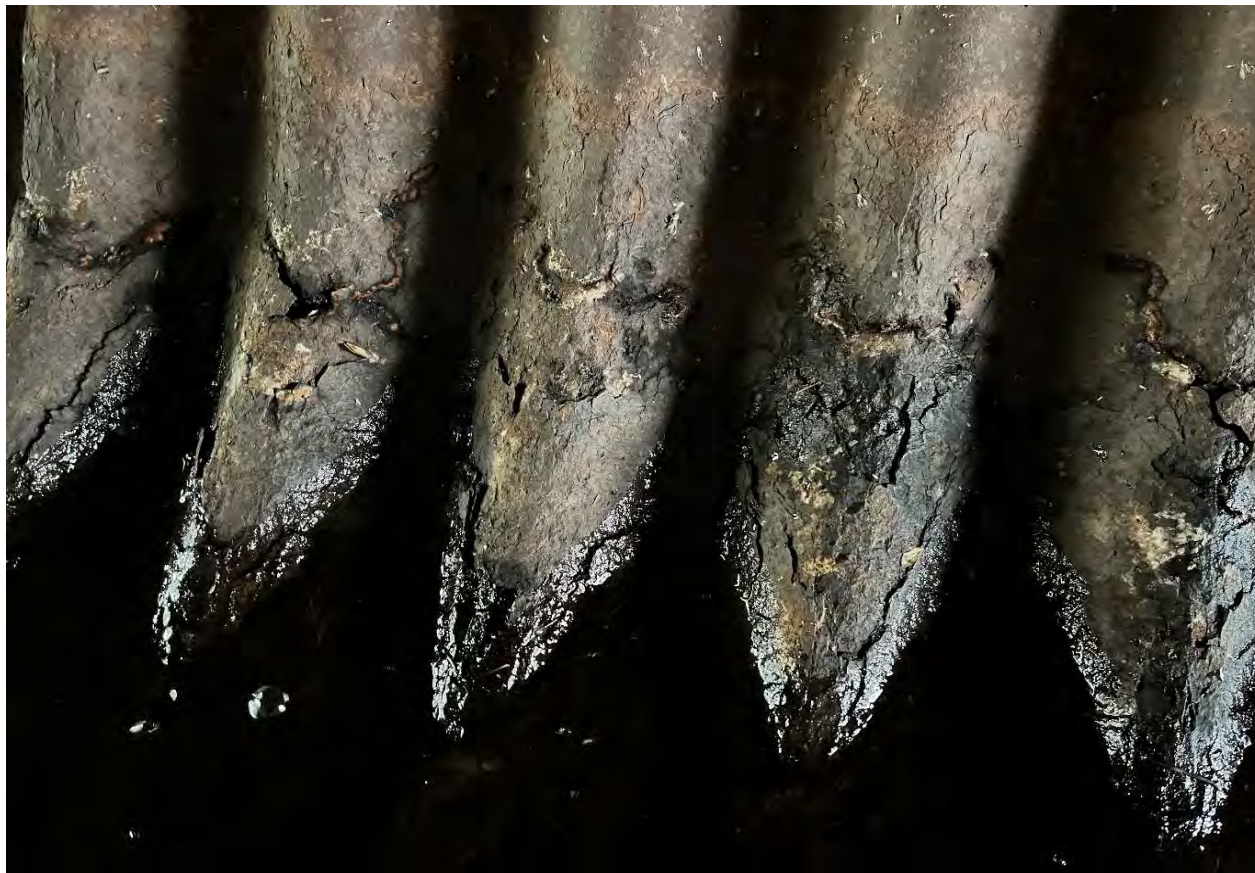
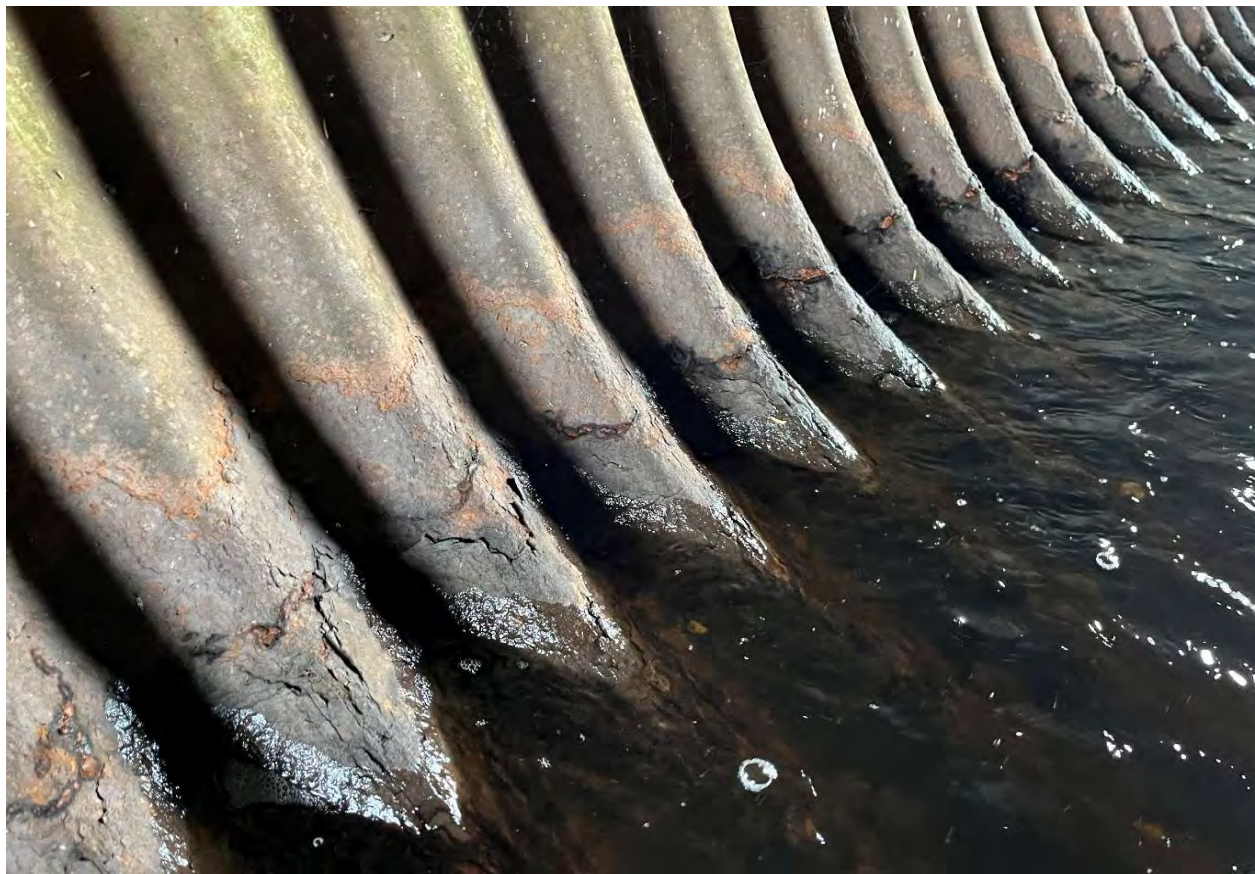
Comments: **Severe corrosion and perforations noted at 100mm above waterline. Isolated section loss at culvert inlet. Medium corrosion from 100mm to 400mm above waterline for full length of culvert. Assumed light to severe corrosion along invert. Light chalking of the galvanized coating starting 400mm above the waterline.**

Description of Photo: Severe corrosion and deterioration

Justification:
<p>This culvert is generally in fair to poor condition. Severe corrosion and perforation noted along waterline, and section loss noted at the inlet. We expect the rate of corrosion will lead to increasing perforations and separation, and rehabilitation should be planned for 1-5 years. The pricing above assumes cast in place culvert relining across the bottom and extending above waterline. Maintenance: Hazard warning signs be installed at the ends of the guide rail for improved roadside safety.</p>

Recommended Work:	Rehab: <input checked="" type="checkbox"/> Replace: <input type="checkbox"/>	Maintenance Needs:	
Urgent: <input type="checkbox"/> 1-5 Years: <input checked="" type="checkbox"/> 6-10 Years: <input type="checkbox"/> None: <input type="checkbox"/>	Urgent: <input type="checkbox"/> 1 Year: <input type="checkbox"/> 2 Year: <input type="checkbox"/>		
Culvert lining

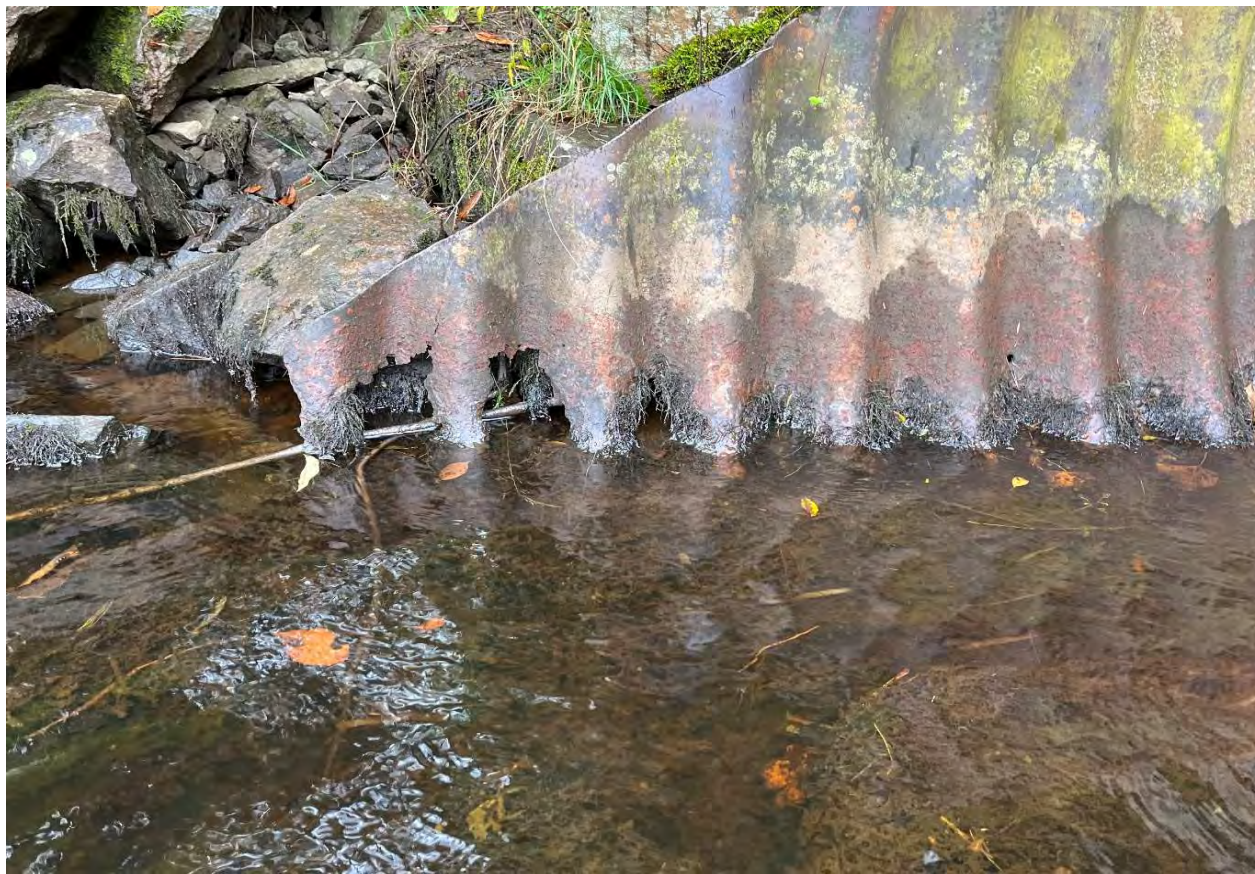
Description of Photo: Section loss at inlet

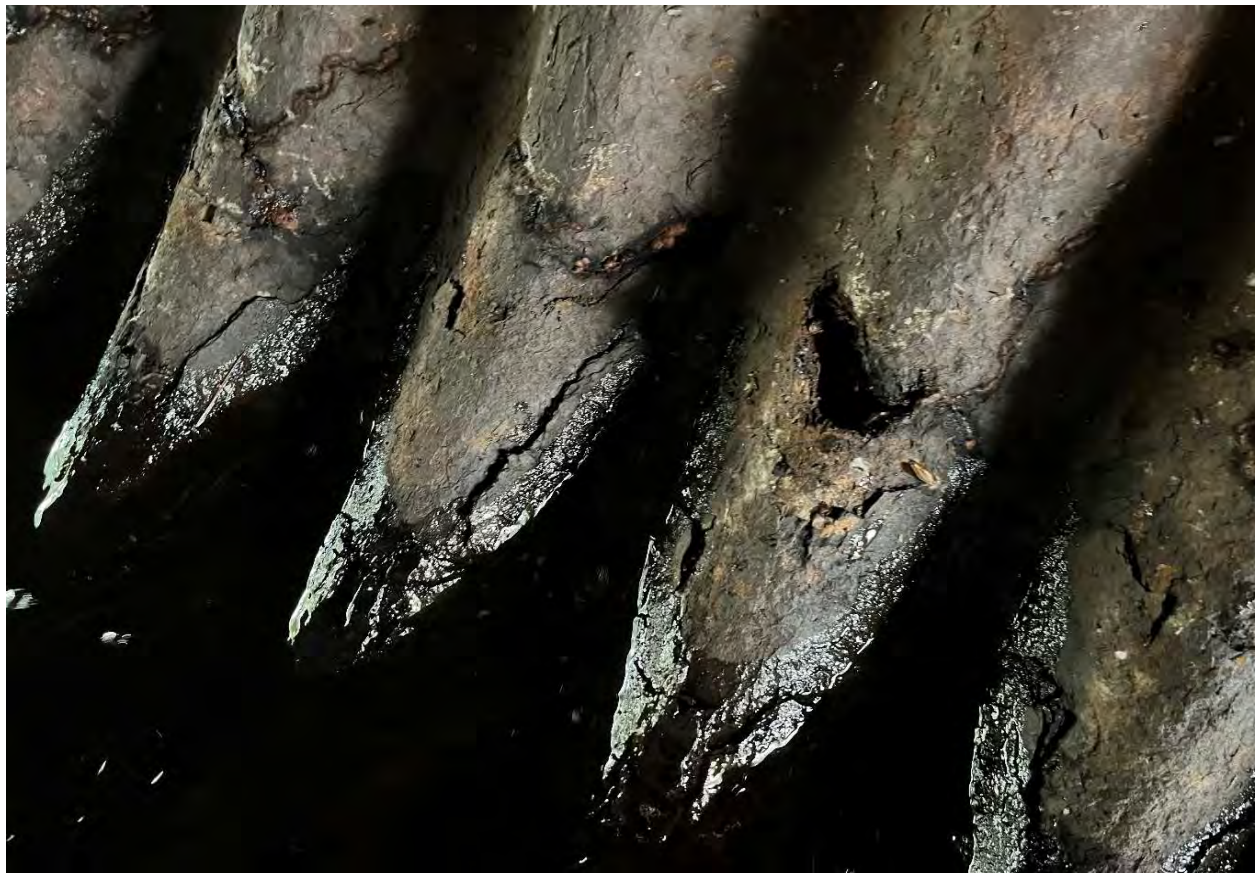
Description of Photo: Severe deterioration and perforation

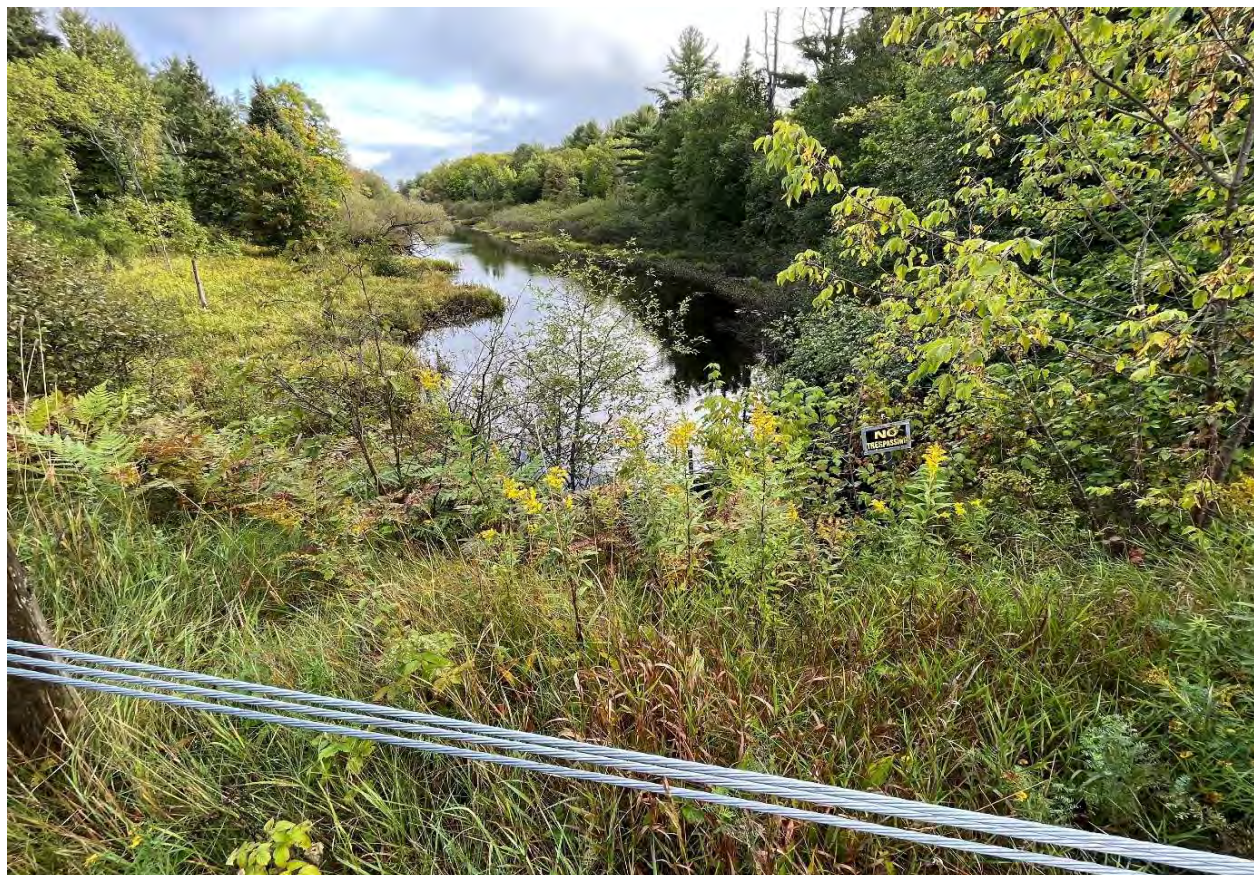
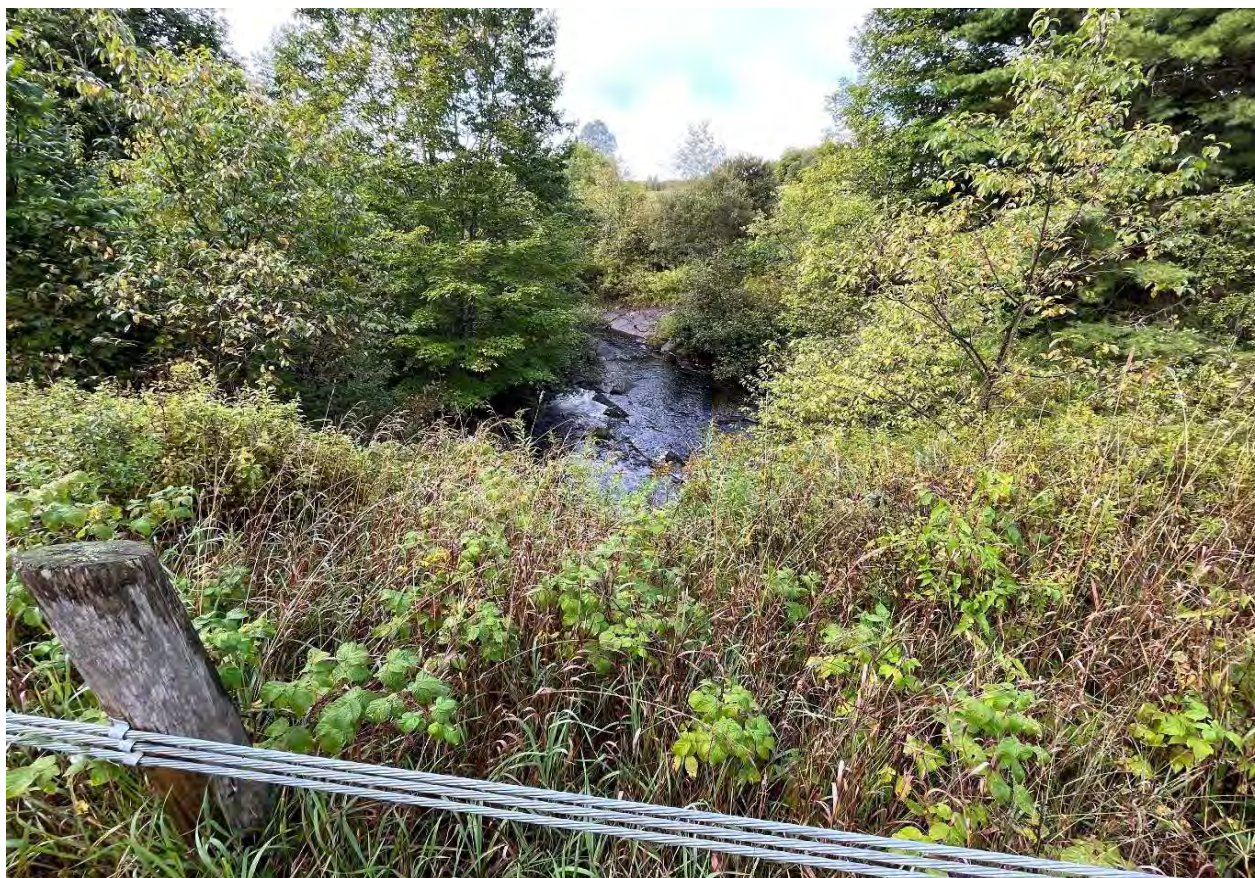
Description of Photo: Upstream

Description of Photo: Downstream

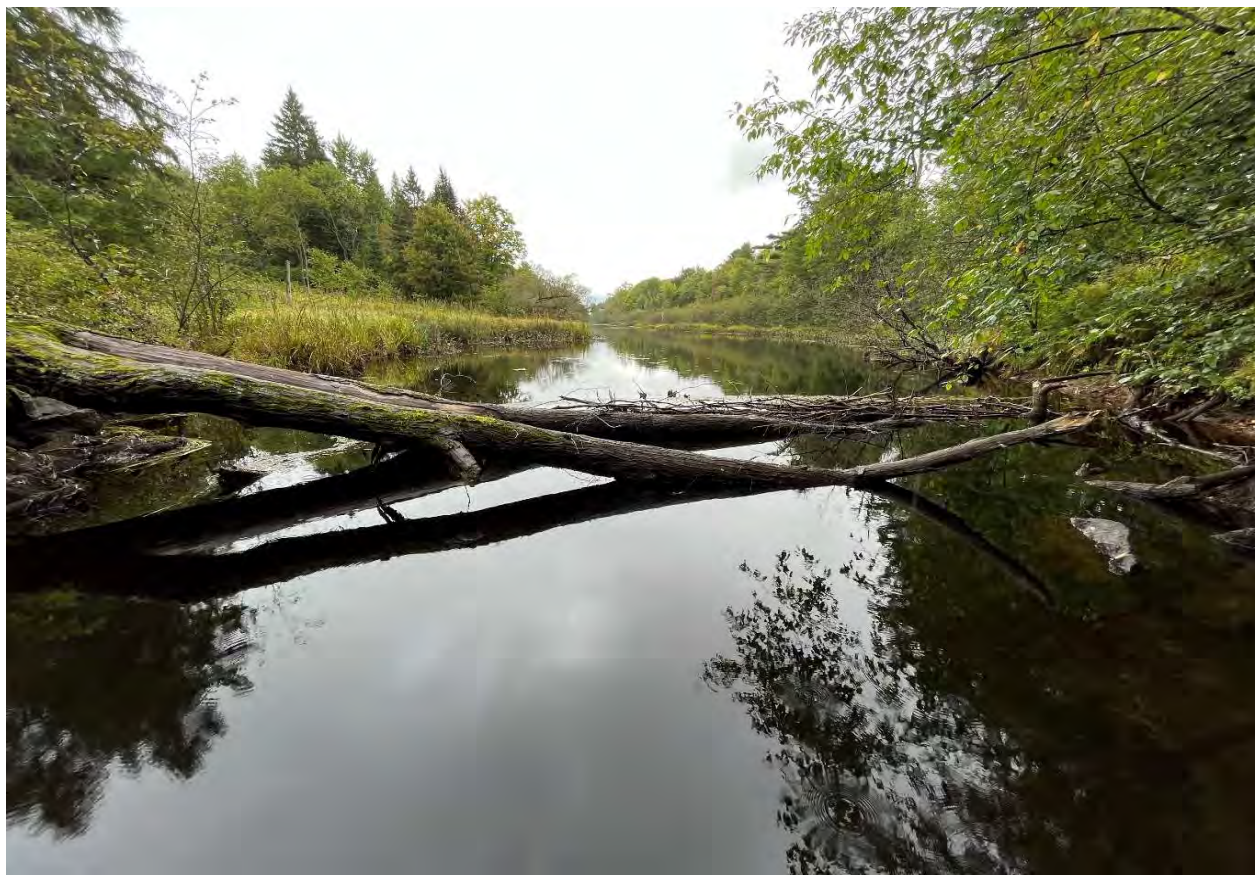
Comments: 1 fallen tree is near culvert inlet. Vegetation and branches in culvert inlet. No other observed defects.

Description of Photo: Fallen tree at upstream

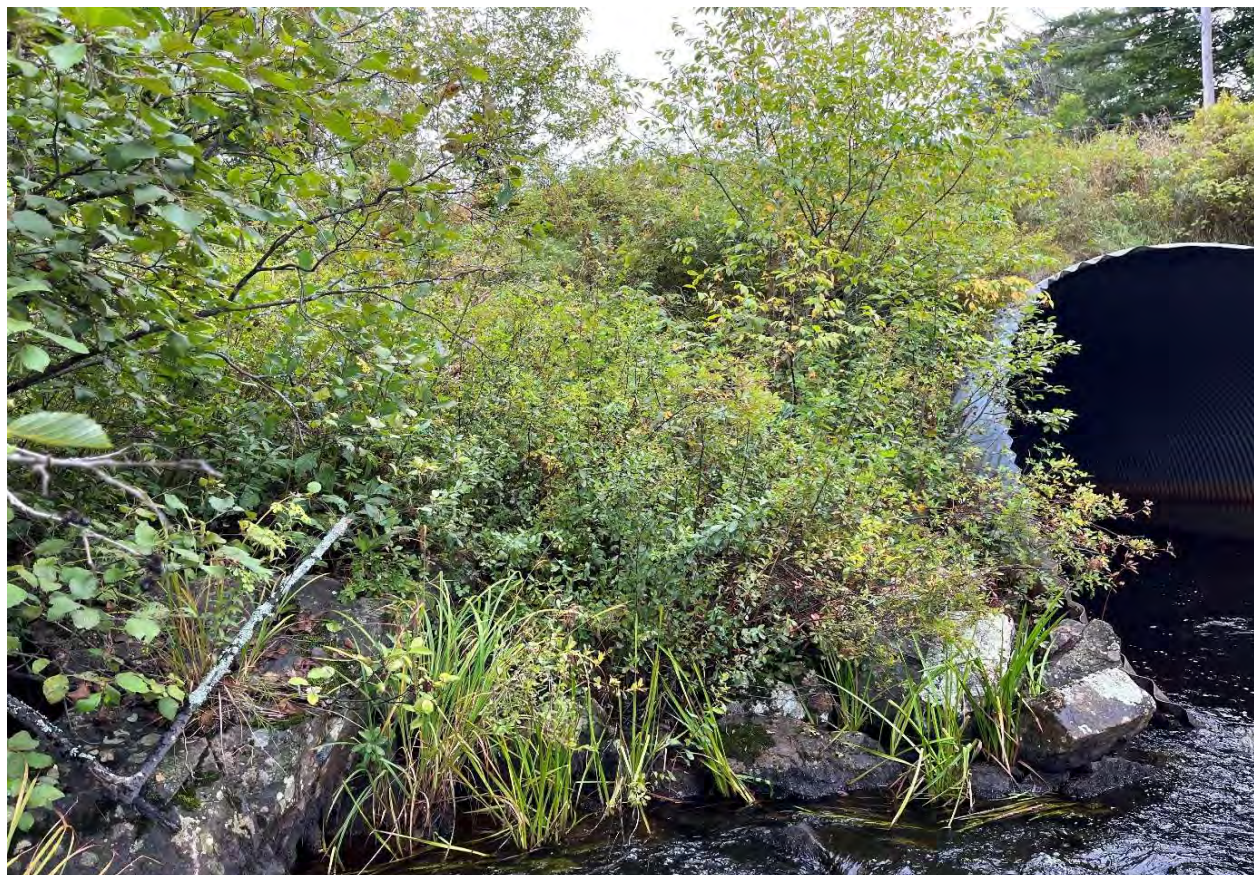
Description of Photo: Embankment, typ.

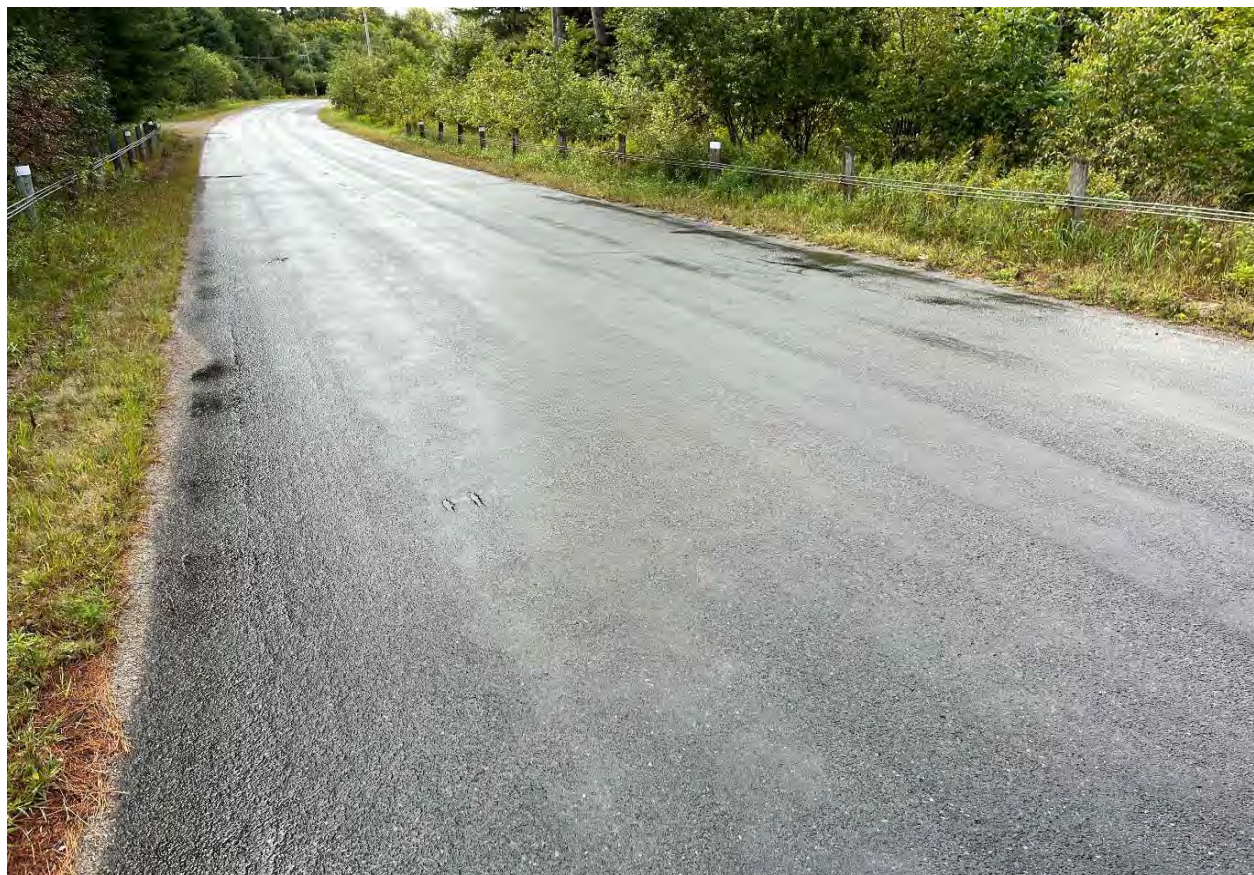
Comments: Light ravelling, typ. 1 medium 6.2 m long transverse crack. 1 light 5.0 m long crack. Isolated severe abrasion noted at 1 location.

Description of Photo: Approach wearing surface

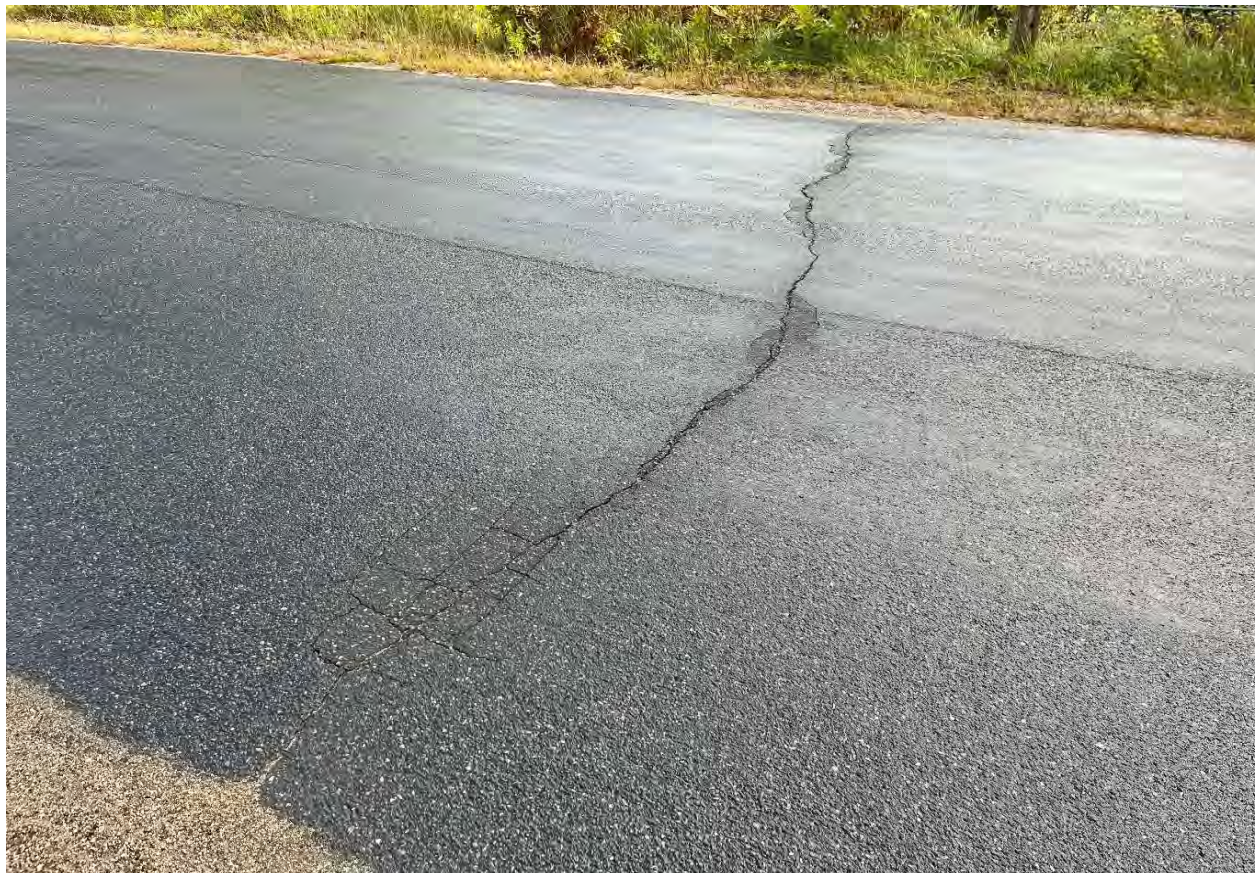
Description of Photo: Transverse crack

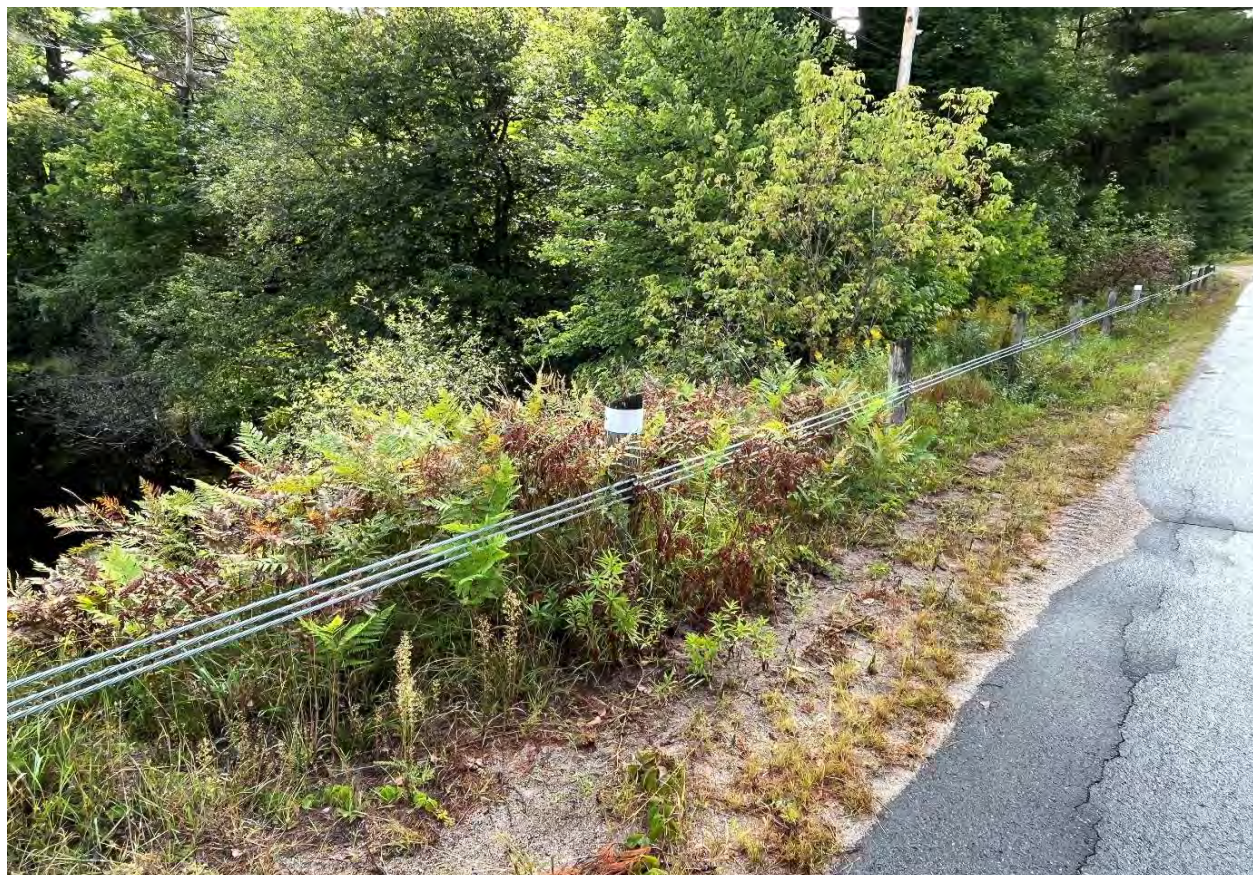
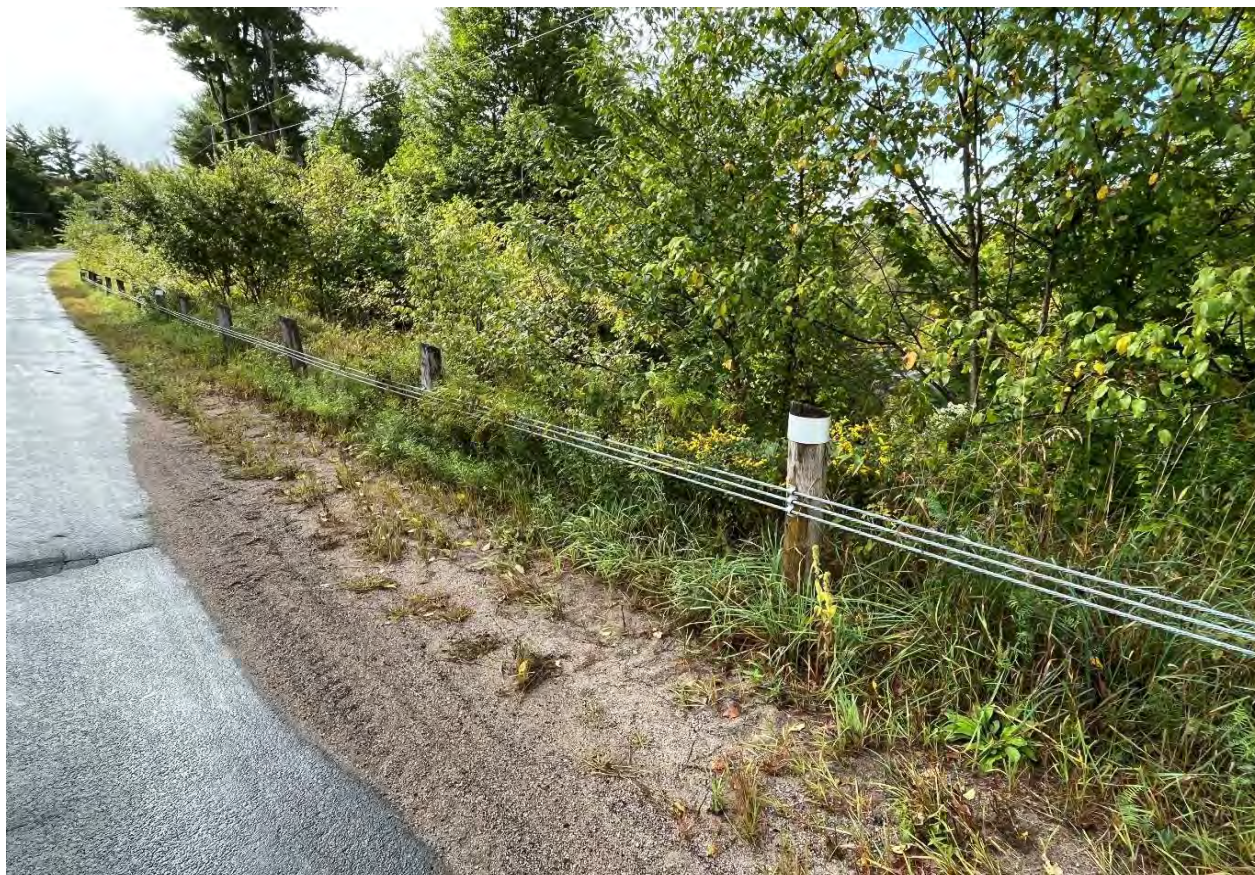
Comments: No damage to steel cables. Some area of cables sagging. 48 wood posts have light splitting. No other observed defects.

Description of Photo: Approach guide rail, typ.

Recommended Work:	Rehab: <input type="checkbox"/>	Replace: <input type="checkbox"/>	Maintenance Needs:	18 - Other Maintenance
Urgent: <input type="checkbox"/>	1-5 Years: <input type="checkbox"/>	6-10 Years: <input type="checkbox"/>	None: <input checked="" type="checkbox"/>	Urgent: <input type="checkbox"/> 1 Year: <input type="checkbox"/> 2 Year: <input checked="" type="checkbox"/>
			Install hazard warning sign.

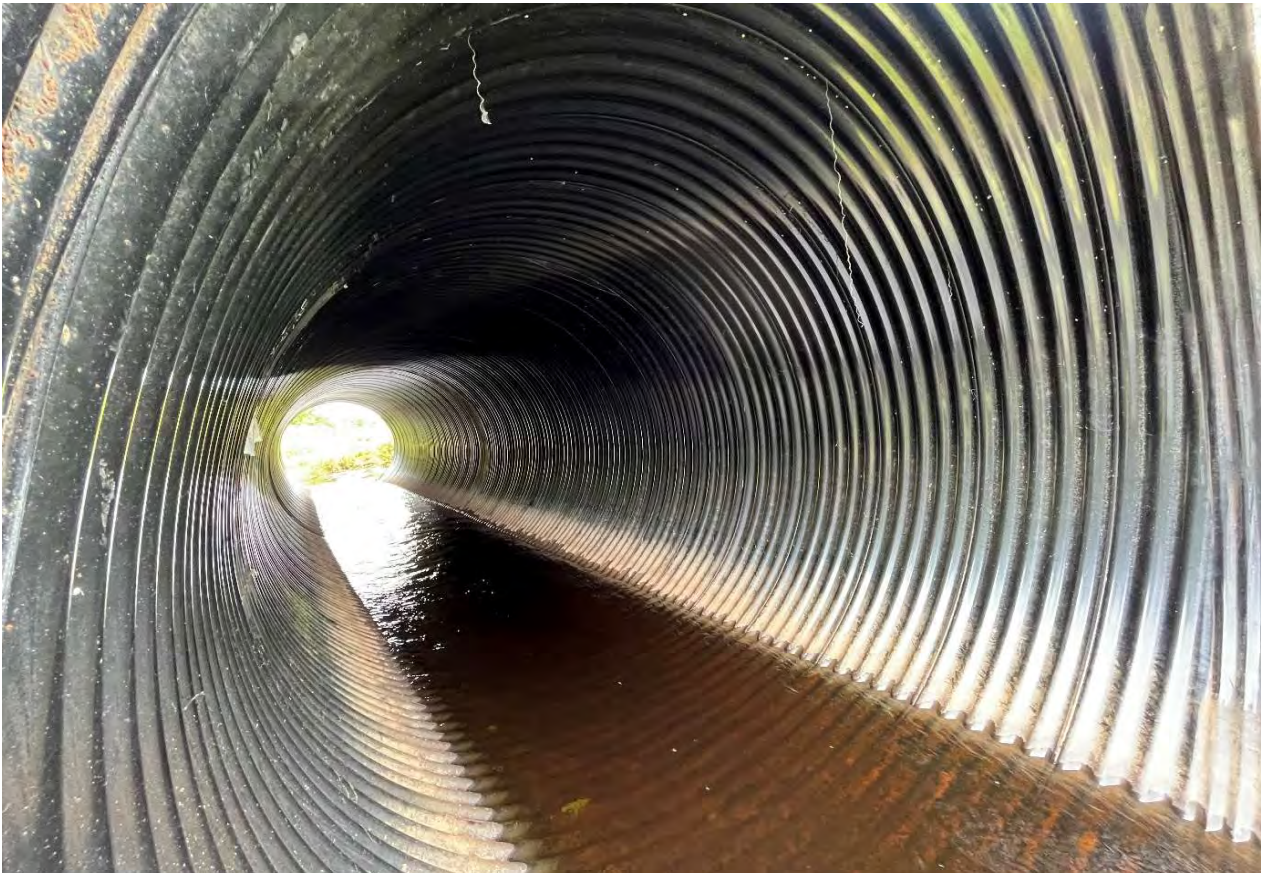
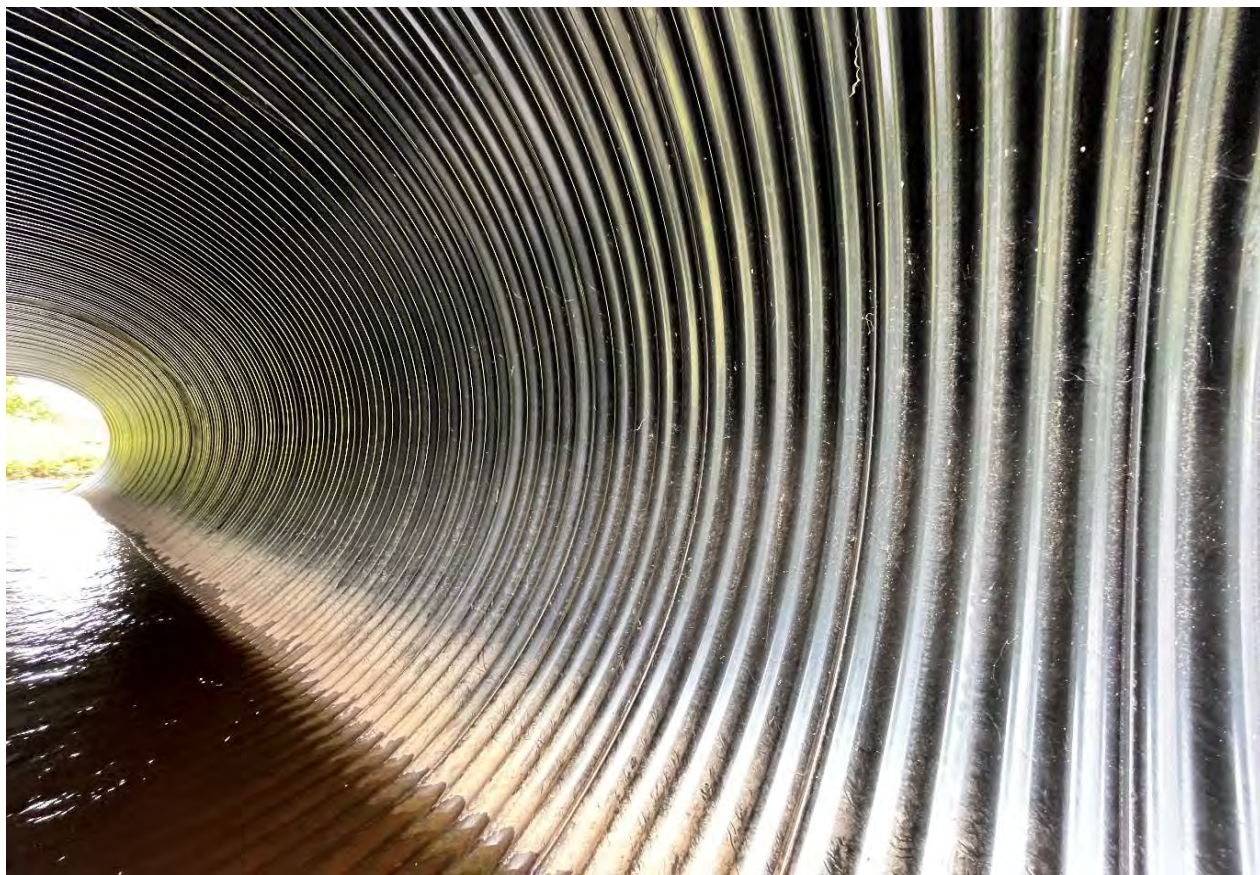
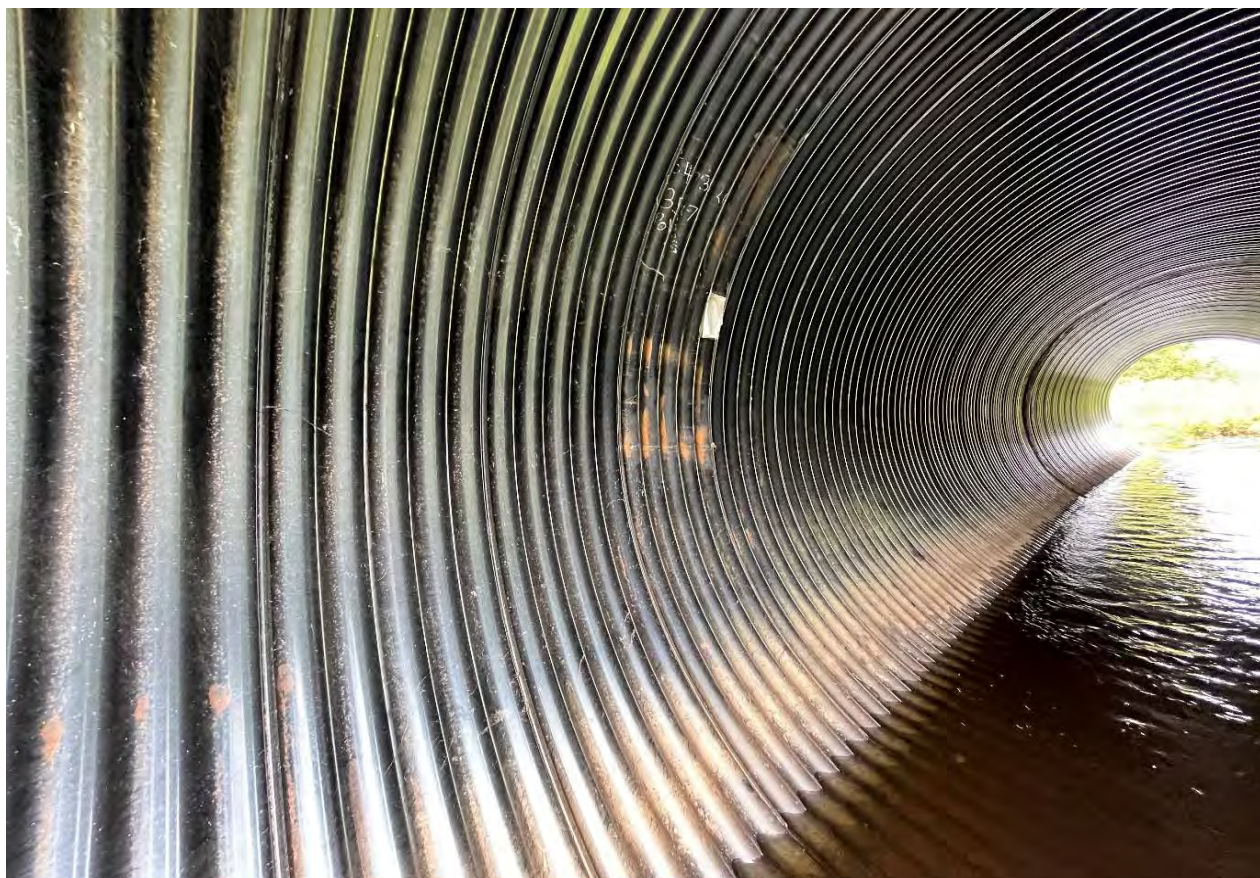
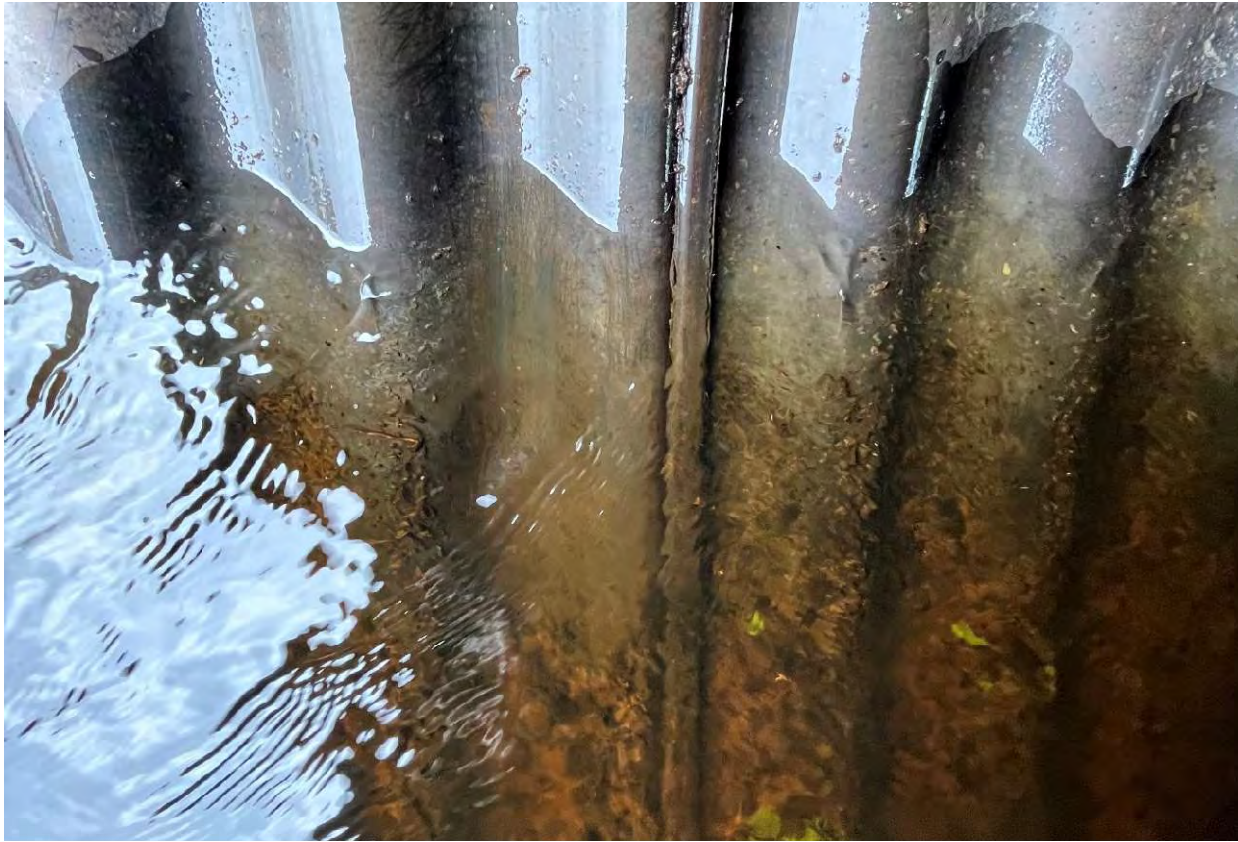
Comments: **No observed defects.**

Description of Photo: Culvert barrel outlet

Description of Photo: Culvert barrel - east face

Description of Photo: Culvert barrel - west face

Description of Photo: Culvert barrel, typ.
