Bridge Needs Study

INSPECTION SUMMARY REPORT

Town of Gravenhurst

August
29, 2024

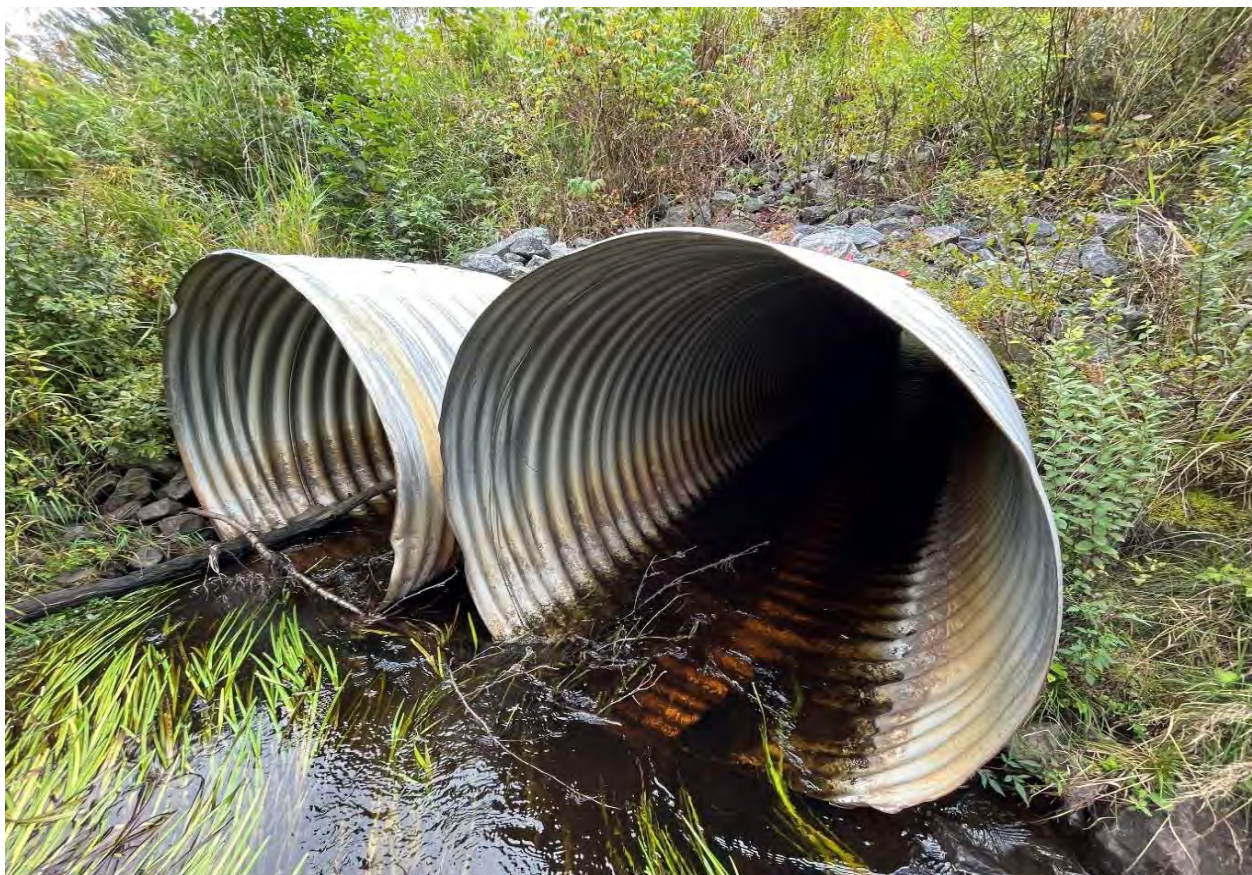
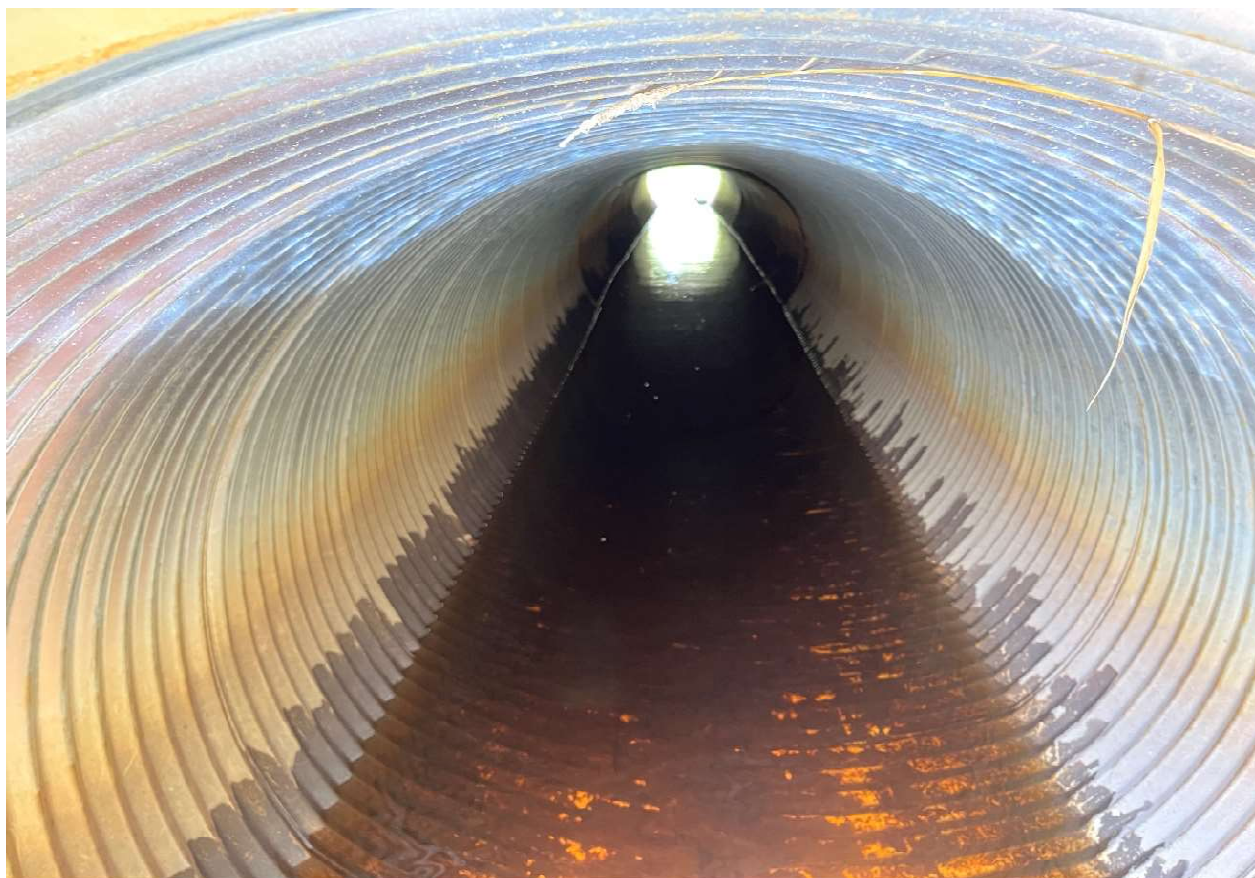
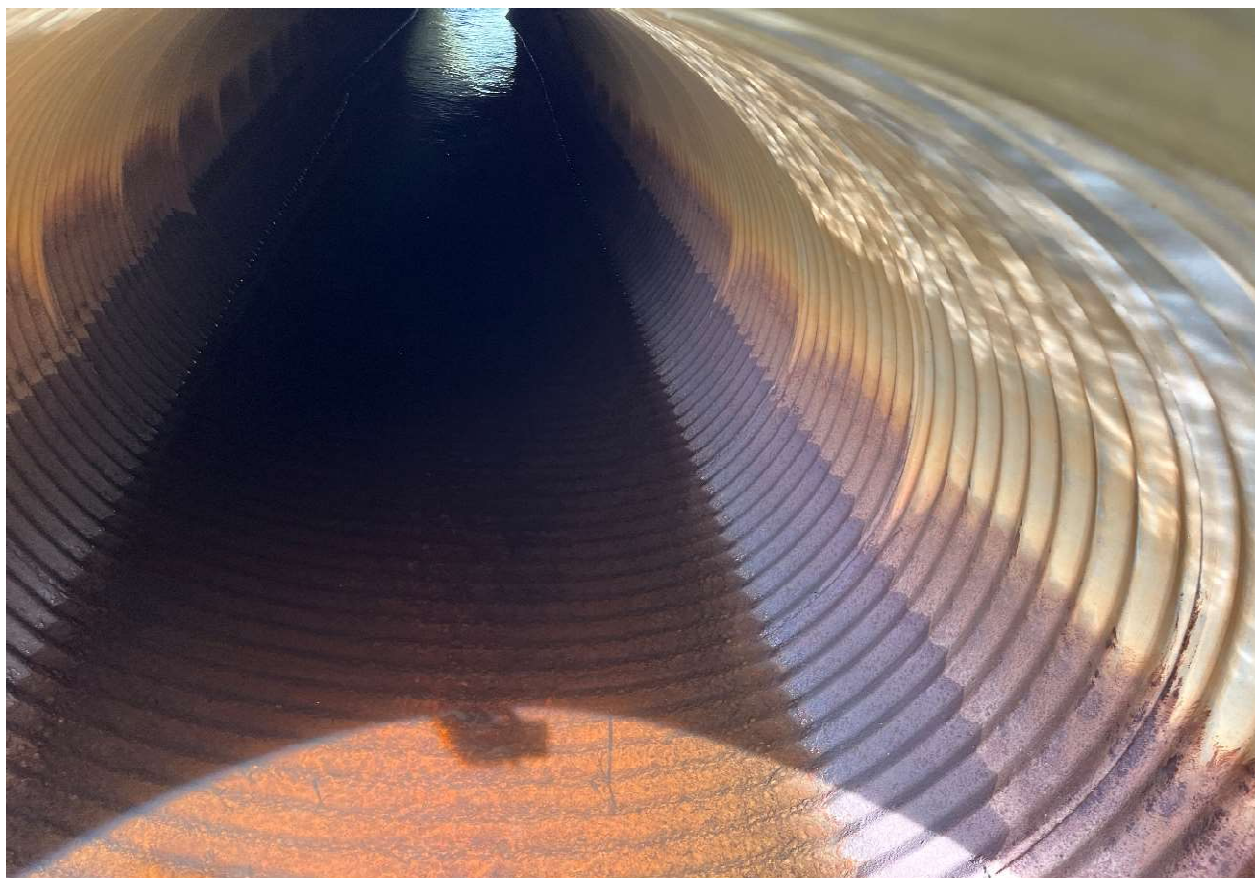
Description of Photo: Culvert barrel inlet

Description of Photo: Culvert barrel, typ.

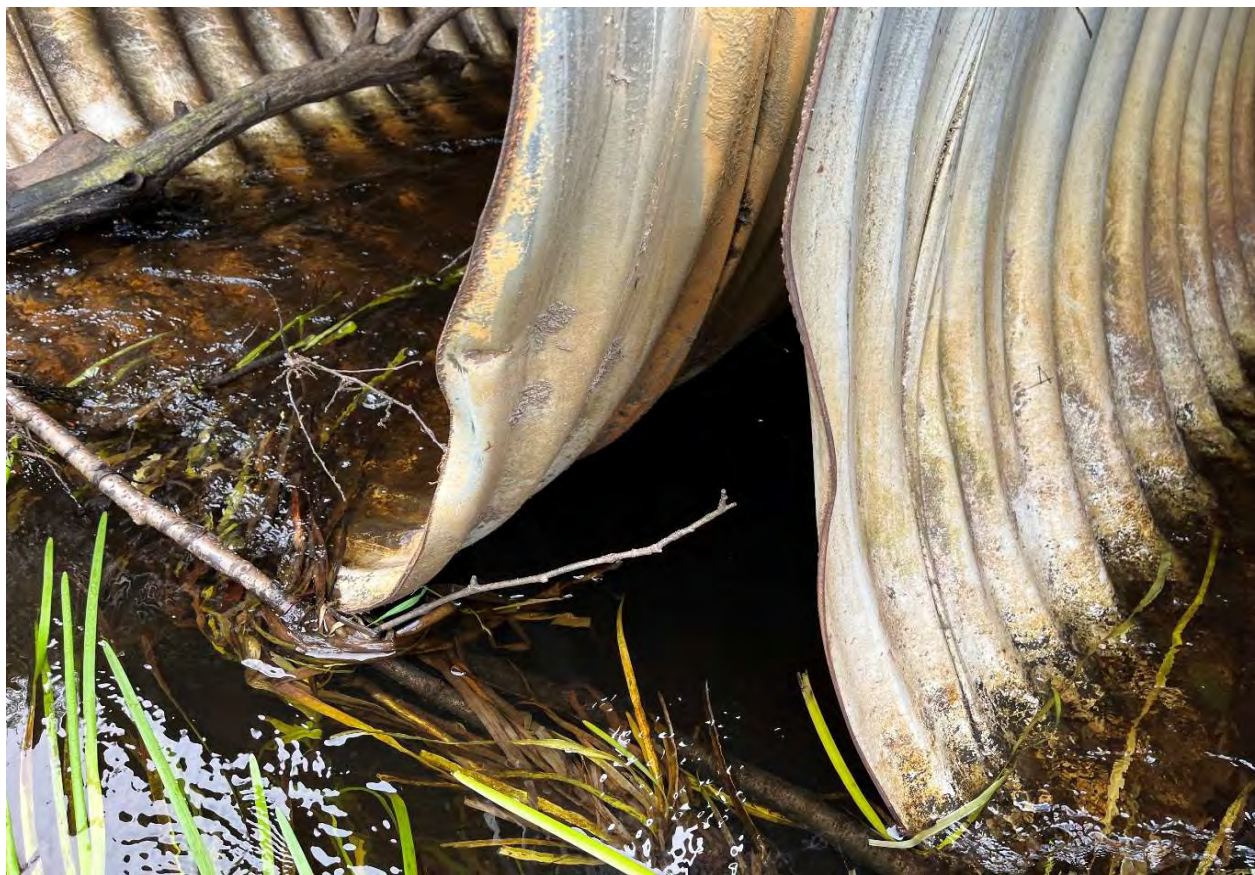
Description of Photo: Deformation at north inlet

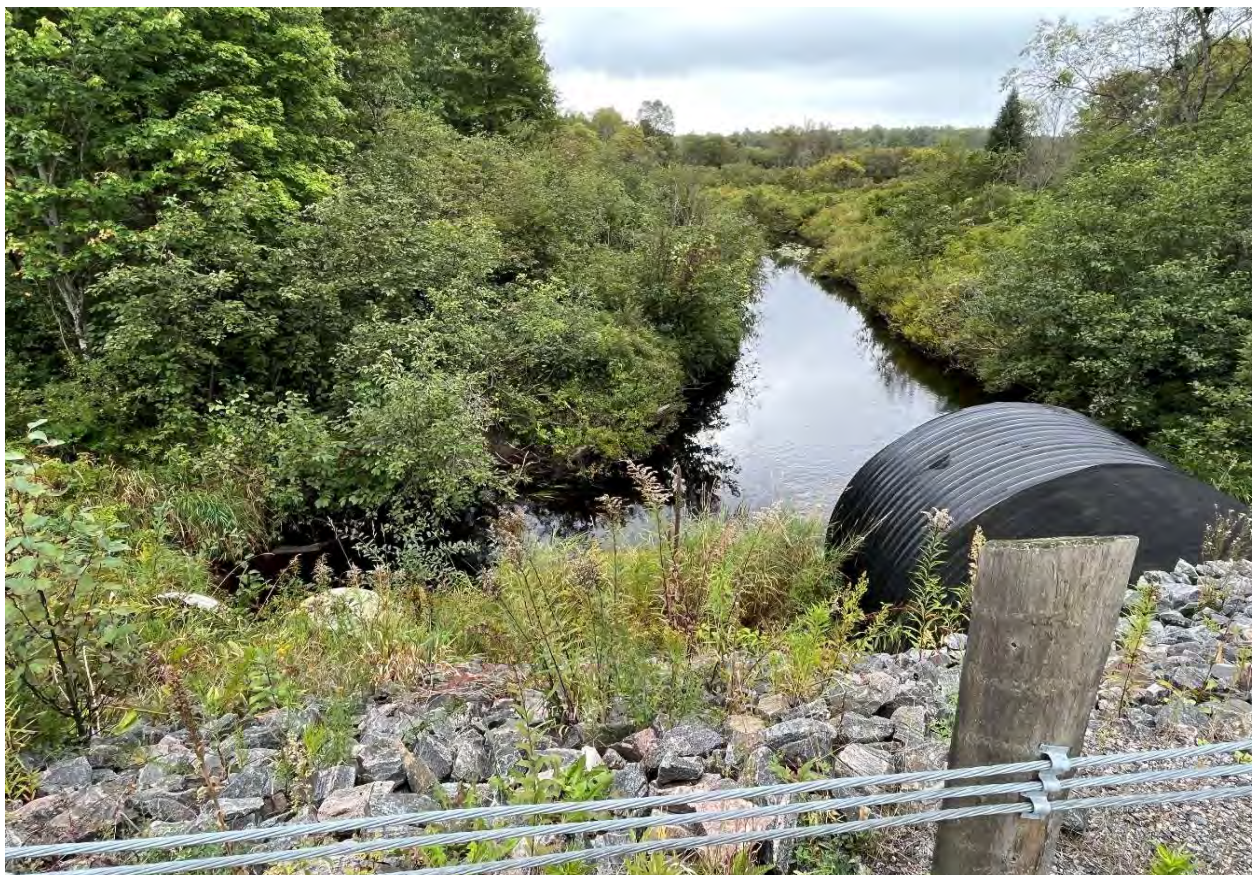
Description of Photo: Downstream

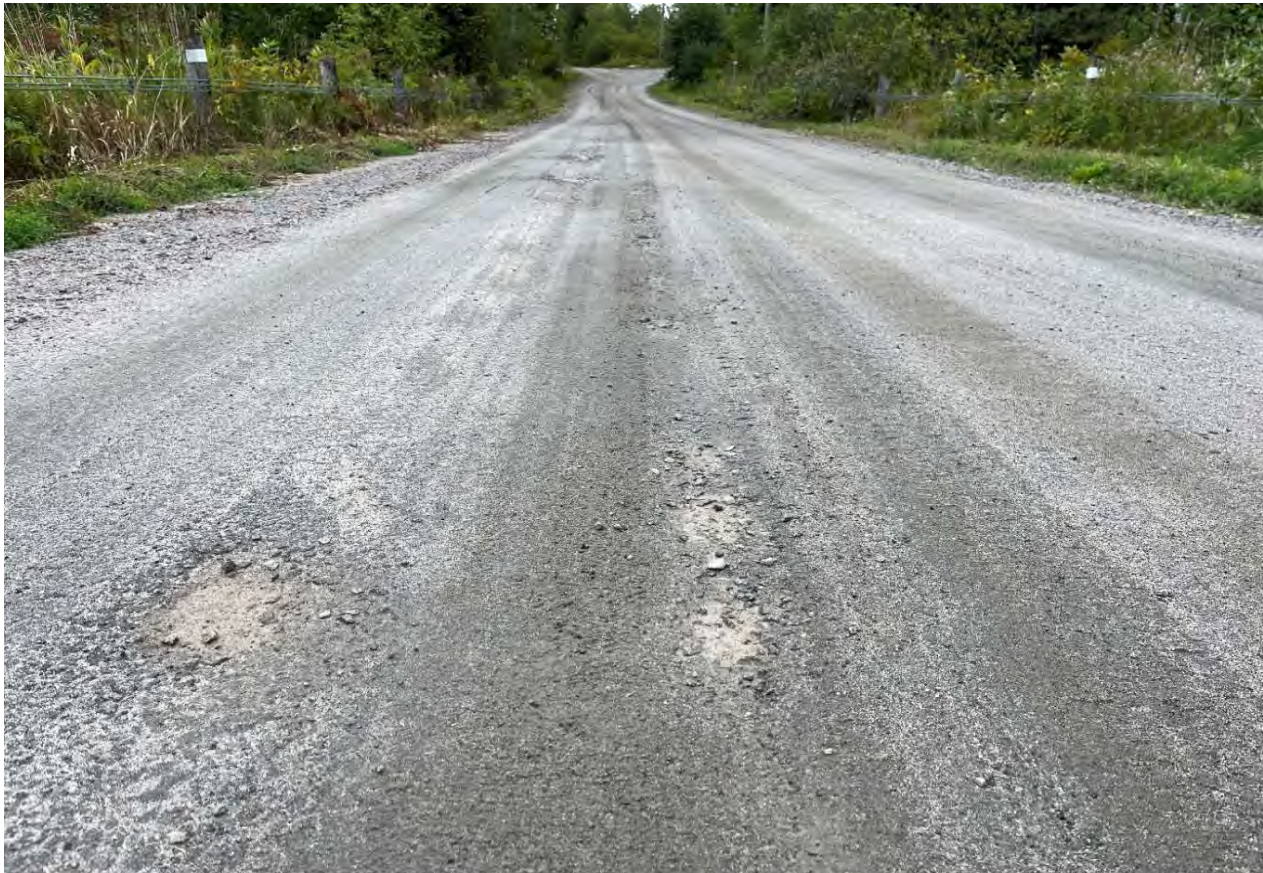
Description of Photo: Approach wearing surface - looking east

Recommended Work:	Rehab: <input type="checkbox"/>	Replace: <input type="checkbox"/>	Maintenance Needs:	12 - Bridge Surface Repair
Urgent: <input type="checkbox"/>	1-5 Years: <input type="checkbox"/>	6-10 Years: <input type="checkbox"/>	None: <input checked="" type="checkbox"/>	Urgent: <input type="checkbox"/> 1 Year: <input checked="" type="checkbox"/> 2 Year: <input type="checkbox"/>
				Regrade gravel

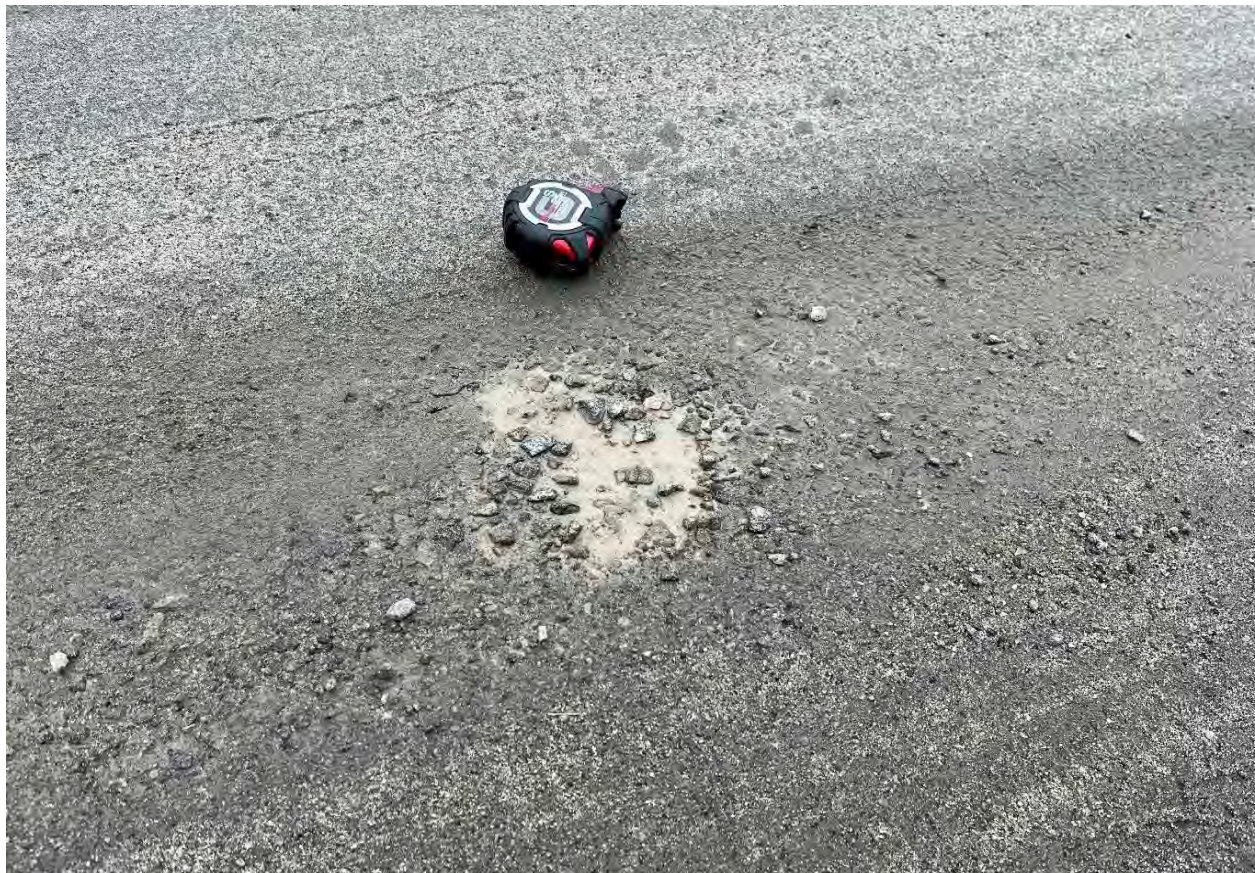
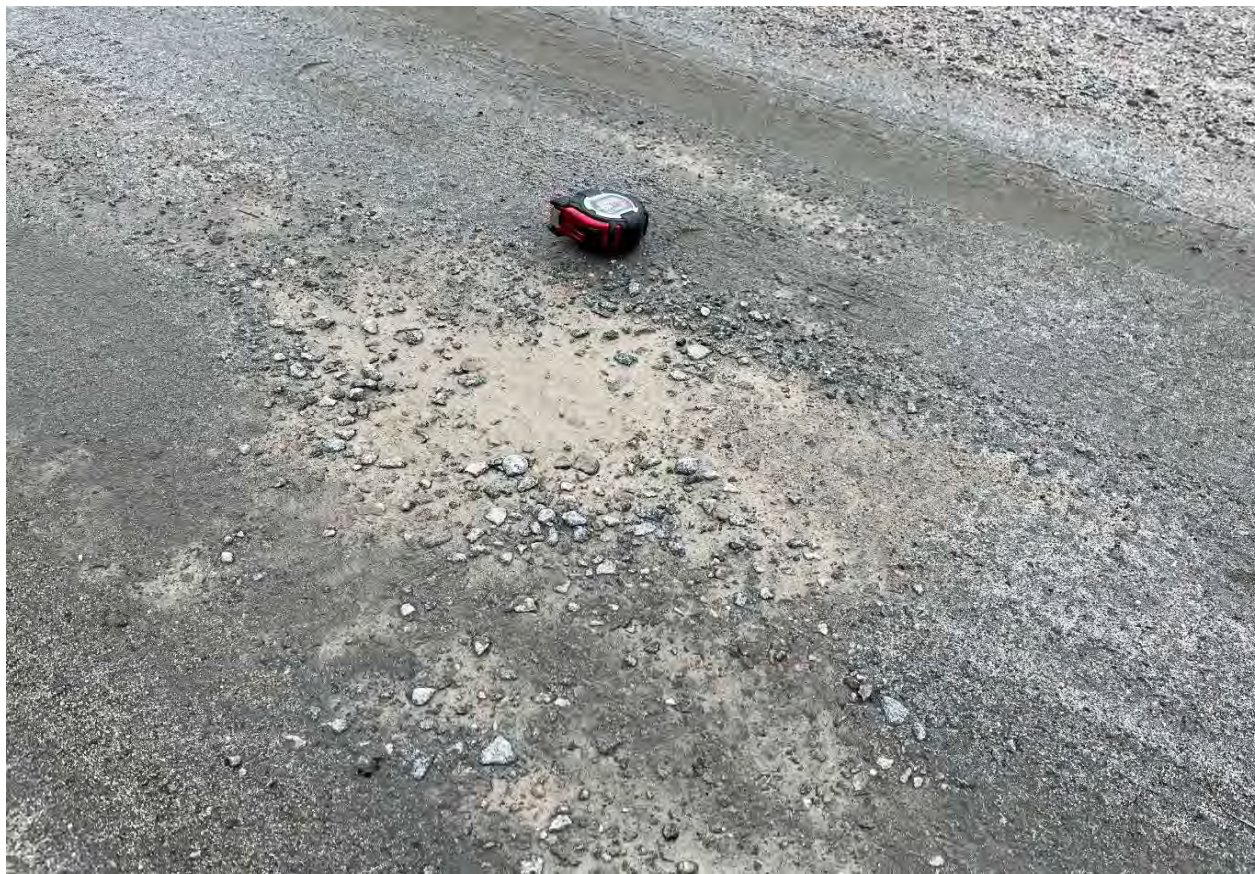
Element Data:							
Element Group:	Approaches			Length:	22.0		
Element Name:	Wearing Surface			Width:	6.7		
Location:				Height:			
Material:	Gravel			Count:	1		
Element Type:				Total Quantity:	147.4		
Environment:	Moderate			Inspected	Yes <input checked="" type="checkbox"/>	No <input type="checkbox"/>	limited <input type="checkbox"/>
Protection System:							Performance Deficiencies
Condition Data:	Units	Excellent	Good	Fair	Poor*		
	sq.m		143.4	3.0	1.0	9 - Rough riding surface

Description of Photo: Pothole, typ.

Justification:
The polymer coated CSP culvert is in excellent condition. The galvanized CSP culverts are in good condition. Maintenance: potholes should be repaired, loose cable on the approach guide rail should be tightened to improve road side safety with 1 year.

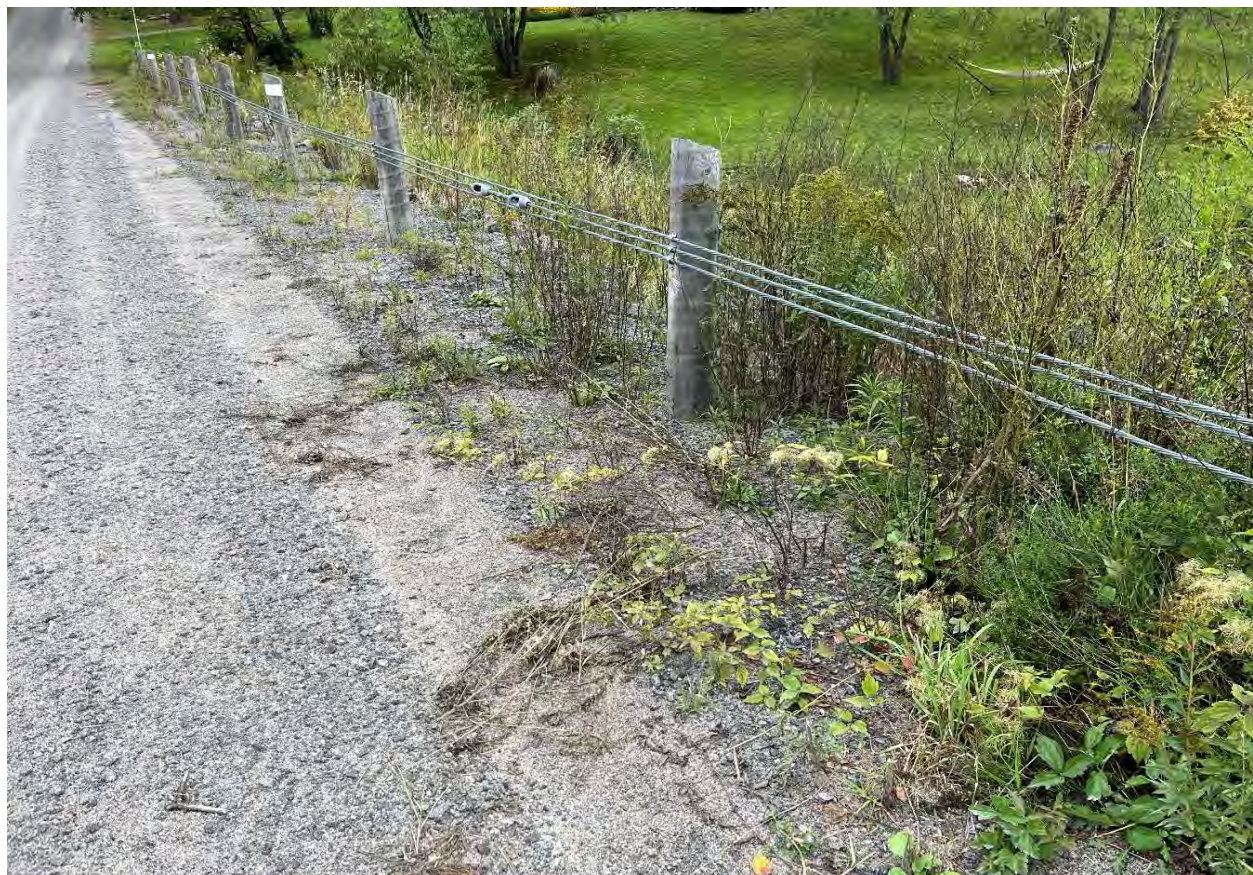
Comments: **Loose cables throughout. No other observed defects.**

Description of Photo: Approach guide rail

Recommended Work:	Rehab: <input type="checkbox"/>	Replace: <input type="checkbox"/>	Maintenance Needs:	3 - Railing System Repair	
Urgent: <input type="checkbox"/>	1-5 Years: <input type="checkbox"/>	6-10 Years: <input type="checkbox"/>	None: <input checked="" type="checkbox"/>	Urgent: <input type="checkbox"/>	1 Year: <input checked="" type="checkbox"/> 2 Year: <input type="checkbox"/>
				Tighten cables, clear vegetation from in front of barrier

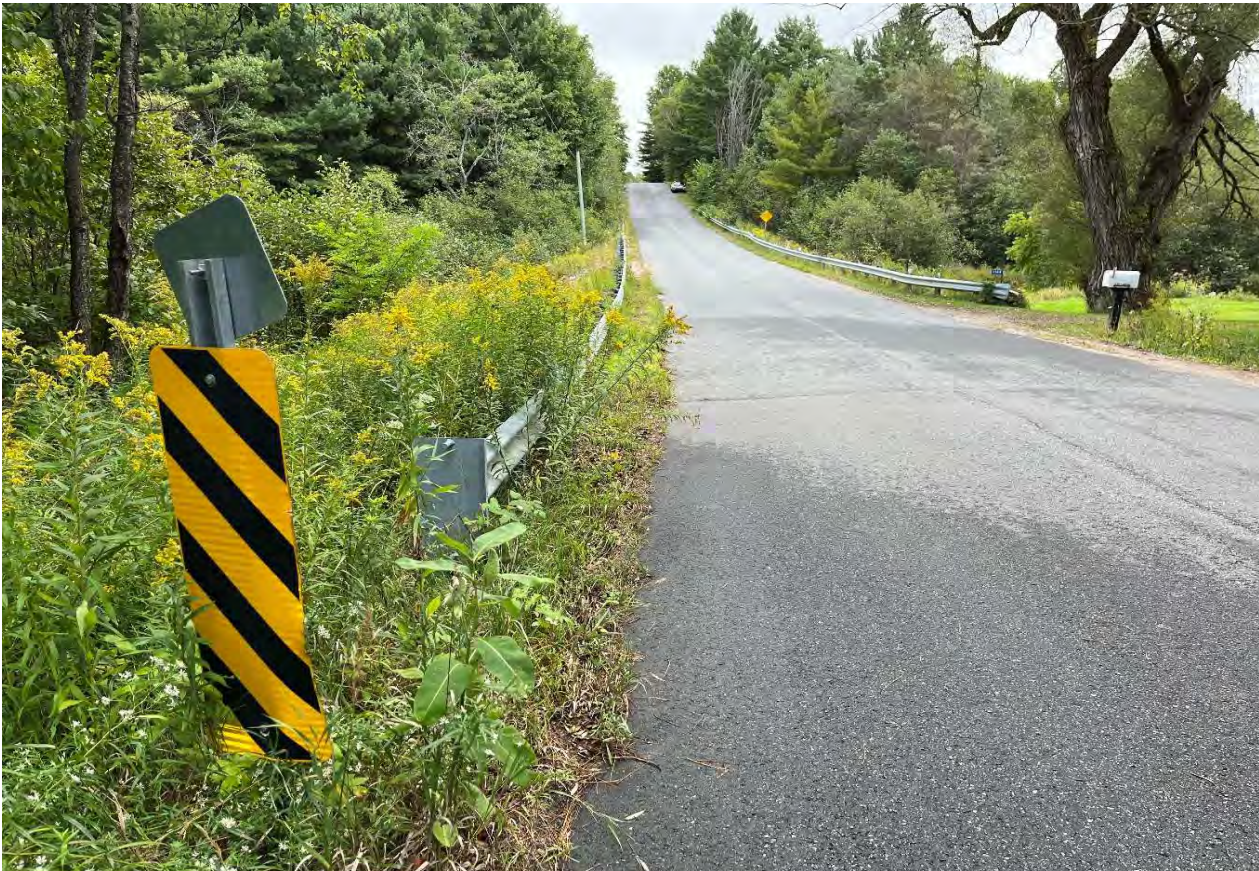
Comments: **Two hazard warning signs are missing. One hazard warning sign is deformed.**

Description of Photo: Hazard warning sign, typ.

Recommended Work:	Rehab: <input type="checkbox"/>	Replace: <input type="checkbox"/>	Maintenance Needs:	18 - Other Maintenance
Urgent: <input type="checkbox"/>	1-5 Years: <input type="checkbox"/>	6-10 Years: <input type="checkbox"/>	None: <input checked="" type="checkbox"/>	Urgent: <input type="checkbox"/> 1 Year: <input checked="" type="checkbox"/> 2 Year: <input type="checkbox"/>
			Install two hazard warning signs.

Justification:
The structure is generally in excellent condition. Maintenance includes repairing the damaged section of the guide rail, and installation of two hazard warning signs.

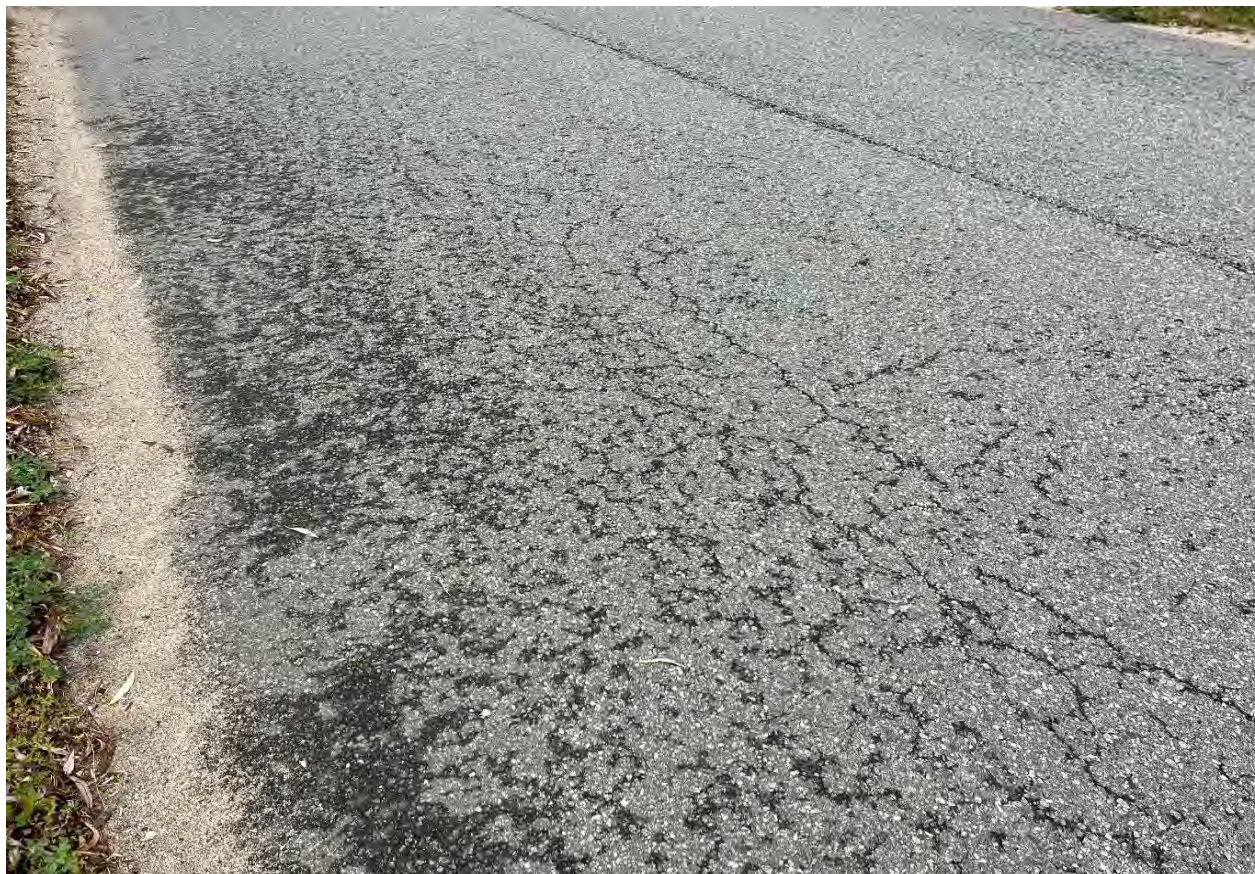
Comments: **No observed defects. Isolated light alligator cracking.**

Description of Photo: Alligator crack

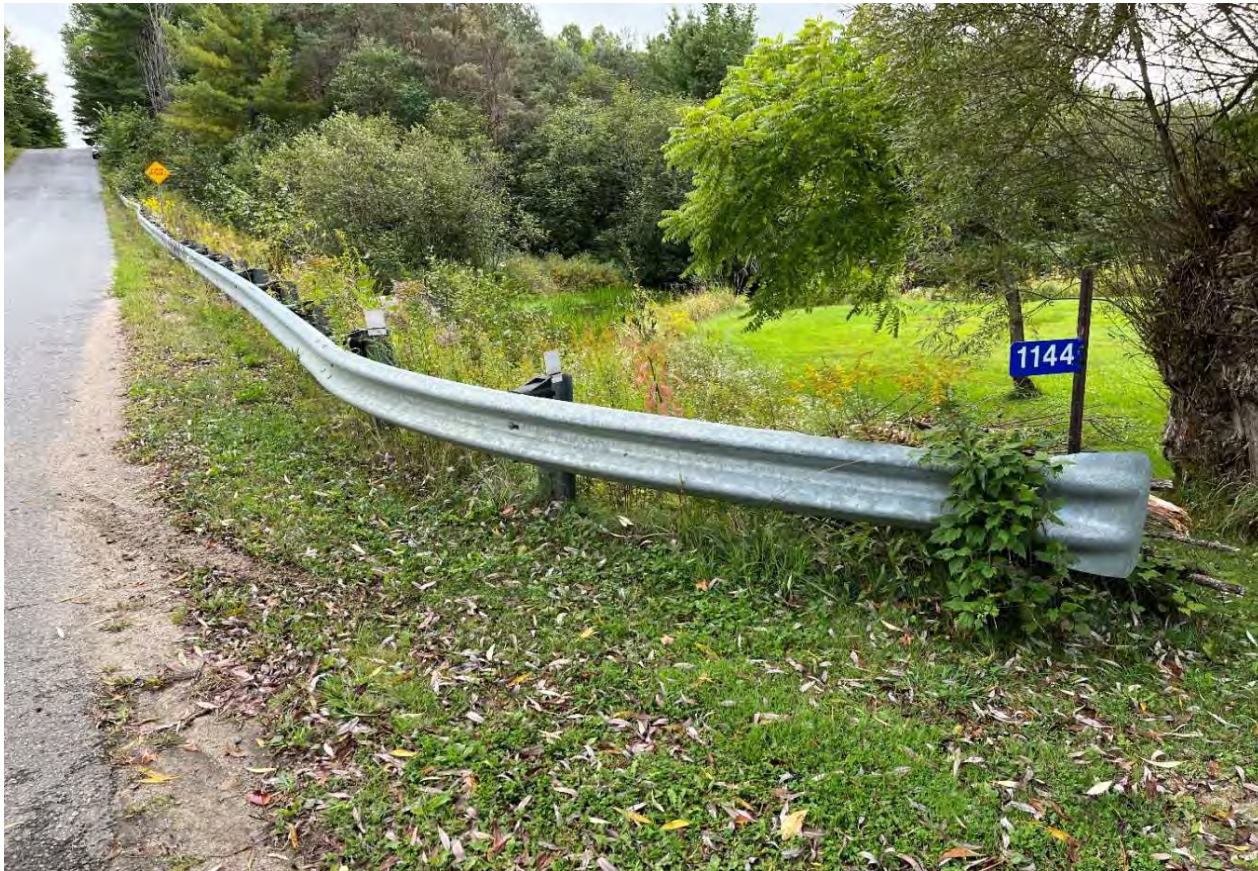
Description of Photo: Northwest quadrant approach guide rail

Replace section with damaged rail and tilted posts.

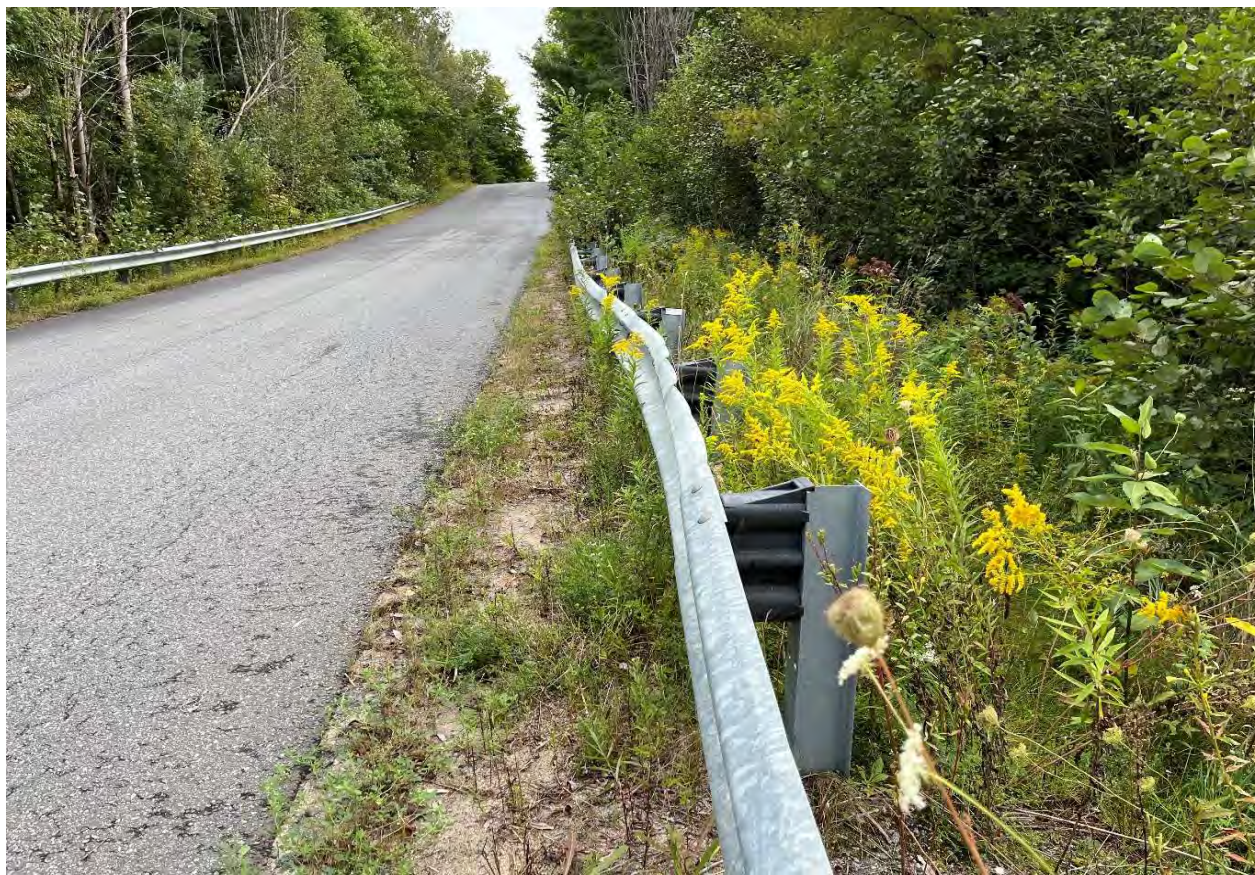
Description of Photo: Approach guide rail - impacted damage

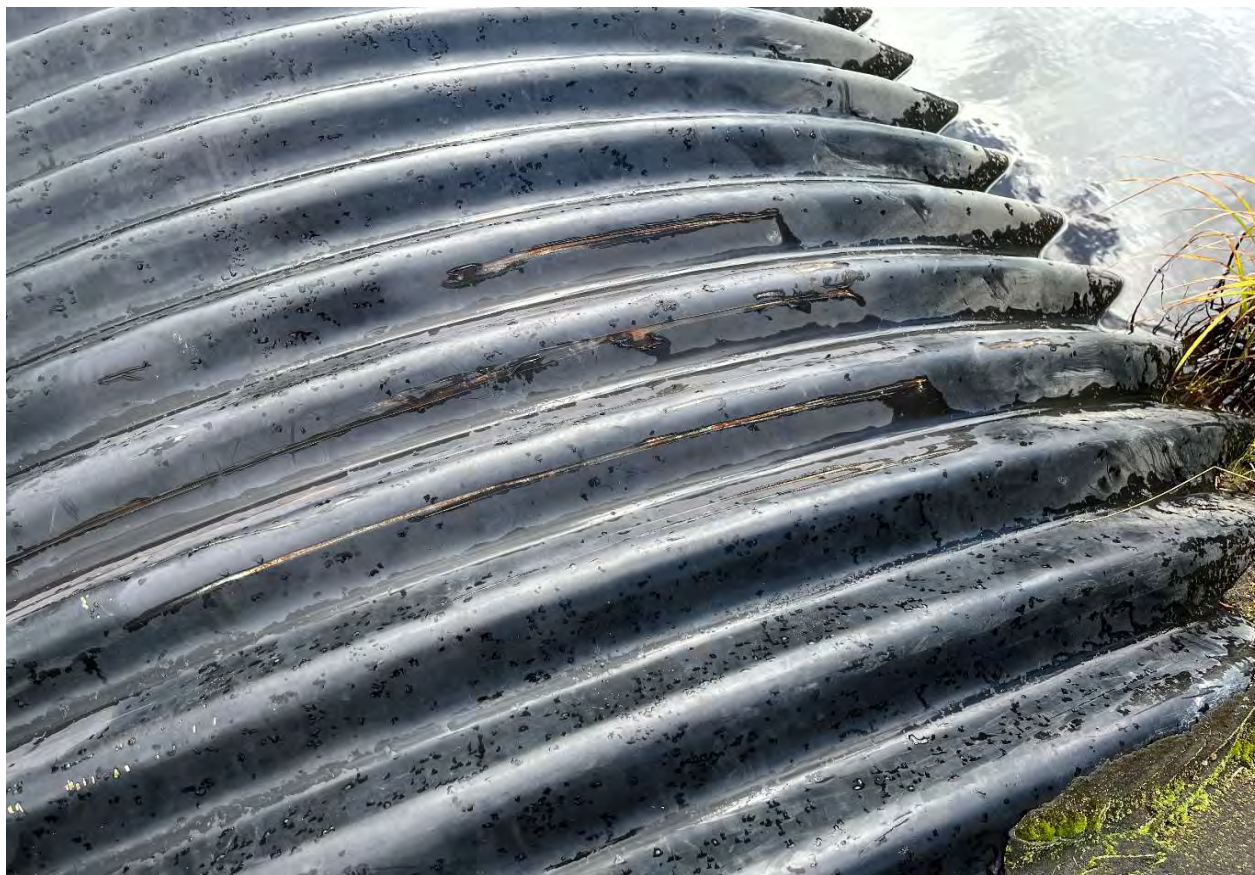
Description of Photo: Scratch on the coating

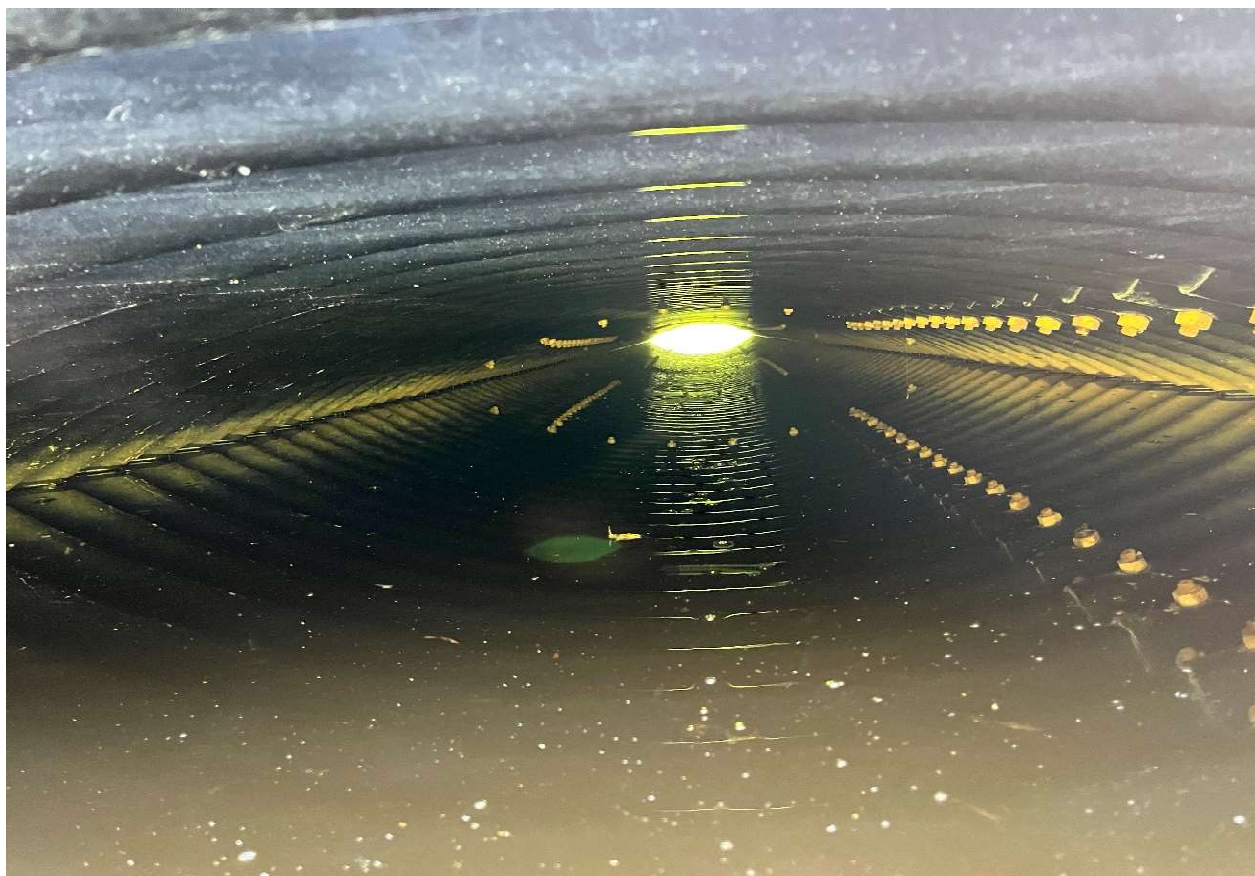
Description of Photo: Culvert barrel, typ.

Comments: **No observed defects.**

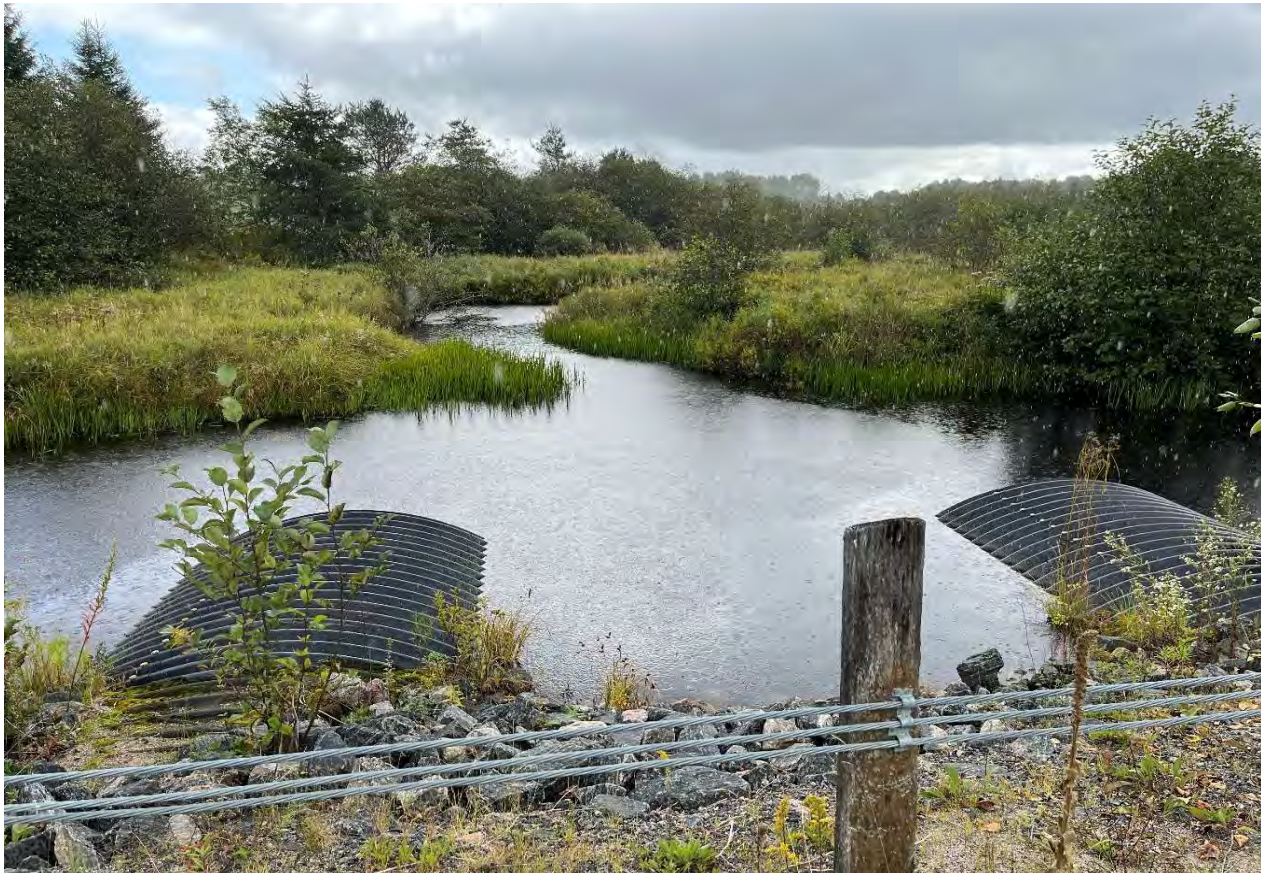
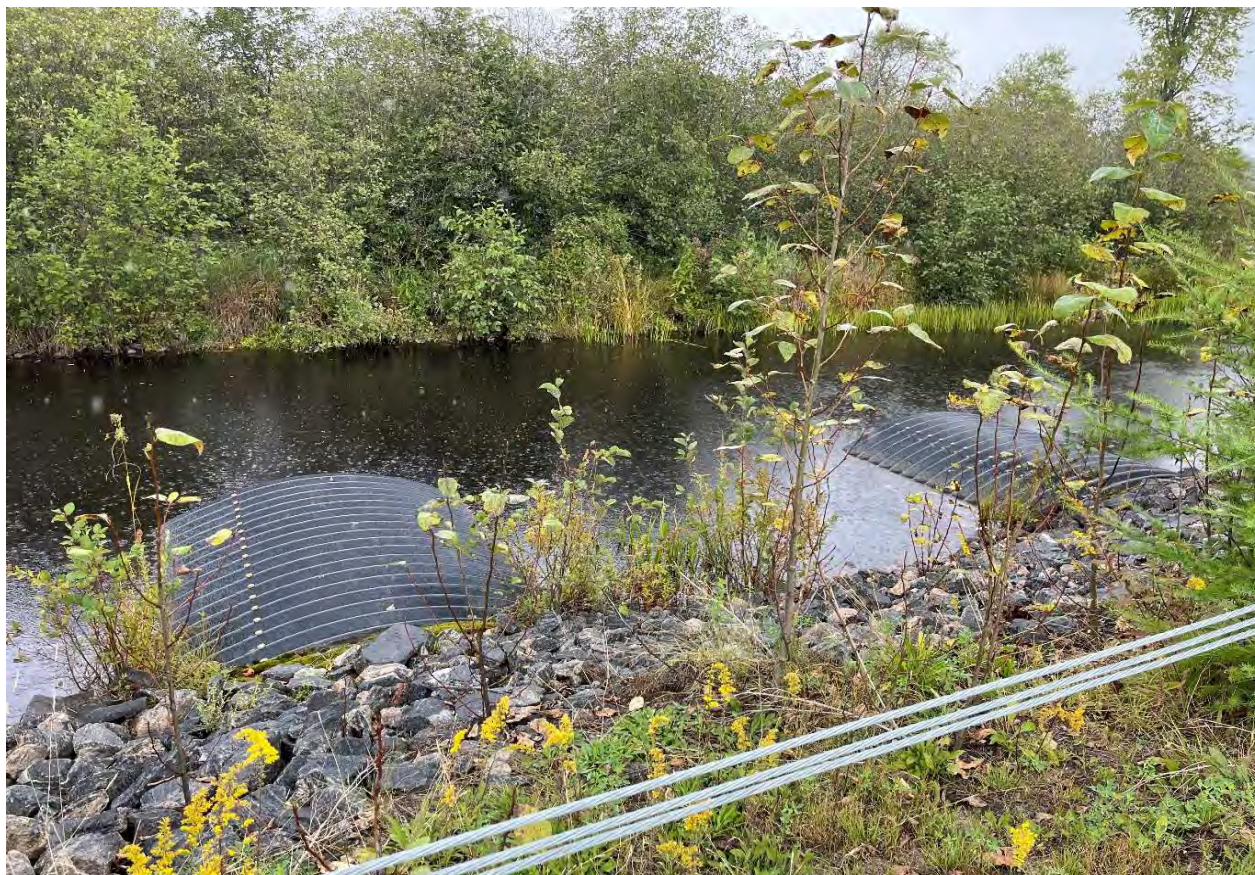
Description of Photo: Watercourse

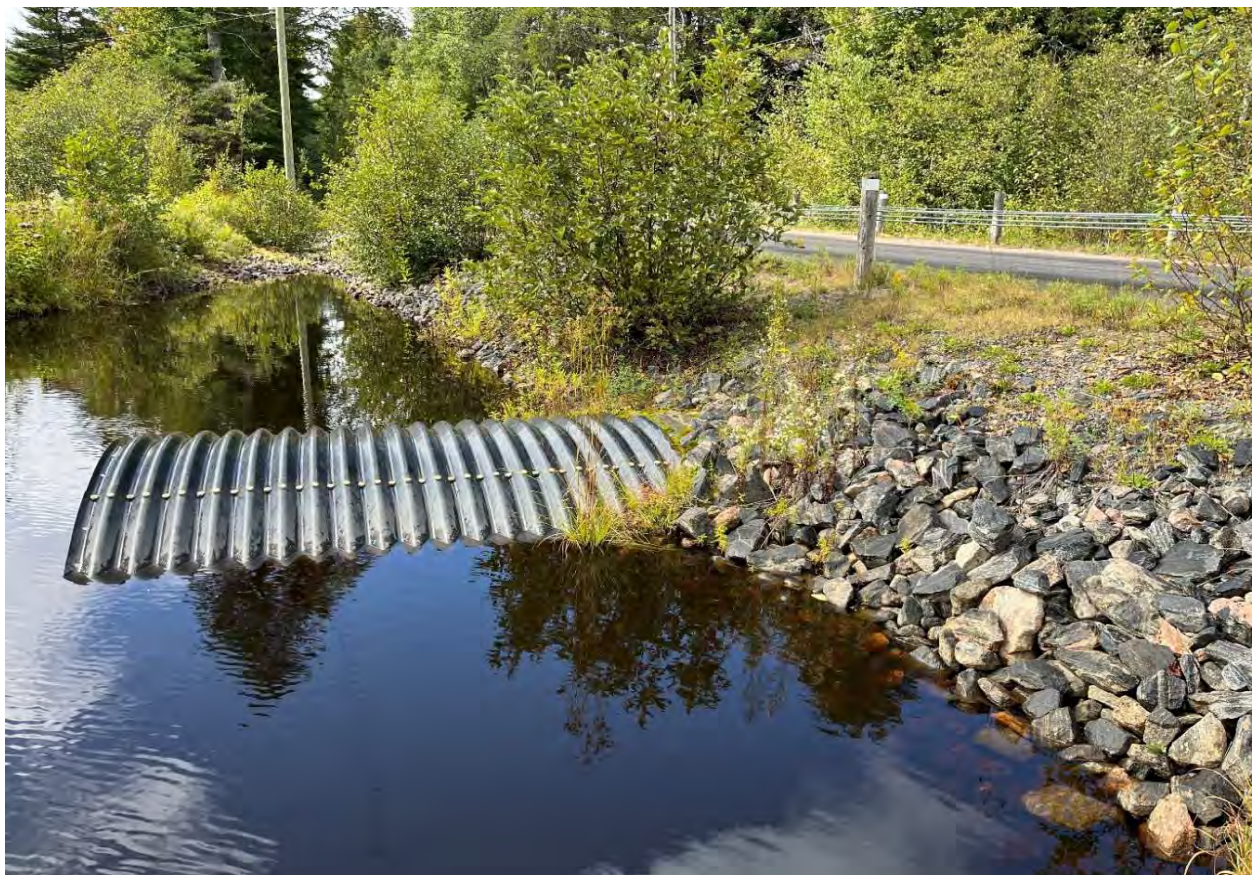
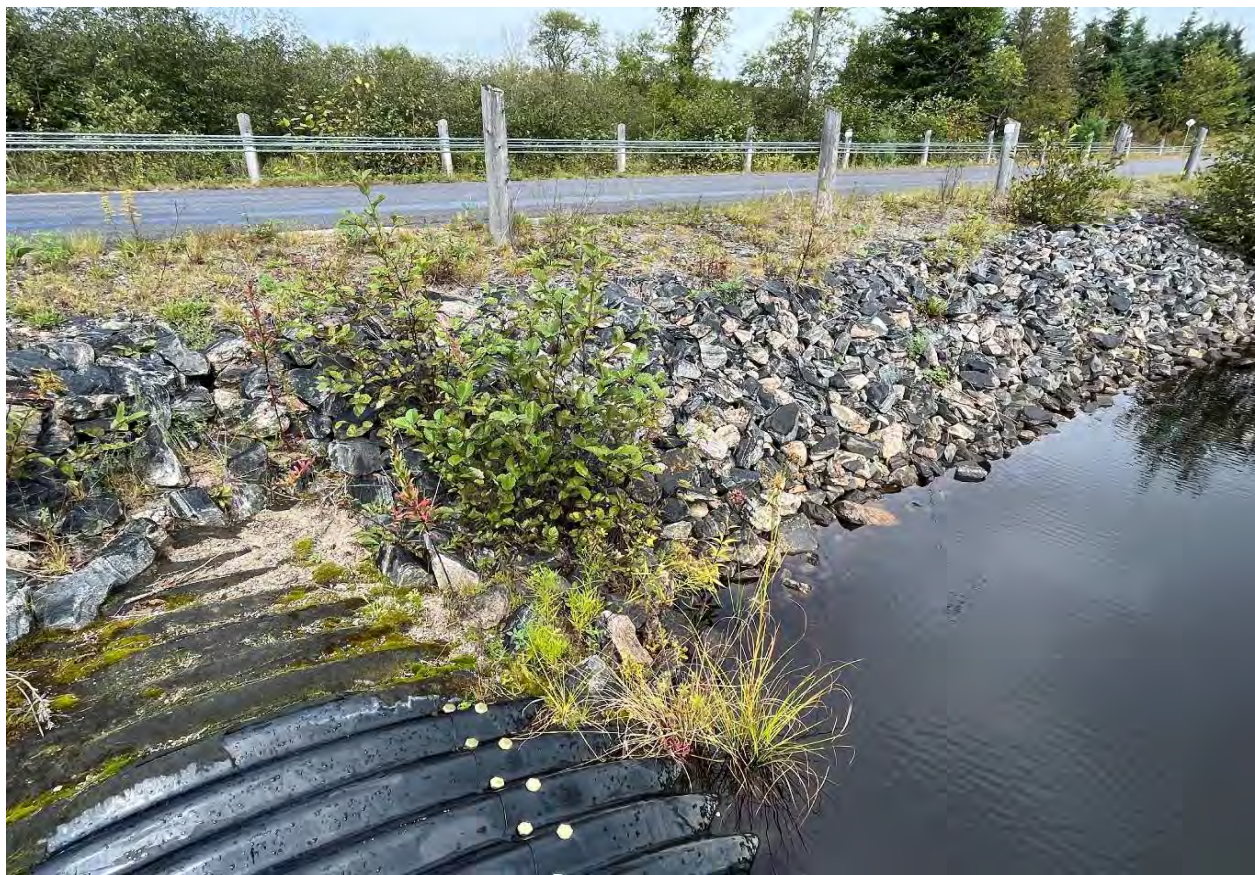
Comments: **No observed defects.**

Description of Photo: Embankment, typ.

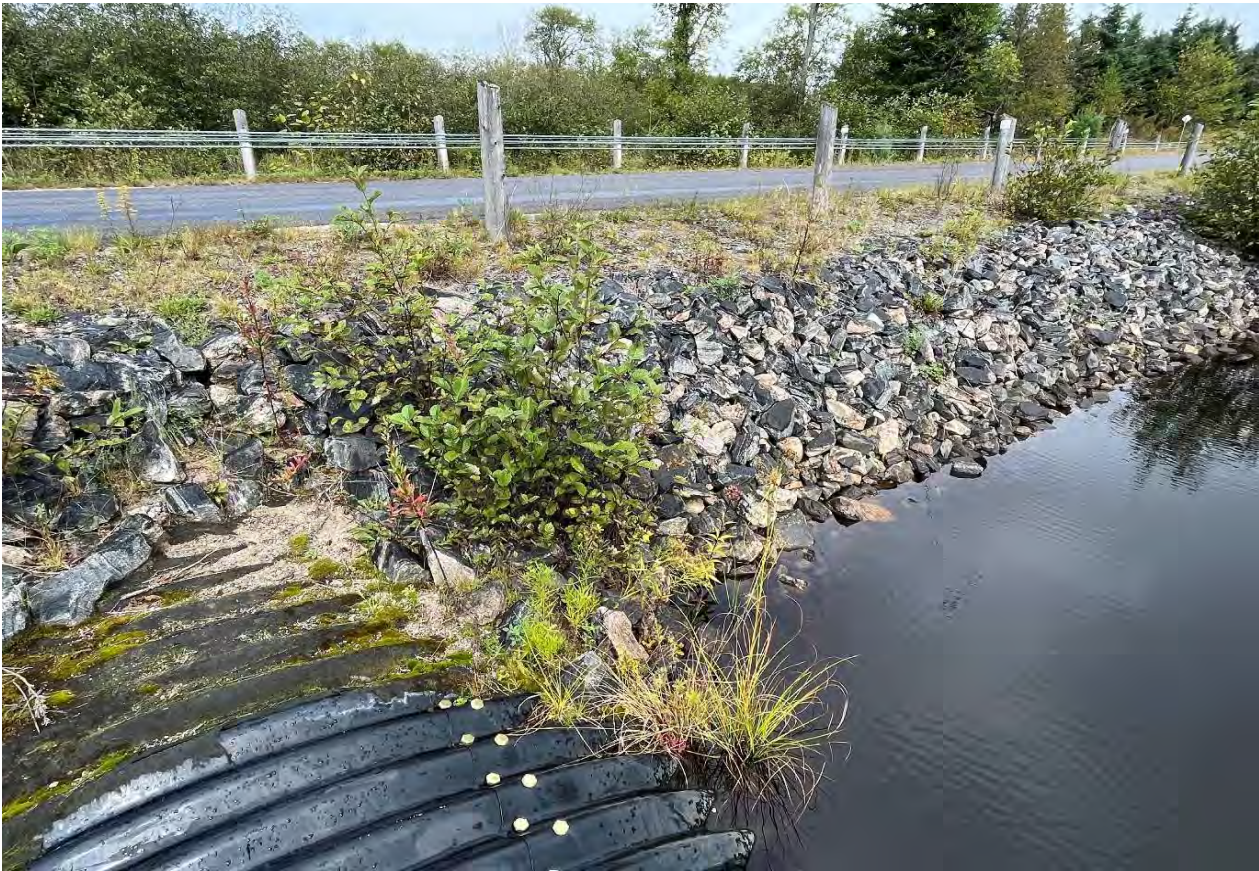
Description of Photo: Slope protection, typ.
