Bridge Needs Study

INSPECTION SUMMARY REPORT

Town of Gravenhurst

August
29, 2024

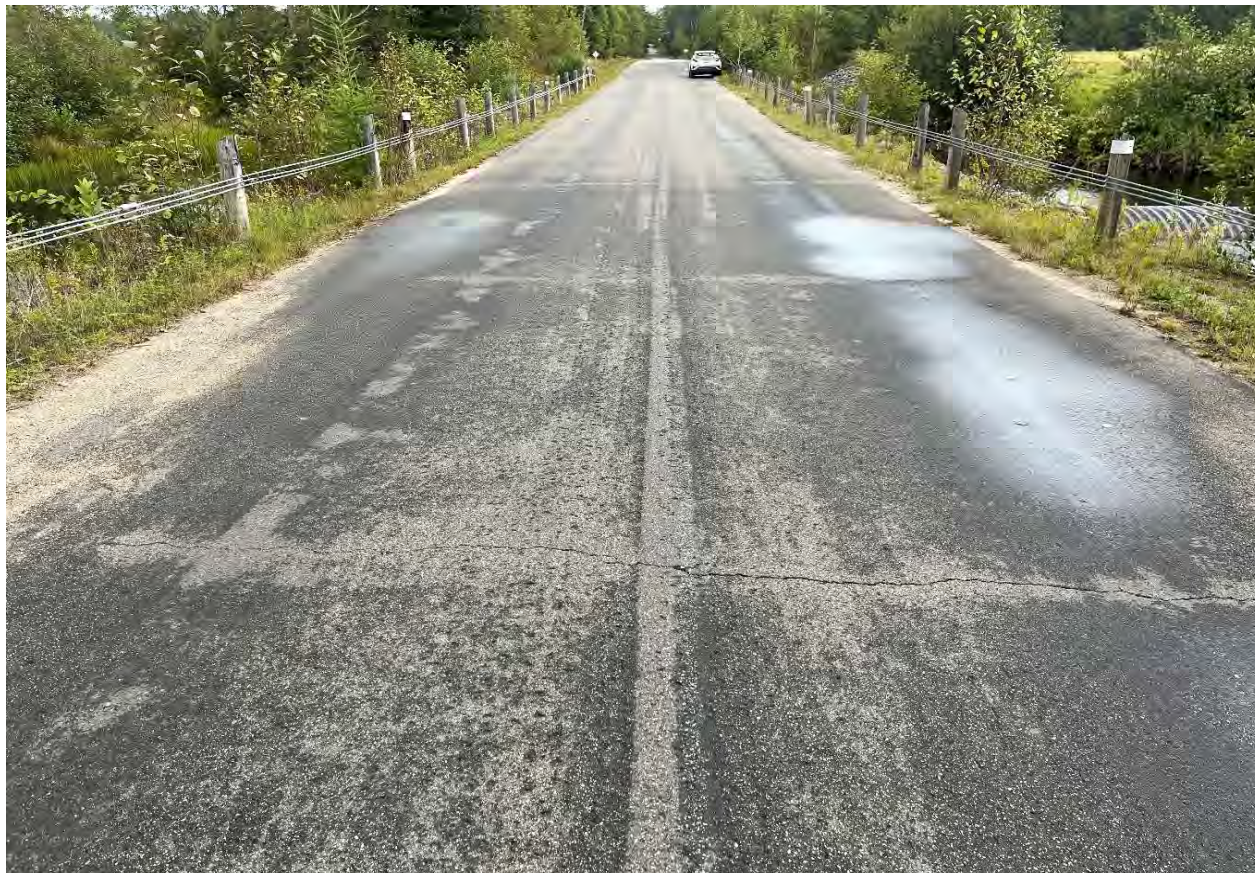
Comments: Light ravelling, typ. 5 - full width light to medium transverse cracks.

Description of Photo: Approach wearing surface - looking east

Description of Photo: Approach wearing surface - looking west

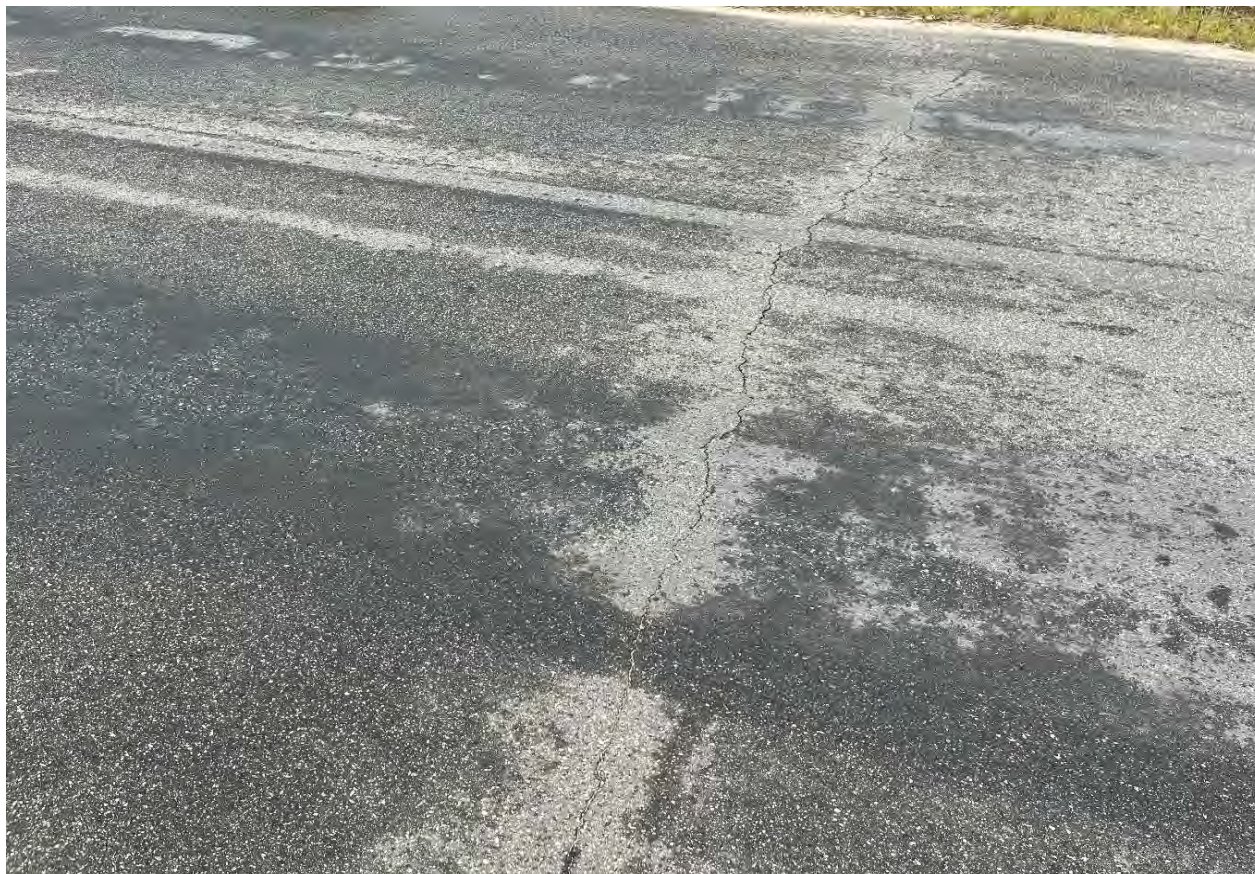
Description of Photo: Transverse crack

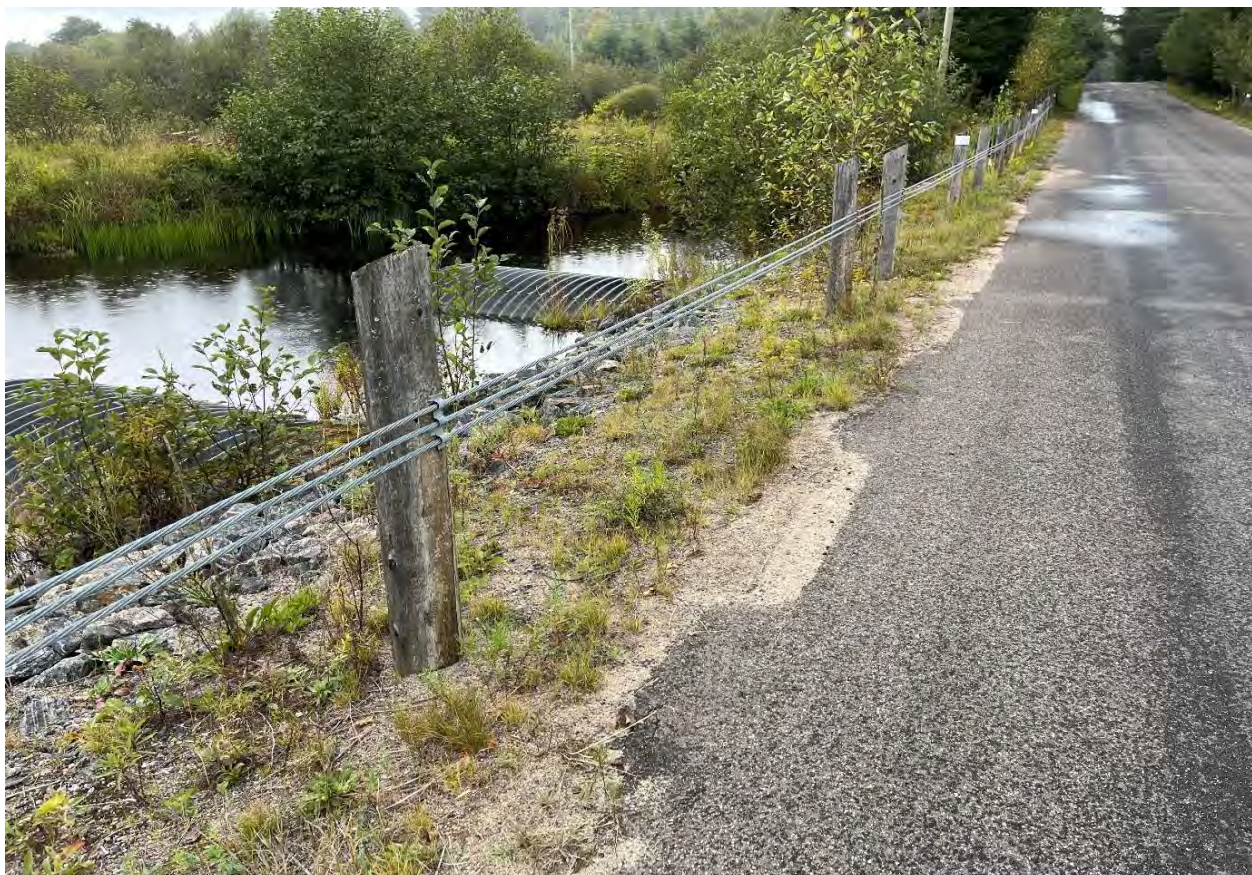
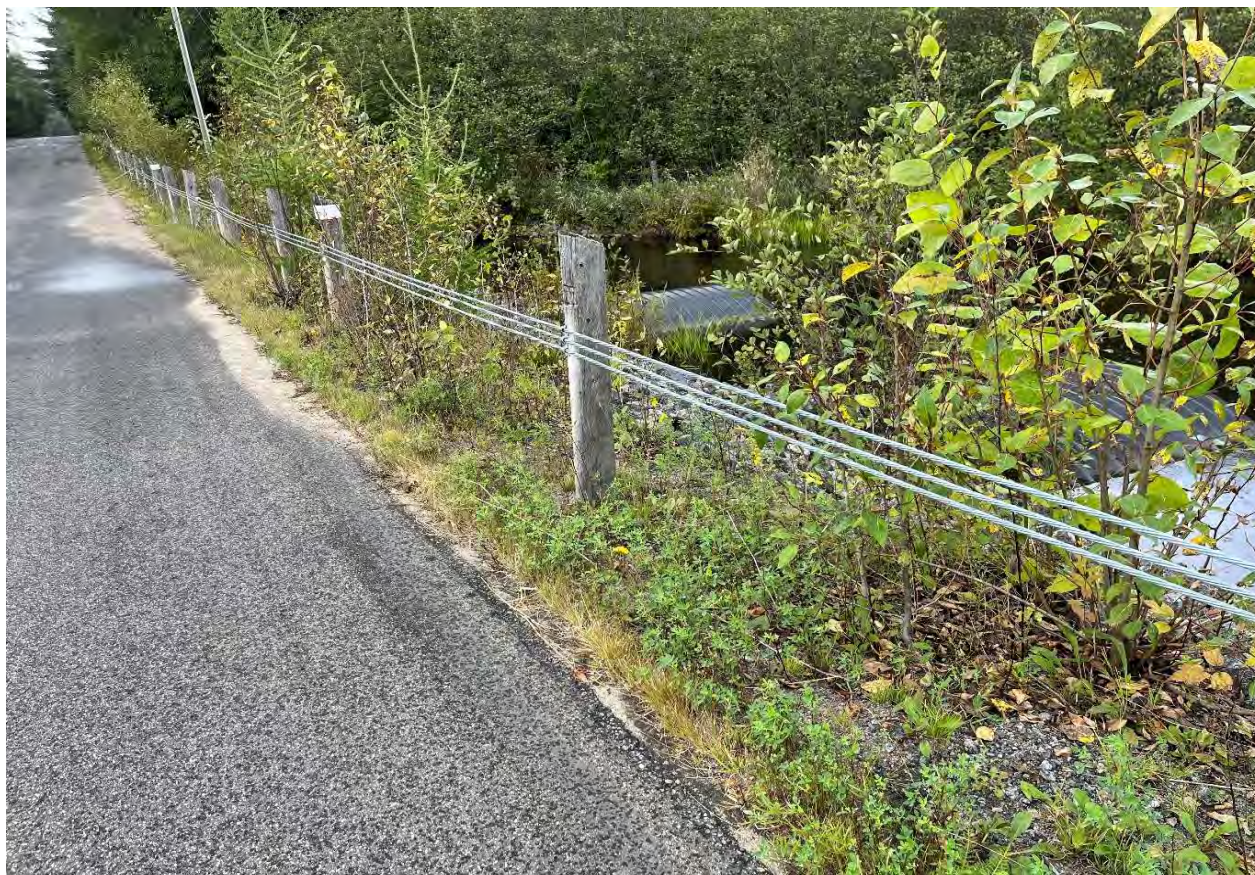
Comments: Light to medium splits in posts, typ. No other observed defects.

Description of Photo: South approach guide rail

Description of Photo: North approach guide rail

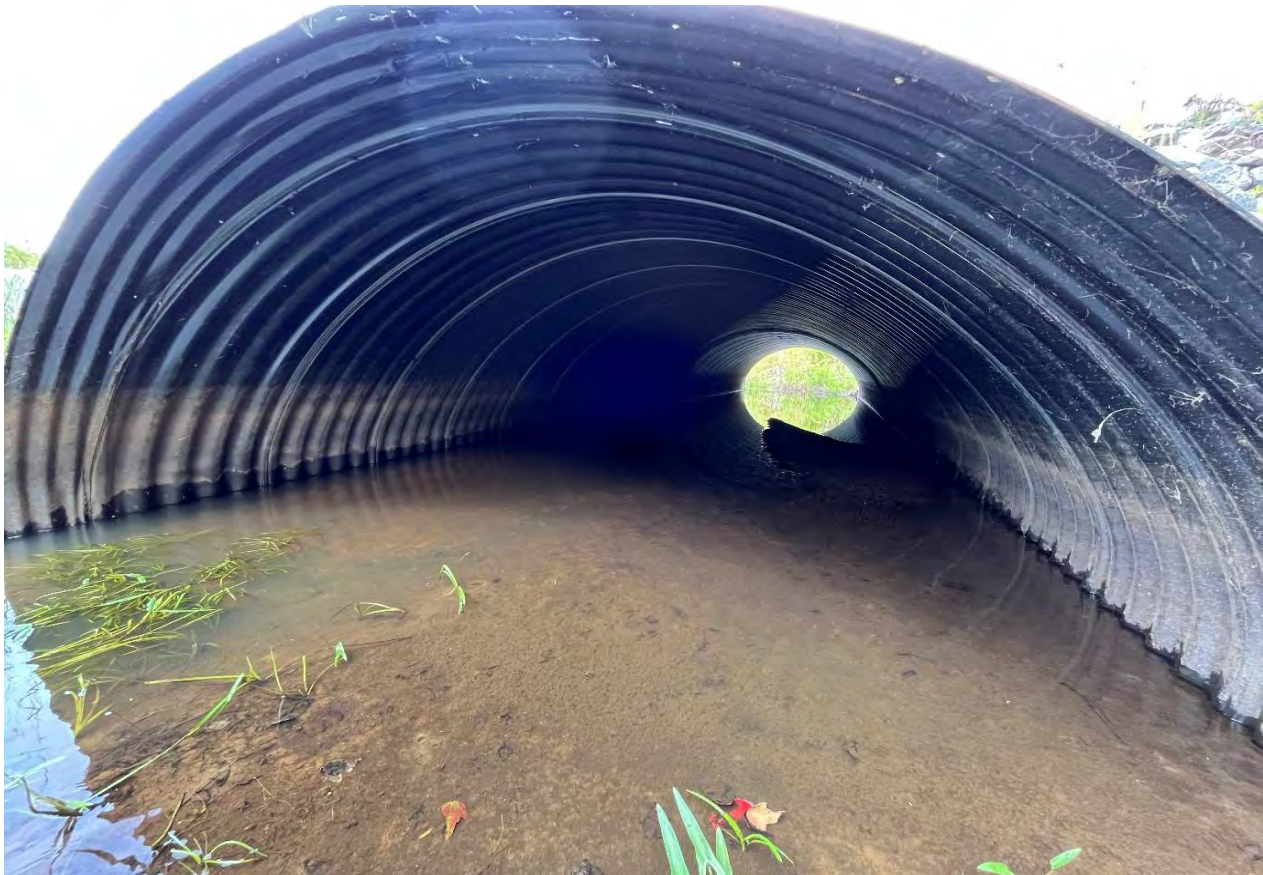
Description of Photo: Culvert barrel, typ.

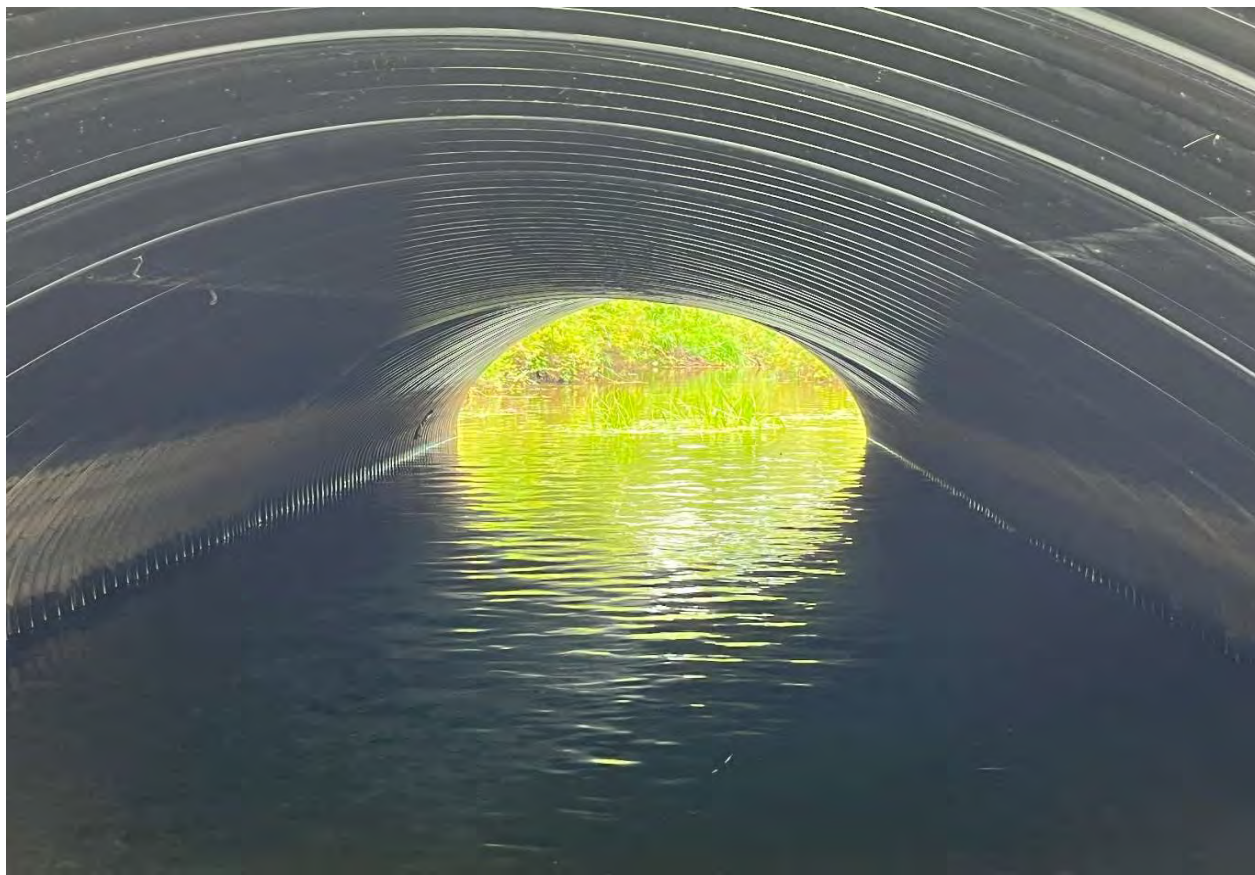
Comments: A 150 mm long hole noted on the north culvert east end, likely occurred during construction. The middle culvert is slightly sag at the mid span. Light deformation and light corrosion noted at culvert end. No other observed defects.

Description of Photo: Sag at mid area

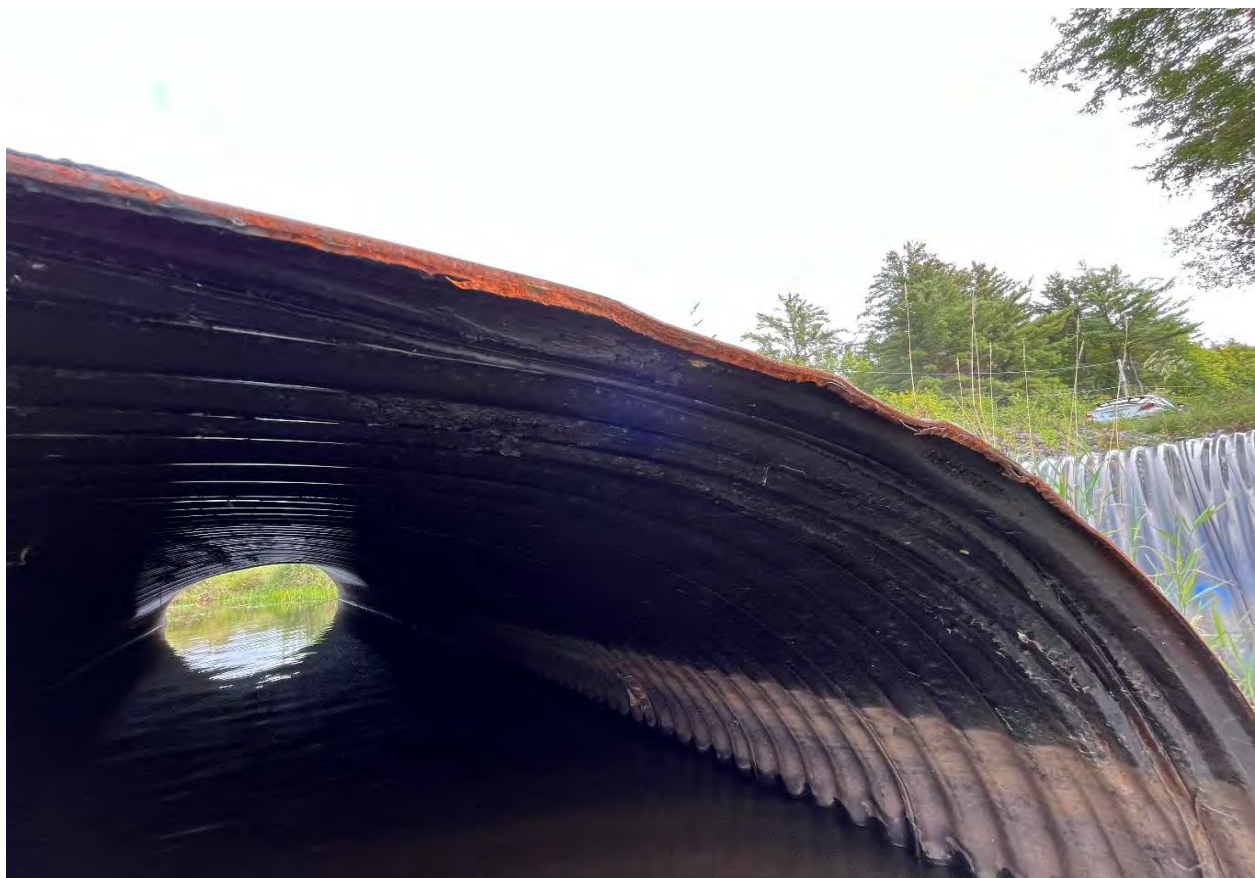
Description of Photo: Deformation at culvert barrel end

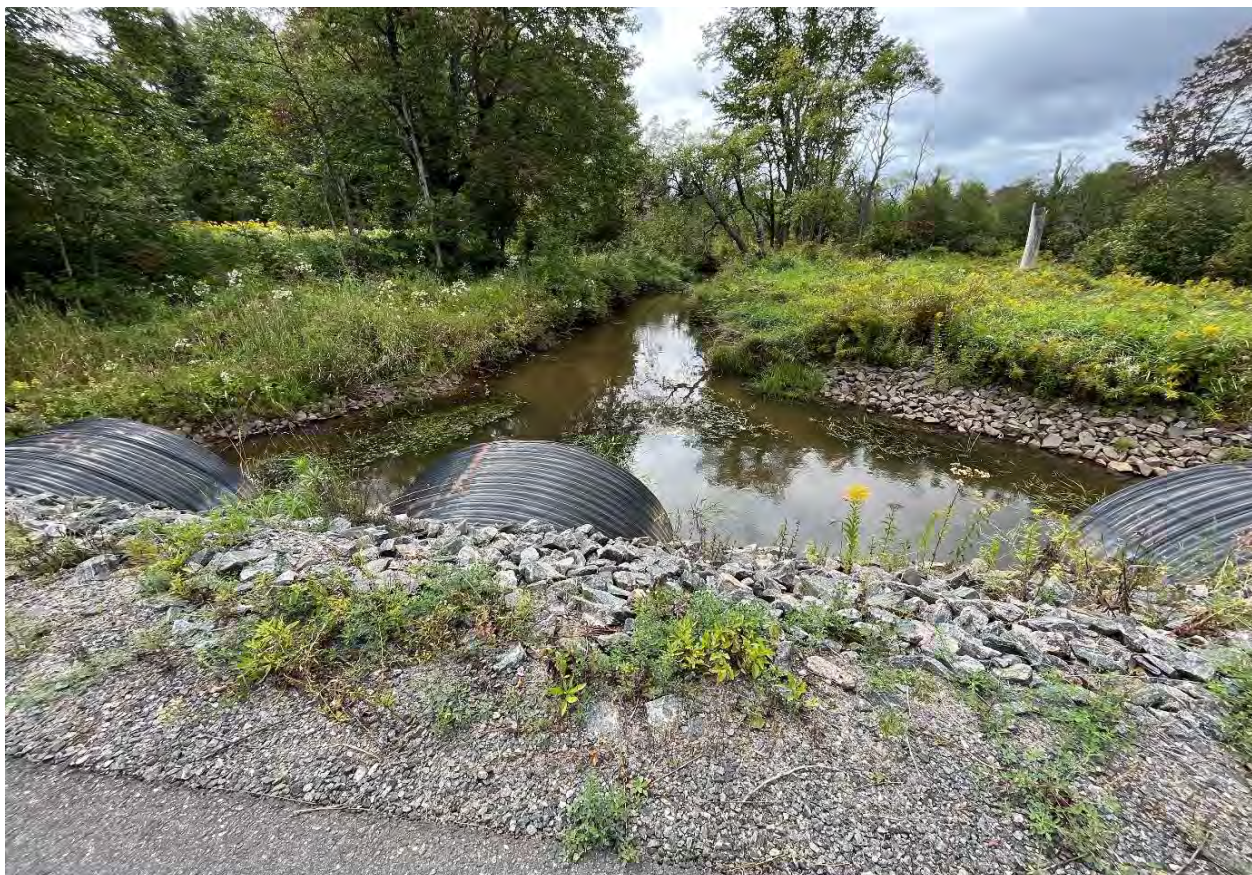
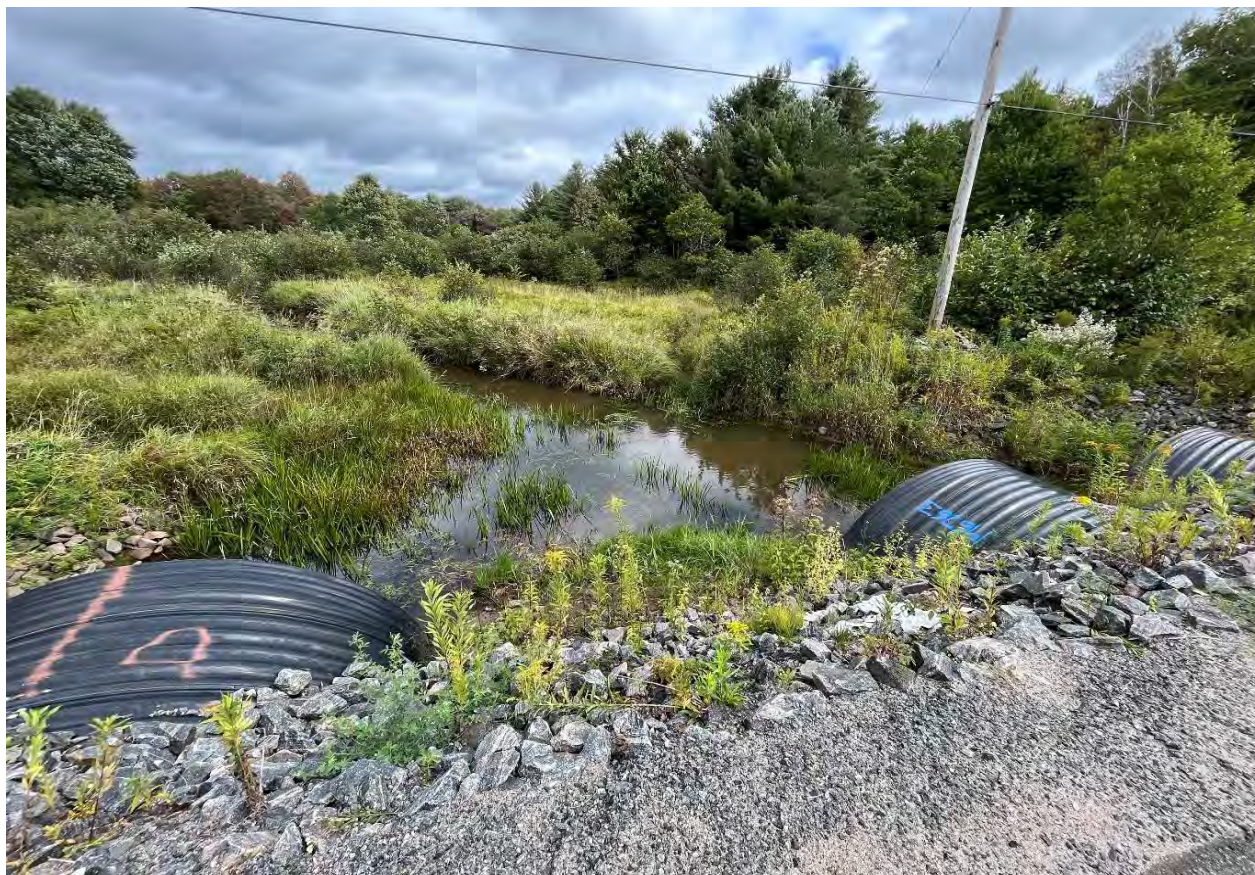
Comments: **No observed defects.**

Description of Photo: Watercourse

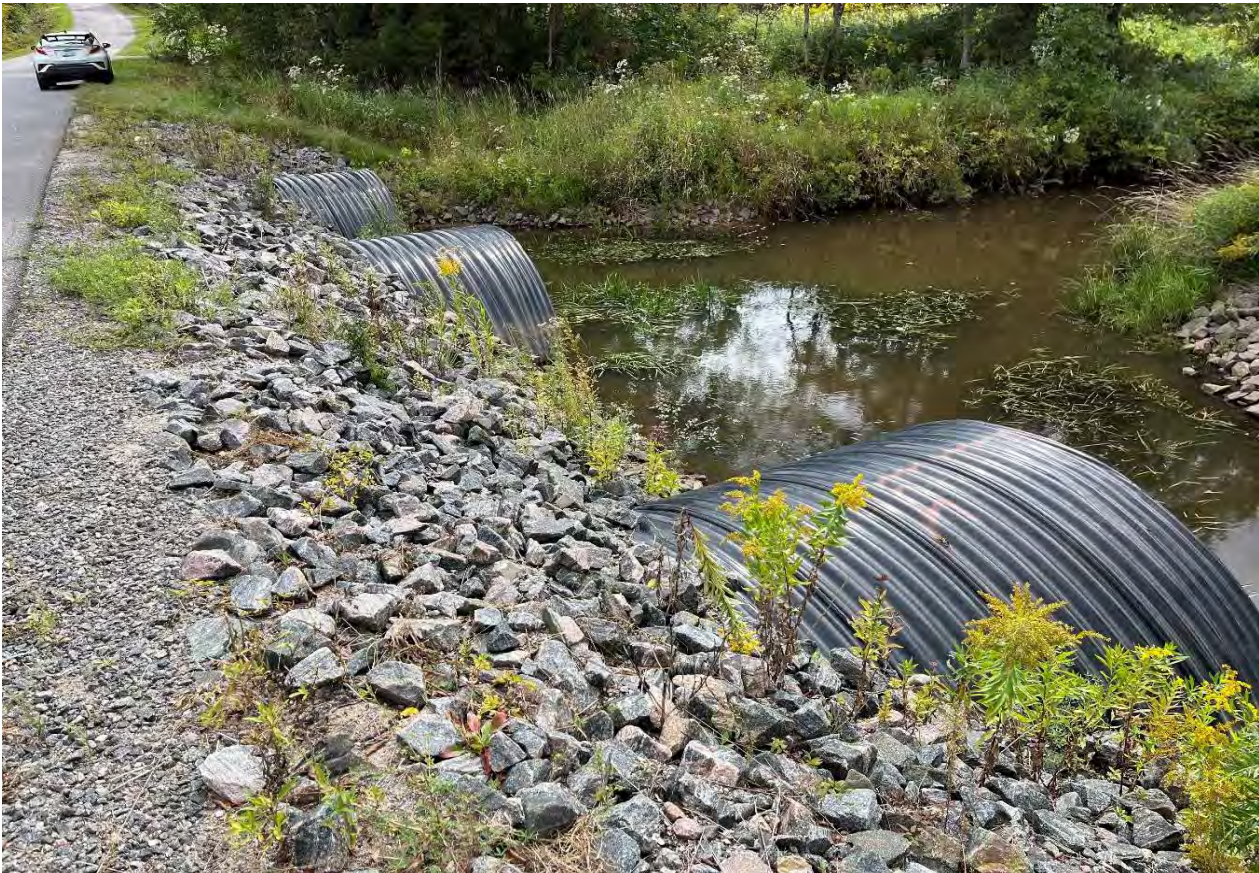
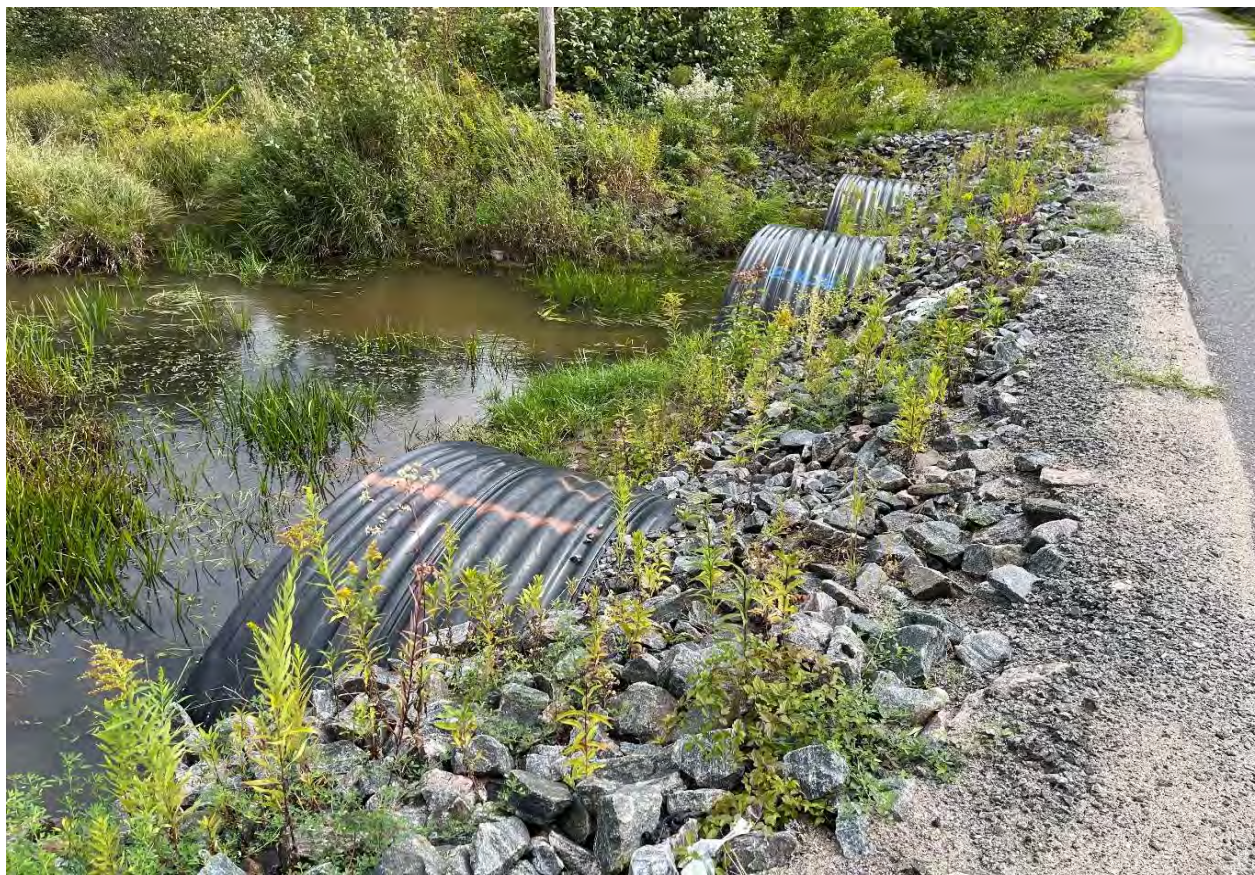
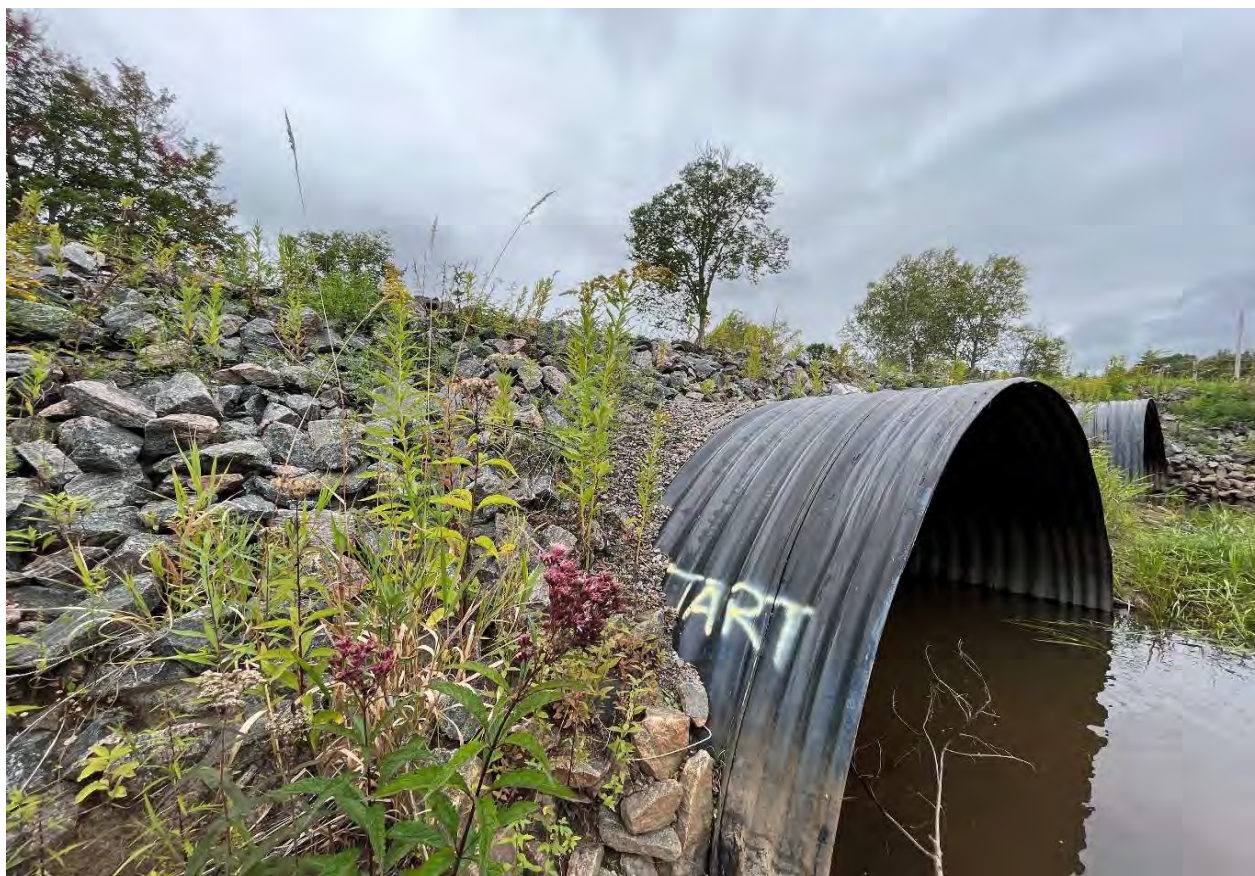
Comments: **No observed defects.**

**Description of Photo:** Embankment, typ.

Description of Photo: Embankment, typ.

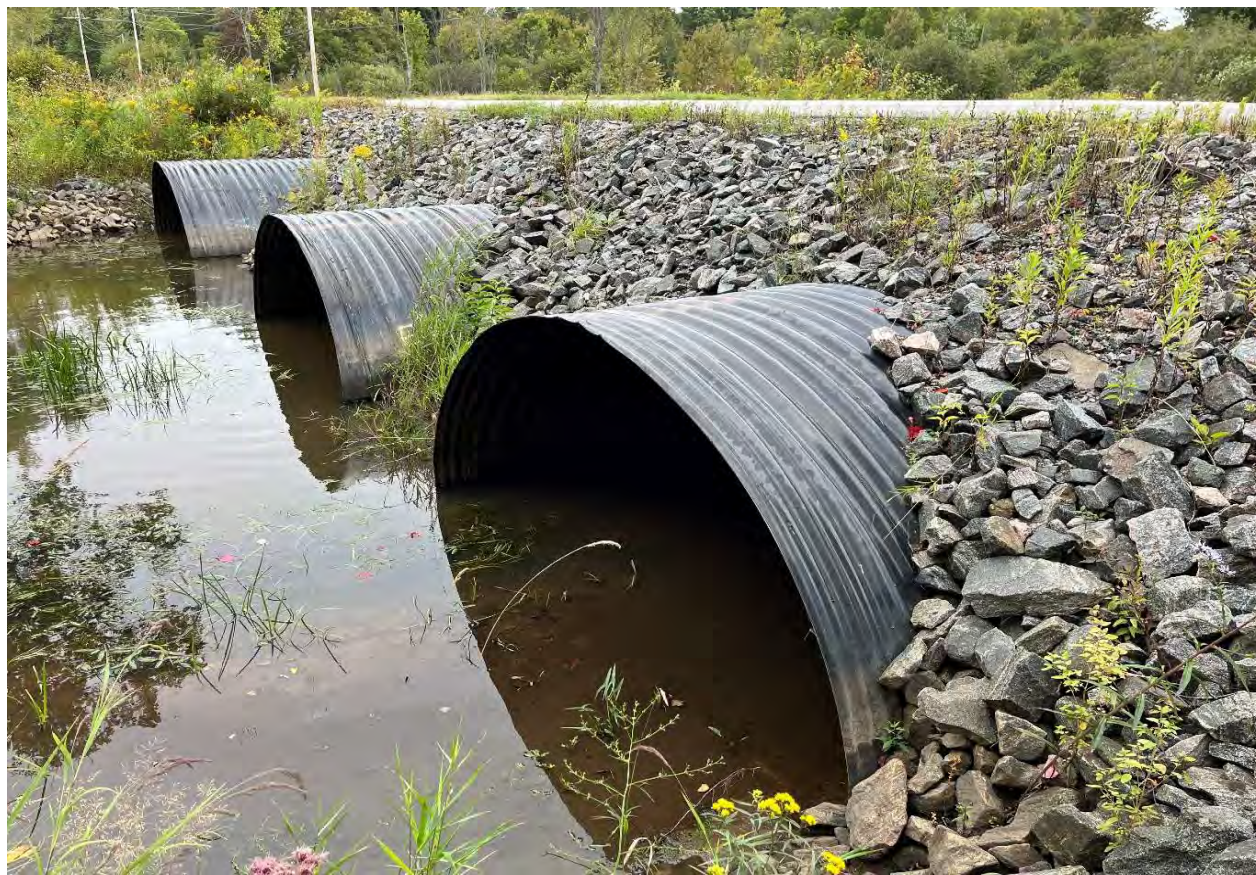
Description of Photo: Slope protection

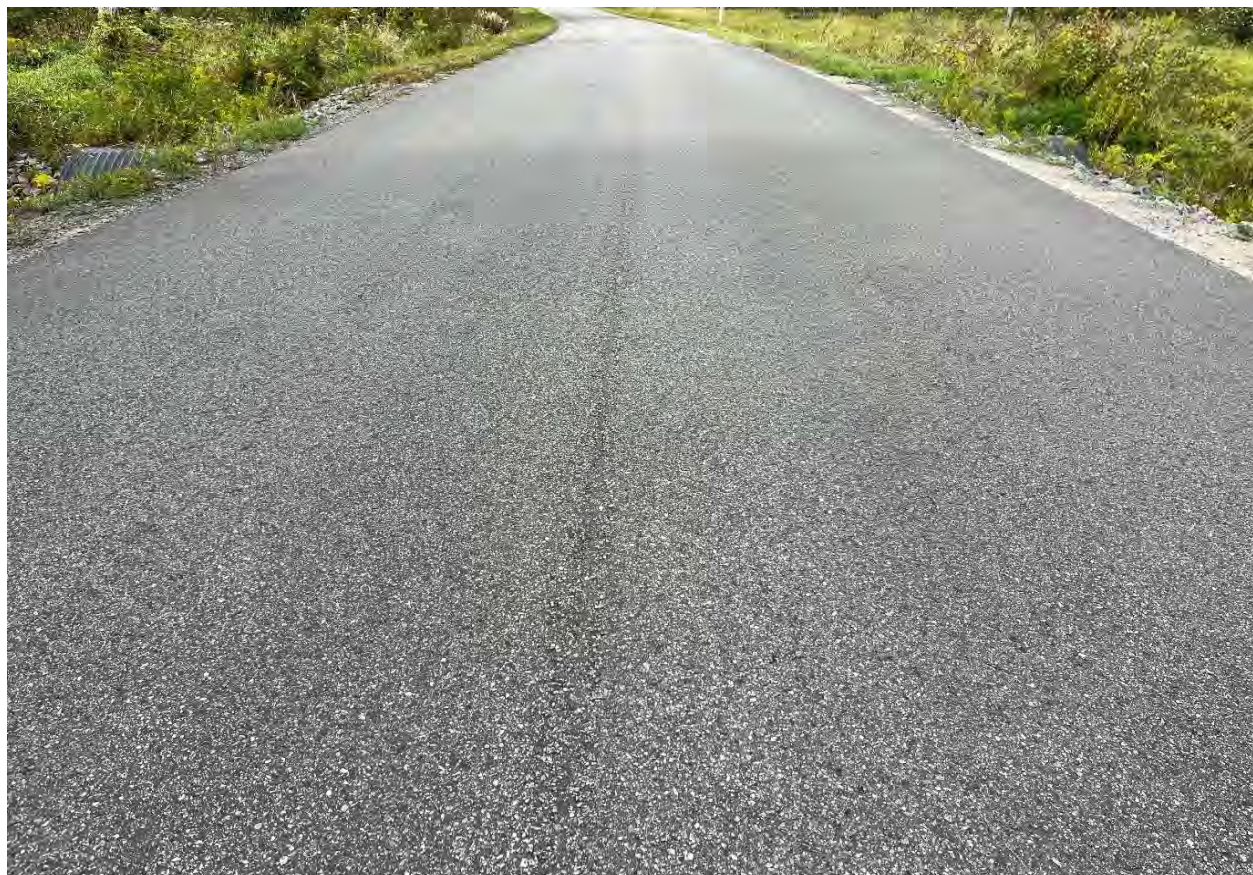
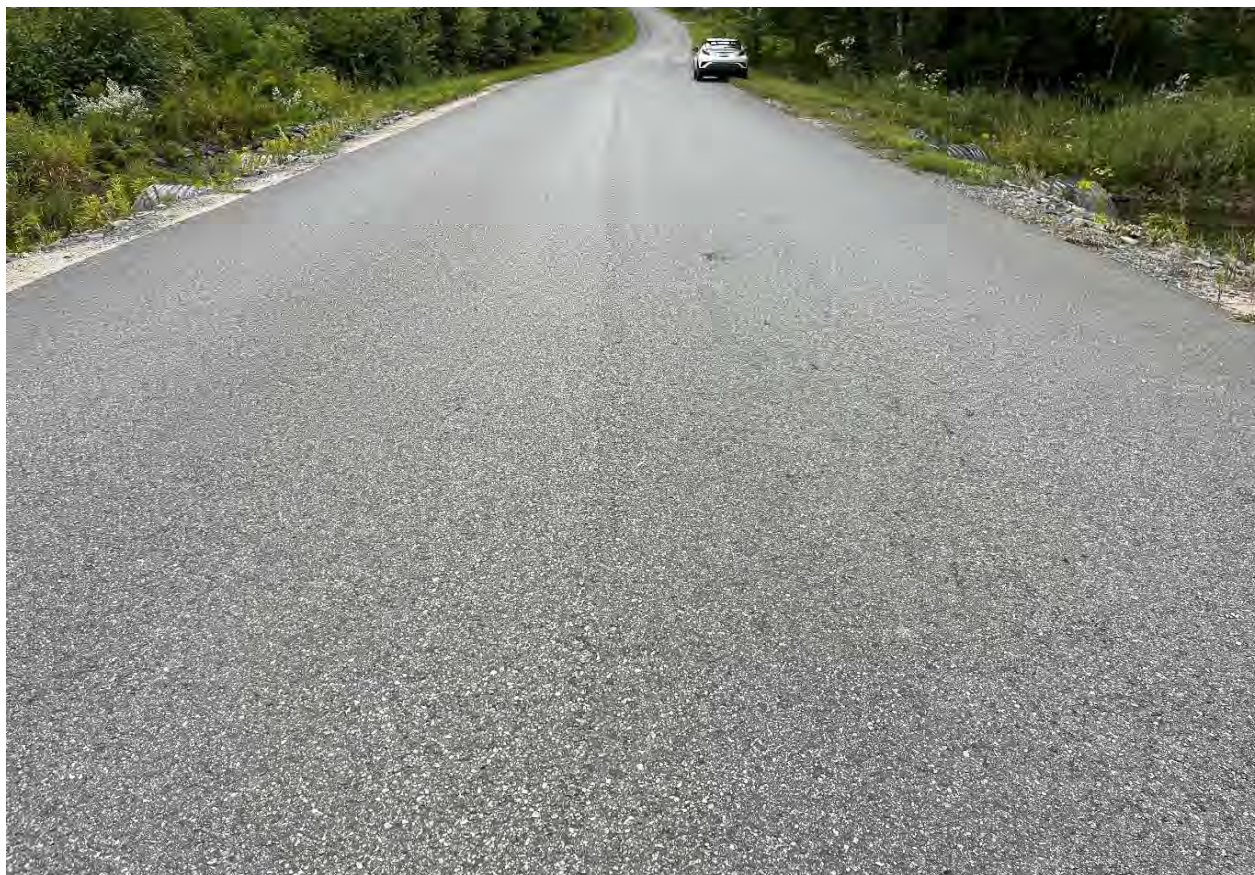
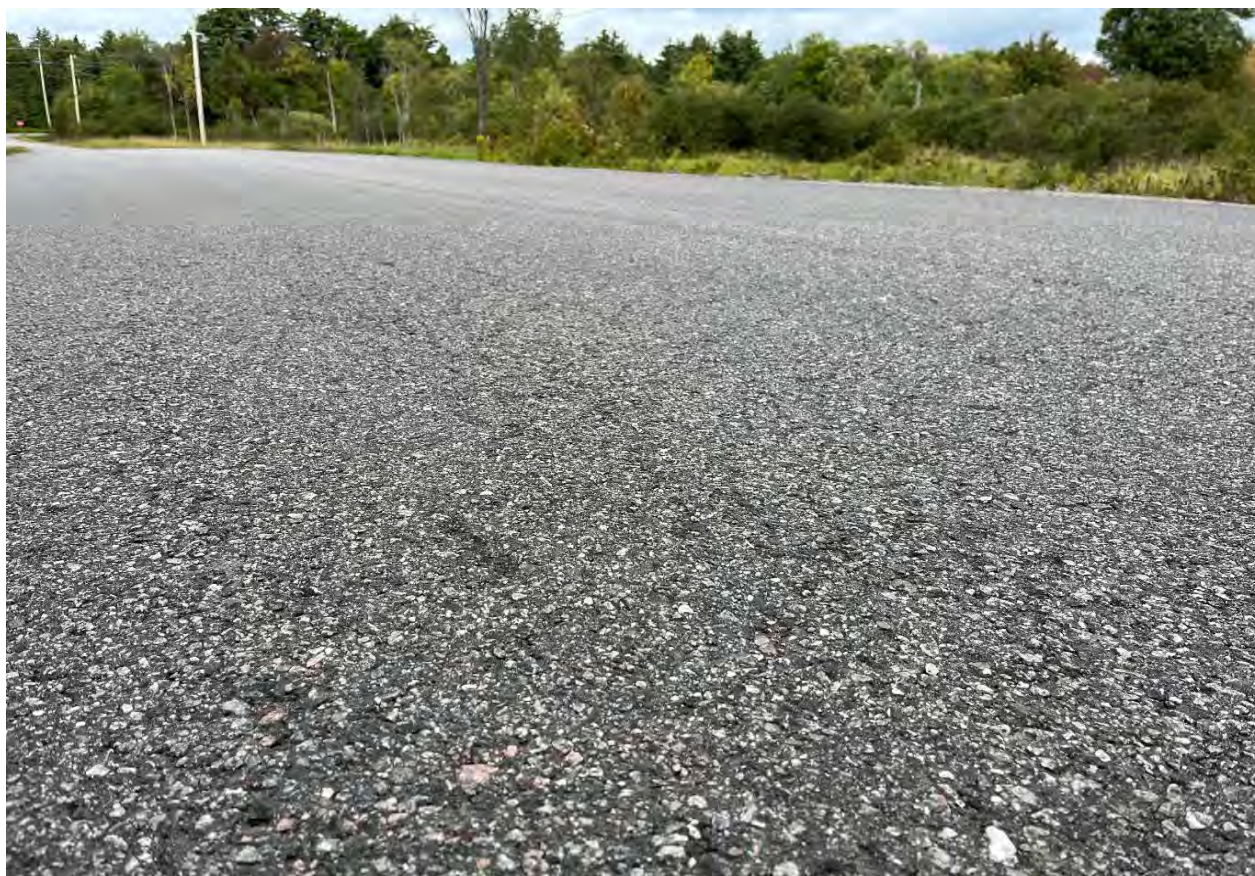
Comments: **No observed defects.**

**Description of Photo:** Approach wearing surface - looking north

Description of Photo: Approach wearing surface - looking south

Description of Photo: Approach wearing surface

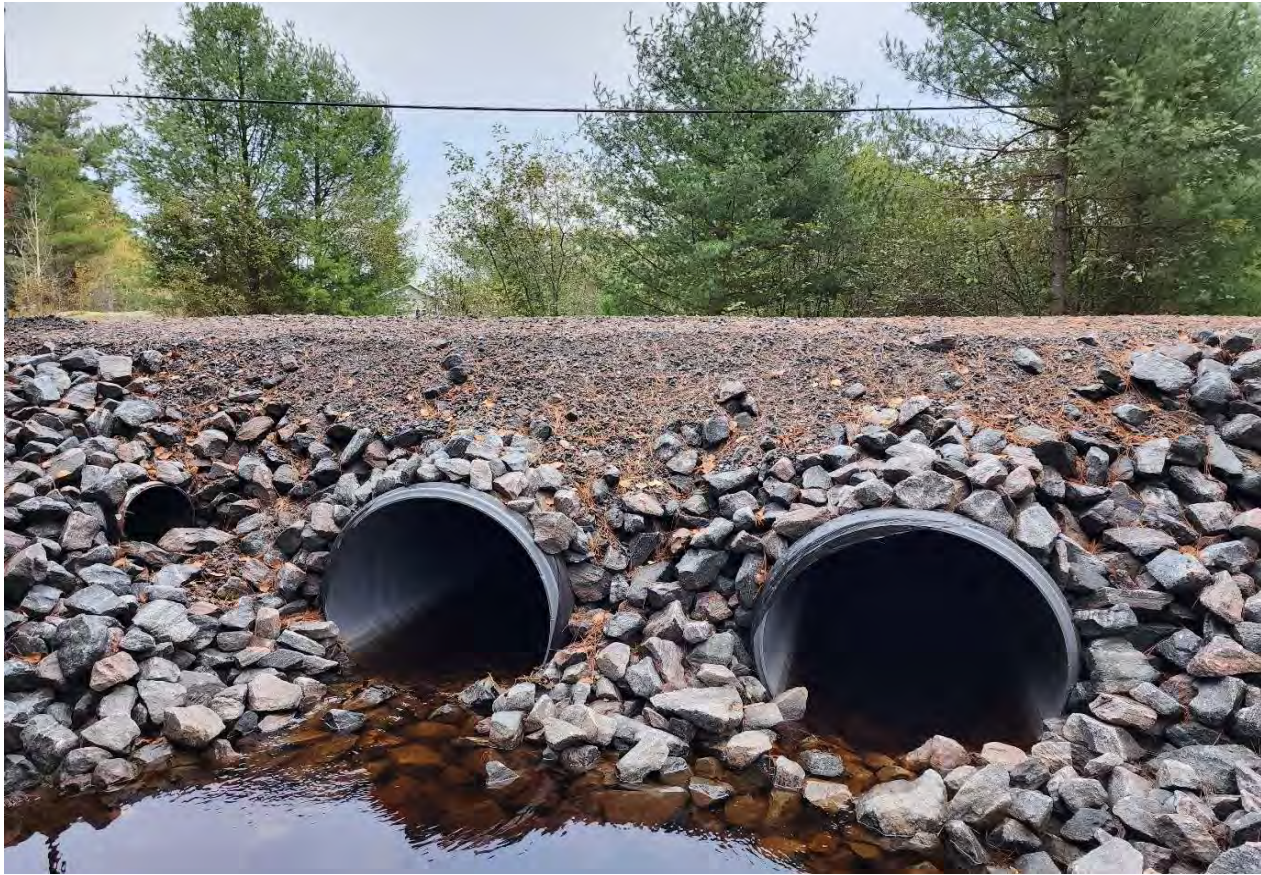
Description of Photo: Culvert barrel, typ.

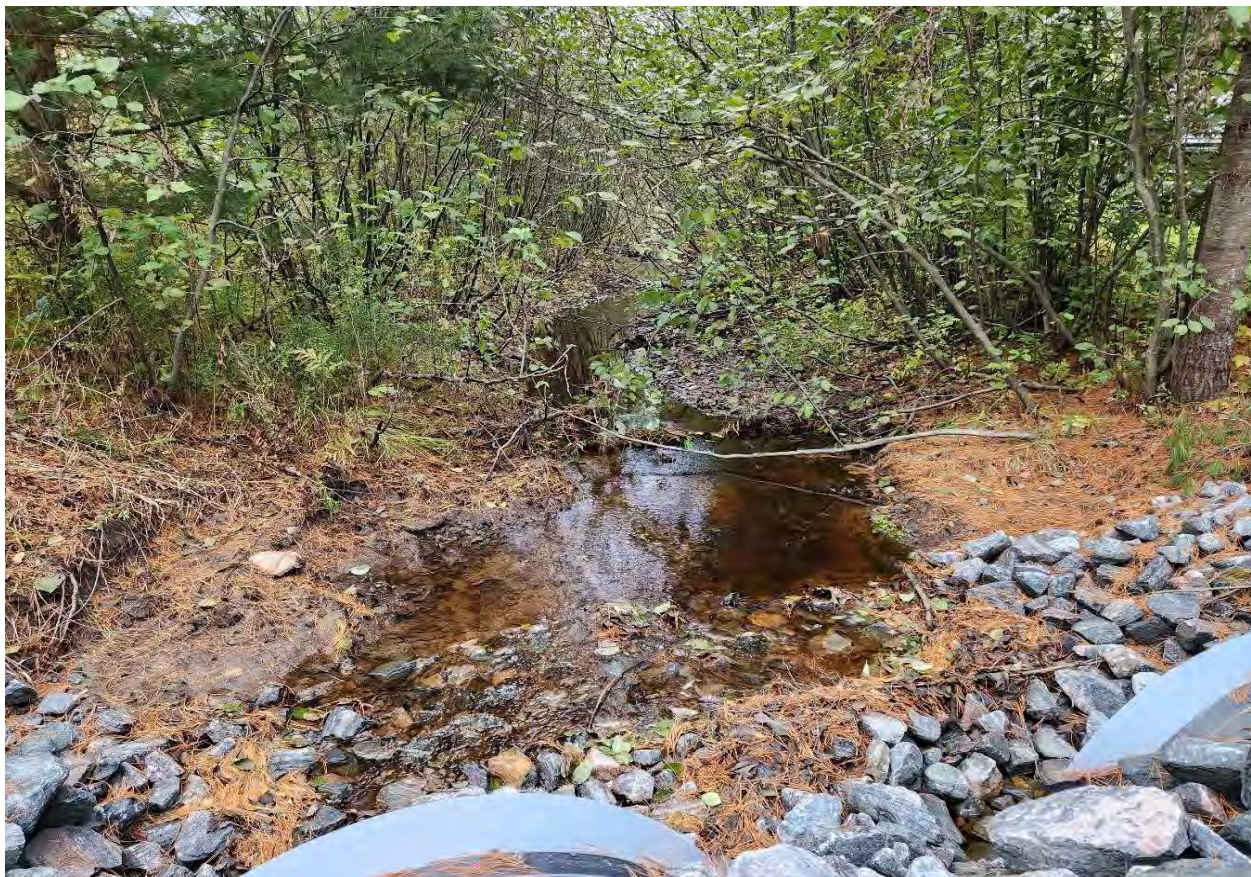
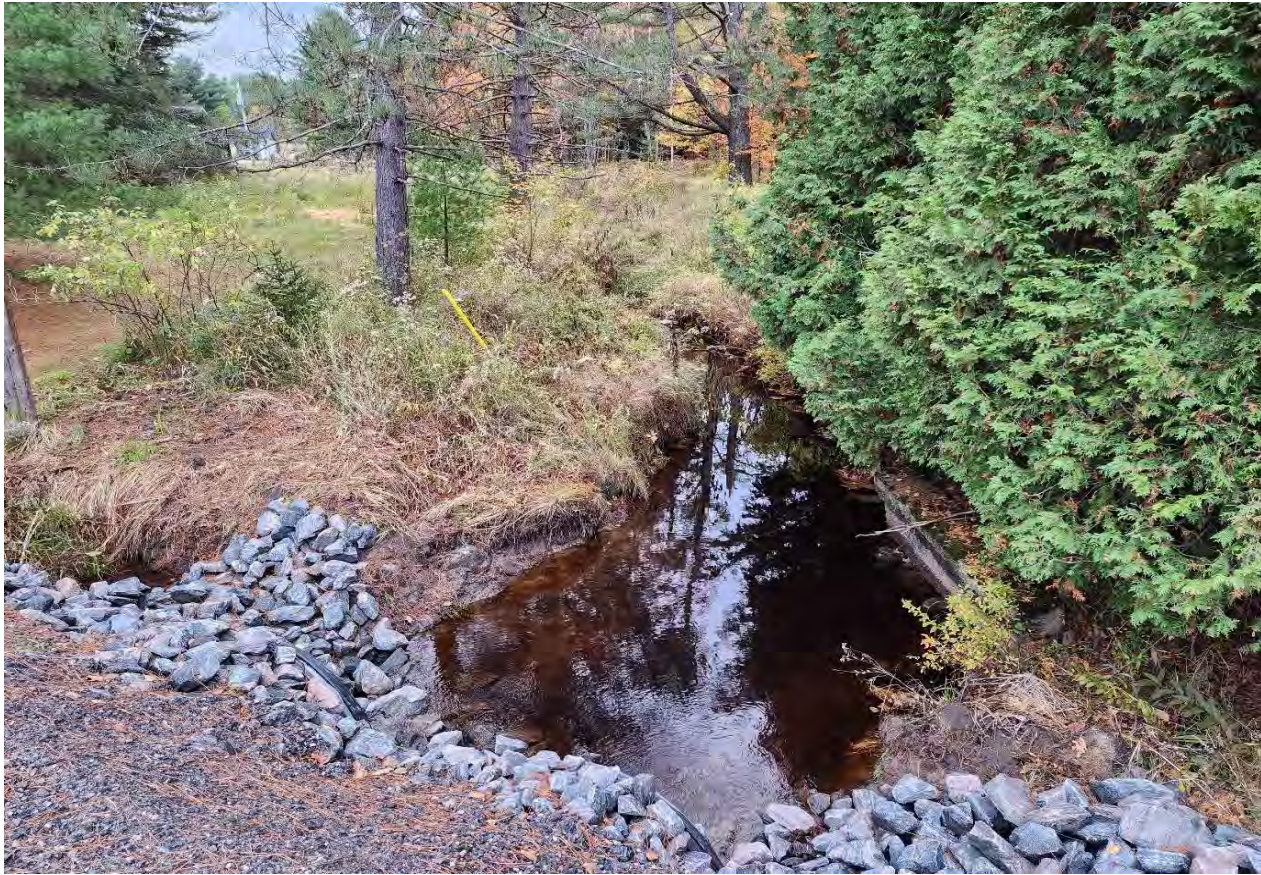
Comments: No observed defects.

Description of Photo: Watercourse
