Bridge Needs Study

INSPECTION SUMMARY REPORT

Town of Gravenhurst

August
29, 2024

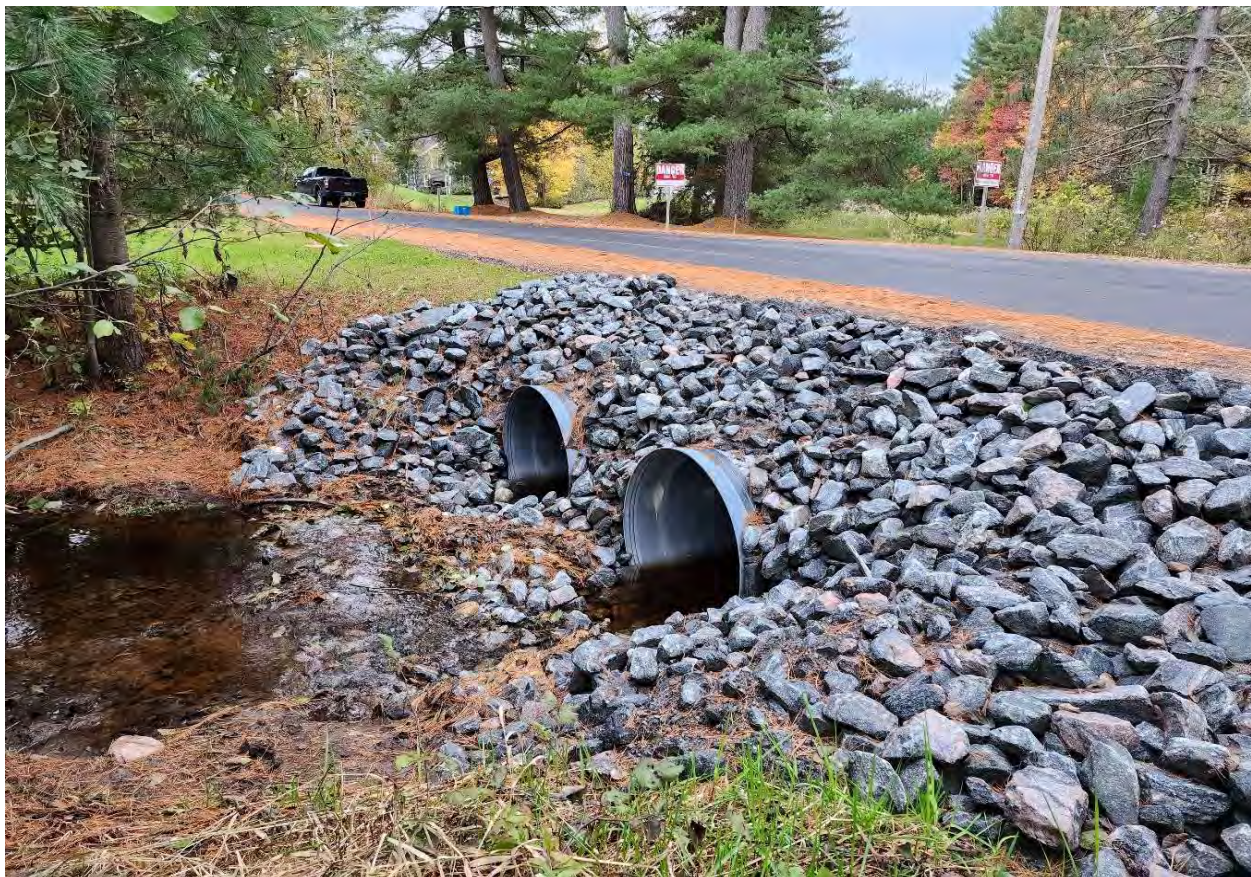
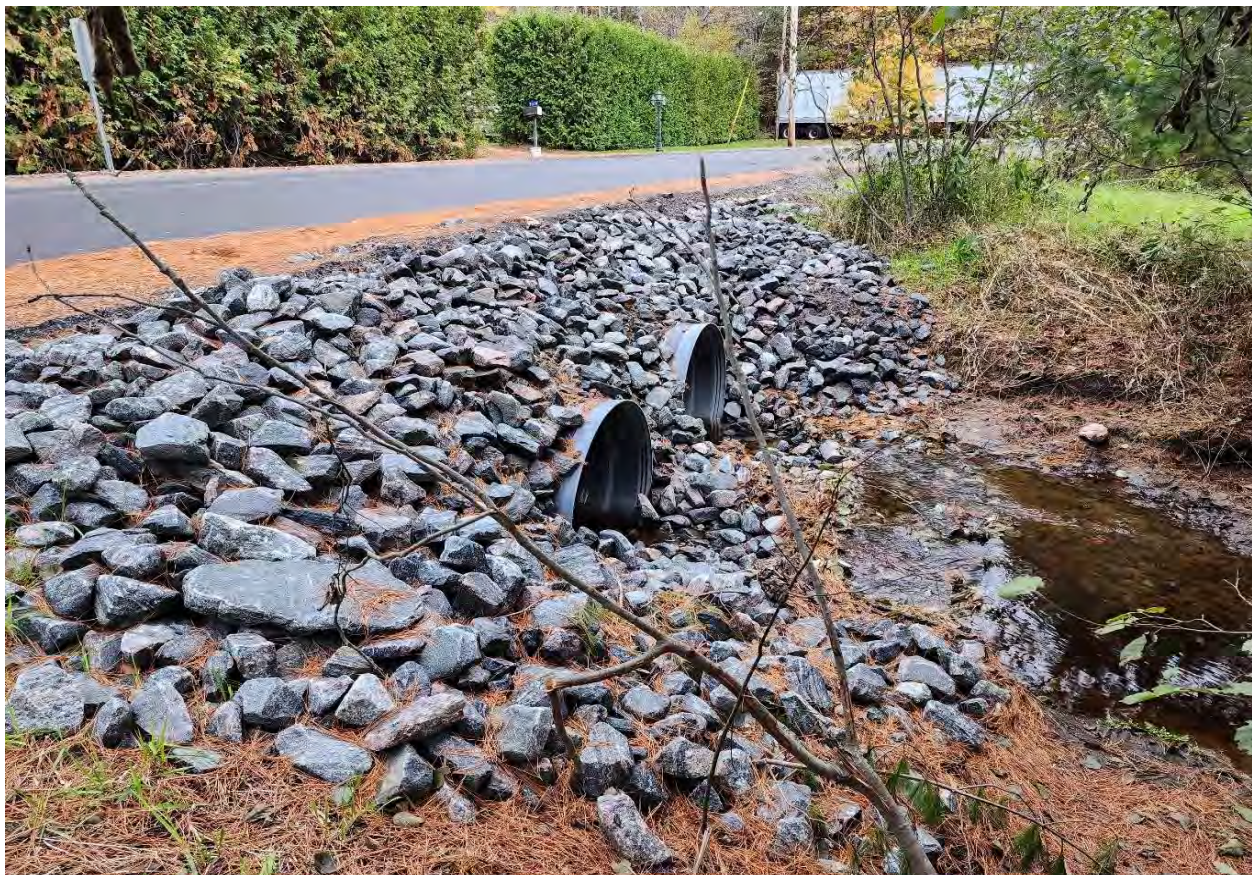
Comments: No observed defects.

Description of Photo: Embankment, typ.

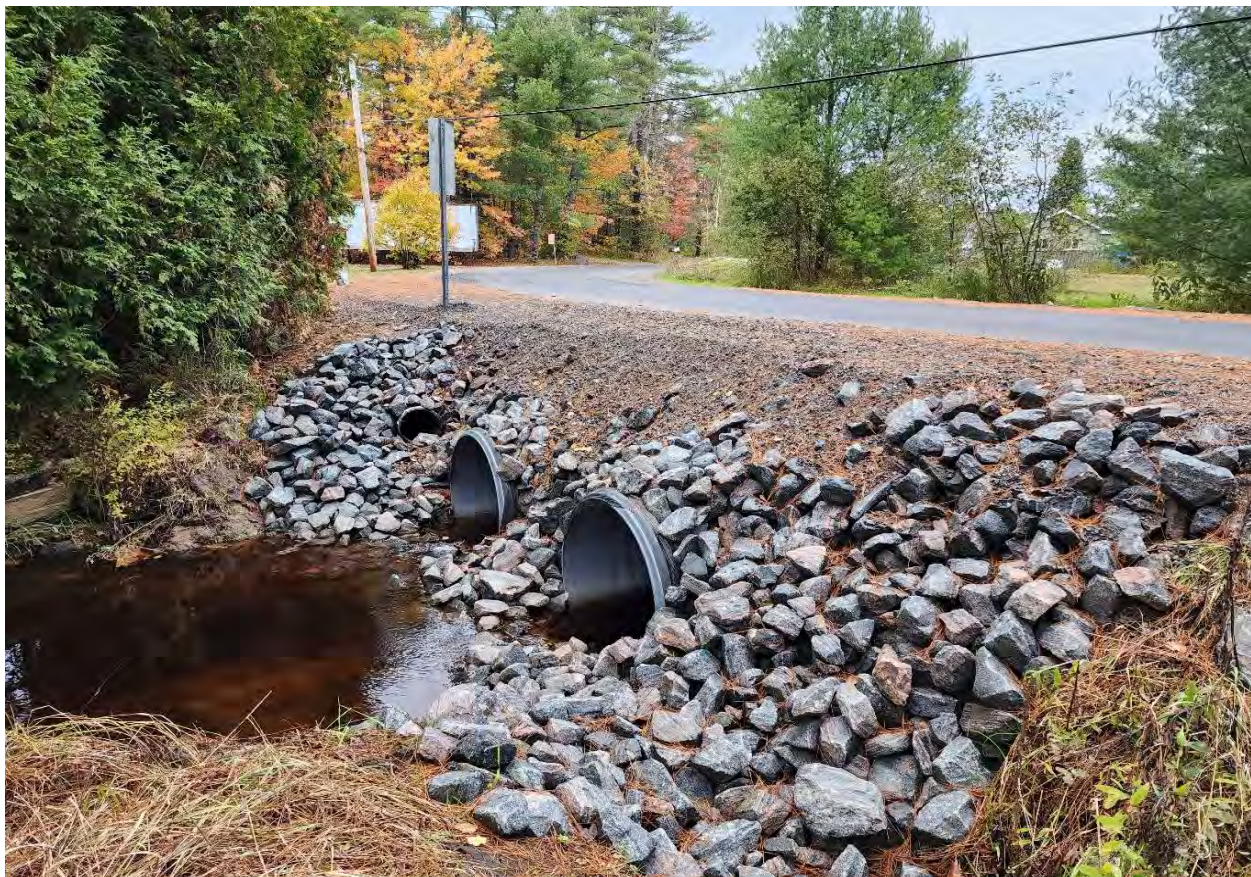
Comments: No observed defects.

Description of Photo: Slope protection, typ.

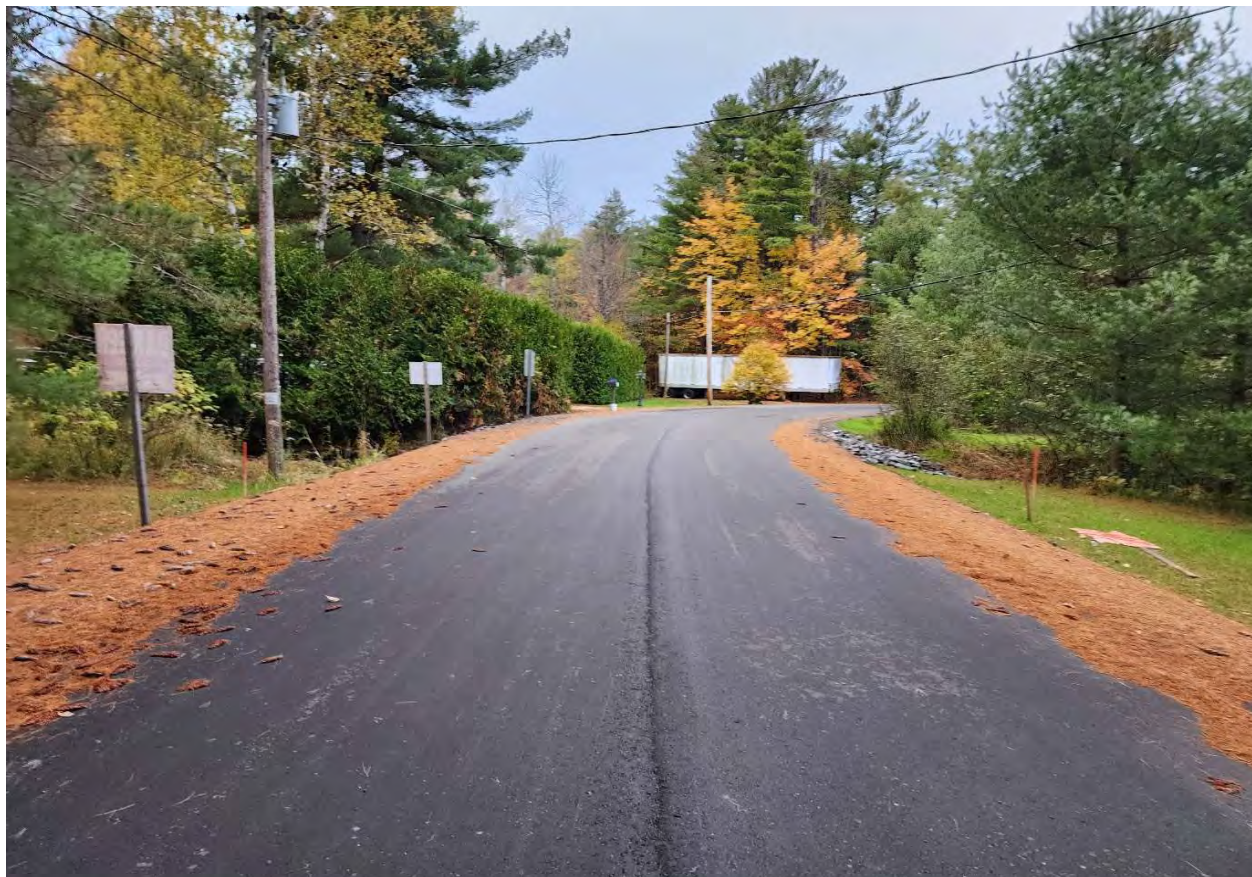
Comments: **No observed defects.**

Description of Photo: Approach wearing surface - looking north

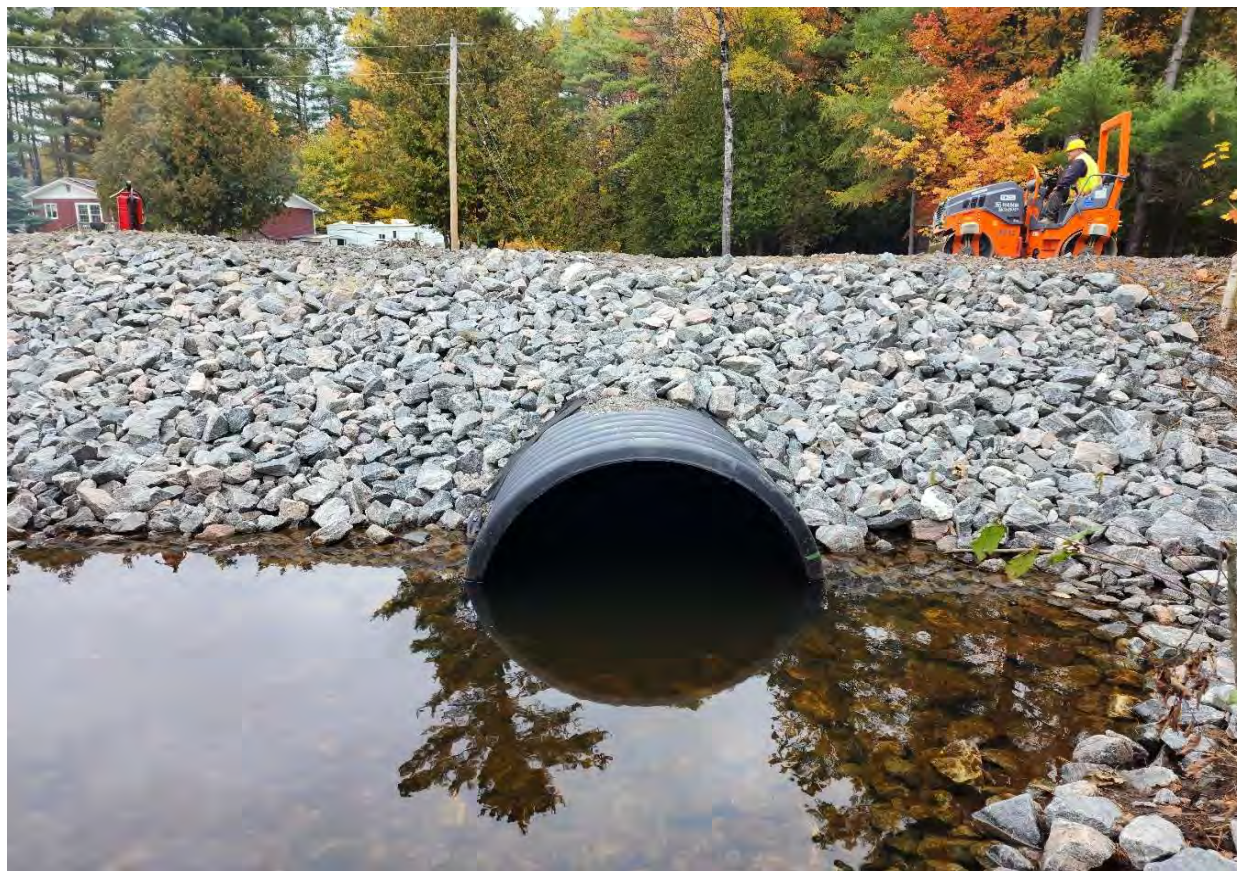
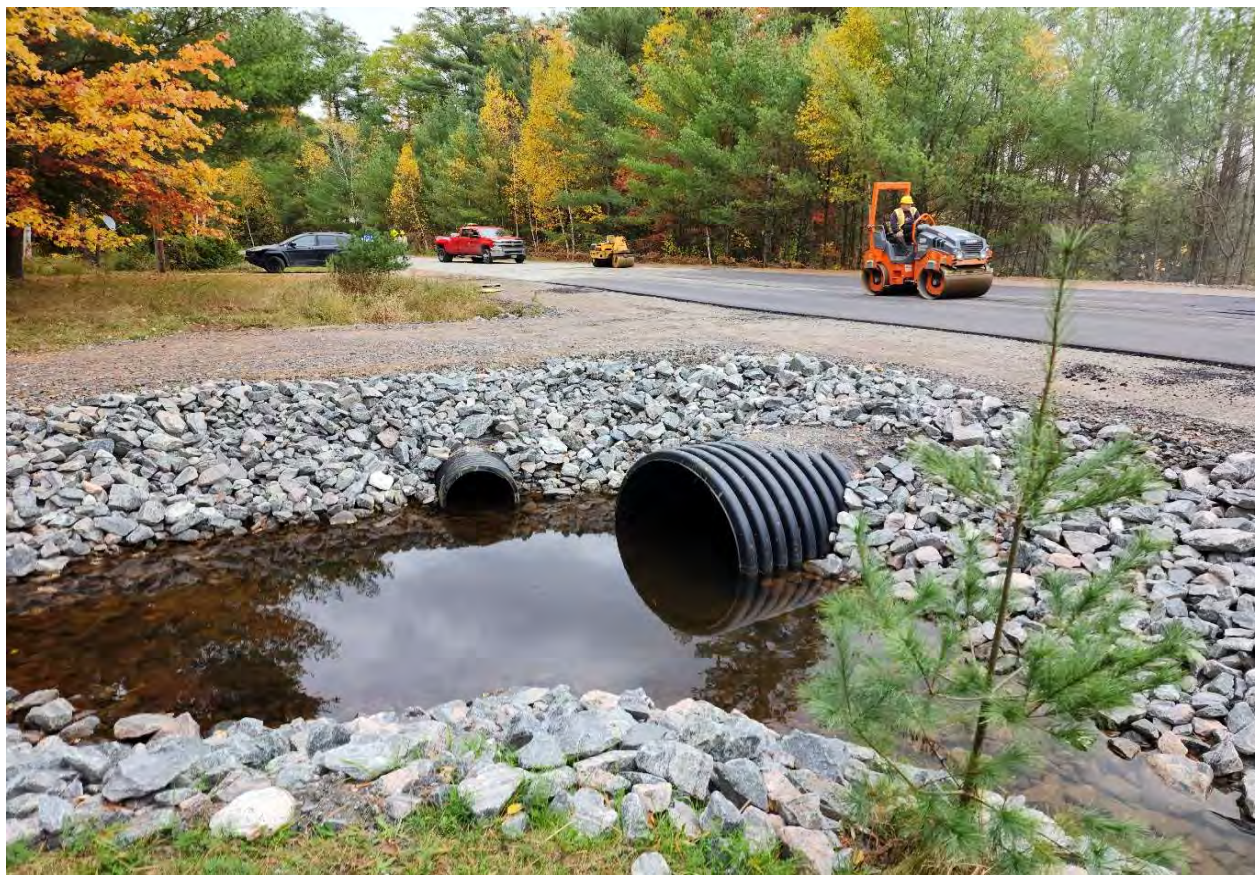
Comments: **No observed defects.**

Description of Photo: Culvert barrel, typ.

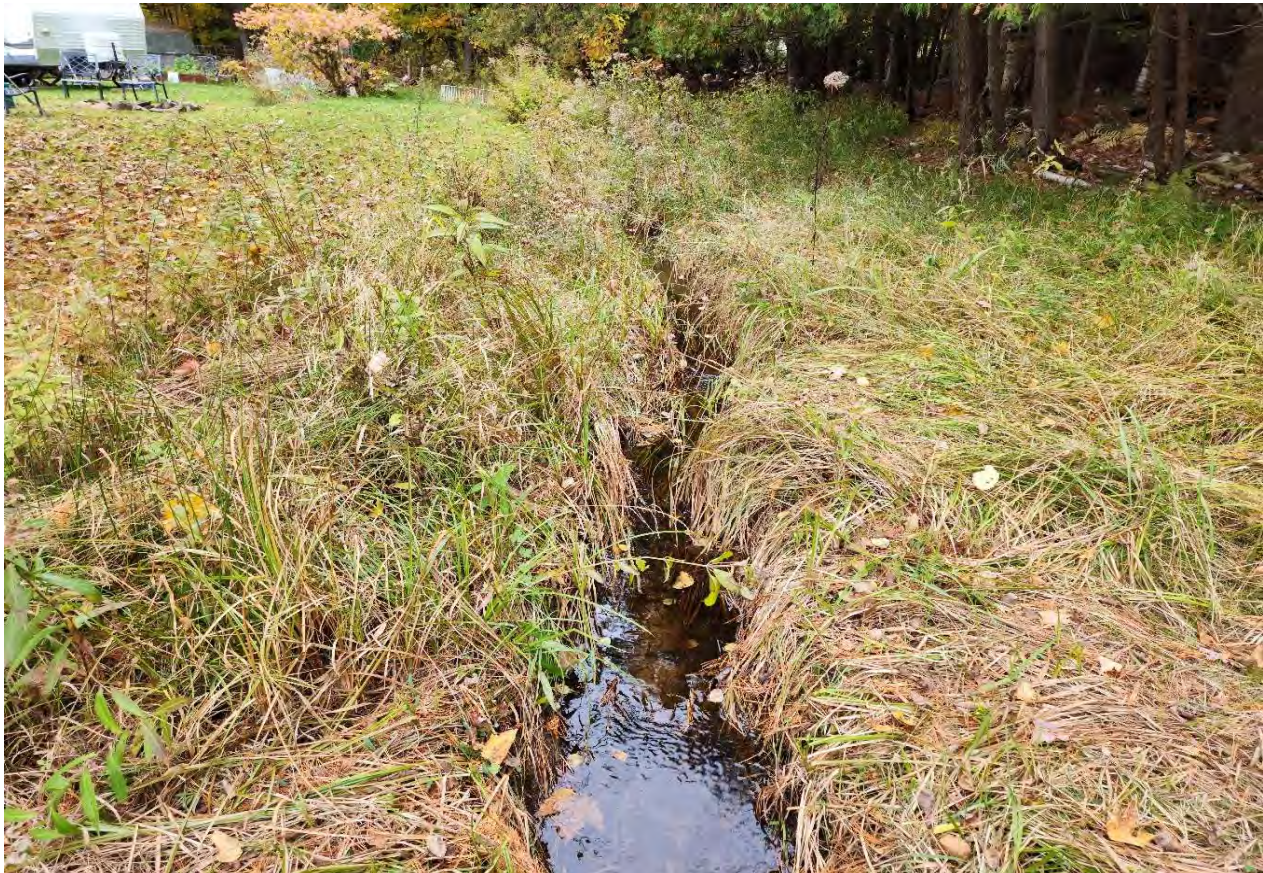
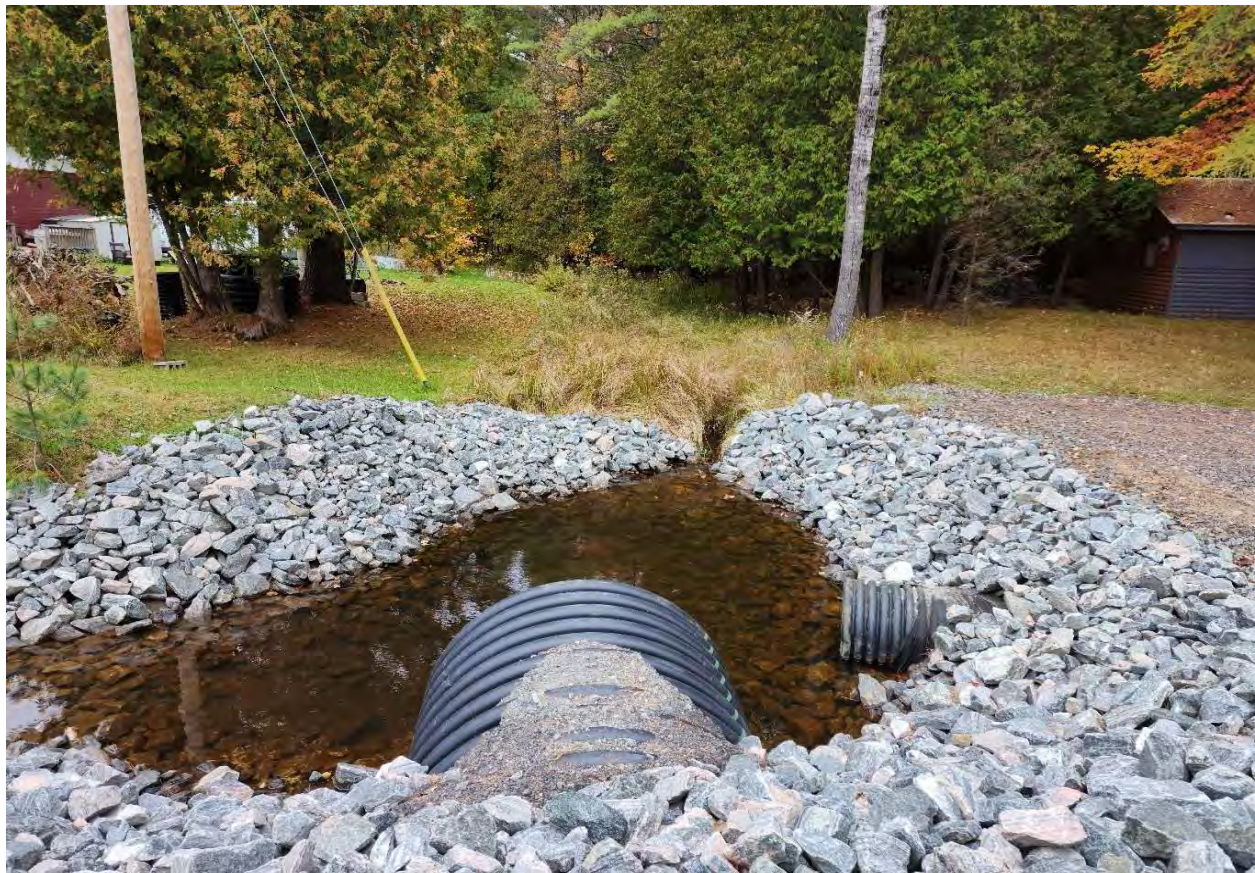
Description of Photo:
 Watercourse

Description of Photo: Watercourse

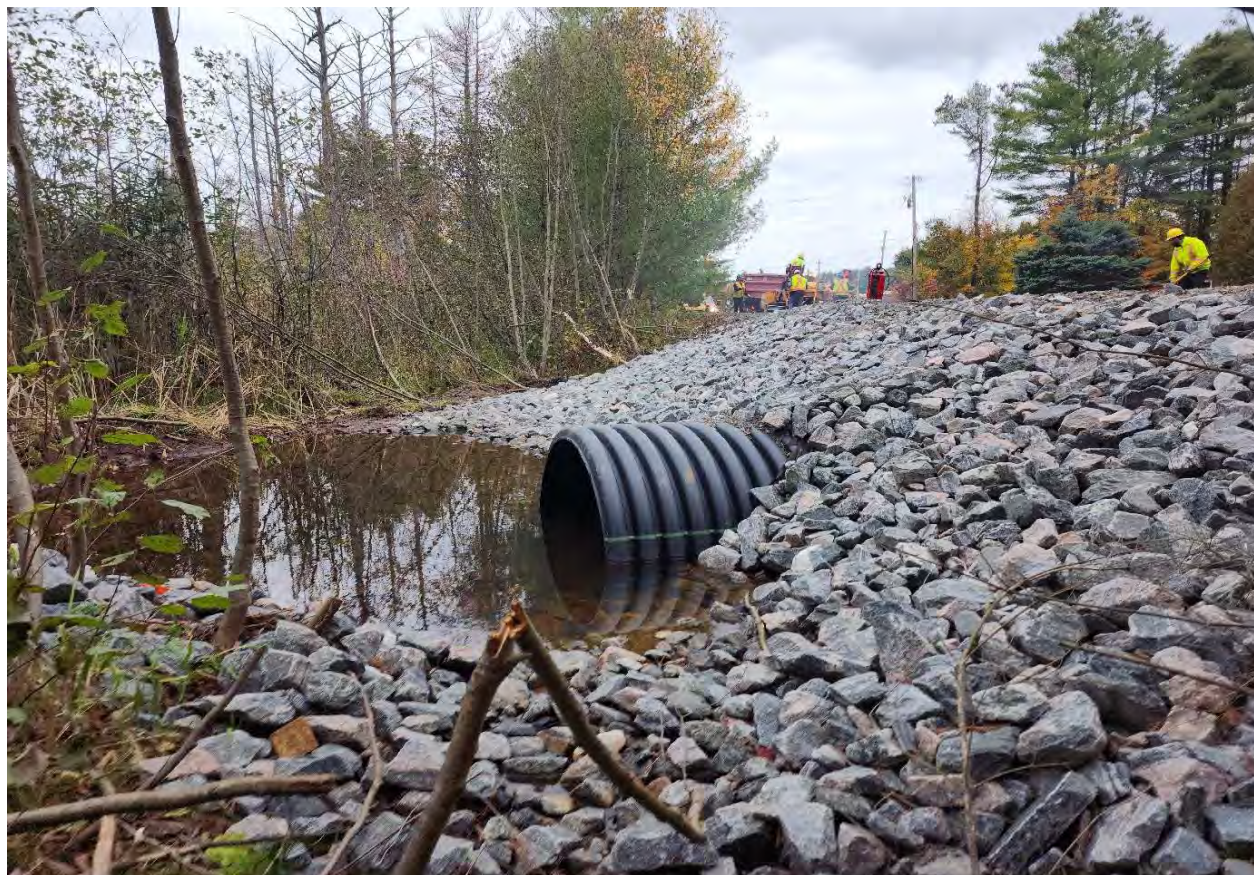
Description of Photo: Embankment, typ.

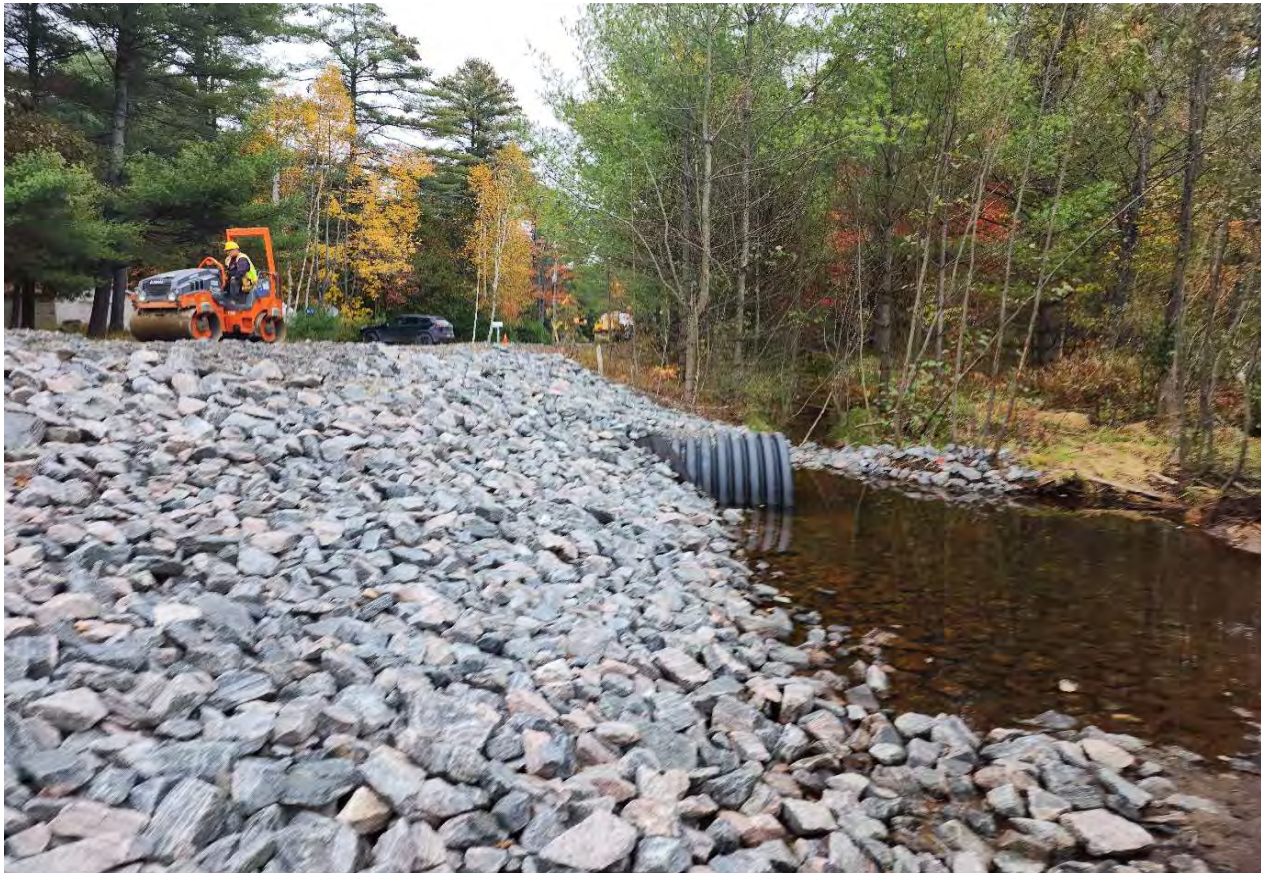
Description of Photo: Slope protection, typ.

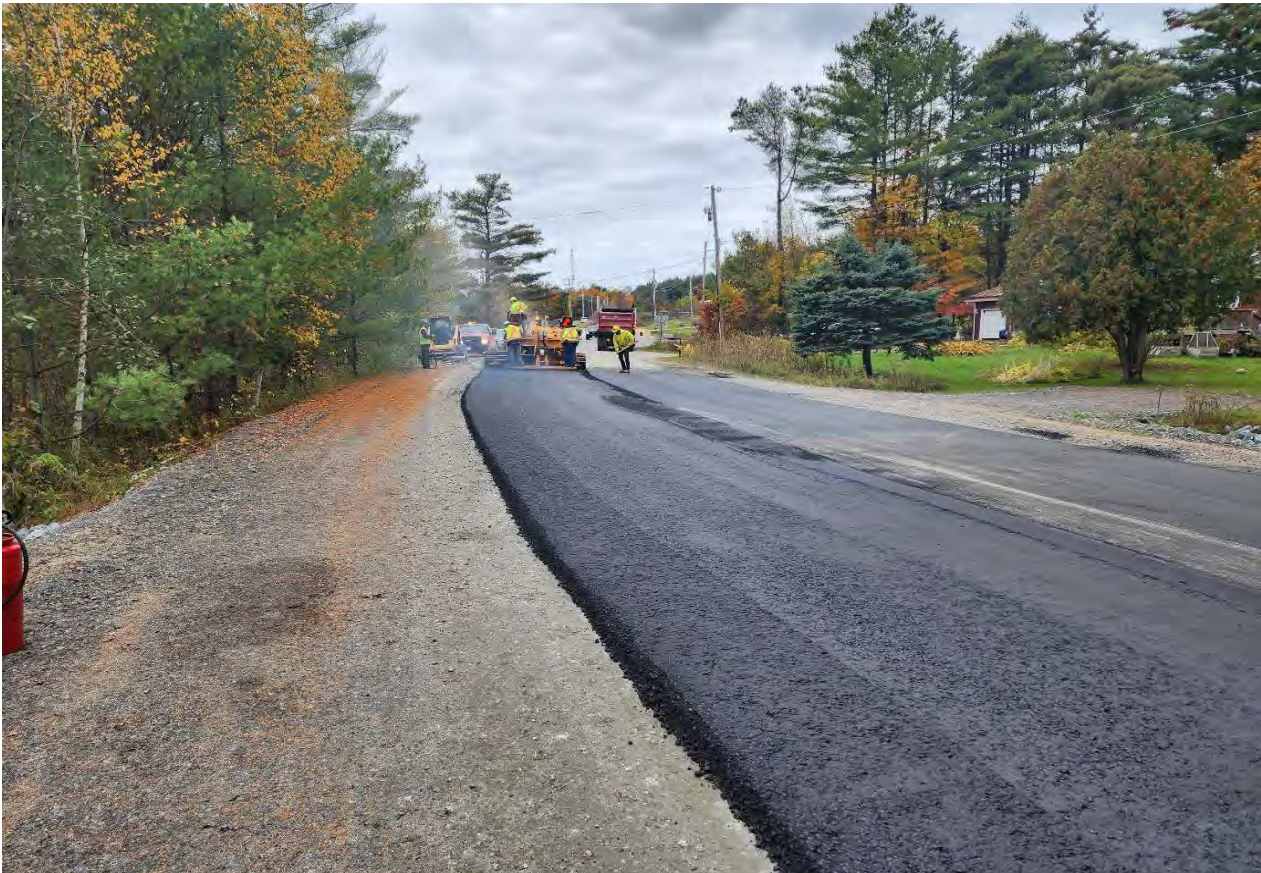
**Description of Photo:** Approach wearing surface, typ.
